# Eel Point Road Restoration and Resilience

An interactive Qualifying Project submitted to the Faculty of  
WORCESTER POLYTECHNIC INSTITUTE  
in partial fulfillment of the requirements for the  
Degree of Bachelor of Science

*December 15, 2023*

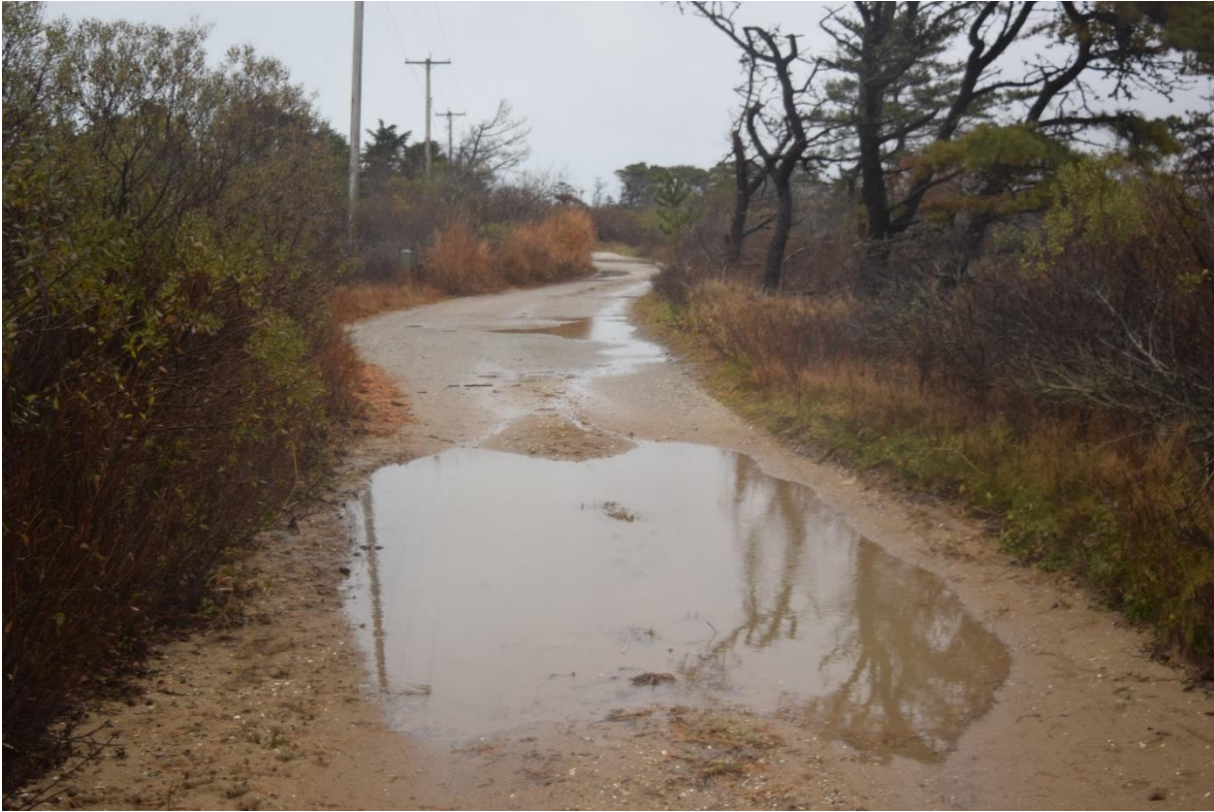
*Picture of Eel Point Road after rainfall.*

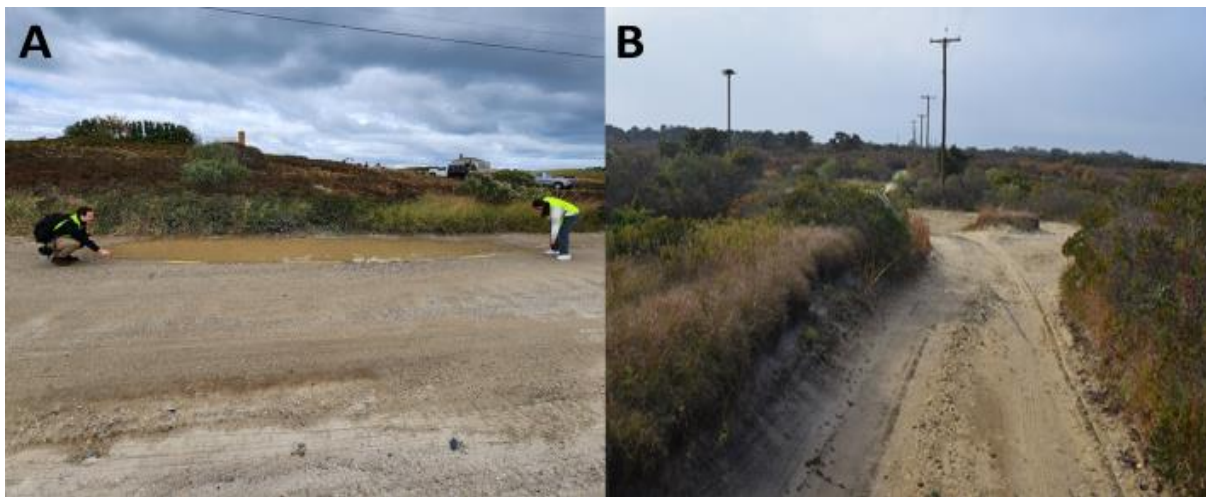
**Figure 3.** Images of flooding and erosion on Eel Point Road.

**A.** A depression on EPR flooded with water.

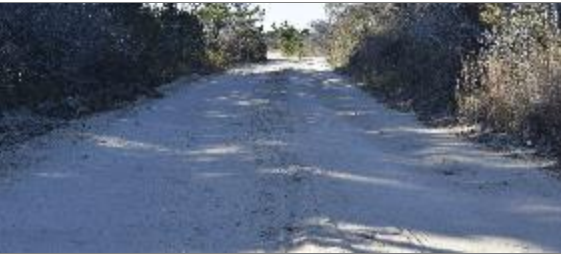
| Distress Type <sup>13</sup> | Description | Photograph |
|---|--|--|
| <b>Improper cross section</b> | The W-shape of the road prevents water from flowing off the road surface. The slope of the road surface is insufficient to carry water off the road. | |

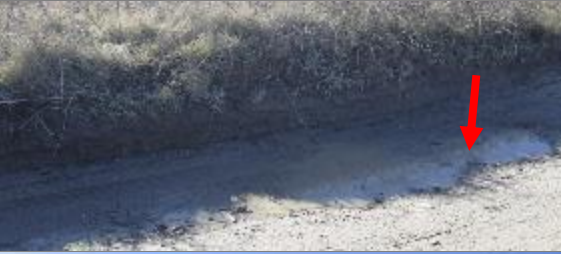
| Distress Type <sup>13</sup> | Description | Photograph |
|---|--|--|
| <b>Inadequate roadside drainage</b> | Water is prevented from moving off the road surface due to a lack of drainage and entrenching of the road into the surrounding land. | |

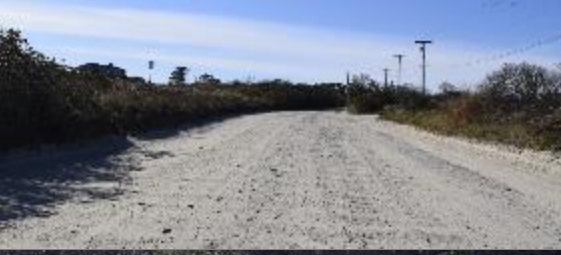
| Distress Type <sup>13</sup> | Description | Photograph |
|---|--|--|
| <b>Corrugation</b> | Ripples have formed in the road surface due to damage from heavy vehicles and high-speed vehicle traffic (S. Engelbourg, personal communication). | |

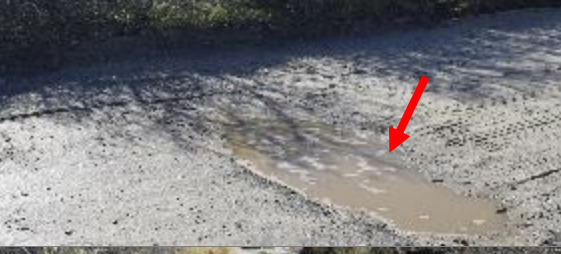
| Distress Type <sup>13</sup> | Description | Photograph |
|---|--|--|
| <b>Potholes</b> | Large, water-retaining potholes have formed in areas of soft surface material. Traffic and water inundation contribute to the growth of potholes along the road. | |

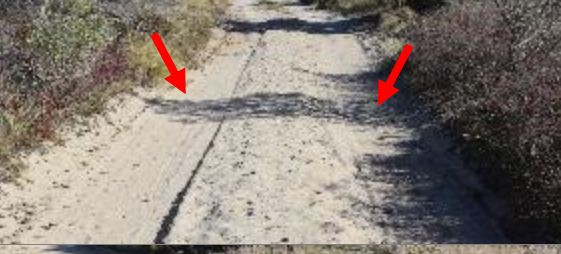
| Distress Type <sup>13</sup> | Description | Photograph |
|---|--|--|
| <b>Rutting</b> | Vehicle traffic has caused rutting in areas of the road surface where surface materials are soft and easily erodible. | |

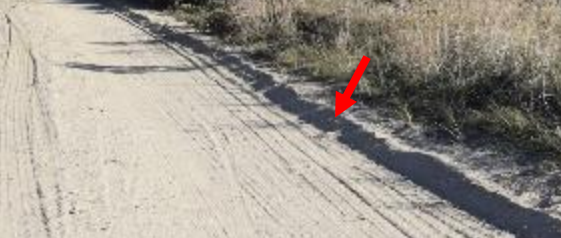
| Distress Type <sup>13</sup> | Description | Photograph |
|---|--|--|
| <b>Loose aggregate</b> | Loose road surface materials have been pushed onto the road shoulder from vehicle traffic and erosion. | |

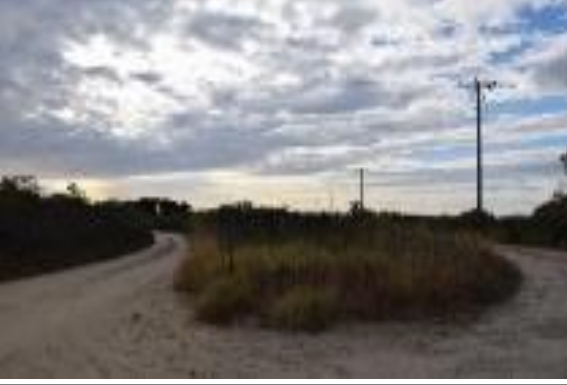
| Condition | Description | Photograph |
|---|--|--|
| <b>Desire paths</b> | Traffic over time has produced additional paths along EPR. These paths fragment surrounding habitat and cause variations in road width. | |

The LLNF should establish a single road path on EPR by blocking off the additional road paths that have been created over time. By establishing a single road path for EPR, a set boundary of the road can be created for which regular maintenance can be performed. As shown in Figure 17, this can be done by installing snow stakes or wooden bollards at the sides of EPR to block vehicle traffic from moving off the established road. These installations should be monitored and replaced as needed.

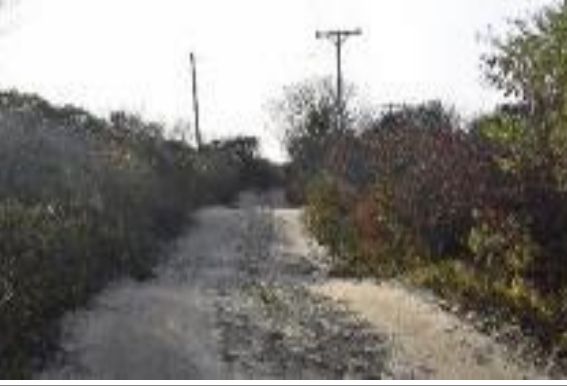
| Condition | Description | Photograph |
|---|--|--|
| <b>Road height</b> | Large variations in the height of the road are inconsistent with surrounding terrain elevation. | |

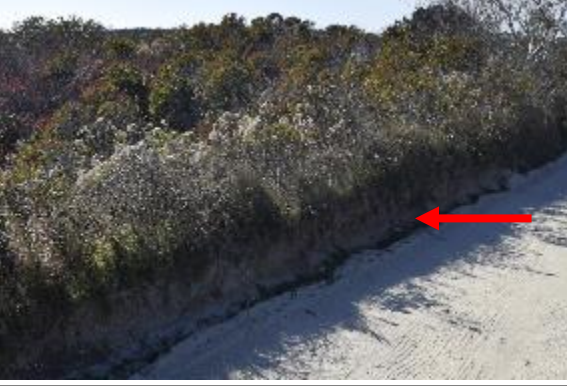
| Condition | Description | Photograph |
|---|--|--|
| <b>Entrenchment</b> | Erosion of the road surface has depressed the elevation of the road below the surface of surrounding terrain. | |

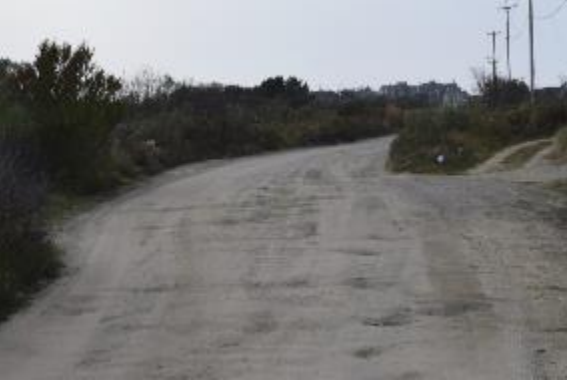
| Condition | Description | Photograph |
|---|--|--|
| <b>Width variation</b> | Traffic has irregularly expanded the width of EPR. Expansion of the road surface encroaches into surrounding habitat and contributes to erosion. | |
