## Urban Renewal Planning For Downtown Spencer, MA

An Interdisciplinary Qualifying Project  
Submitted to the faculty of  
Worcester Polytechnic Institute  
In partial fulfillment of the requirements for the  
Degree of Bachelor of Science

**Sponsoring Agency:**  
Town of Spencer, Massachusetts Planning Board  
Carter Terenzini - Town Administrator  
Karen M. Cullen, AICP - Director of Development & Inspectional Services

November 7, 2005

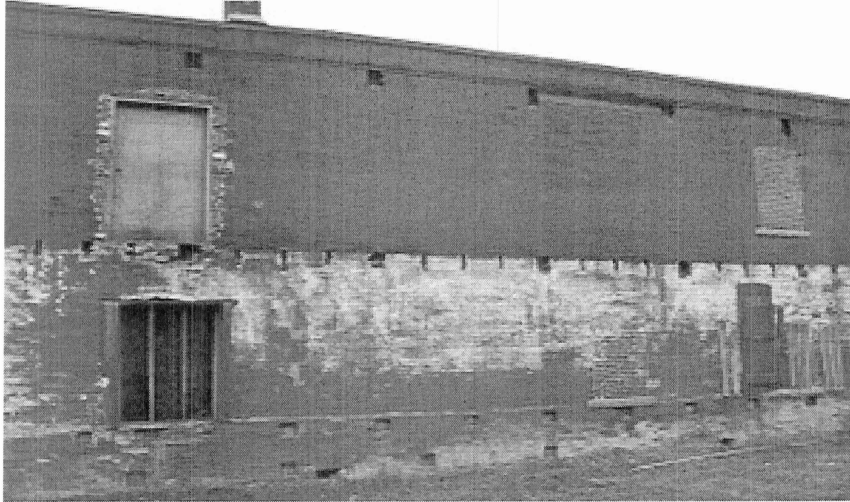
An example of a “Worst” rating can look something like this (see Figure 12):

Figure 12. Building with a rating of worst.

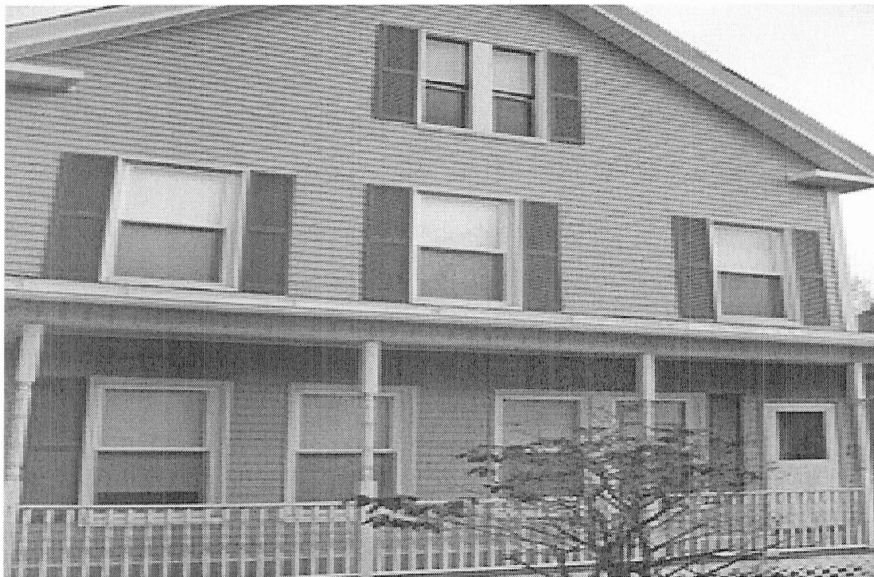
An example of a “best” rating is provided in the picture below (see Figure 13).

Figure 13. Building with a rating of best.

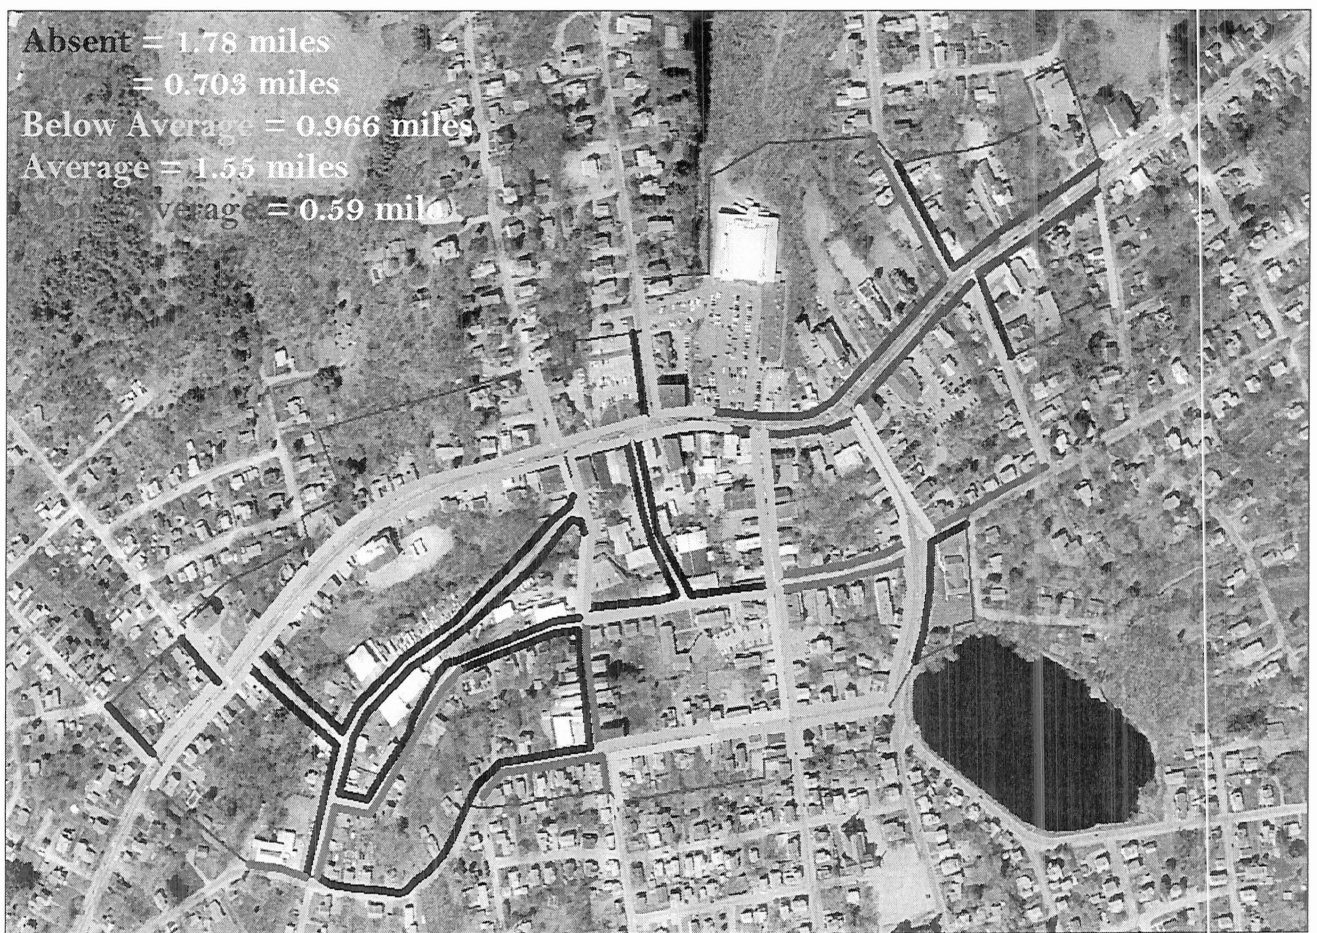
From this map we were able to spot critical sections where there are no to low grade sidewalks (see Figure 33). This is a significant observation due to the fact that this is a safety issue. Individuals need to walk in the streets or on dangerous paths to move about through the town.

Figure 33. Sidewalk map distinguishing the portions of sidewalk that range from absent to above average.

An interesting trend to notice in our downtown study area is that, starting from the northeast section of the study area and traveling down Route 9, sidewalks greatly deteriorated. This can be compared to the building density. There appears to be more buildings in areas with better sidewalks.

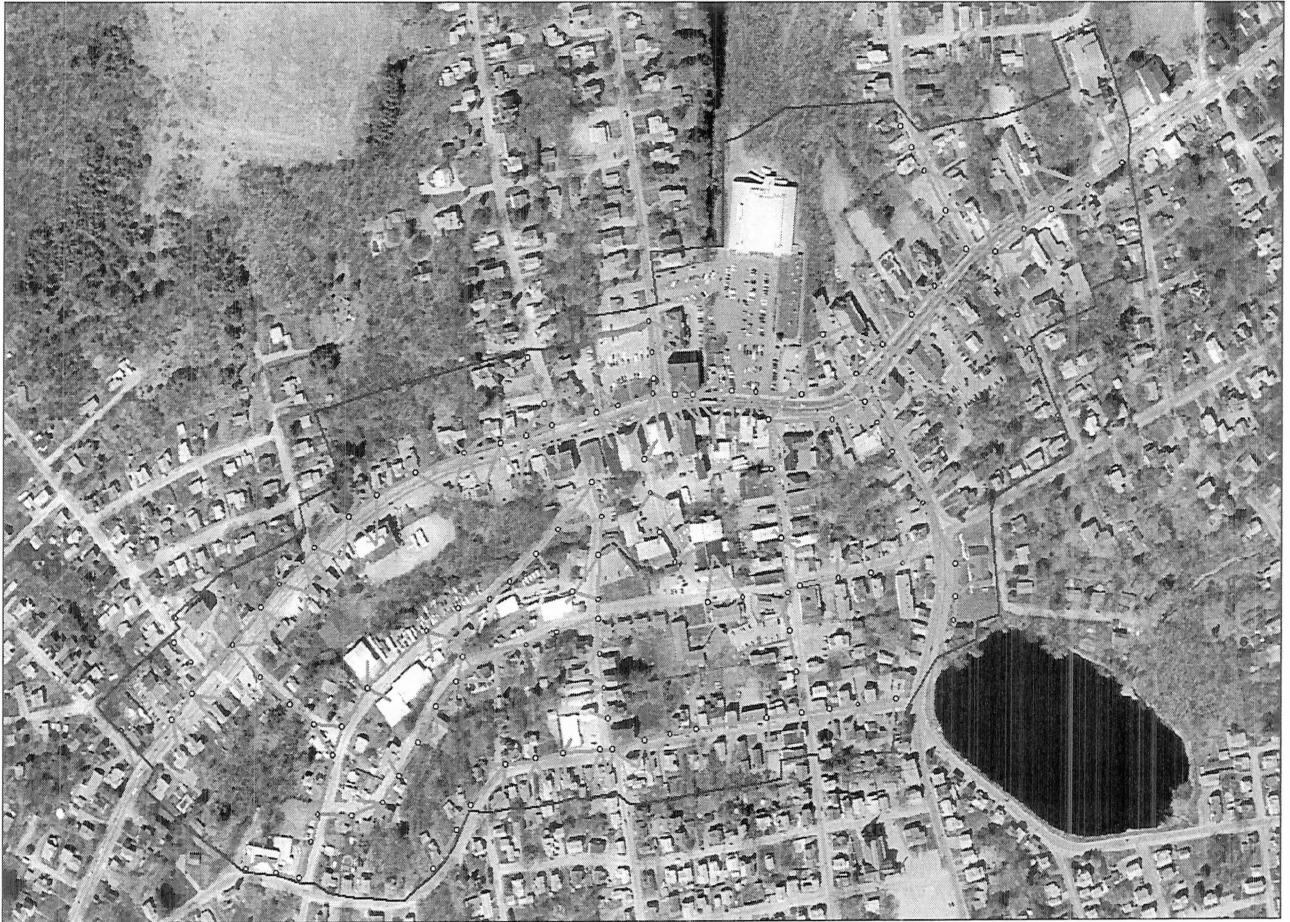
The orange lines drawn on the map represent a power line stringer. The yellow dots show where a telephone pole is located. The map shows how cluttered the streets are, especially on the Route 9 stretch of road (see Figure 37).

Figure 37. Telephone poles and stringers in the study area.

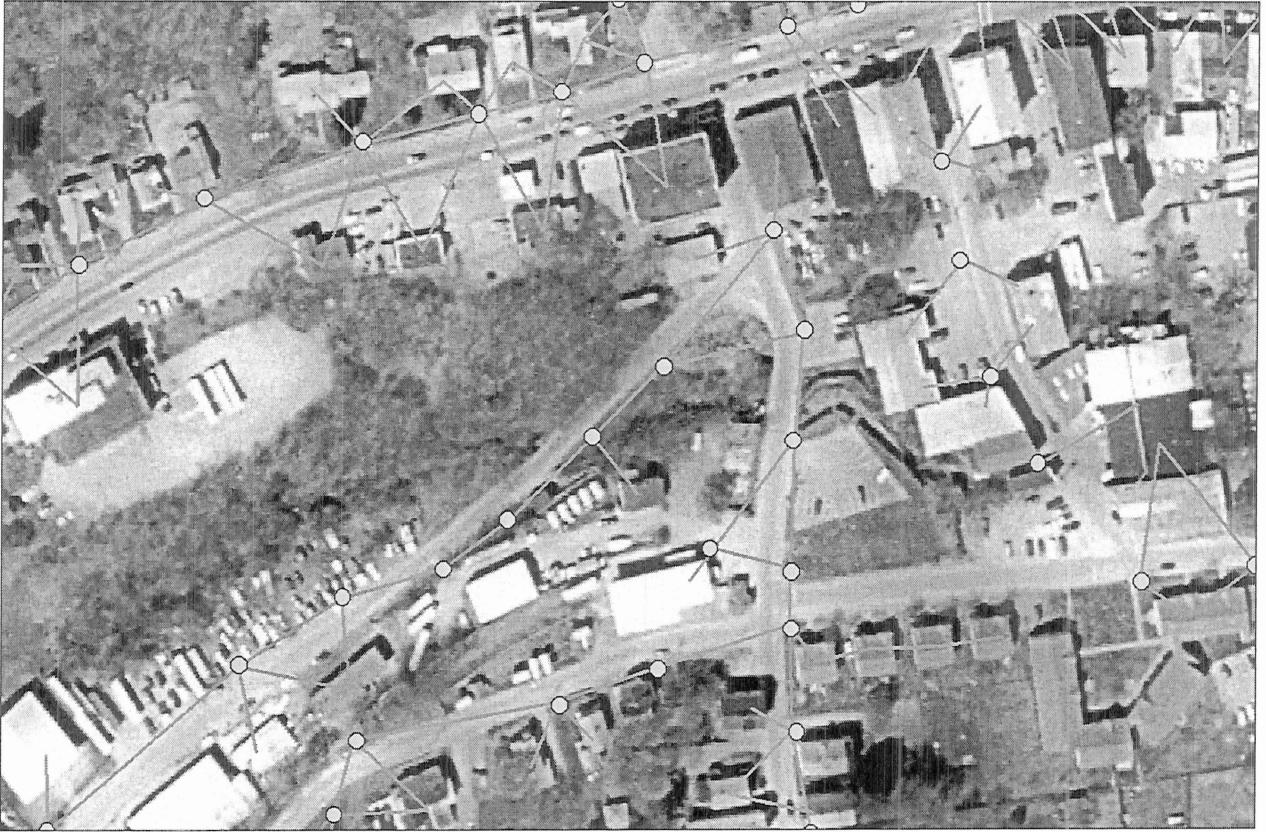
Pictured below is a close up view of the above telephone and power lines mainly along Route 9 in Downtown Spencer (see Figure 38).

Figure 38. Close-up of stringers along Route 9.

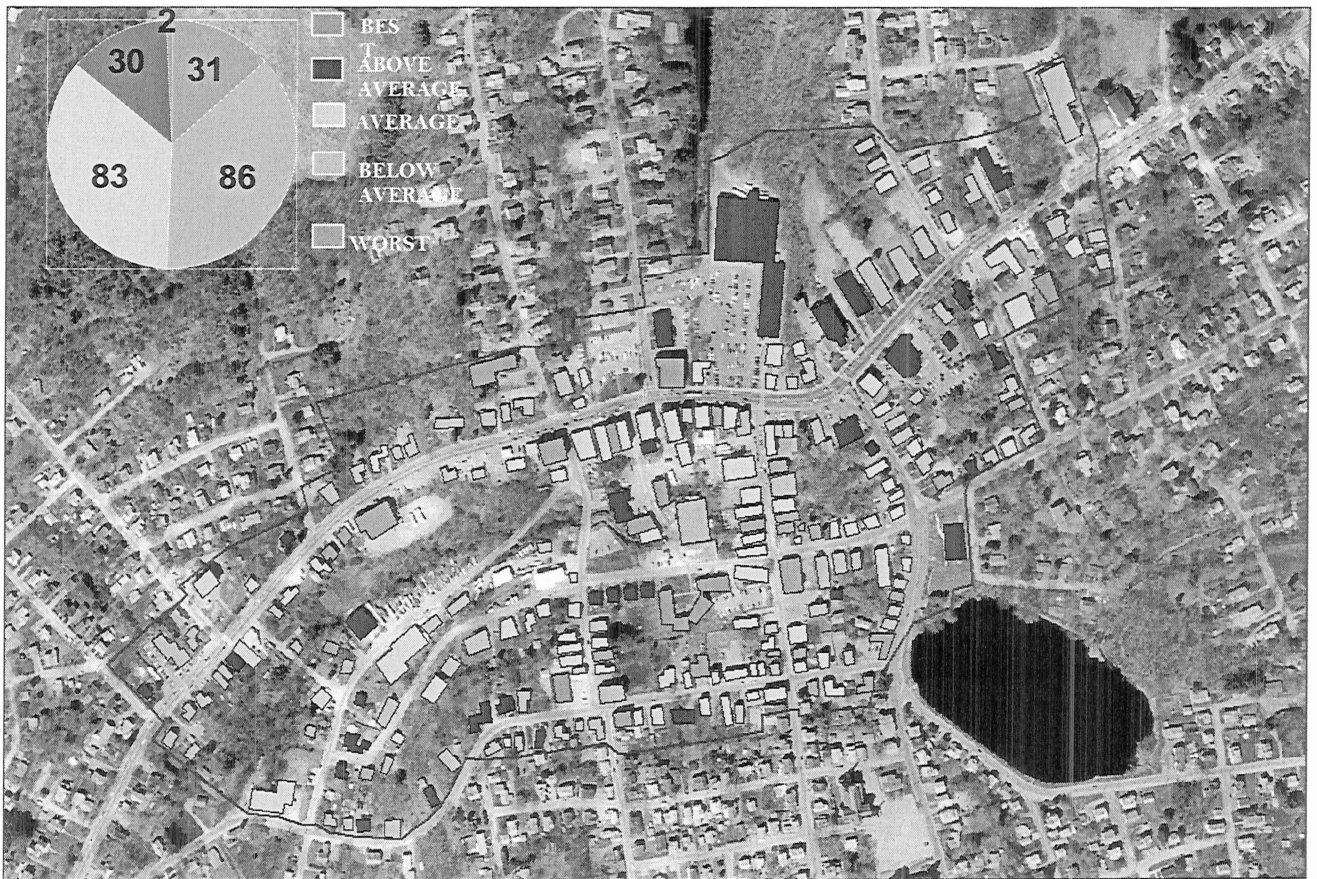
The overall ratings for the structures in the target area were solved by using a weighted formula that is described in section 3.5. Our overall building rating results section was put together from all the information extracted from our study. Like mentioned in section 3.5, we took into consideration all components, facades, windows of each structure. The results by total number of buildings in each rating are shown in Figure 40.

Figure 40. Structure map distinguishing buildings that rat from worst to best.

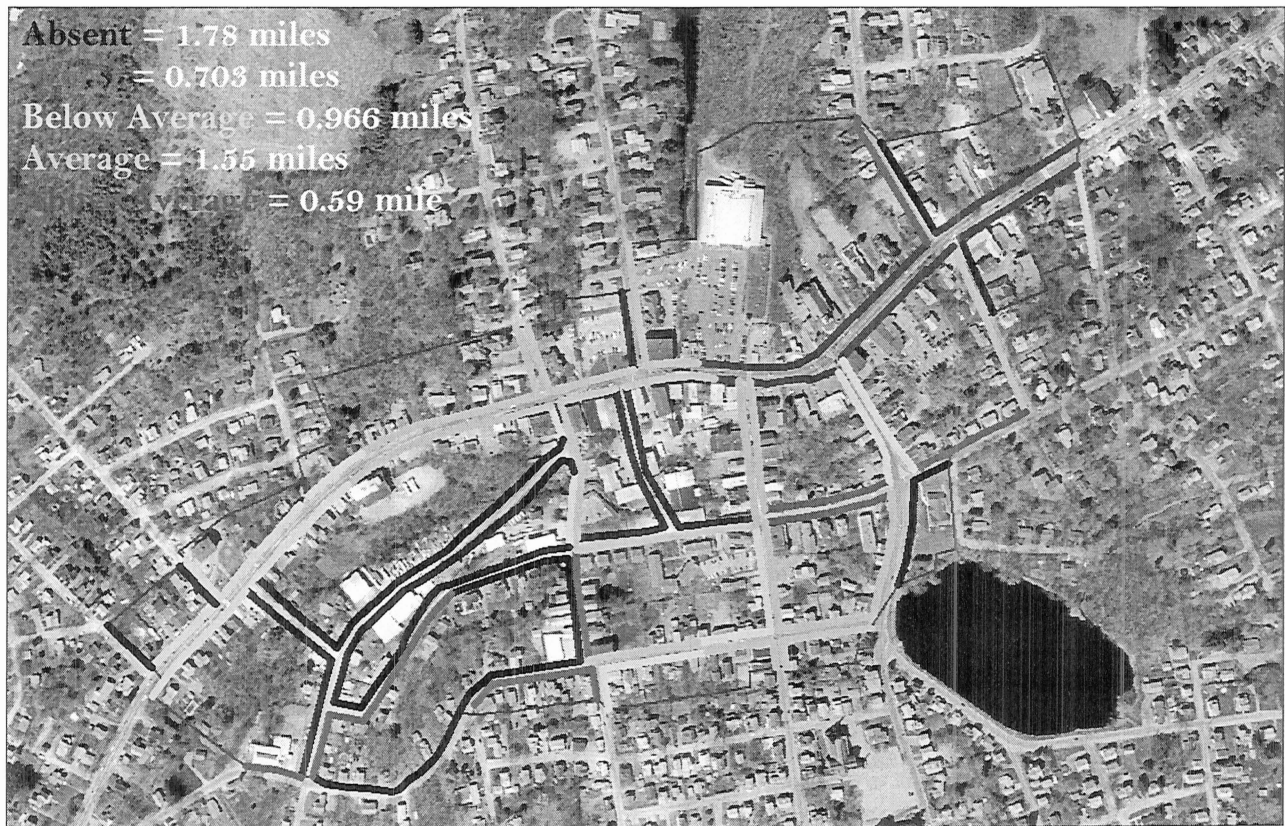
As shown in Figure 43 there are nearly 2 miles of roads that do not contain sidewalks in the study area. The construction and repair of these problematic sidewalks will add to the comfort of town's people walking in the downtown area. Sidewalks are a very important part of the daily safety for individuals. Of the total 5.589 miles of sidewalk in the study area, 3.449 miles of sidewalk remains to be either absent or less than average.

Figure 43. Sidewalk Results in Downtown Spencer.

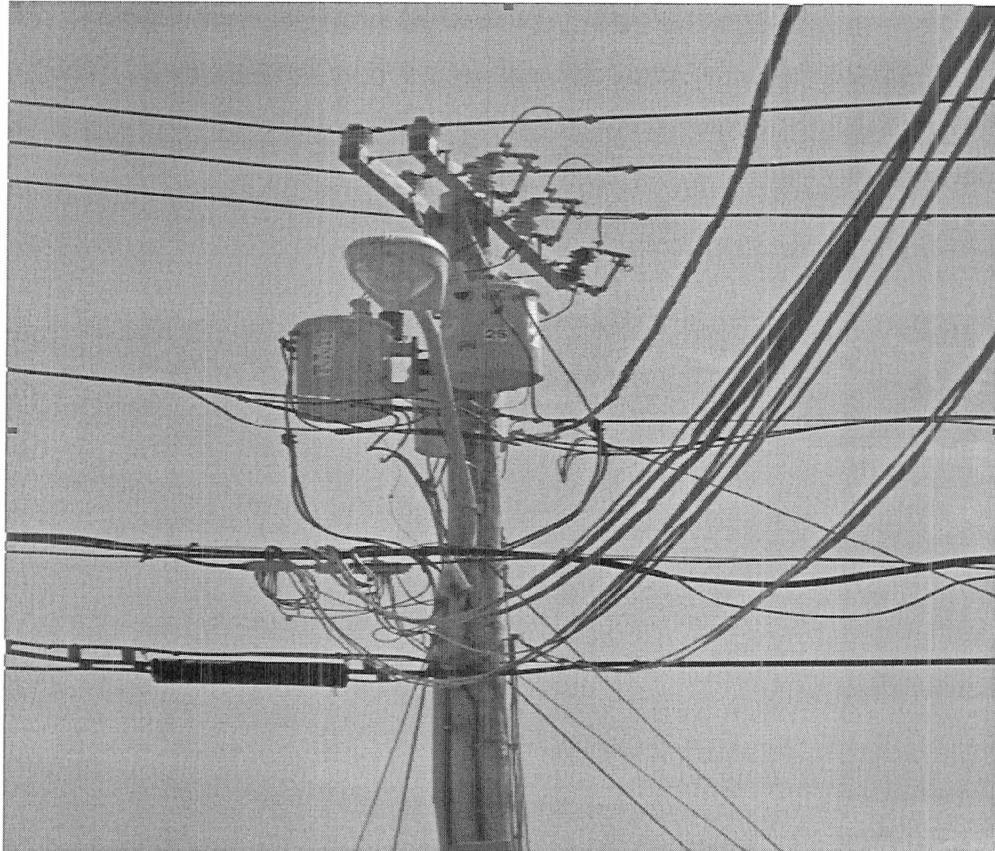
The following picture is an example of how bad this problem is (see Figure 45). This telephone pole is located on the corner outside Spencer City Hall. It branches off in many directions and causes an extreme eye-sore.

Figure 45. Close-up of a typical utility pole in Downtown Spencer.

A solution to this problem may be to use the acquired grant money to remove these wires and replace them underground, as was recently done in downtown Holden, MA. It is not financially feasible without grant money to accomplish this, as it is very involved. After contacting an Engineer from Massachusetts Electric, he informed us that the company would have to come on site and estimate any costs.
