PRODUCT LIABILITY

An Interactive Qualifying Project Report

Date: May 3, 1999

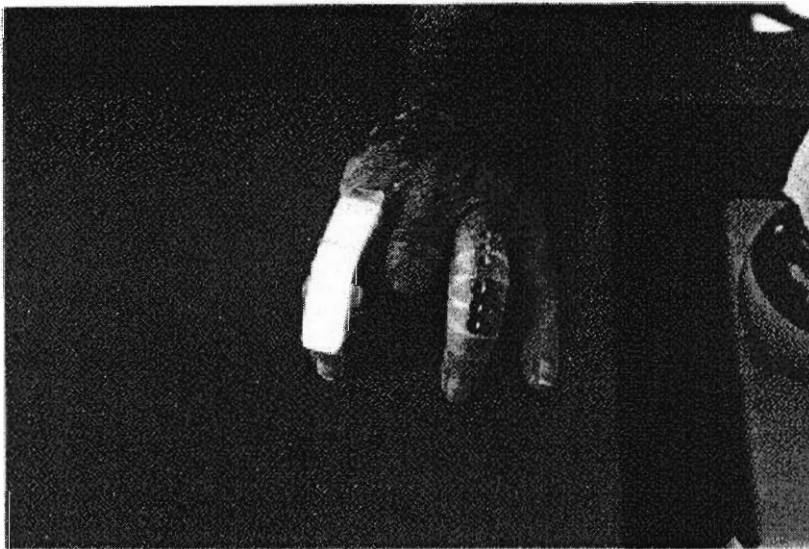
Figure 2-2: The Injury

After the accident, Mr. Frazier's left hand had severe injury. The middle finger was amputated, the ring finger and index finger were fractured and semi amputated only remaining attached to his left hand by a little skin, and the thumb was cut down through the nail almost to the first knuckle. Mr. Frazier claimed that he had little use of his left hand since the accident because of the injuries along with nerve destruction in the hand. Mr. Frazier had numerous surgeries from the date of the accident to May 1997. At the present time, he has little to no feeling in his left ring finger, his left middle finger is

amputated and the stump is very sore (see Figure 2-2). Mr. Frazier's index finger had metal in it which was recently removed and he has no feeling in it. As far as activities being curtailed, he said that he is prevented from performing most of his normal activities with his left hand. To date, Mr. Frazier has incurred approximately \$44,483 in medical expenses.

In this part of the deposition, this project team found a very suspicious phenomenon that could be a key to the case: the little finger did not get cut! If Mr. Frazier was operating the saw like he said in the previous part of the deposition, the little finger should contact the blade before any finger else in his left hand. The only reasonable answer to this is that his left hand was behind the blade just before the accident. But, did the kickback cause his hand being thrown to the back of the blade? We need to see more evidences to decide.

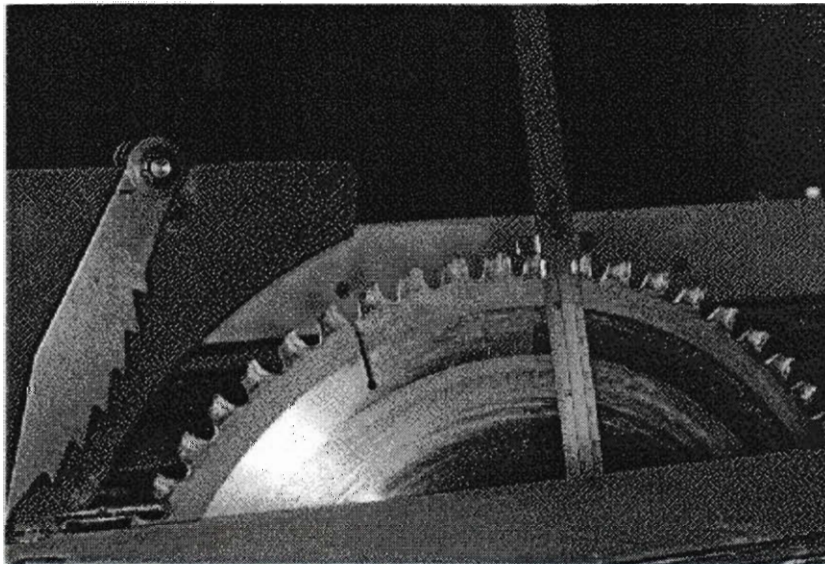
Figure 2-3: The Height of the Blade (appears to be over 2 inches)

The project team agrees that it had become Frazier's own fault for not using the push stick for this specific operation, since the push stick is required by the user's manual. The blade height (Figure 2-3) does not agree with the safety height required by

the user's manual. These two points give us evidence that Mr. Frazier did not follow the instructions given in the user's guide. Negligence can not apply in this part of the case.

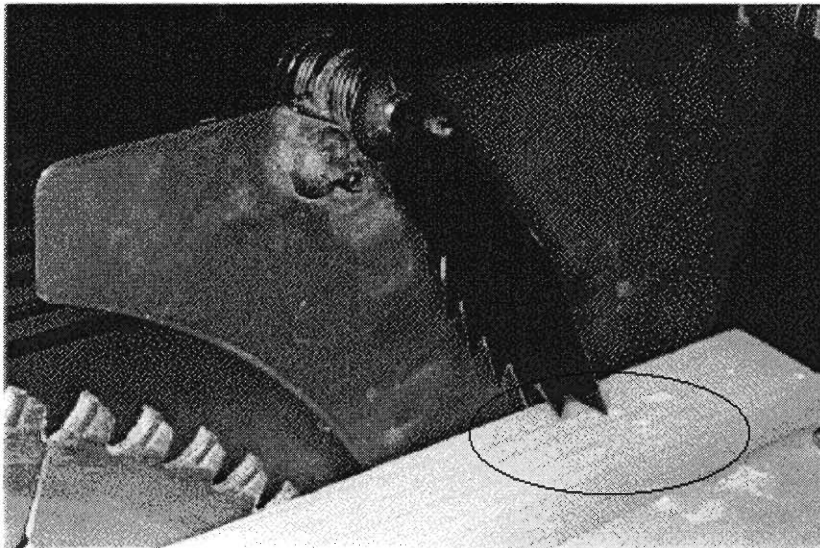
Figure 2-4: Marks on the Wood (circled area)

- 1) The little finger is not damaged: why the physical evidence shows that the blade entered the thumb first? The only reasonable answer to this is that Mr. Frazier's left hand was in the back of the saw blade.
- 2) The teeth marks on the piece of wood: why do they appear to be dig into the side of the wood? (Figure 2-4) This project team feel that Mr. Frazier pulled the wood away from the fence and caused those teeth marks, and consequently, the act caused a kickback that threw the wood back towards Mr. Frazier.

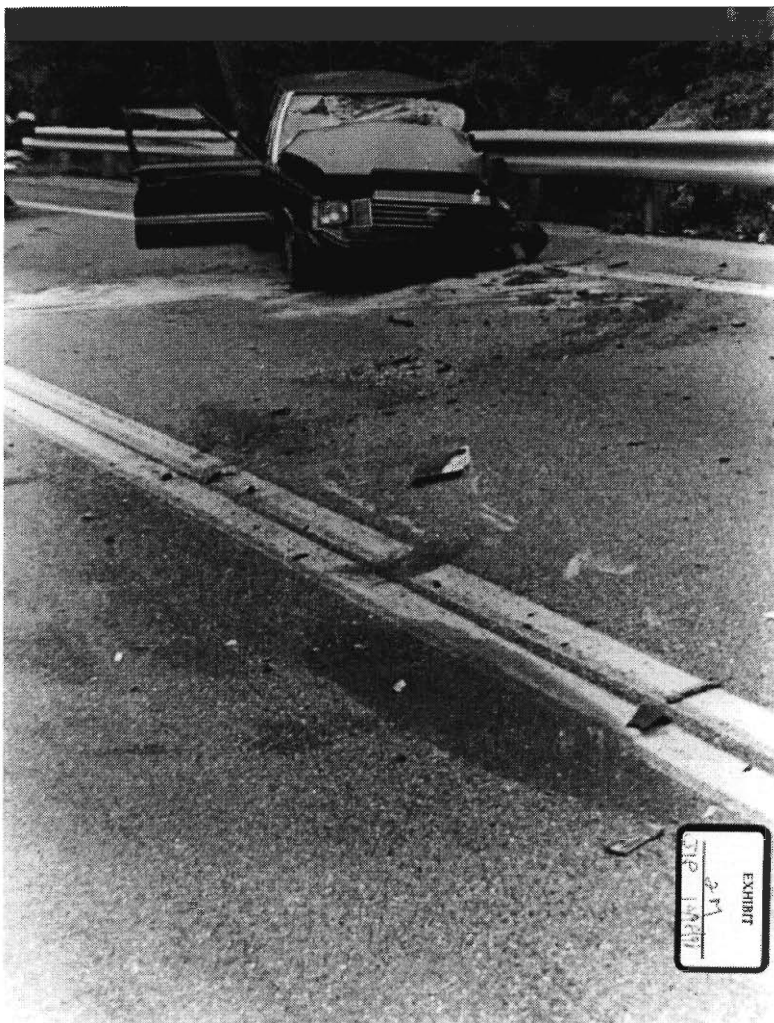
Figure 3-2

Of course, that is sheer speculation and is not hard core fact. A greater understanding of what happened in the accident between Ms. Hernandez and Mr. Mackenzie; can be accomplished from examining the police photographs and other photographs taken by both sides of the case. Portrayed in the picture below, is the centerline of the road with several white scrape marks in the northbound lane. Also there are several tire marks on or around the centerline.

Charles Dietrich claimed that the large tire mark was where the tractor had begun to bounce after impact with the Aires. He also claimed that the tractor was in its proper lane because this tire mark was in the proper lane. According to Dietrich, the tractor was not displaced in any direction, by colliding with the Aires, because of its relative mass. In this case the masses of the tractor trailer to car ratio is in the order of ten to one. Yes, it is a great difference, but even simple conservation of momentum one would figure that the tractor-trailer would have to be displaced a little bit. All it would have to be displaced is a few inches to be on the wrong side of the road.

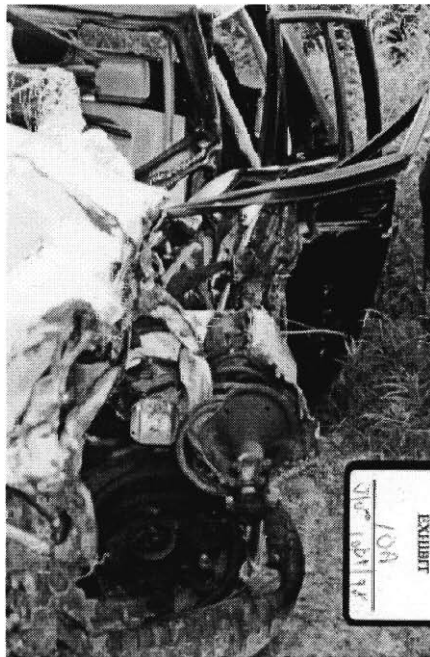
Figure 3-3

Another important fact is the relative height of the tractor-trailer's bumper to the bumper of the car. The tractor trailer's bumper is much higher than the bumper of the car. In fact one could almost fit the hood of the car under the tractor. In head on collisions between tractors and cars, the tractor tends to ride up onto the bumper, and then the hood of the car. Evidence of this is found in the picture below:

As one can see, the damage done to front, left tire and suspension of the car the appears to have been pulled away and smashed into the ground. This would hold true to the white scrape marks seen in picture2 on the northbound side of the centerline. The cars undercarrage actually slammed into the ground and caused those scrape marks. The truck actually drove up the left side of the car. Since the weight of the truck, the cars frame gave way and ripped down and outward. Splitting the tire and the suspension from the car.

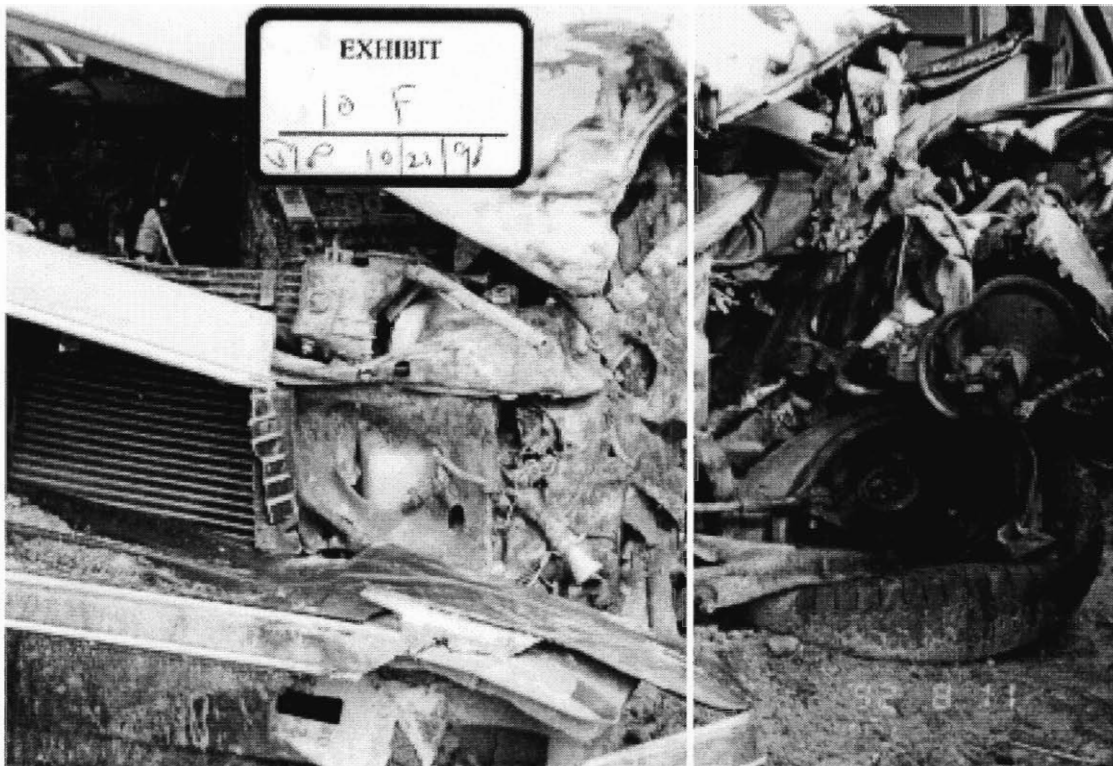
Figure 3-4

In picture seen below, we can actually determine an approximate point of impact.

Upon examining the photograph, the area in which the car suspension and tire was originally located had been completely devastated. Yet the front left headlight and bumper only received a fair amount of damage. It almost appears to be pulled back by a glancing hit. This would lead to the conclusion that the truck actually came into contact just behind the headlight, in the area is completely destroyed. In picture five, there is a

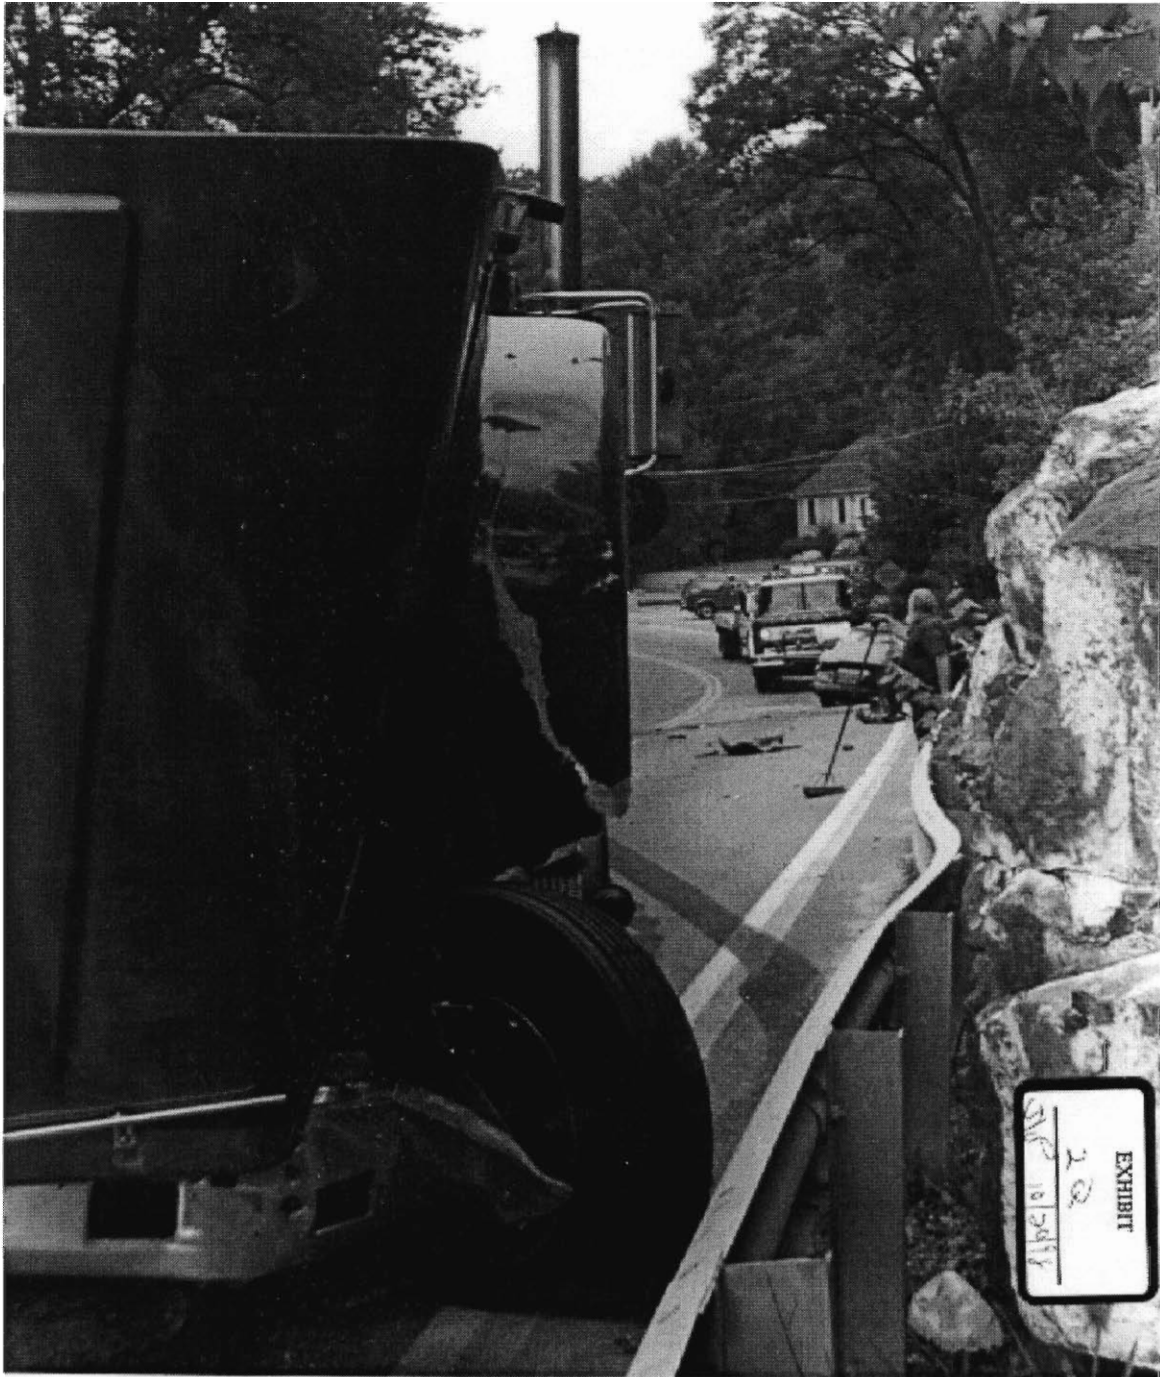
Figure 3-5

We will assume that Mr. Mackenzie did not drive into the wall on purpose, but was forced into the wall. The reason why he was forced into the wall, was from damage done to the steering from the collision of the car. As seen in the picture below the bumper is actually bent behind the tire.

The bumper would have been bent back upon initial impact with the car. This is only logical. Both the car and the tractor were travelling at speeds faster than thirty miles an hour. The bumper would have easily given under the enormous force created upon

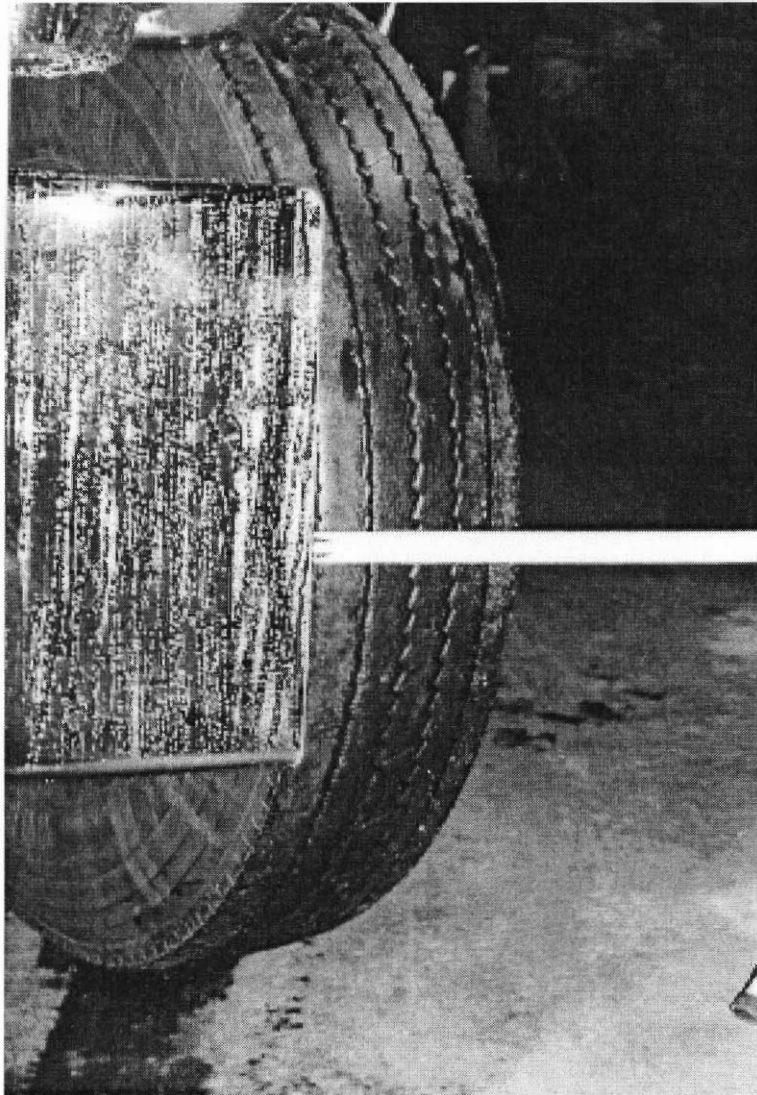
Figure 3-6

impact. The force would have moved the bumper back and around the tire. Except in the picture above the bumper is behind the tire. In order for this phenomenon to occur the tire must have been turned outward as seen below.

It cannot be explained why the driver turned left immediately before the accident, but according to the physical evidence Mr. MacKenzie turned into Ms. Hernandez's lane.

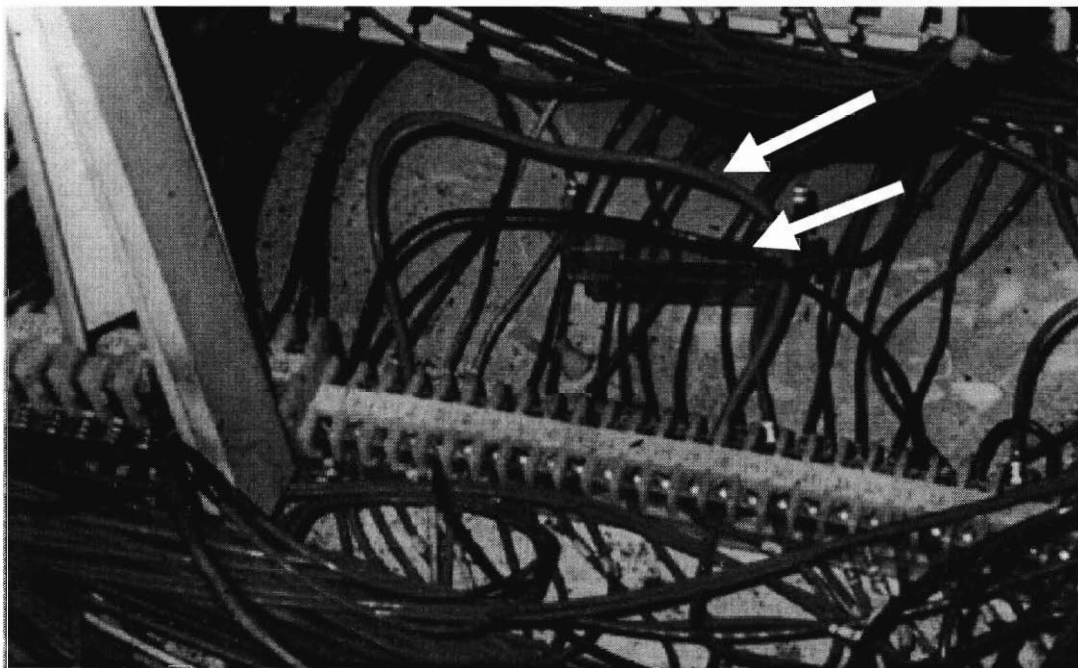
come over and begin running in that spool. In the meantime, the operator could unload the full spool and load another spool onto the right side. The counter measures the footage of the material passing through it and also provides a signal to the control panel to maintain a constant speed. The machine would not run if there is nothing going through the counter. Note: Encore was using only the takeup to spool wire, the counter was not involved. Therefore, Encore must have changed the original design setting of the machine. (See Figure 4-2, two terminals have been short wired.)

Figure 4-2: Two Terminals Have Been Short Wired on the Set-up Panel

(Encore has changed the original electrical set-up for dangerous unspooling function.)
