PERFORMANCE BASED DESIGN

An Interactive Qualifying Project Report

WORCESTER POLYTECHNIC INSTITUTE

Date: May 1, 2007

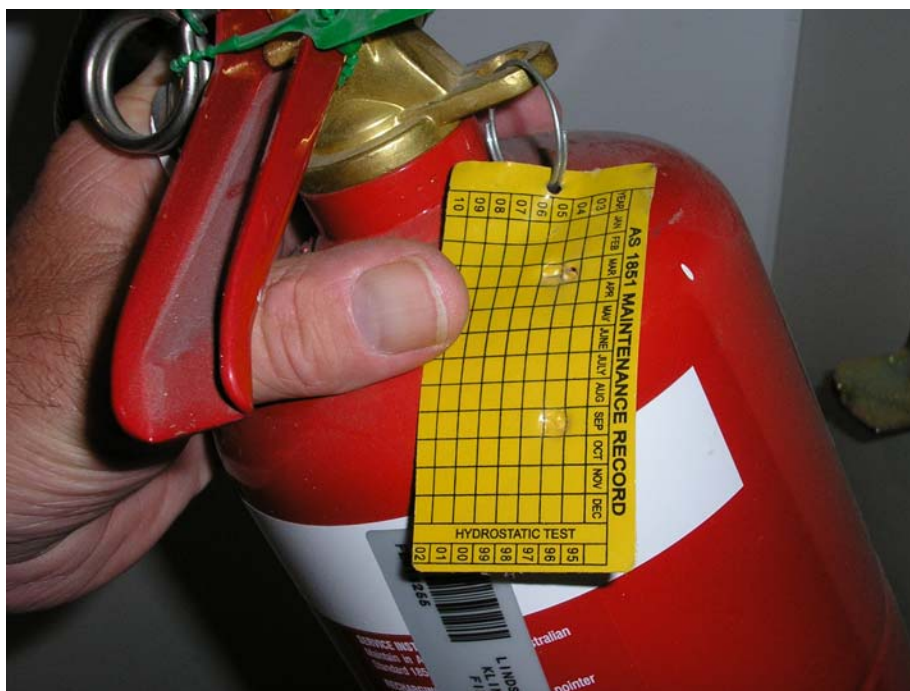
Building B was found to contain several deficiencies which, when combined, created a potentially dangerous situation. The specific issues found during the site visit are detailed in Section C.2. The main source of these faults seemed to come from improper or nonexistent maintenance. For example, all of the portable fire extinguishers seen had not been serviced for at least two years, as opposed to the

required biannual checks. In Figure 12-1, the tag on the fire extinguisher shows that there has not been any maintenance on the extinguisher for about two years prior to the date of the visit. In some cases the fire extinguishers were missing altogether. The single stair in the building was required to be sterile, but there was debris found in the bottom of the stairwell which presents a hazard, especially if it were to ignite. In another case, the maintenance logs for the sprinklers indicated that the required maintenance had been performed, but a fault with the sprinkler running warning light was found each time for the past year and never seemed to be repaired. This fault has the potential for serious consequences. If the pump motor is running unnoticed, it could burn out leaving the sprinklers inoperable in the event of a fire.

Figure 12-1: Overdue Maintenance on Fire Extinguishers in Building B

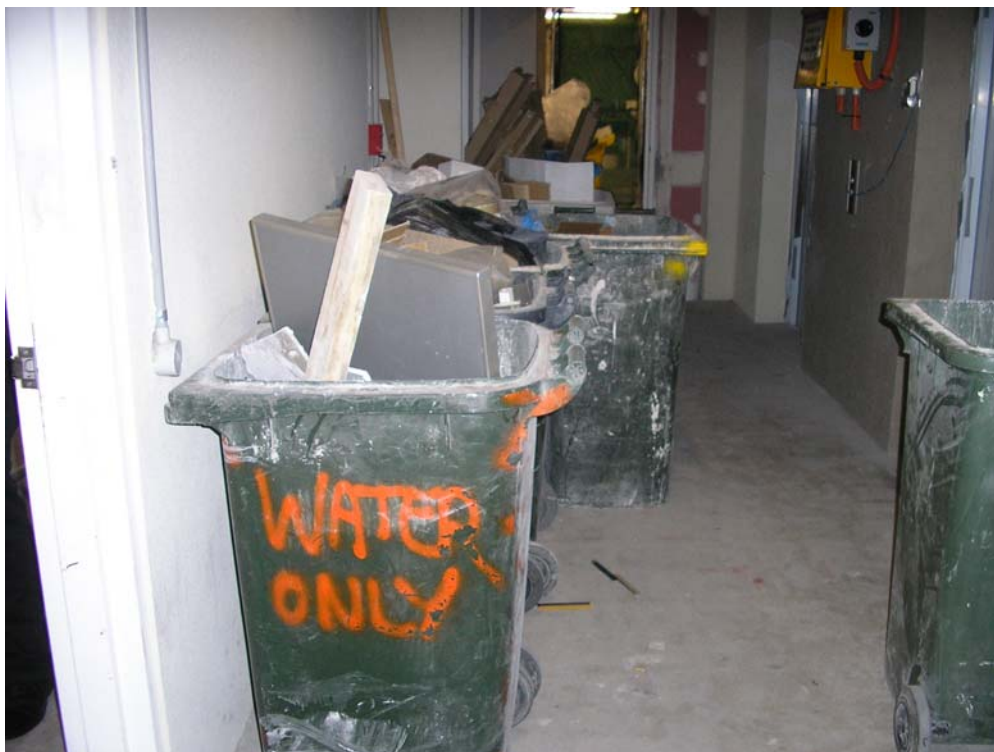
The issues found in Building C were more serious than those in B, and had the potential to be disastrous. The results of the site visit are detailed in Section C.3. A lack of communication seemed to be the primary source of these deficiencies. The building utilized staged occupancy, which means occupancy had started while the construction workers were completing the building. This practice is not necessarily dangerous, but it must be clear to construction workers that safety requirements for an occupied building are different from those for a construction site. It is common practice for workers on a construction site to prop open doors to make it easier to move around. This, however, affects compartmentalization in an occupied building.

This building in particular relied on a single stairway, pressurized to keep smoke out. With the doors open this system would not work properly, causing the only exit from the building to become unusable as it fills with smoke. The issue of certain building areas changing use due to ongoing construction could also be seen with the storage of trash in the first floor lift lobby. Figure 12-2: shows bins of debris on one of the car park levels. Most of the carpark levels did not have an automatic sprinkler system, which were deleted as part of the alternative solution for the building. This deletion did not account for the kind of fuel load which was present as a result of the rubbish.

Figure 12-2: Rubbish in First Floor Lift Lobby of Building C

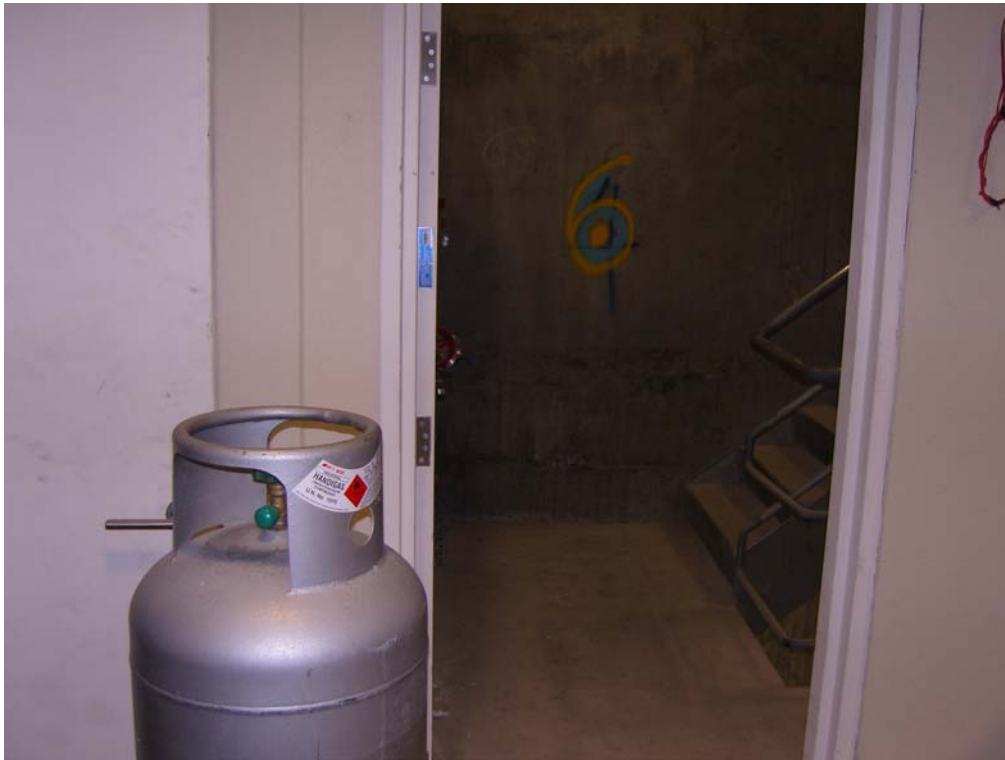
Because Building C was the place of residence for the team, the process of forcing change on the building was observed easily during the course of the project. The rectification process involved several participants, including MFB, the Municipal Building Surveyor (MBS) for Melbourne, and Worksafe. It took approximately two weeks for significant improvements to be made to the building's use. Part of this delay was caused by the complexity of the situation. There was confusion as to who had authority due to the dual nature of the building as both a construction site and an occupied residential building. The quickest organization to get results was Worksafe, which was able to have a 45 kilogram Liquid Petroleum Gas (LPG) tank placed near

an open fire door to the stair, as shown in Figure 12-3, removed within 24 hours of the filing of a complaint. Eventually, through the combined efforts of the MFB and the MBS, changes were made to the way the building was used, but these changes were slow in coming.

Figure 12-3: LPG Tank in Lift Lobby Outside Open Door to Stairway in Building C

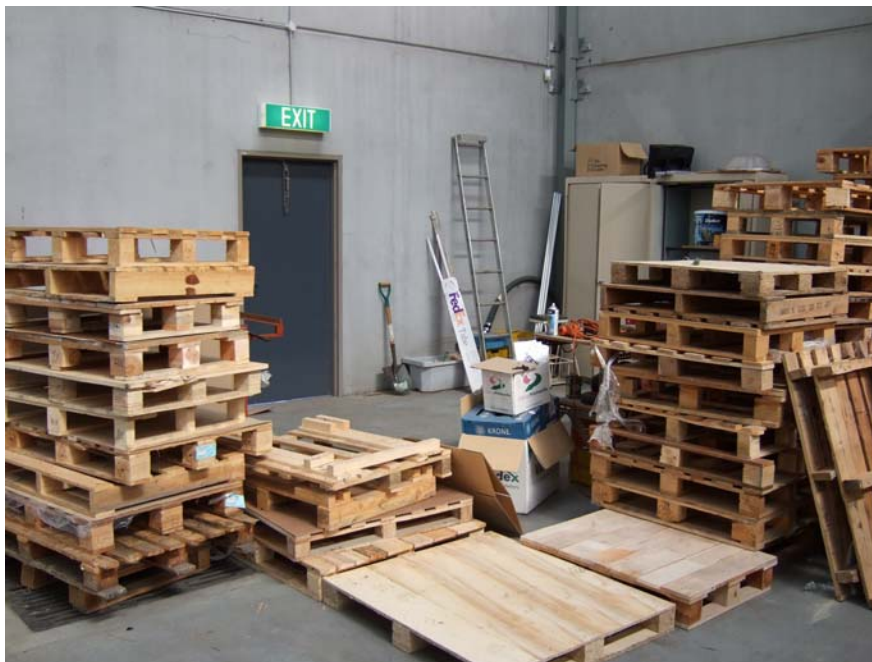
Building F was found to have some very significant issues, which are detailed in Section C.6. There were several problem areas which could create problems in the event of fire. One was obstructed egress paths. There was one fire exit which had

large stacks of wooden pallets blocking it, as shown in Figure -12-4. Additionally, there was a lot of paper in the printing room, making egress more difficult there. The more significant issue was fuel load. The fire engineering analysis specified that the storage in the warehouse be kept below four meters in height and under a certain volume, which was calculated to be four rows of shelving. When the team visited the building it found that there were five rows of shelving. Additionally, the team measured the height of the goods on the shelving to be between 5.6 and 6 meters on two of the rows. These were the highest point at which the containers were stored, although all the shelves had goods stored higher than four meters as the top shelf itself was just less than four meters high and each row had goods stored on the top shelf. This additional fuel load could result in a fire which is much more intense than what the building was designed to handle.

Figure -12-4: Obstructed Exit in Building F
