# **The Church Floors in Venice, Italy: An Archeological Study and Analysis**

31 July 2002

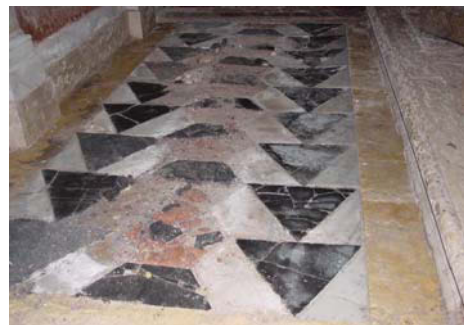
Figure 3: Severe wearing found in the San Marcilliano

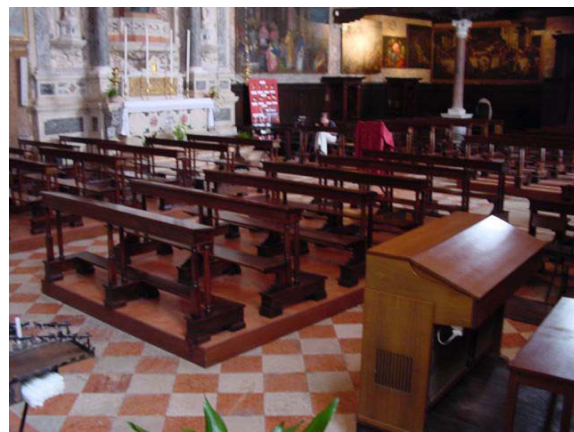
Figure 4: Raised pews in the *Sant' Alvise*.

Practical methods we found to prevent damage to church floors and artifacts included roping off areas of importance, increasing the price of admission and implementing various guided tours involving the churches of Venice to raise funds for restoration. We also suggested using redesigned pews in order to prevent damage to the floor and artifacts the pews are placed upon (Figure 4).

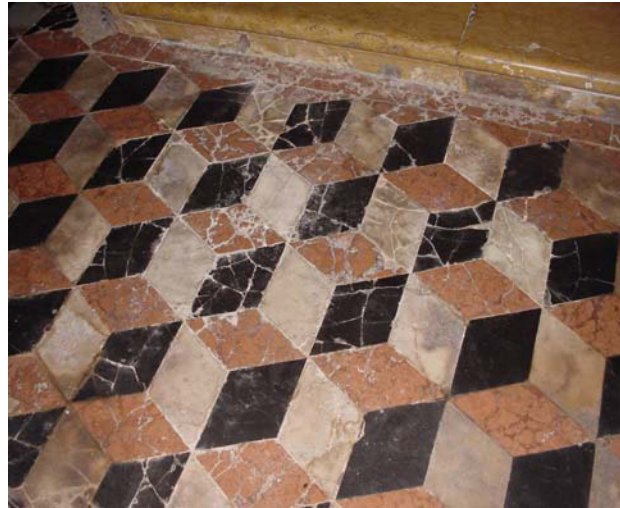
Figure 22: An example of cracks seen in the *Santa Maria Assunta dei Gesuiti*.

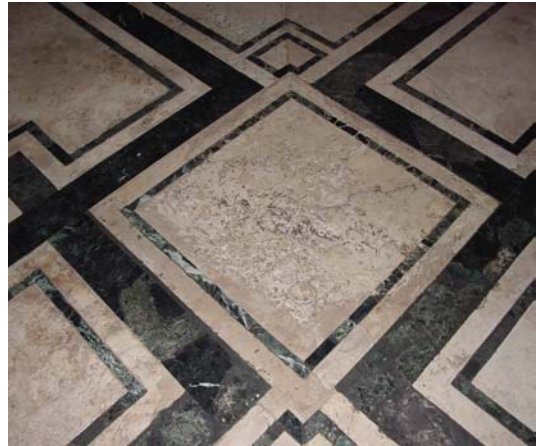
We discovered other types of surface damage besides fading and wearing as we looked at the churches. One of the common examples of this is pitting (Figure 23). When these conditions arose we noted the percentage of surface area that was affected within the quadrant.

Figure 23: Pitting of the floor seen in the *Santa Maria Assunta dei Gesuiti*.

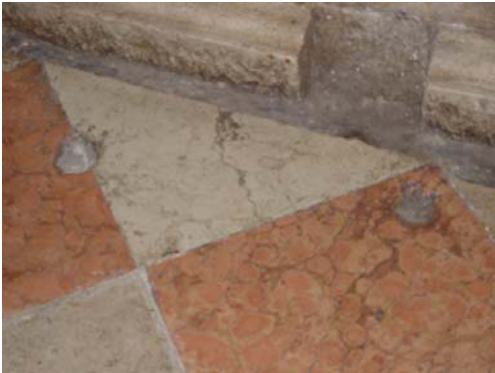
Figure 24: A pair of holes found in the *San Giovanni Elemosinario*.

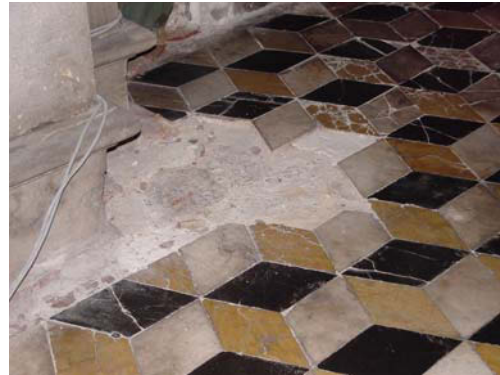
At times we found pieces of the floor to be entirely missing. A missing corner of a floor tile or the loss of multiple whole tiles, as depicted in Figure 25, would qualify as floor detachment. When this occurred we recorded the percentage of the quadrant that was affected by this problem.

Figure 25: Floor detachment in the *Santa Maria Assunta dei Gesuiti*.

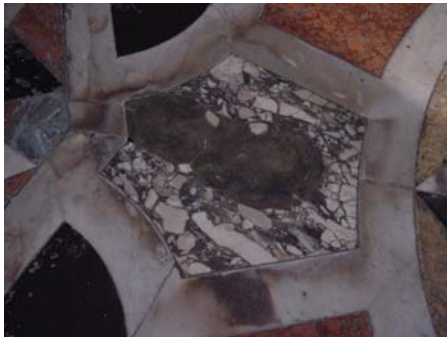
Figure 26: An example of floor replacement found in the *Santa Maria Della Salute*

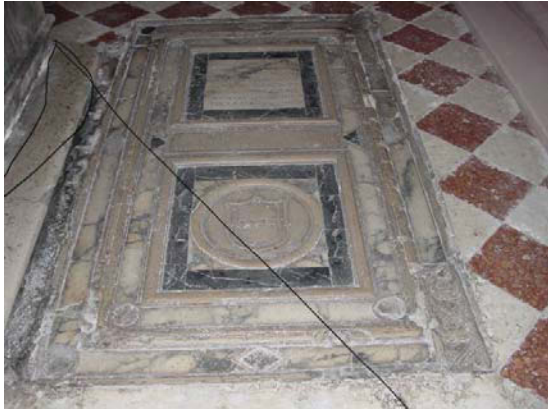
Figure 29: This artifact found in the *San Giobbe* contained a high percentage of surface cracks

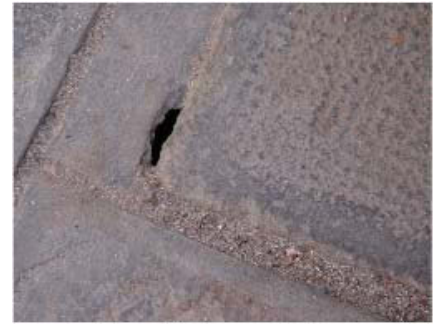
We measured the length and width of any gaps that occurred between slabs or blocks of material (Figure 30). These gap measurements were then added together in order to find the total surface area of the artifact that must be caulked.

Figure 30: A joint gap example

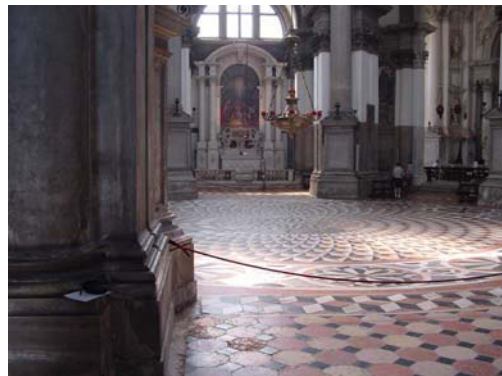
Figure 66: The center of the *Santa Maria della Salute* has been roped off.
