# Assessing Environmental Damage at Stream Crossings in El Yunque National Forest

## Interactive Qualifying Project

Sponsoring Agency: United States Forest Service, El Yunque National Forest

Date: 5 May 2011

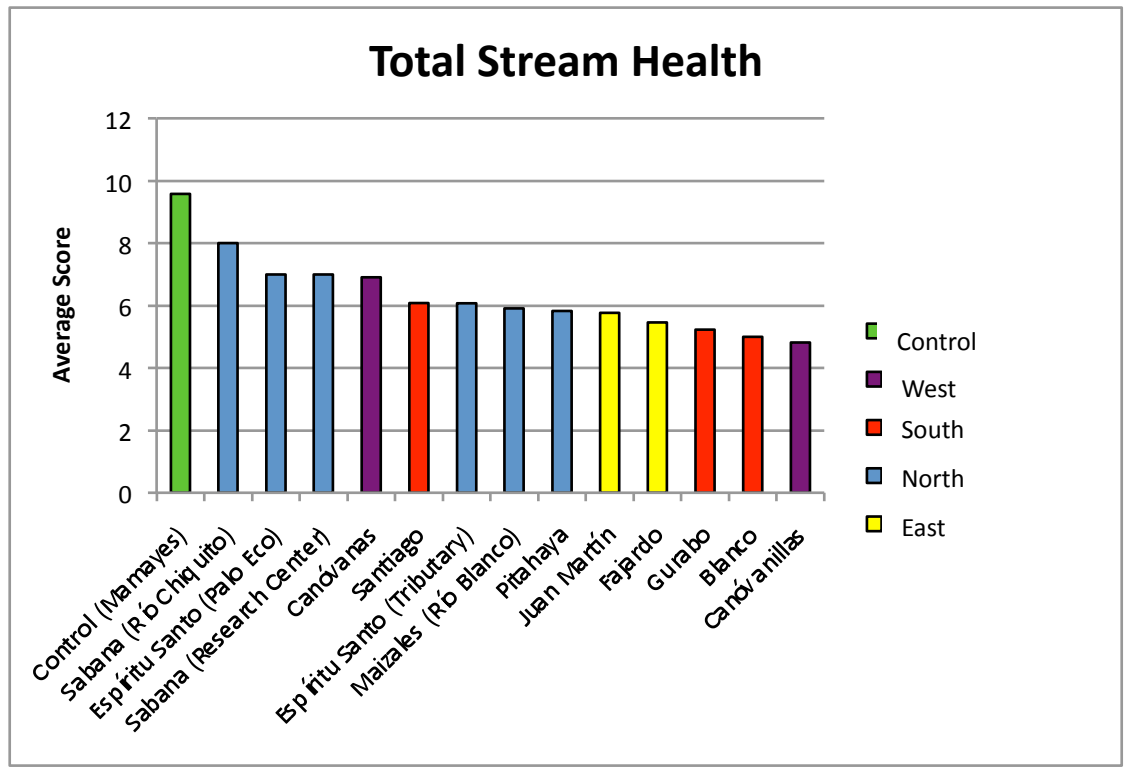
Figure 6: Total Stream Health Graph

This graph displays the average stream health scores for fourteen assessment sites. The control's health was assessed at two locations and averaged into the final score shown in green. The streams are shown in order of decreasing health, where the control is the healthiest and Río Canóvanillas is the least healthy. The stream scores are further broken down according to the direction of flow; see the legend on the right. As whole, the northern streams were the least impacted by human activity. The southern and eastern streams were more heavily impacted on the whole than the northern streams. There was no correlation between the two western streams; one was healthy and the other was the unhealthiest of all of the streams.

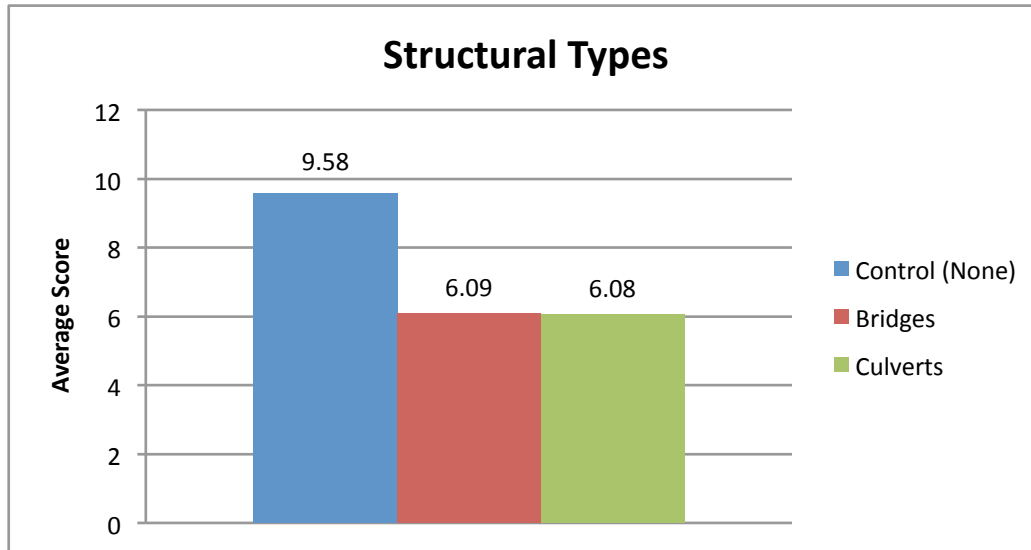
**Figure 10: Structural Type Comparison Graph**

Bridges and culverts had almost the same average score. The difference was much less than one percent. However, all of the culverts had similar scores. The lowest score was 5.23 and highest was 6.91, a range of 1.68. By contrast, bridges had both the highest and lowest scores of the streams with a range of 3.82. Culverts were not present in the three healthiest streams and only one of the three unhealthiest streams was a culvert. Although the averages are nearly the same, bridges have a greater diversity of stream health than the culverts. There was no correlation between stream health and crossing structure for our team to base our recommendations upon.

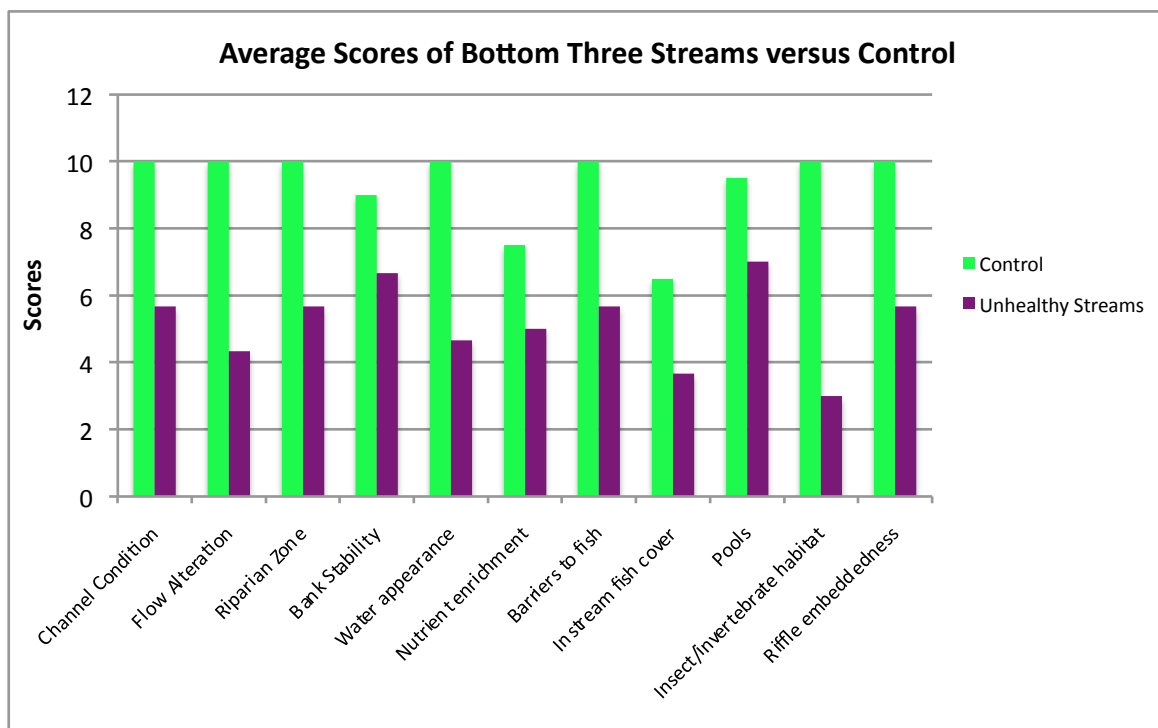
Figure 12: Graph of Average Factor Score of Worst Streams versus Control

This graph shows the average scores for the unhealthy rivers as well as how the scores compare to the control. The lowest scores for the worst streams are registered in insect and invertebrate habitat, in-stream fish cover and areas of flow alteration. The smallest differences between the two data sets were bank stability, pools and nutrient enrichment. The biggest dissimilarity was in insect and invertebrate habitats, where the averages were seven points apart. Other large deviations included flow alteration and water appearance. The factors with large differences display the most notable discrepancies between healthy and unhealthy streams, which helped determine what factors need to be improved. However, it must be noted that these are averages. Sometimes one river in poor health scored lower or higher than another. For example, although the water appearance average is low for unhealthy streams, Río Gurabo scored an eight, which is a high score. This led us to evaluate the three worst rivers separately, concluding that they have unique problems that cause poor health.

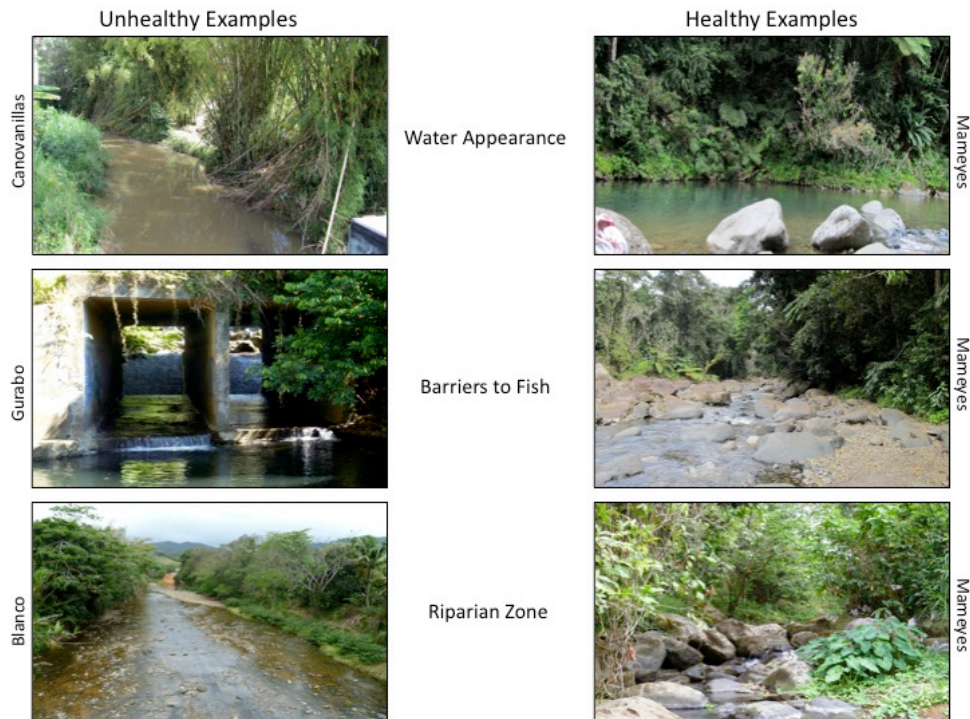
**Figure 13: Visual Differences between Healthy and Unhealthy Streams**

Each of the three unhealthiest rivers had one factor in which they all scored a one, the lowest score possible. For Río Canóvanillas, it was water appearance. Río Blanco scored extremely low in riparian vegetation and Río Gurabo had a barrier to fish movement (a drop culvert). The visual difference between these low scores and the perfect scores of the control (10) are shown in Figure 13.

Although the river is evaluated as a whole, sometimes one or two factors can change the overall average of the score. Even in the almost perfect controls, low scores were obtained for in-stream fish cover and nutrient enrichment. For our worst streams, all three of them were given a lower average due in major part to one score. Knowing these correlations helped us to develop better recommendations for individual streams as well as for the watersheds as a whole.

Although Río Blanco scored better than Río Gurabo on fish passage, the two rivers had similarly low scores. For the Río Blanco, this was due to the lack of riparian vegetation. Riparian zone vegetation needs to extend at least half of the stream width to be considered healthy (NRCS, 1998). By our estimation, the Río Blanco riparian zone extended less than a third of the stream width on either side. The most common way to repair this area is to replant it with native woody species (Kauffman et al, 1997).
