AN ARCHEOLOGICAL AND ANALYTICAL STUDY OF VENETIAN CHURCH FLOORS

A Preliminary Qualifying Project Proposal
Submitted to the Faculty of the
WORCESTER POLYTECHNIC INSTITUTE
In partial fulfillment of the requirements for the
Degree of Bachelor of Science By:

30 July 2003

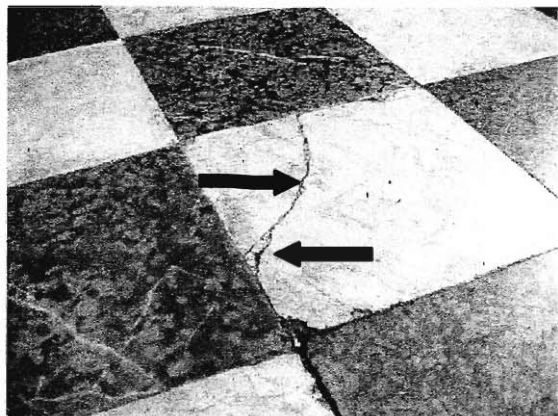
In each quadrant, a varying number of cracks were present. Cracks indicate weakness in the floor, and are possible sites for future floor detachment or replacement. These cracks also may indicate hidden problems in the ground under the walking floor and high foot traffic in that area. Different factors were assessed when rating cracks, such as the size of cracks and whether the cracks were considered problematic.

Figure 26: An example of large cracks (shown in the center of the white Istrian tile) and small cracks (shown in the bottom left on the red Verona tile)

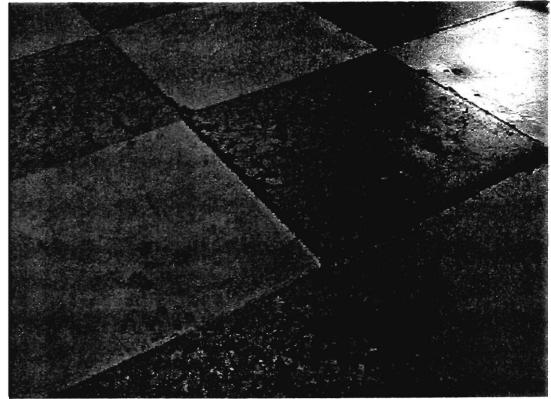
A joint gap was considered to be a larger than usual separation between floor tiles where normal sealant might be added. Figure 28 shows an example of a joint gap in the floor tile. To assess joint gaps that were present on the floors we used a 0 to 4 scale similar to the scales we developed for cracks and holes. This scale is explained in Table 6.

Figure 28: An example of a joint gap

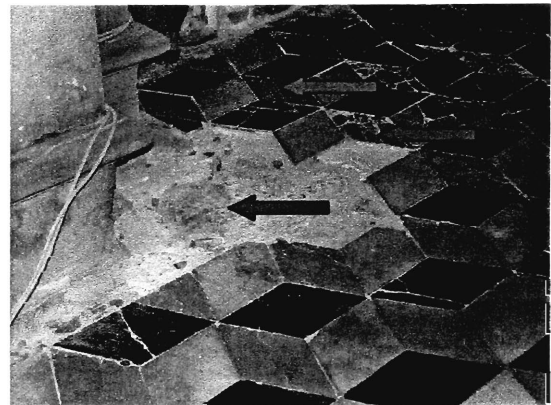
We considered a missing corner of a floor tile or the loss of whole tiles as floor detachment. Figure 29 shows an example of the loss of whole tiles. The percentage of the surface area of the quadrant that is detached was estimated and recorded for our analysis.

Figure 29: An example of floor detachment

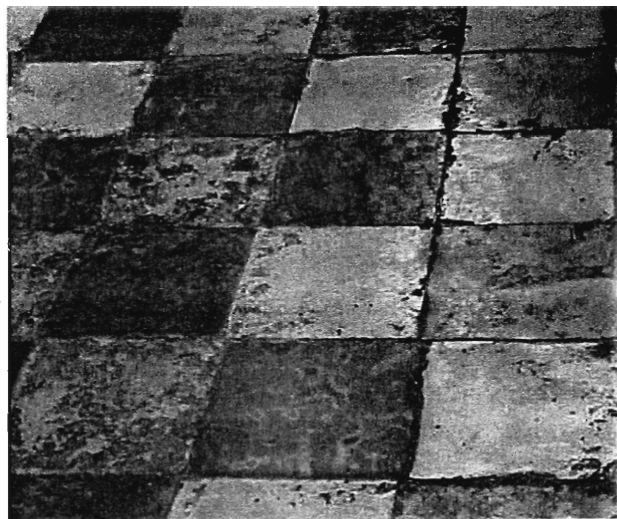
There are many types of surface damage caused by age and the flooding waters from beneath the churches. The team rated the amount of surface damage in each quadrant according to a five point scale that ranged from 0 to 4. This condition assessment scale is described in Table 7. The type or types of damage present in significant amounts on the floor were also identified. The team looked for three main types of surface damage, wearing and fading, pitting, and discoloration.

Figure 31: An example of two types of surface damage, wearing/fading and pitting.

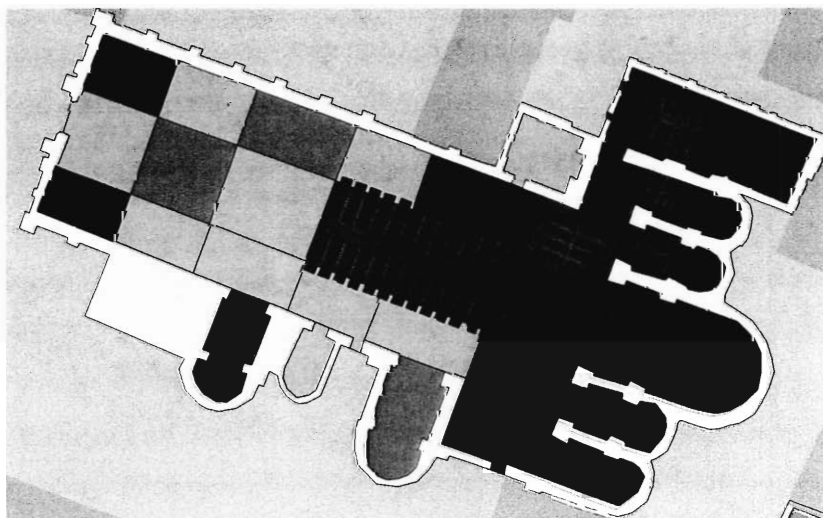
Figure 93: The correlation between surface condition and pew location in Ss. Giovanni e Paolo
