# Evaluating Effectiveness of the Signage and Other Markings for Guidance and Warning Placed by OCN

An Interactive Qualifying Project submitted to the faculty of  
WORCESTER POLYTECHNIC INSTITUTE in partial fulfillment of  
the requirements for the degree of Bachelor of Science

12/17/2013

Sponsoring Agency: Department of Natural and Environmental Resources in Puerto Rico

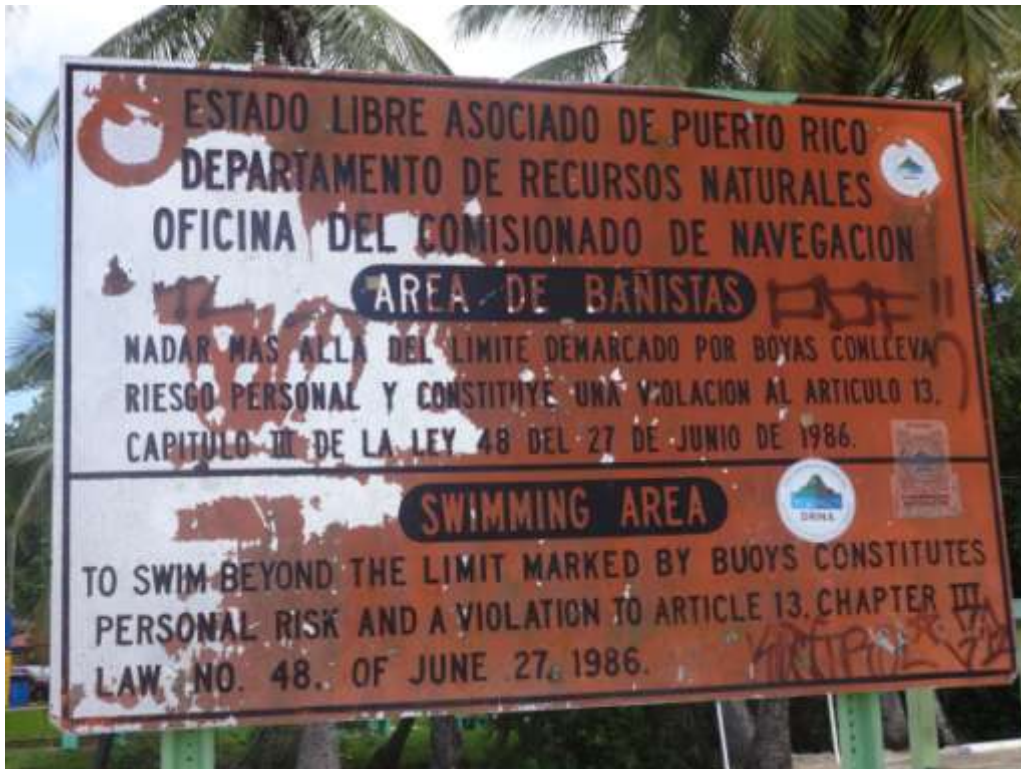
**Figure 23: Swimming Area Sign at Crashboat**

However, people entering on the right side would not notice this sign due to its location. The sign is also not facing the parking lot where people would be entering from. Shown below is a view of the left side of the beach and a blank wall for signs. The right and left side are separated by a small bridge.

- We recommend changing the signs used at Playa Jobos.
- We recommend adding more signs to Ocean Park Beach.
- We recommend adding a sign to the boating side of Crashboat Beach indicating where the swimming area is located.
- We recommend placing “strong current” signs at the relevant areas of La Pared.

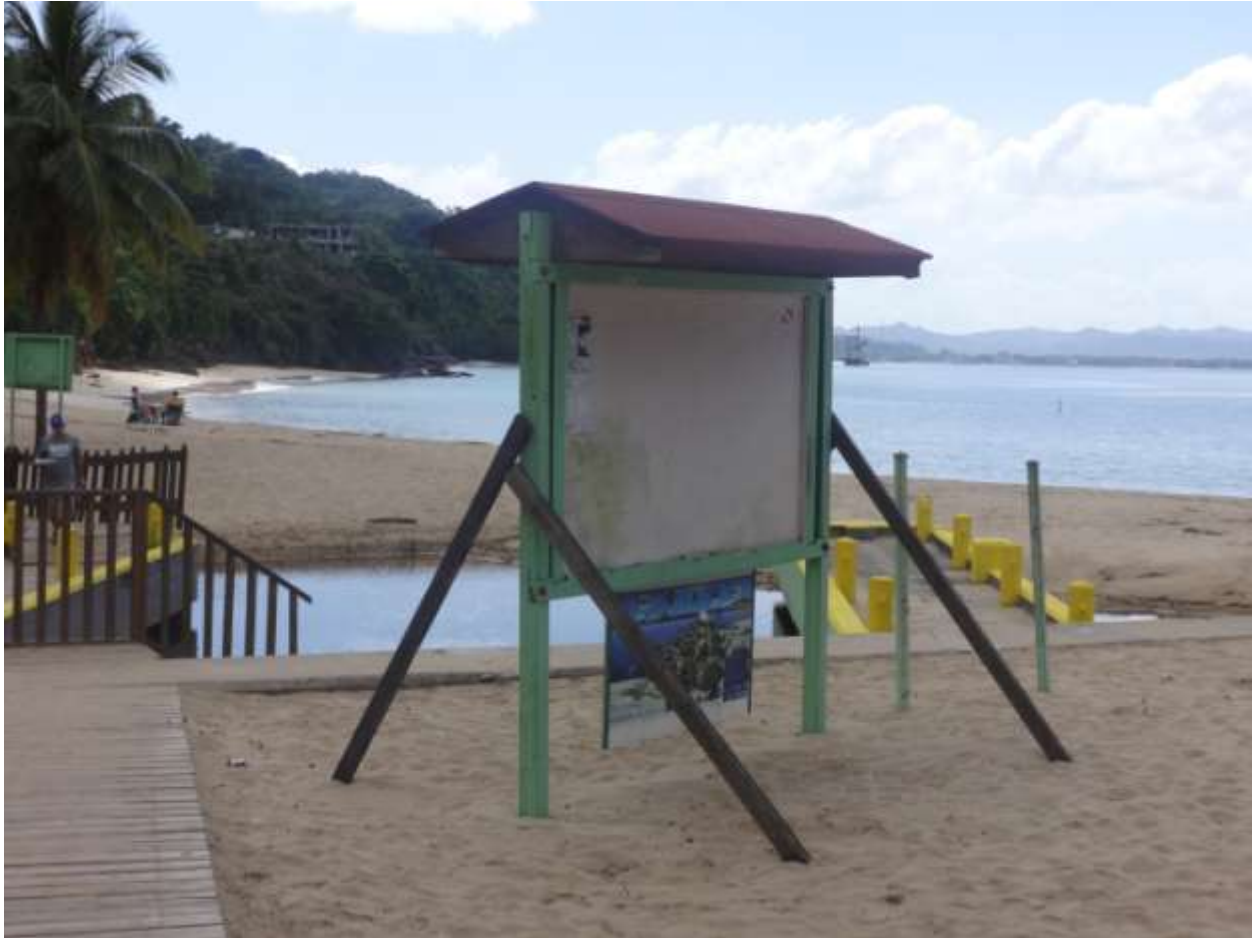
**Figure 24: Empty Board at Crashboat**

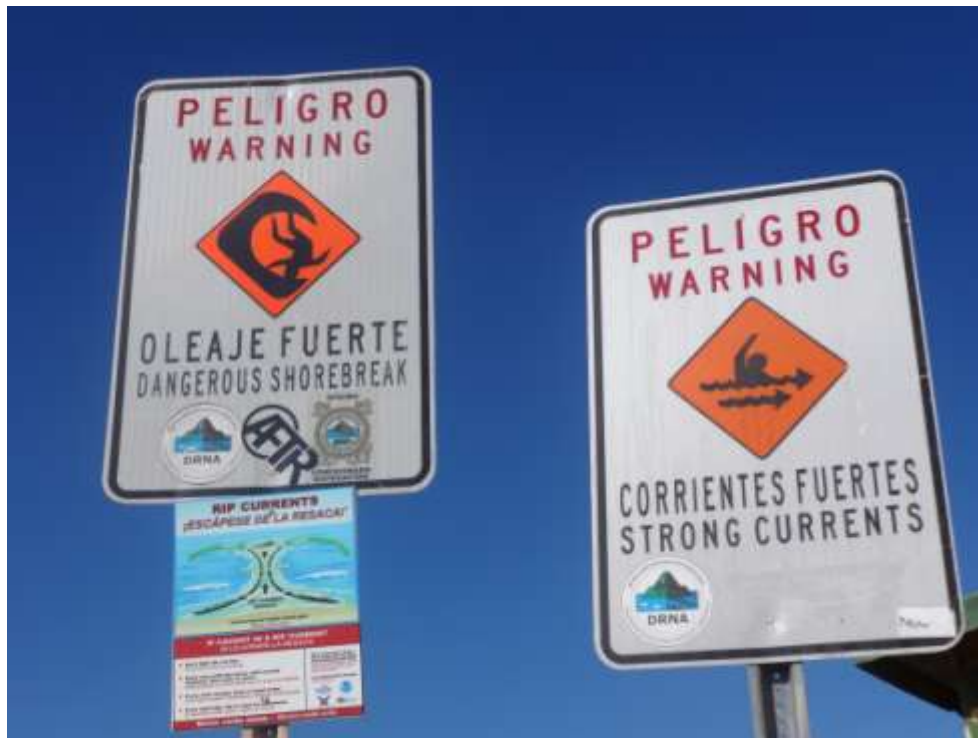
This beach had a parking lot as the only likely entrance so everybody should have a clear look at the warning signs. This beach had three signs to warn beachgoers of potential dangers. All three signs were located at the edge of the beach facing towards the parking lot and were written in both English and Spanish. One sign warned beachgoers about strong currents and had a picture of a swimmer in water. The other two signs were next to this sign. One told beachgoers to be careful about dangerous shorebreaks and had a picture of a person being knocked over by a wave. Directly below that sign was a small notice instructing beachgoers about how to escape a rip current. This sign had a brief diagram to help explain its message. The writing on the sign was very small but still portrayed the message well.

Figure 26: Warning Signs at La Poza del Obispo

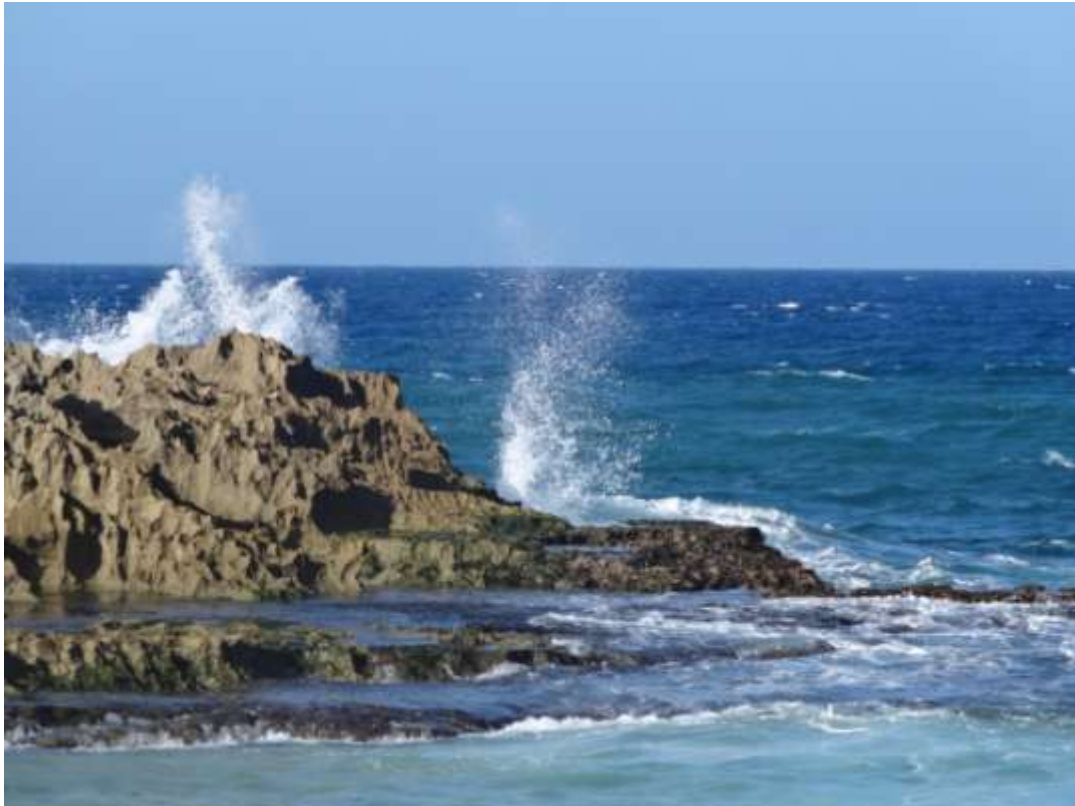
La Poza del Obispo contained large rock and ledge formations to the left that could pose a problem in times of strong swells and large waves. The strong currents could have easily pulled swimmers out into rock formations.

**Figure 27: Waves and Rock Formations at La Poza del Obispo**

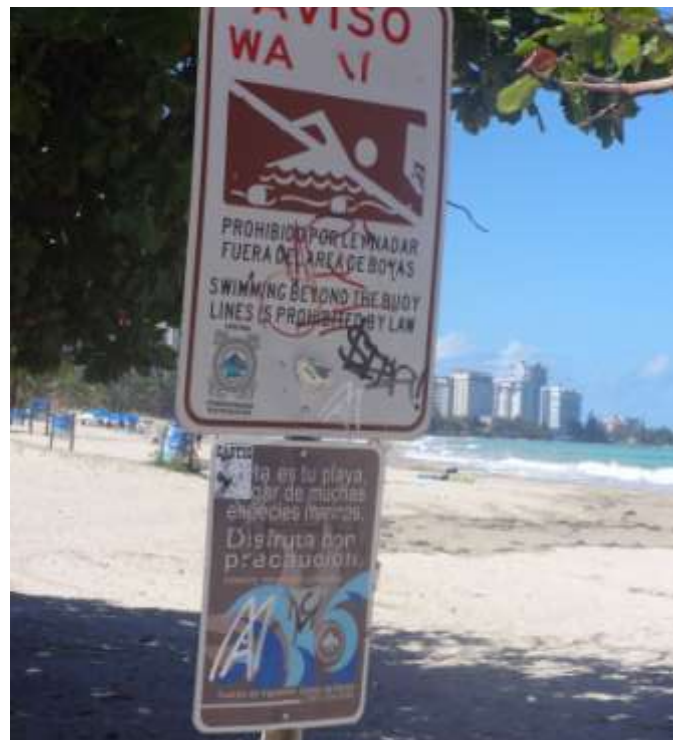
There was a line of buoys around the swimming area. There was a sign written in English and Spanish instructing beachgoers to not swim past the buoys because it was against the law. The sign had some graffiti on it which made it more difficult to read. Also, the word “Warning” was written in English and Spanish but some of the English letters were missing. The sign faced parallel to the coast and was positioned near the center of the beach. It also had a picture of a person swimming with the buoy line next to him and a diagonal slash went through the picture.

Figure 28: Damaged Sign at Isla Verde

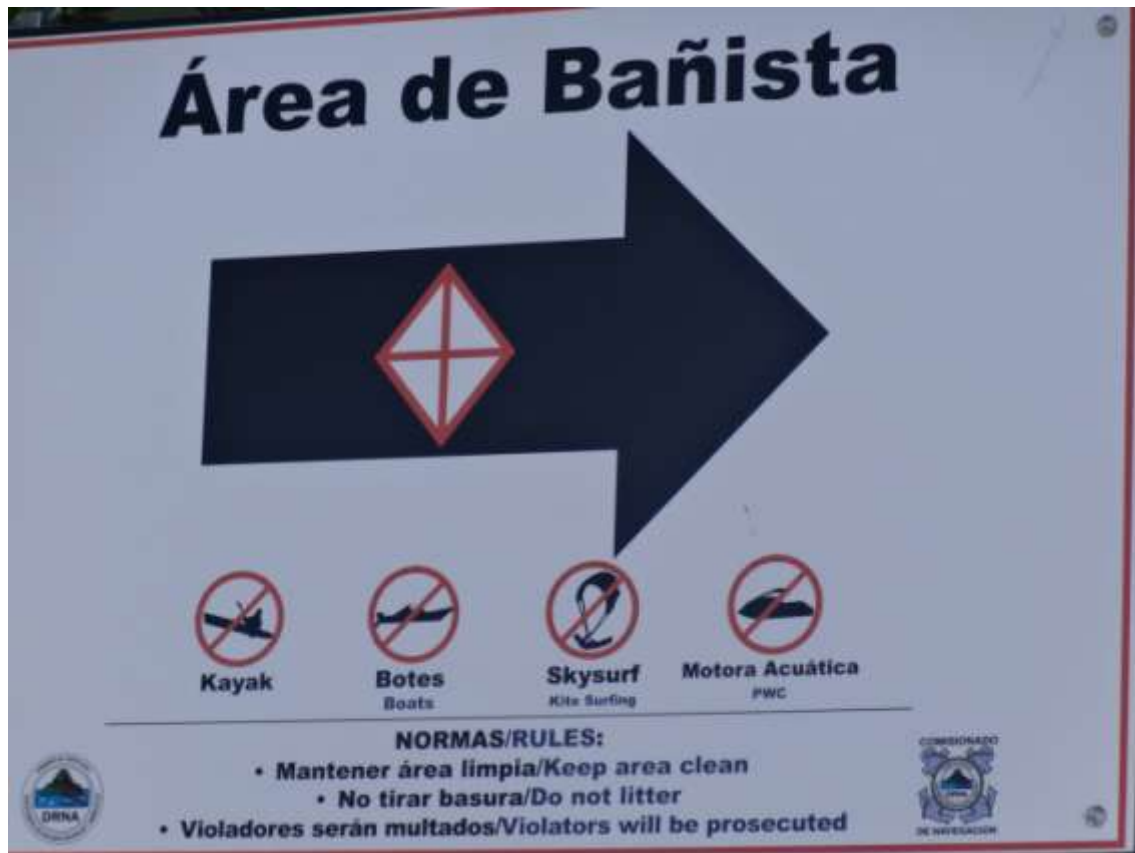
caption that read “Swimming Area” in Spanish only. The signs also said that kayaks, boats, surfboards, and motorboats were not allowed in the swimming area.

Figure 29: Swimming Area Sign at Isla Verde

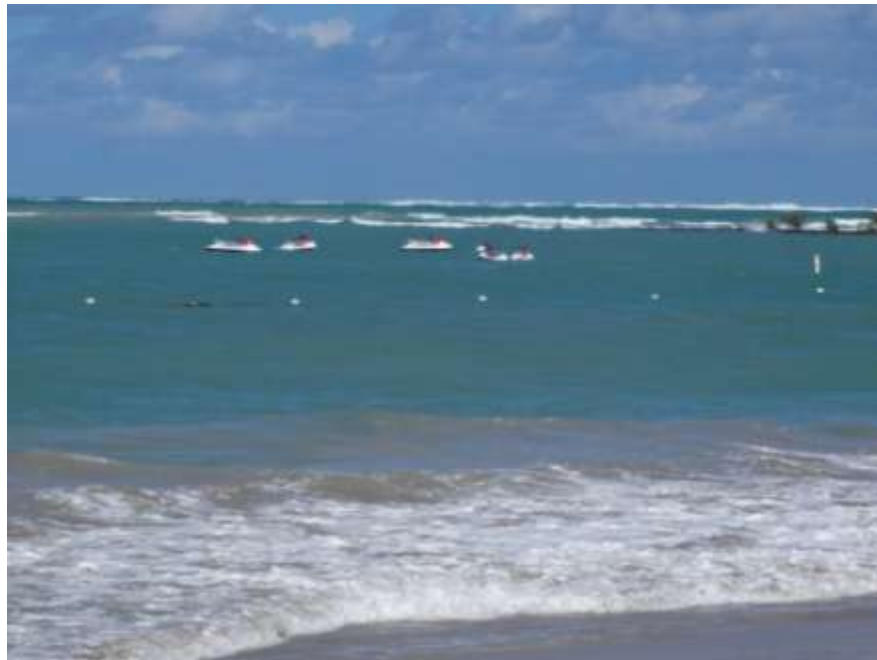
On the day of our team's visit to Isla Verde, there were high winds at speeds of 10-15 miles per hour. The waves that were breaking at shore varied from 2-3 feet and 5-7 feet depending on the location on the beach. The currents these waves produced were generally small although the waves were sometimes larger. The currents would not cause a serious problem at this beach unless waves were significantly higher. There were also large amounts of sand and seaweed in the water, meaning the waves broke with high amounts of power. The marked swimming areas were also split in two because of a path for jet skis to enter the ocean. This could pose a problem if people are not paying attention to the marked swimming areas.

**Figure 30: Jetski Area at Isla Verde**

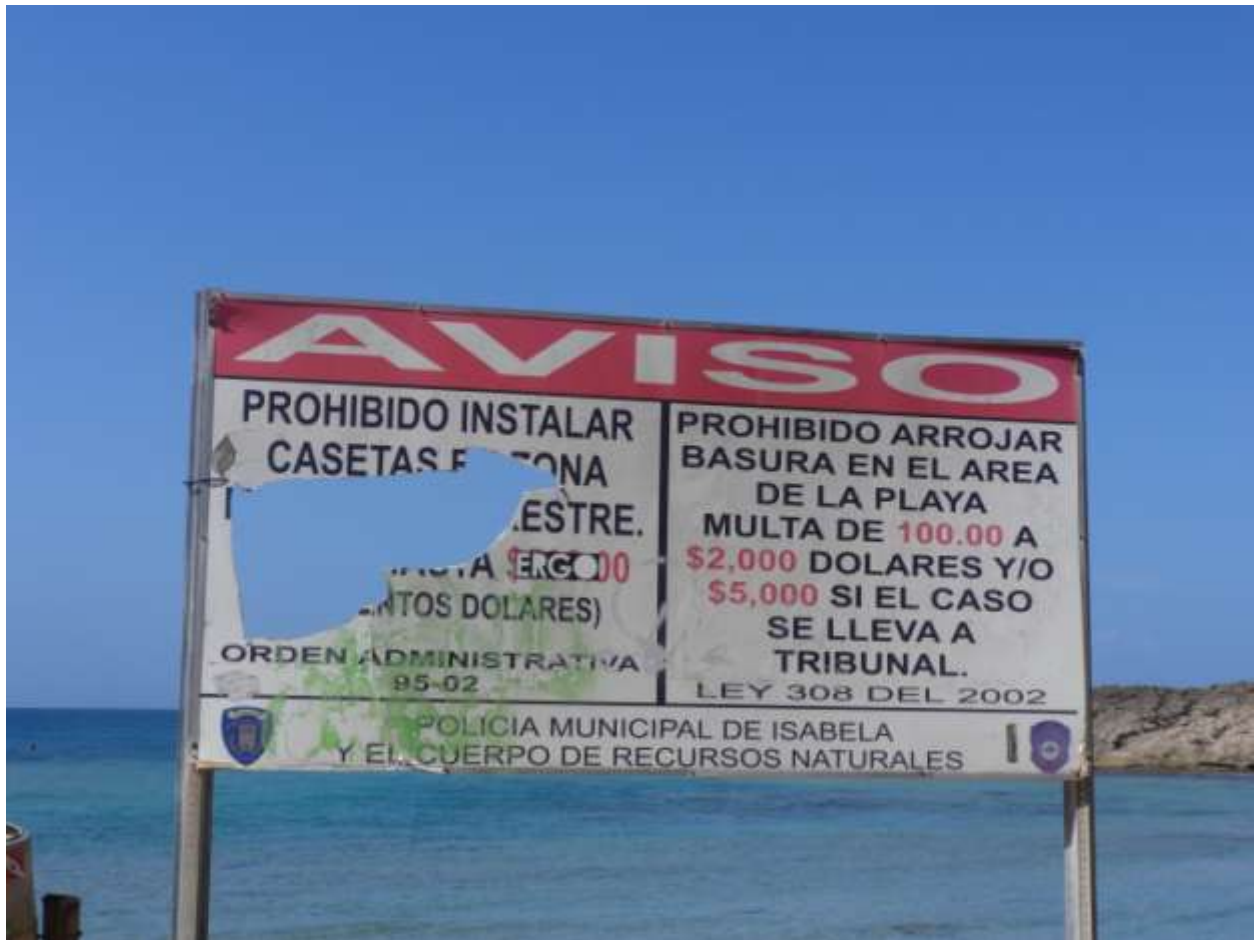
locations of the signs. The first is a large warning sign written only in Spanish with a very large hole in it, as seen in the picture below.

**Figure 31: Damaged Sign at Jobos**

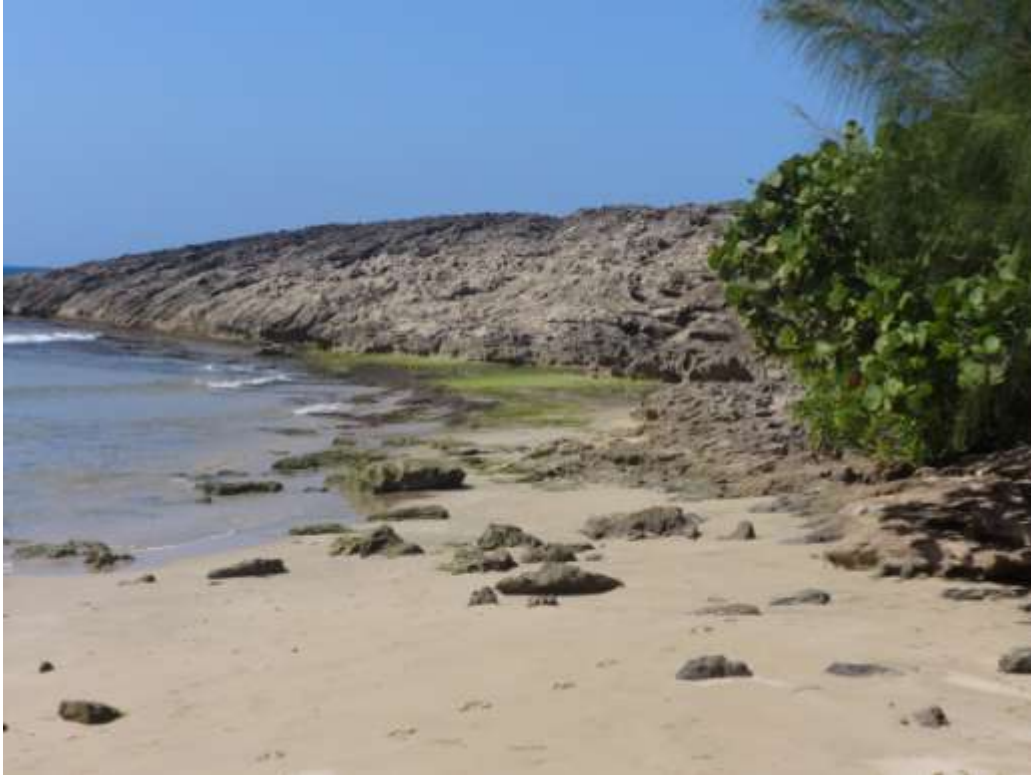
On the right side of Jobos, there is a very large rock formation and even rocks along much of the shore, shown below.

**Figure 32: Large Rock Formation at Jobs**

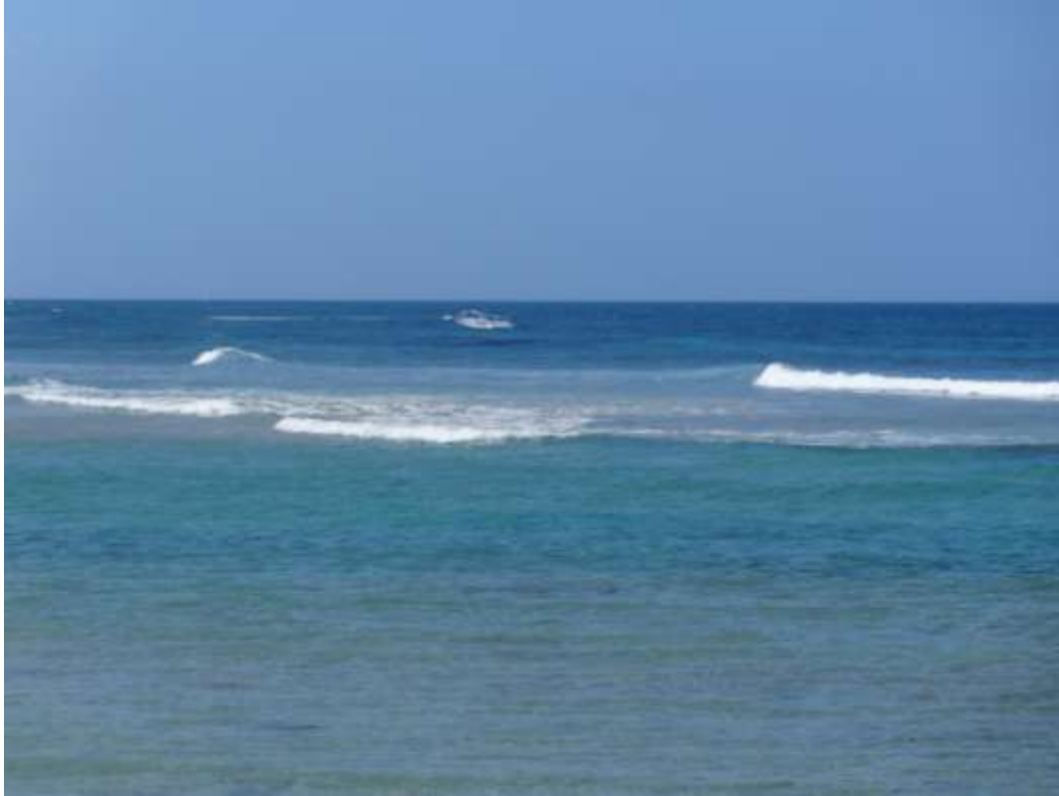
Most of the visitors come from the left side of the beach, so the rocks to the right pose no problems to them. Also, most of the swimmers stayed away from the rocky areas. There was also a sandbar in the water, which could be dangerous to swimmers during larger swells because it may give them a false sense of security. The sandbar is shown below.

**Figure 33: Sandbar at Jobos Beach**

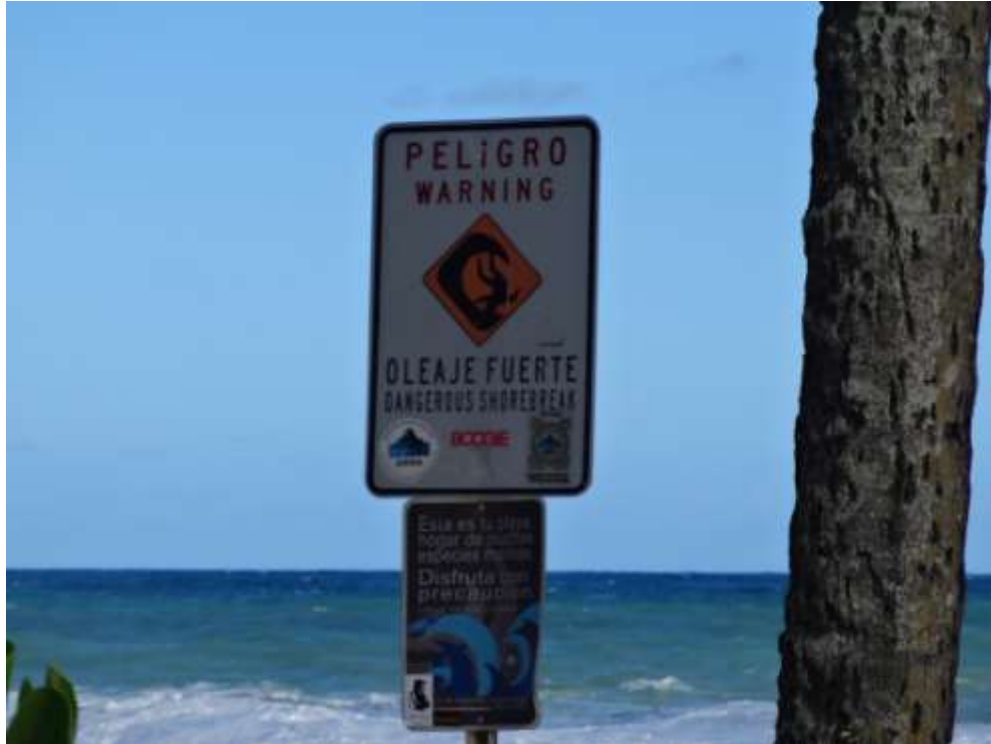
There were multiple small entrances to the beach from the street where beachgoers could enter in which there were no signs, apart from the main entrance above. If somebody entered through one of these smaller entrances, the important information would not be known by the person. At Aviones, there are two other signposts. However, at one post, the sign is completely removed so it is unknown what that sign displayed. The other post has two signs, one displaying that there is a “dangerous shorebreak,” which is conveyed through a picture and is in both English and Spanish. The other sign shows large waves but is only written in Spanish. These signs are shown below.

**Figure 35: Dangerous Shorebreak Sign**

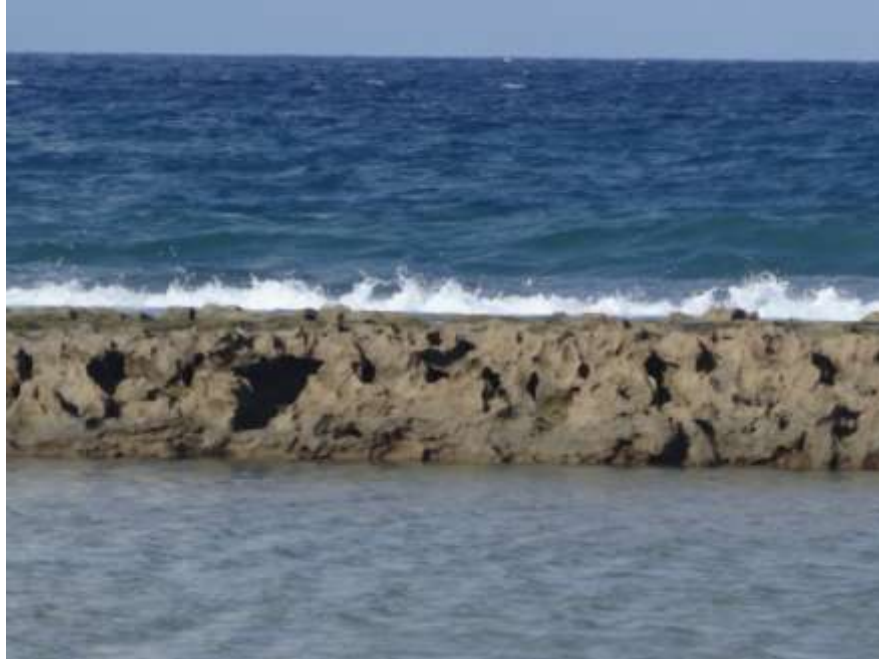
There is a large wave breaker at La Poceta that separates most of the water from the rest of the ocean, as shown in the picture below. The side of the wave breaker closest to shore is very calm, where most swimmers would be. However, the side of the ocean gets continuously pounded by large waves.

**Figure 39: Wave Breakers at La Poceta**

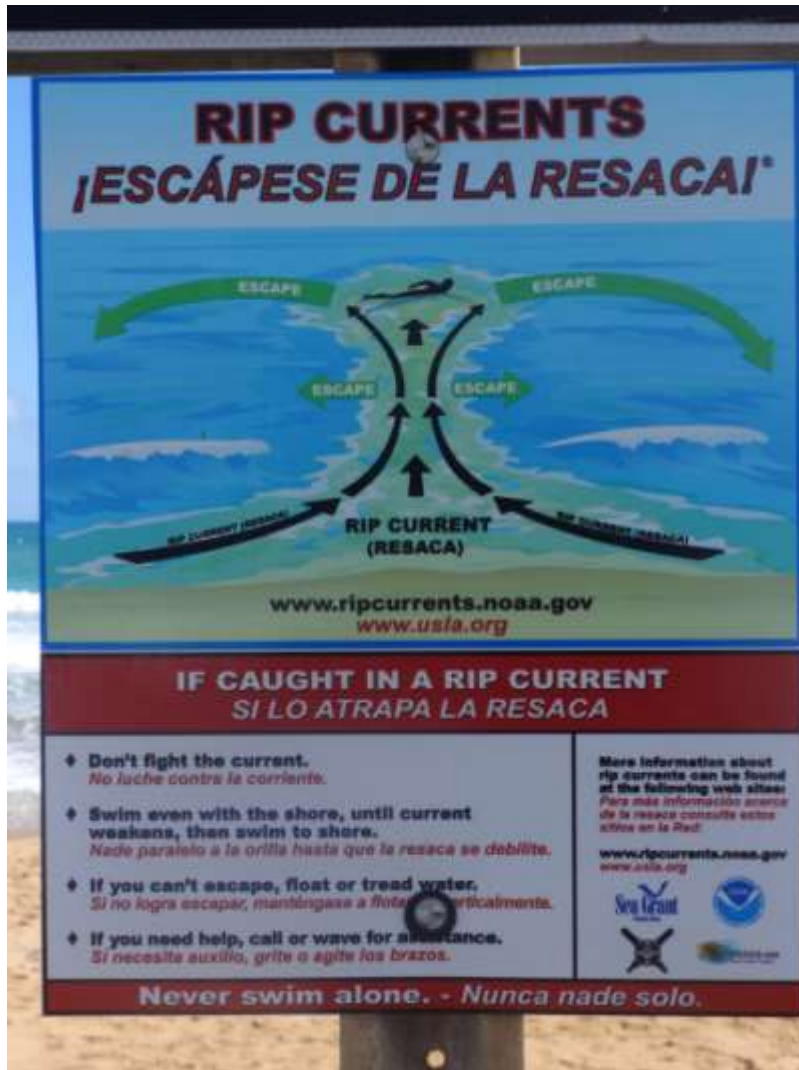
This is especially important at La Pared because of the dangers the beach poses. A talk with a local safety volunteer also stated that he wished more beaches had these escape plans because many people do not know the steps to take if caught in a rip current. A better view of the escape plan is shown below, with a picture and written in both English and Spanish.

Figure 42: Rip Current Escape Plan at La Pared

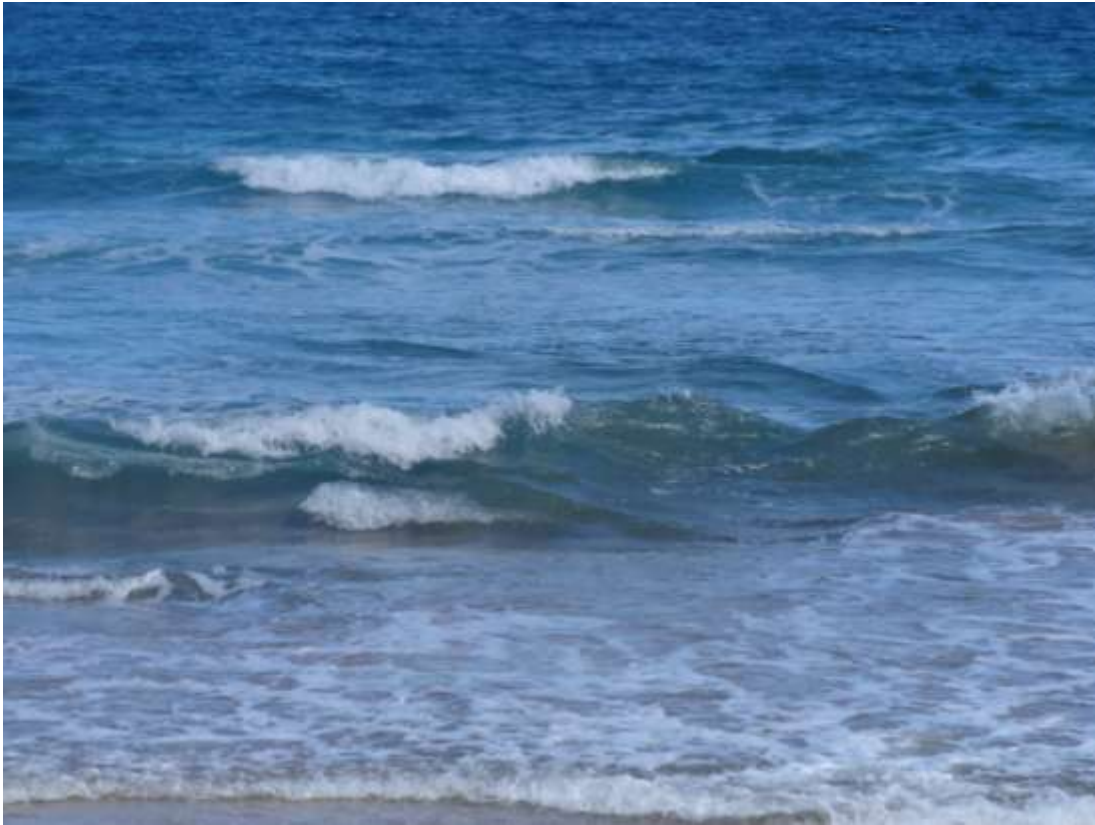
Although the wind was a low 4 miles per hour and the waves were a relatively small 2-3 feet consistently, the rip currents were very significant.

**Figure 43: Consistent Waves at La Pared**

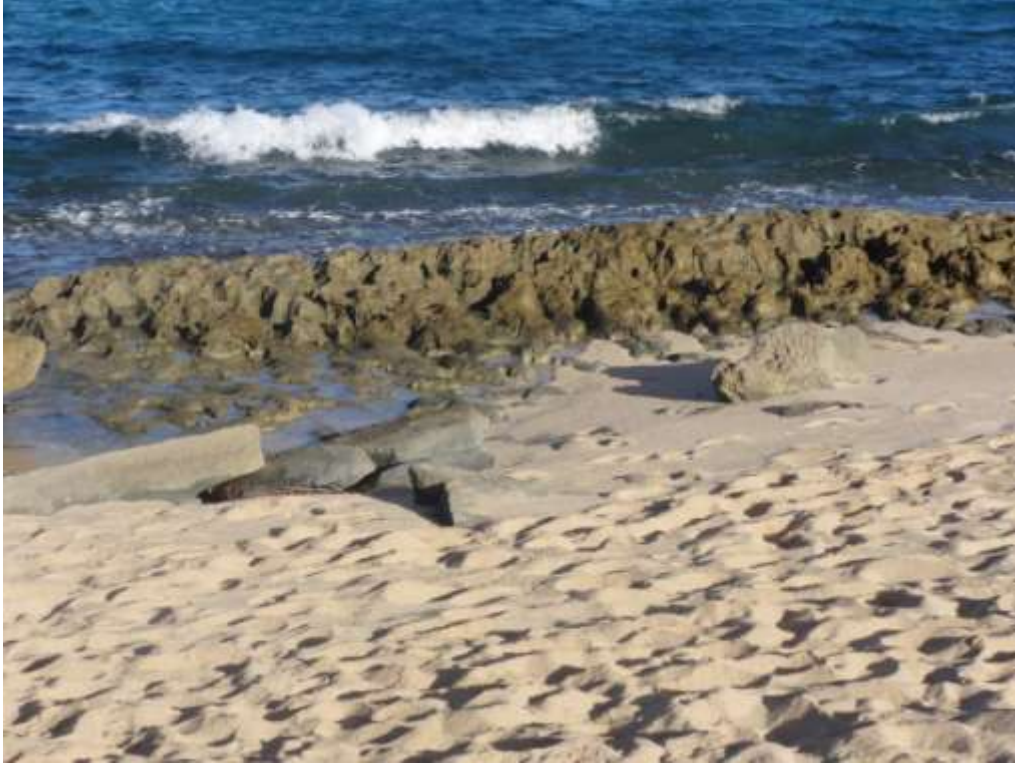
While the current at this beach was very strong, most of the force of the currents was blocked by rocks and only a small inlet allowed water to pass through into the main beach area. The waves break early and there are many rocks in the area around the shore, as seen below.

**Figure 46: Rocky Shore at Mar Chiquita**

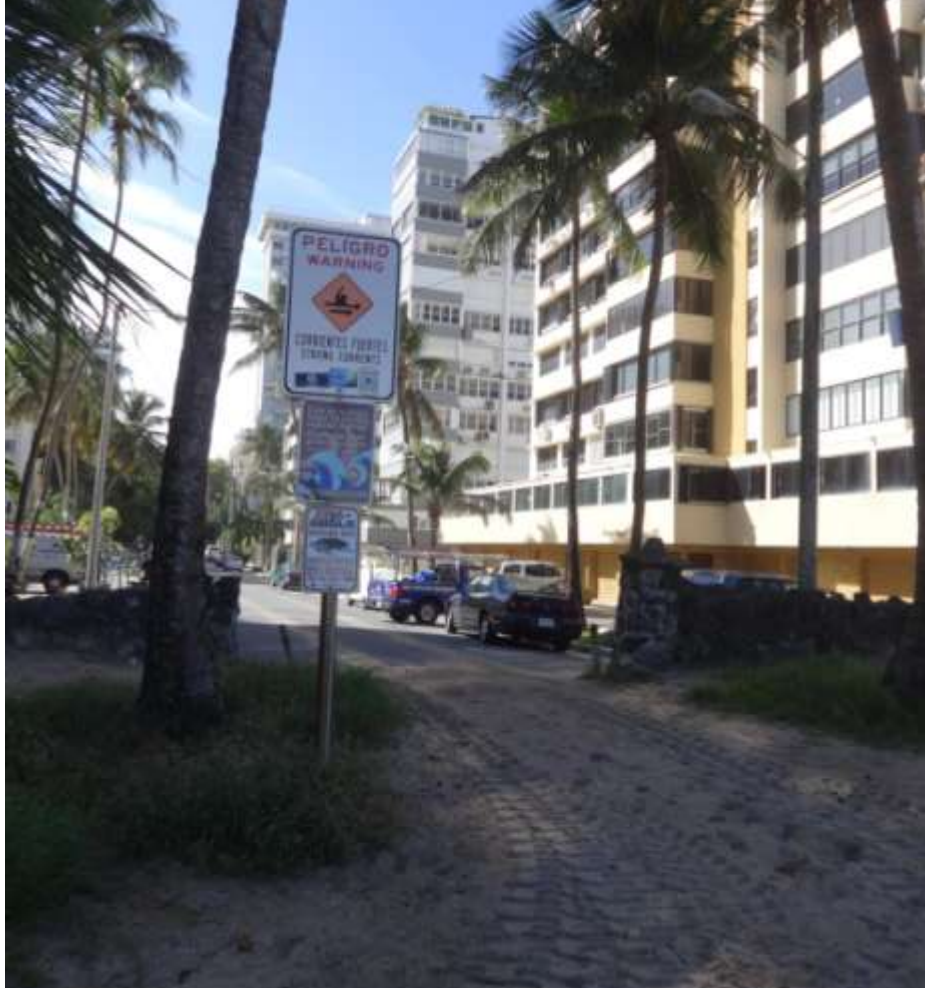
In the stretch of beach that our team analyzed, there are various routes from the hotels and streets that people can enter the beach. Out of all the entrances that are available to beachgoers, there are only two signs warning of dangers at the particular beach, although one is at an entrance. As with most of the northern coast of Puerto Rico, Ocean Park has very strong currents. The two signs both display “strong currents” in English and Spanish, as well as a picture of a current. However, these signs are back away from shore, under trees, in areas that are most likely only viewable if beachgoers are specifically looking for signs.

**Figure 49: Strong Current Sign at Ocean Park**

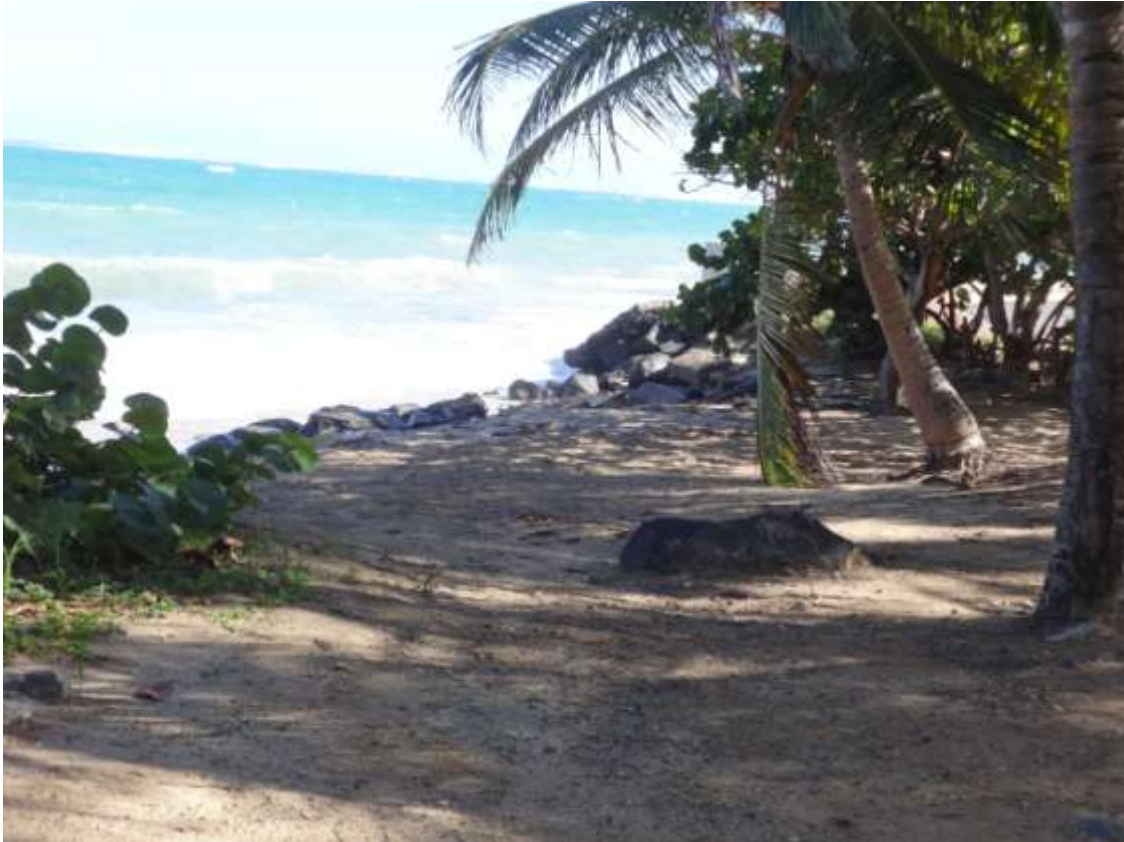
Último Trolley is located next to a road that runs parallel for the duration of the stretch of beach. Although there is a small wall separating the sidewalk from the sand, people can enter the beach at any point. There is a main entrance with a large “no swimming past buoys” sign. The sign is written in English and Spanish and also has a picture. However, this picture can be easily confused with a “no swimming” sign if glanced at quickly. A better picture would more easily convey this message and avoid any confusion. The sign is very large compared to signs at other beaches and can be seen from any entrance to the beach. Also, there is a large rocky area to the right edge of the beach, seen through the trees in the picture below.

**Figure 51: Rocky Shore at Último Trolley**

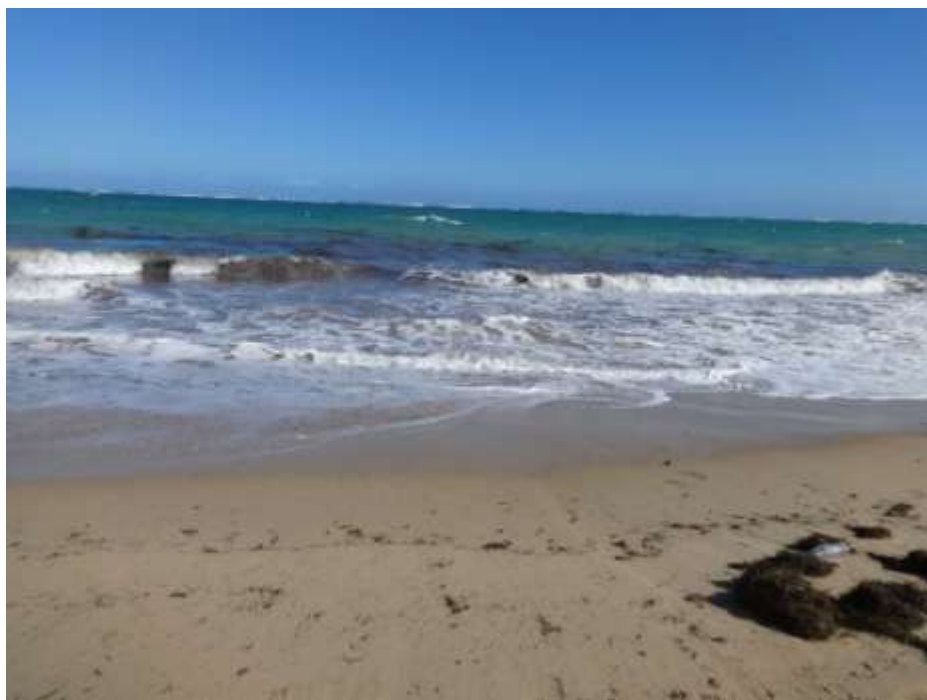
There was a large amount of sand and seaweed, which means that waves and currents are strong enough to keep material off the beach, as seen in the picture above and the picture below.

**Figure 53: Seaweed in Water at Último Trolley**

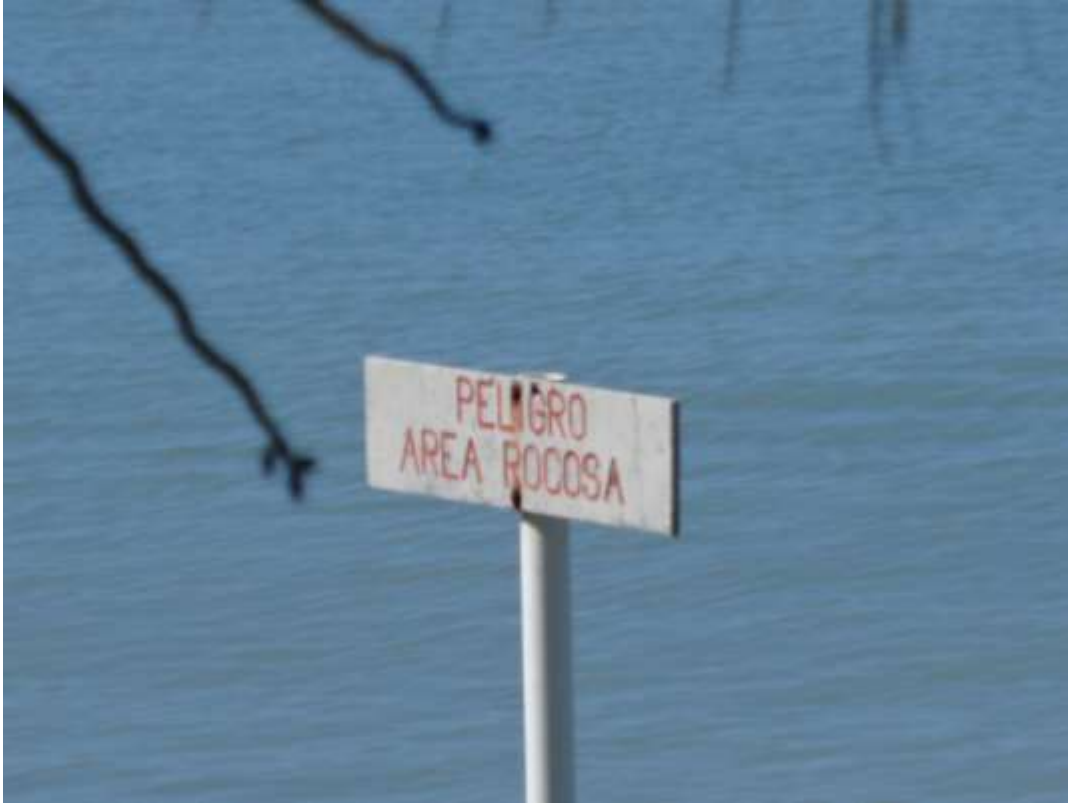
There is also a sign telling about the Blue Flag program and what criteria the beach must meet. Along with the overall rules, there are two signs that display “danger, rocky areas” that are only written in Spanish.

**Figure 55: Rocky Area Sign at Boquerón**

This is a problem if people do not understand Spanish because the rocks could pose a serious problem if swimmers are near them. Lastly, there is a sign displaying what the color of each flag means. The Spanish side of the sign is clear but the English side is completely unreadable. Some signs are also missing letters and are not very noticeable in the location they are in.

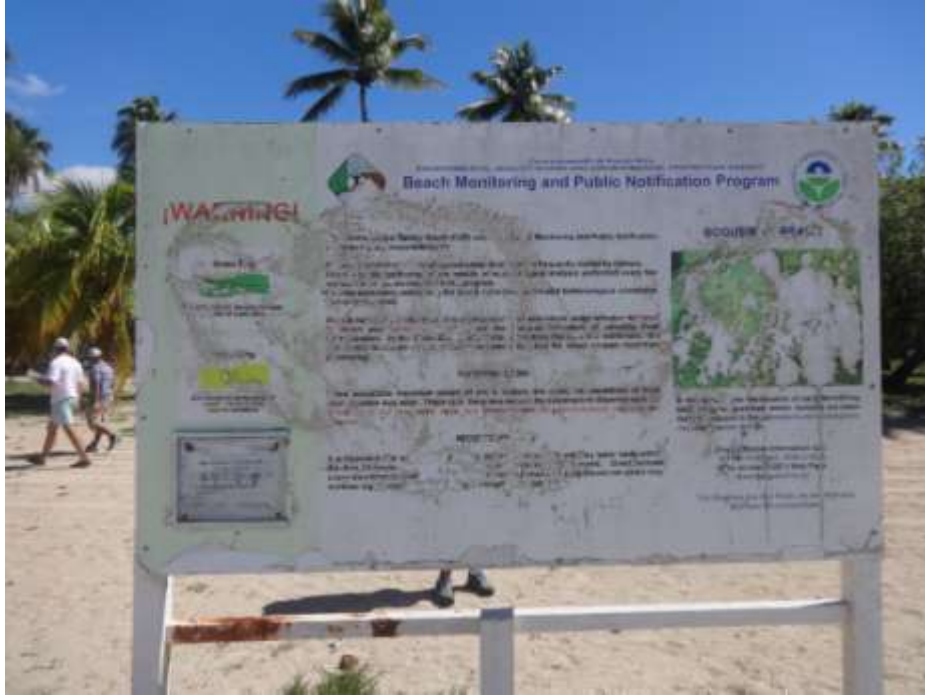
Figure 56: Badly Damaged Sign at Boquerón

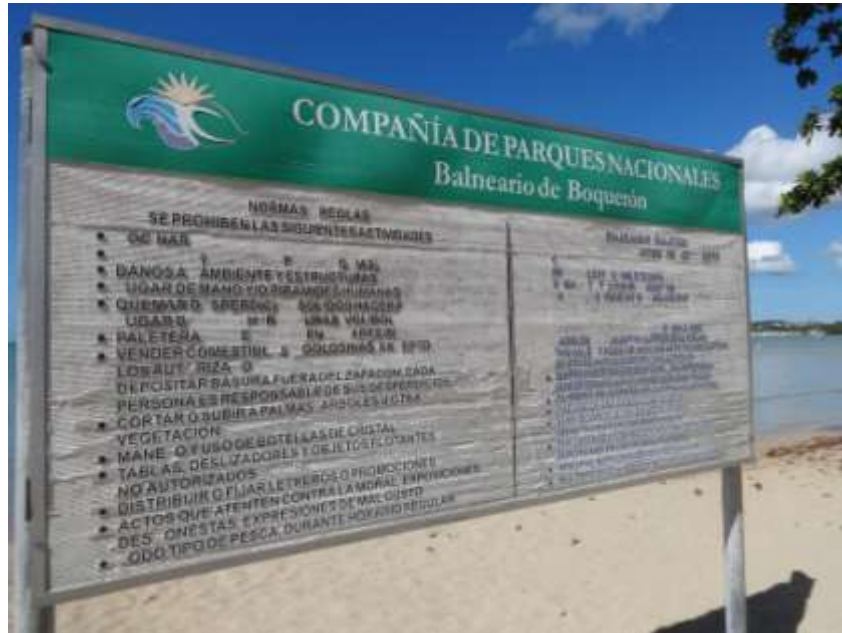
Figure 57: Damaged Sign at Boquerón

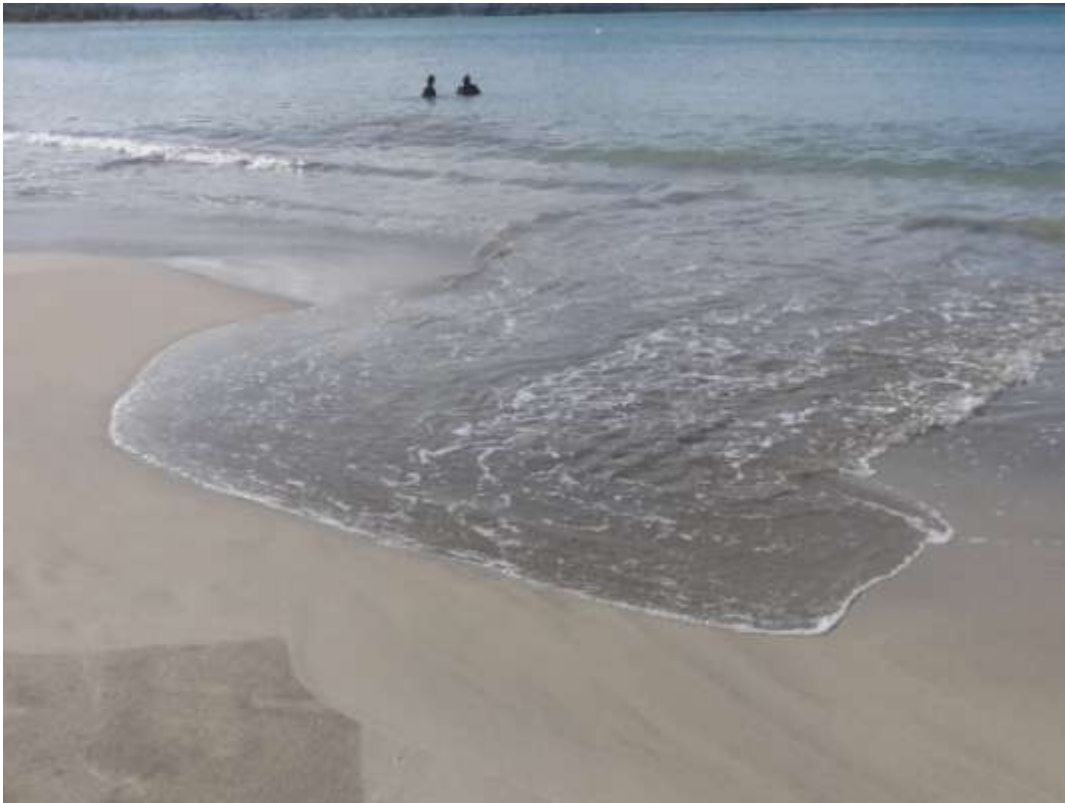
**Figure 65: Small Rip Current at La Monserrate**

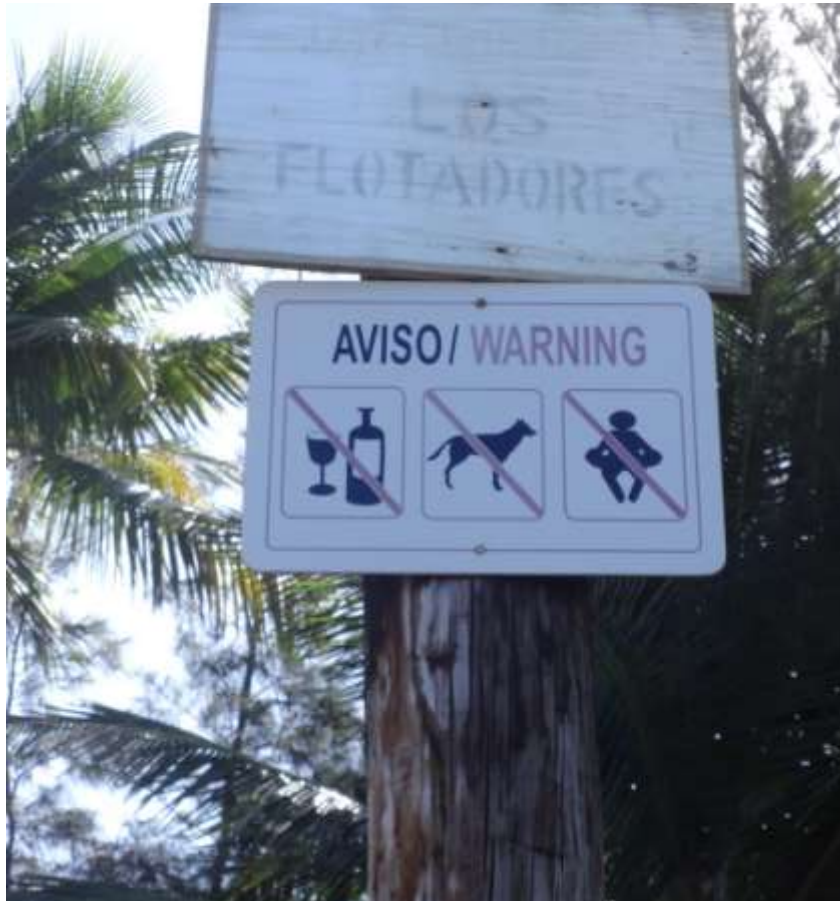
Figure 69: Faded Sign & Warning Sign at Punta Salinas

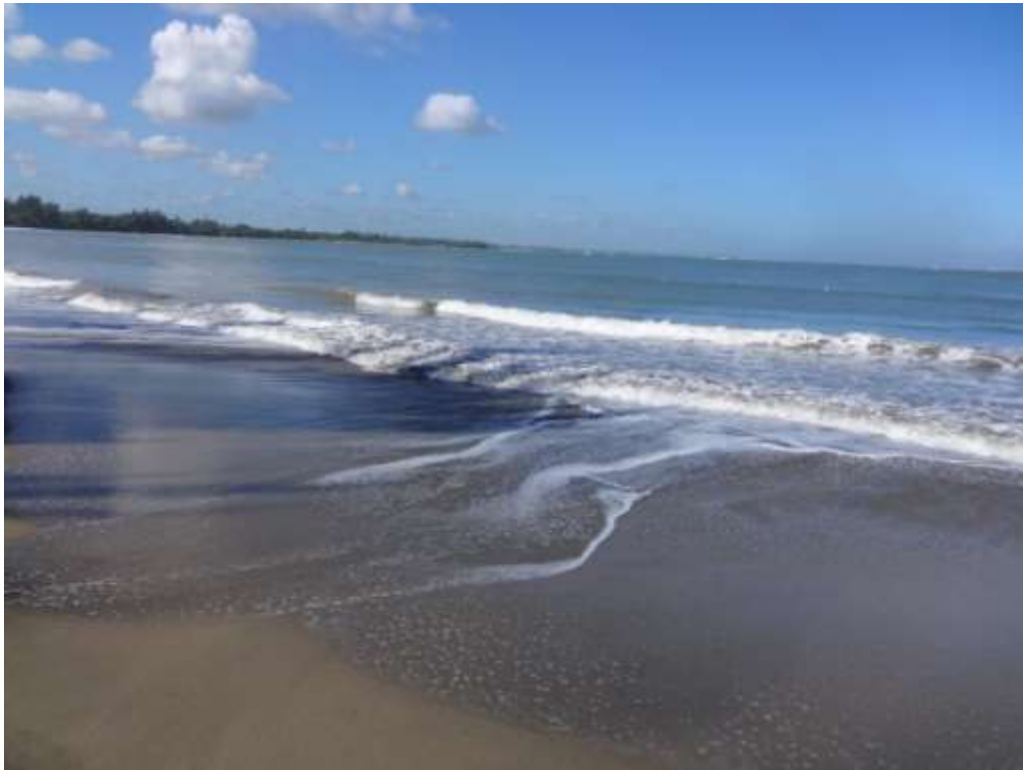
**Figure 70: Small Rip Current at Punta Salinas**
