An Analysis of the Archaeological Potential of Venetian Church Floors

An Interdisciplinary Qualifying Project
Submitted to the faculty of
Worcester Polytechnic Institute
in partial fulfillment of the requirements for the
Degree of Bachelor of Science

Soprintendenza all'Archeologia
UNESCO

Date: July 29, 2004
www.wpi.edu/~mshaw323/venice
churches-c04@wpi.edu

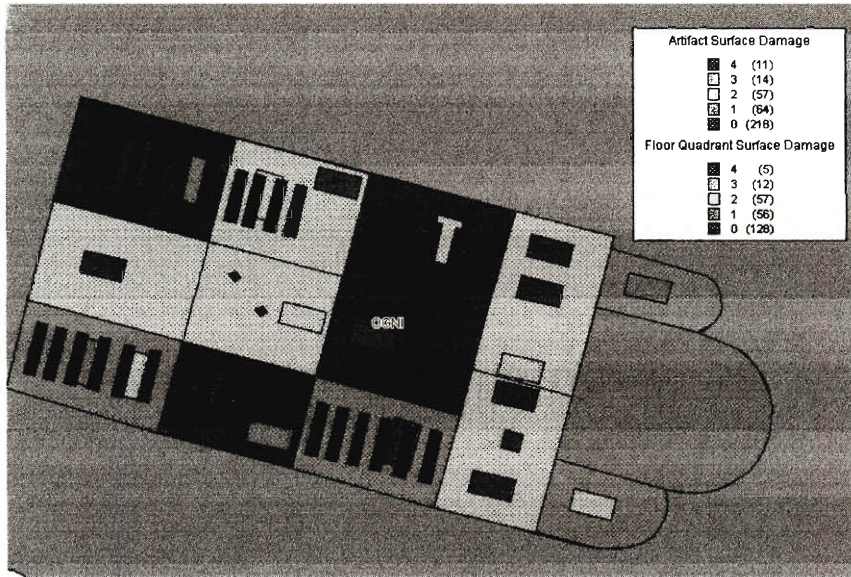
Figure 47: Damage in Ognisanti

An example of this correlation can be seen in Figure 47.

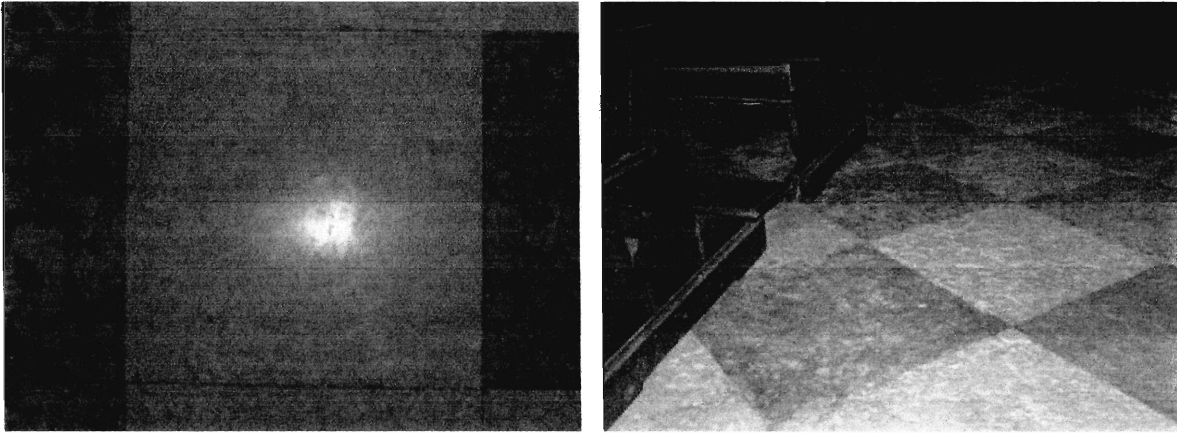
Figure 57: Floor Damage Comparison: New vs. Damaged

The newer the floor the better the condition it should be in, therefore the overall floor damage is another important factor indicating floor replacement. An example of a new, undamaged floor compared with an older, damaged floor can be seen in Figure 57. The churches we studied that we knew contained artifacts beneath their floors all had floors in good condition because of the fact that a new floor was built on top of the old floor containing the artifacts. The floor damage was already in our 0 – 4 scale but a score of 0 was the best scenario and for the rest of our formula, 4 has represented the best scenario, therefore the floor damage numbers will be reversed from their usual meaning, such that a 0 became a 4 for our formula

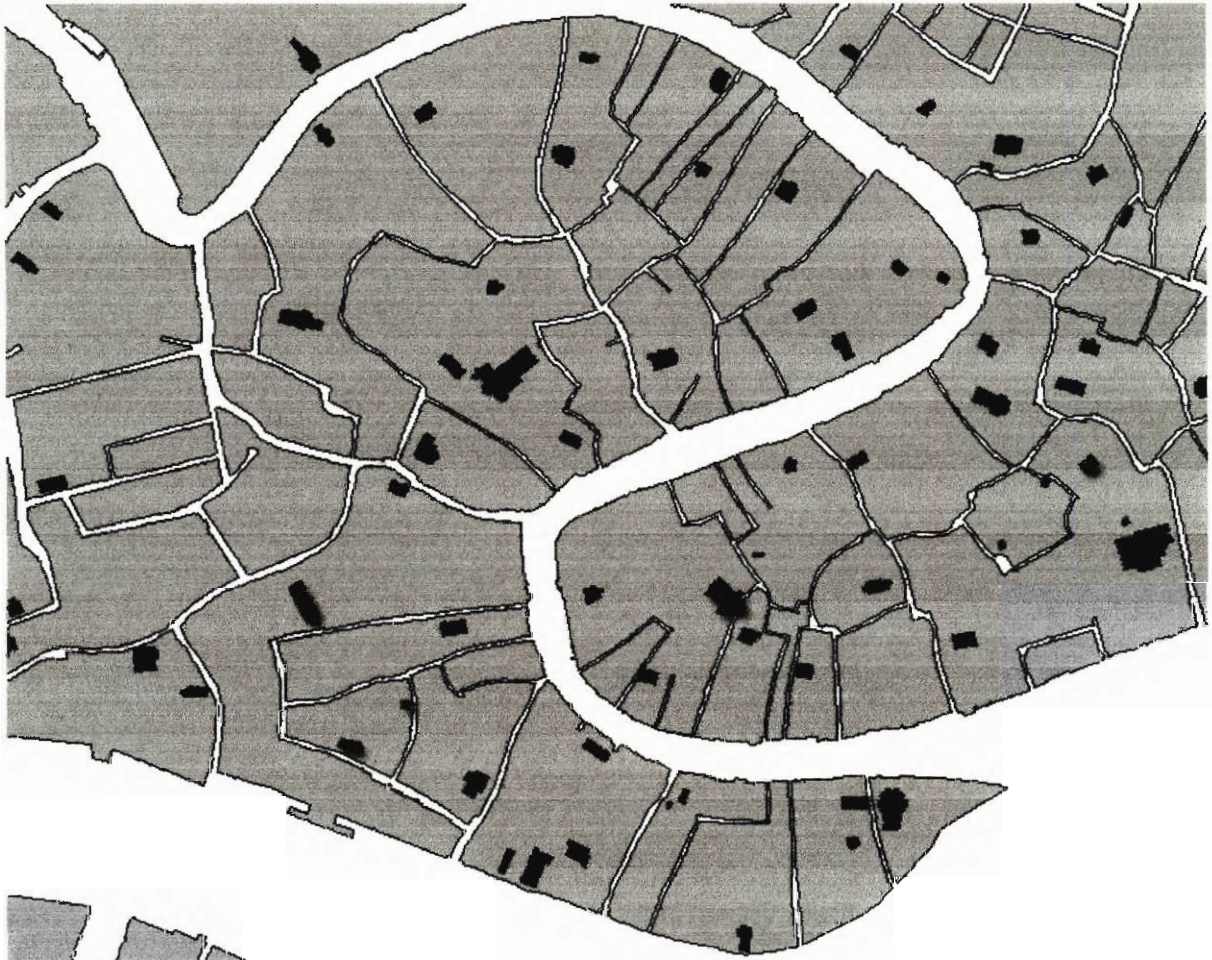
Figure 61: Map of top 5 churches

This is a graph of the archaeological potential and restoration potential, which combine to form the excavation opportunity. The graph is sorted by the restoration potential because we feel that it is the most important factor since only churches that are being restored have the ability to be excavated. The churches with a low restoration potential and high archaeological potential that can be seen on the left side of the graph are lost archaeological opportunities. These churches have artifacts beneath their floors but they also have relatively new floors in good condition that do not have a very good chance of being restored in the near future. The churches on the right side of the graph are the churches we are recommending that the *Soprintendenza all'Archeologia* pay attention to for excavation opportunities. A map of the top five churches can be seen in Figure 61. The five churches that we recommend that the *Soprintendenza all'Archeologia* monitor are *Ognisanti*, *Santa Maria dei Carmini*, *San Stefano*, *San Zulian*, and *Eremitane*.
