An Evaluation of Nantucket's Town Facilities

December 18, 2014

An Interactive Qualifying Project
submitted to the Faculty of
WORCESTER POLYTECHNIC INSTITUTE
in partial fulfillment of the requirements for the
degree of Bachelor of Science

Gregg Tivnan
Nantucket Town Manager's Office

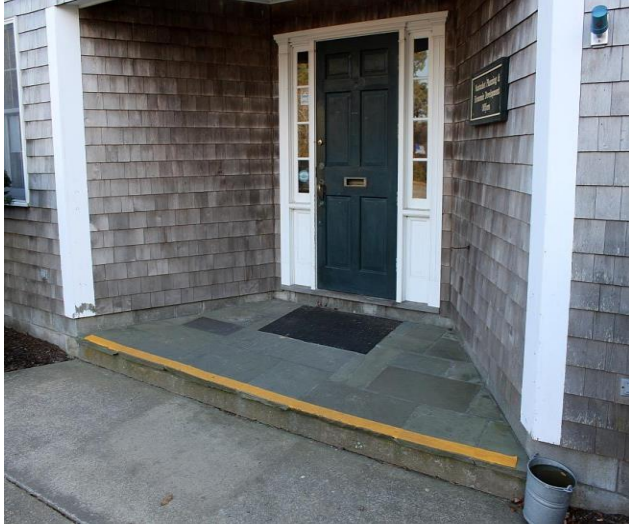
An additional issue spanning across multiple facilities is handicap accessibility and compliance with the American Disability Act (ADA). The PLUS building has a major issue with accessibility due to a large step at the front entrance (see Figure 19). The bathrooms are non-accessible and the offices are so tightly spaced that navigation with any sort of walking disability could be extremely difficult or at the very least hindered. The frequent public use of this facility demands that this issue be addressed. There are similar issues in many other facilities: those located in the downtown area may only be accessed by utilizing the brick sidewalks which are often uneven or broken. Moving outside of the downtown area, the DPW Administrative Building has a ramp at the front entrance, but has a tight 90-degree turn that could be extremely difficult to navigate for larger wheelchairs (see Figure 20). The majority of town facilities do not have automatic or even wide enough doors, and many lack elevators and handicap accessible bathrooms.

Figure 19: Large step at entrance of PLUS

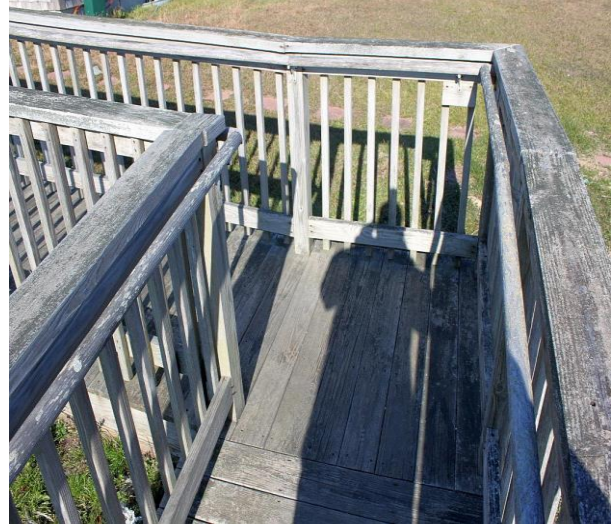
Figure 20: Tight ramp at DPW Administrative Building

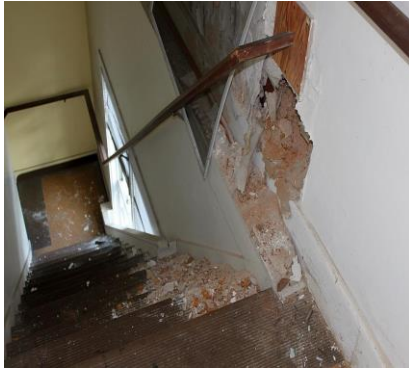
Figure 23: Condemned staircase at 20 South Water St

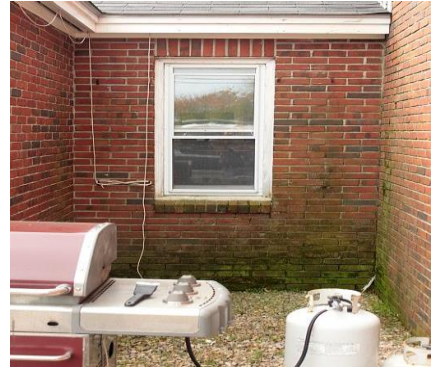
Figure 25: Water damaged brick veneer at main fire station

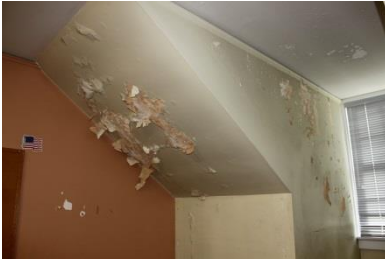
- Currently occupied by only three full-time employees (only use approximately 1000 of the 5200 square feet);
- Drywall deteriorating and insulation falling through ceilings and walls;
- Exposed electrical wires and uninsulated pipes;
- Multiple holes in walls and floors;
- Significant water damage on ceilings/walls, especially second floor (see Figures 32 & 33);
- One of two staircases is condemned according to Facility Manager, Larry Kester;
- Many unused/unidentified wiring systems still in place (see Figure 34); and,
- Outside trim and windows are deteriorating (i.e. rust and rotting wood).

Figure 32: Water damaged ceiling

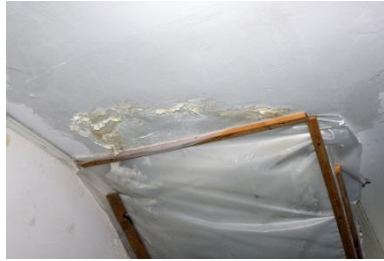
Figure 33: Water damaged ceiling

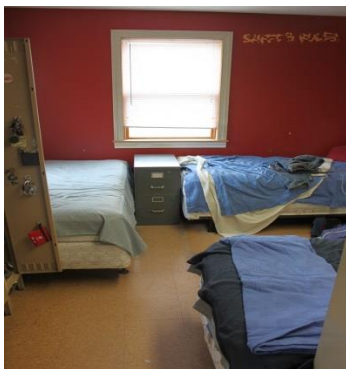
Figure 40: Cramped sleeping quarters

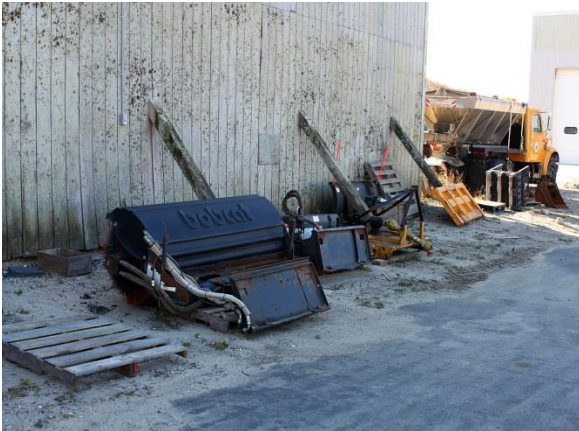
- In generally good condition from a structural standpoint;
- Garages do not provide adequate space to house all of the town's equipment - multiple trucks and pieces of equipment are left outside and exposed to weather (see Figure 56 and 57);
- Inadequate storage space for spare parts for equipment; and,
- Inadequate space to house equipment needed to repair vehicles - it is time-inefficient to not have all equipment on hand, seeing as it already takes, on average, 4-6 weeks for repair requests to get through the procurement process.

Figure 56: Expensive equipment stored outside

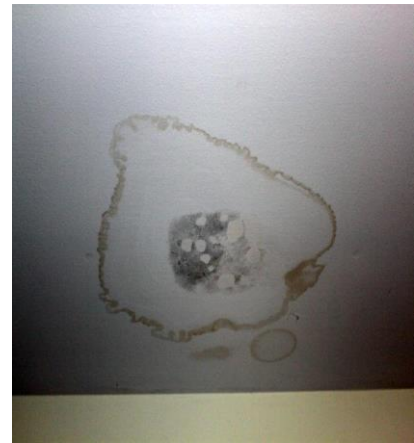
Figure 64: Ceiling leak in the DPW Administration offices

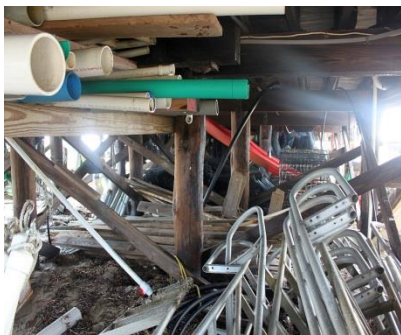
- In off-season, underside of building is used as a space for storing equipment - this area is extremely cluttered and hazardous to people walking around in it (see Figure 78);
- Boat loading dock was recently redone and is in excellent condition;
- Black mold present on building shell, interior windows, and steel beams (see Figure 79);
- No seals around interior supporting pillars (steel) - ground is visible in gaps surrounding pillars (see Figure 80);
- No sealed doors upstairs - this creates the largest facility problem for the shellfish biologist, because it prohibits sterilization and temperature control for optimal shellfish breeding; however,
- Plans are in place for a complete renovation.

Figure 78: Cluttered storage space
