ASSESSING WILDFIRE RISK TO THE BUILT ENVIRONMENT AT THE ESTES PARK YMCA

Sponsor:
The Young Men's Christian Association (YMCA) of the Rockies

May 3, 2022

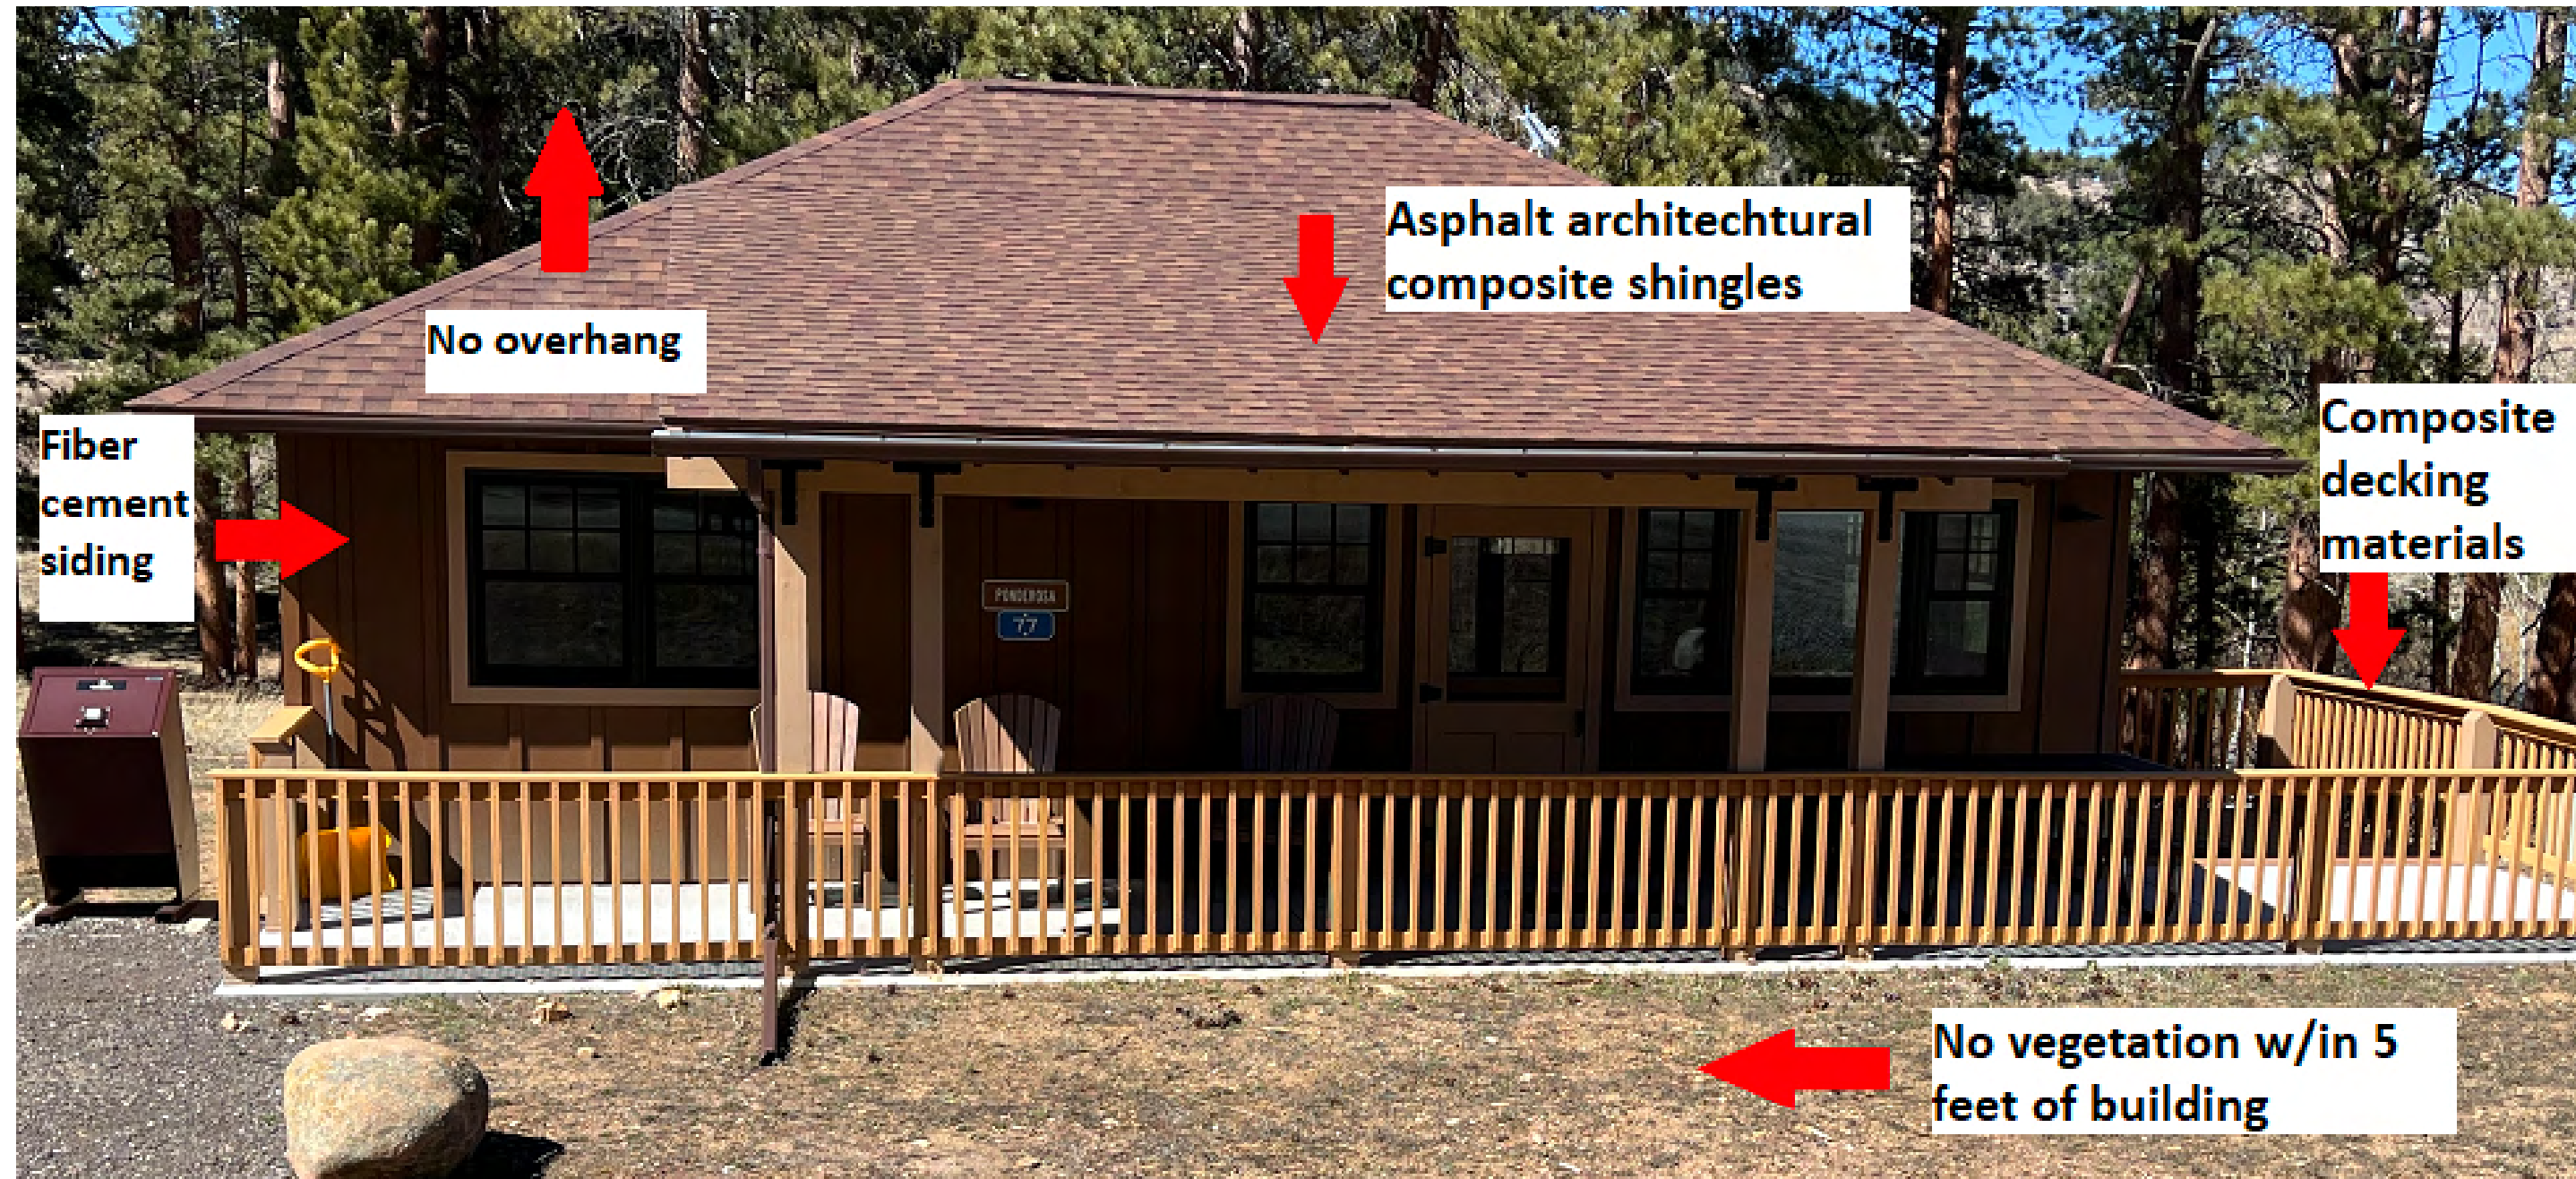
Figure E: Diagram of cabin (Ponderosa) with proposed retrofitting changes

For what the Y should do for existing buildings, wooden siding materials should be replaced with fiber cement panels, and any porches made of wood should instead be replaced with composite decking material if the deck is on an incline. If not on an incline and instead on flat land, the porch should be made out of cement.

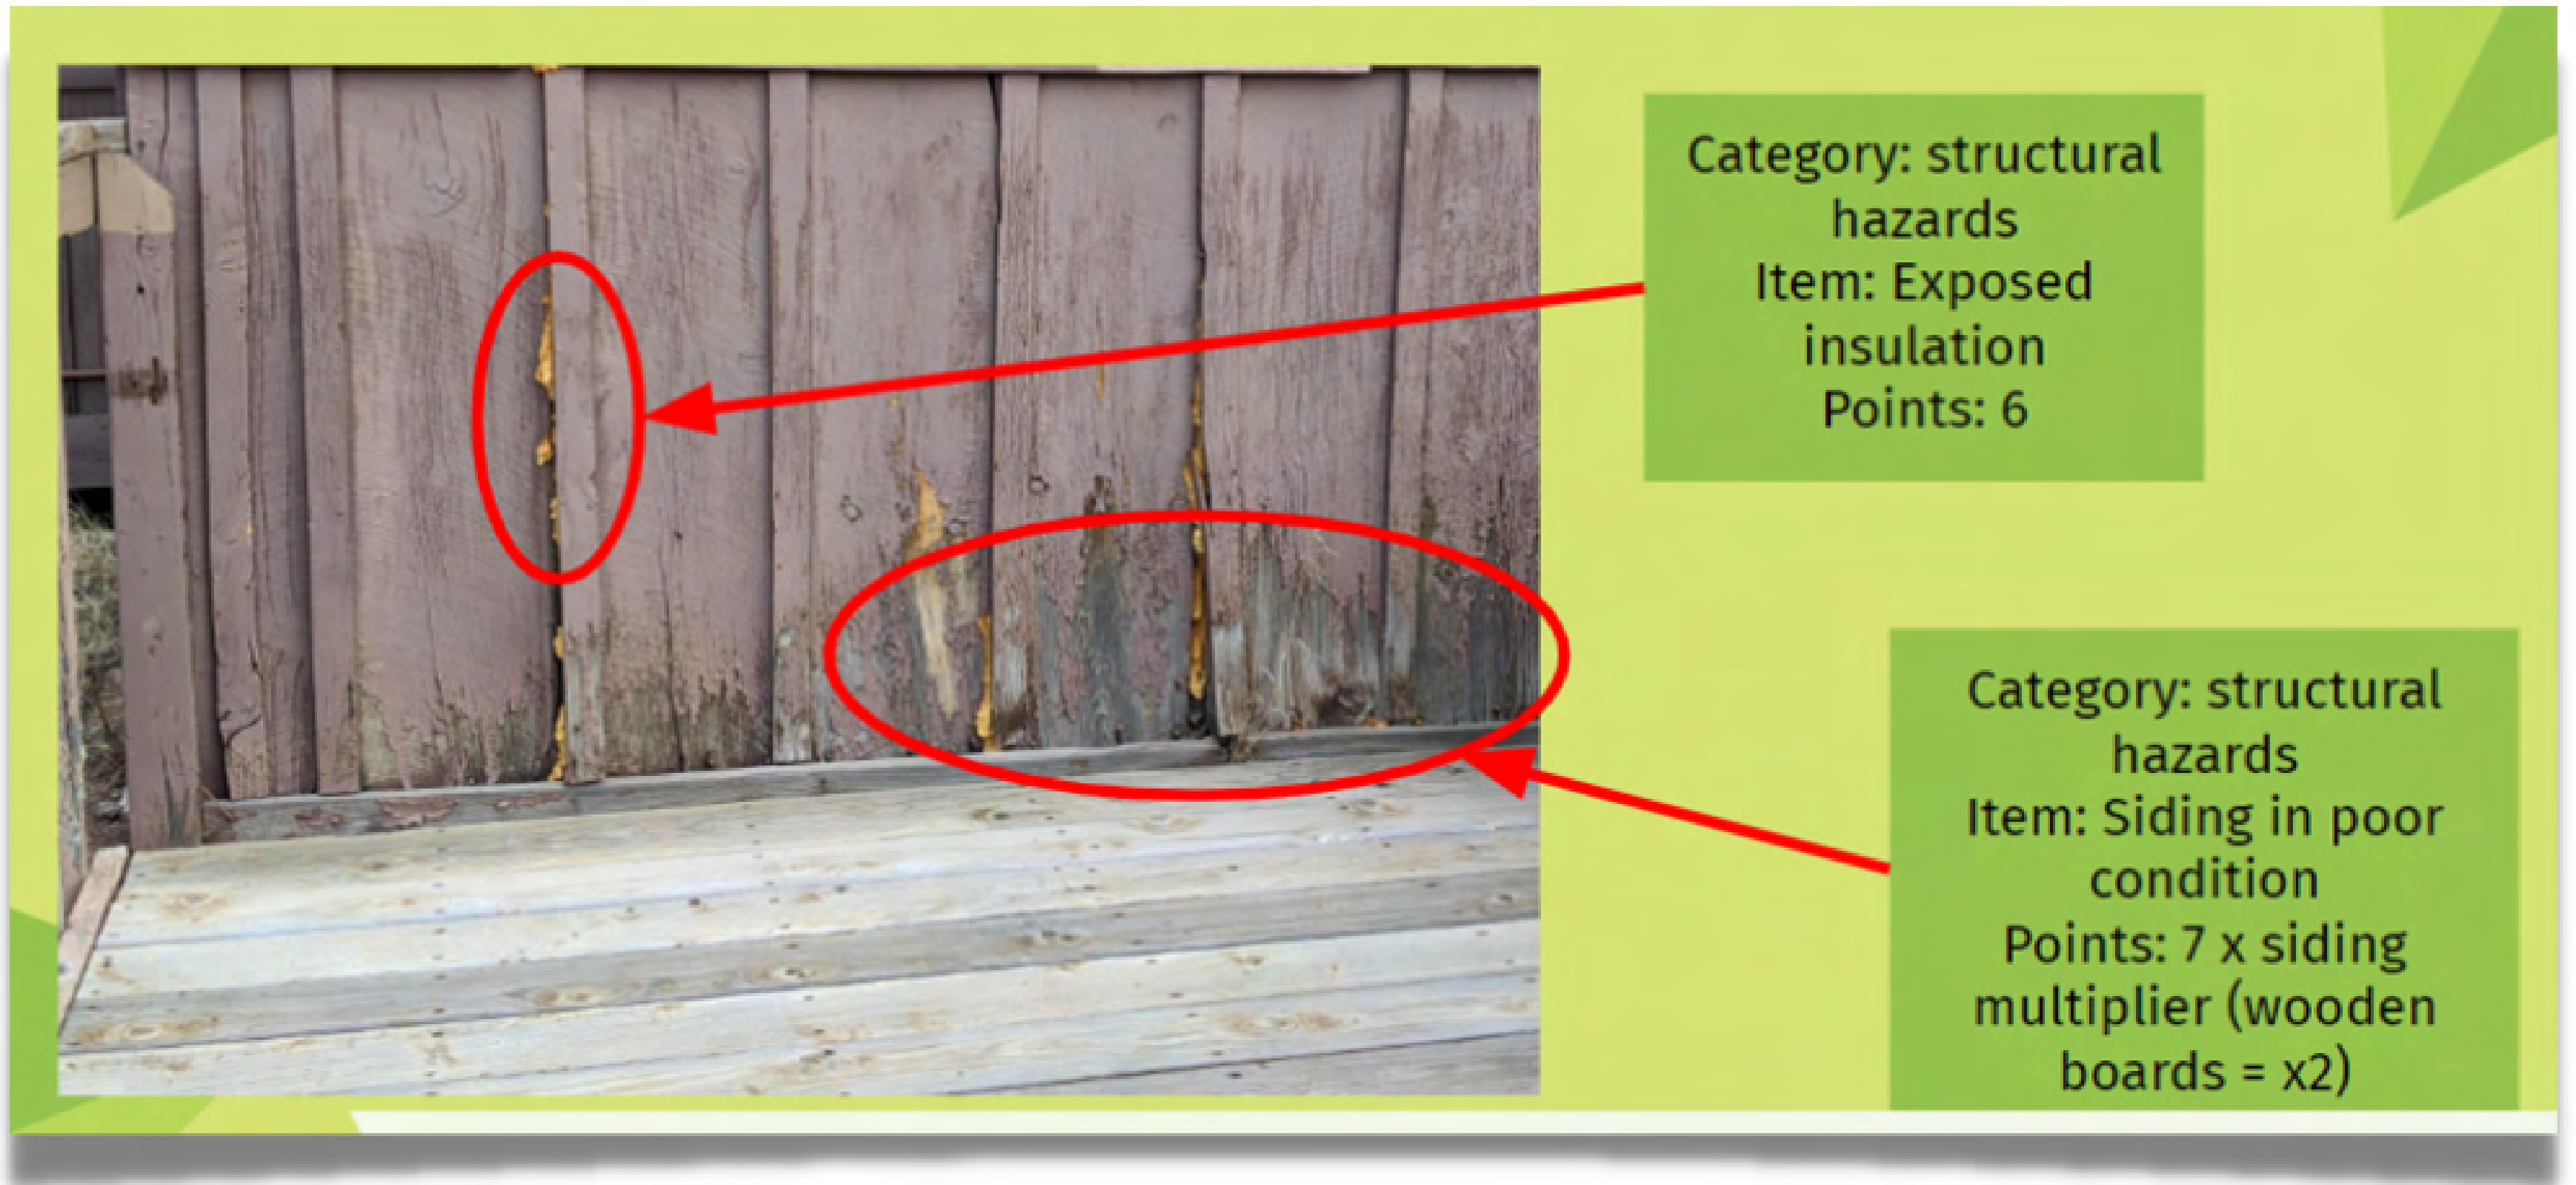
Figure 15: Structural hazards on a cabin and how the vulnerability scoring system was applied to said cabin.

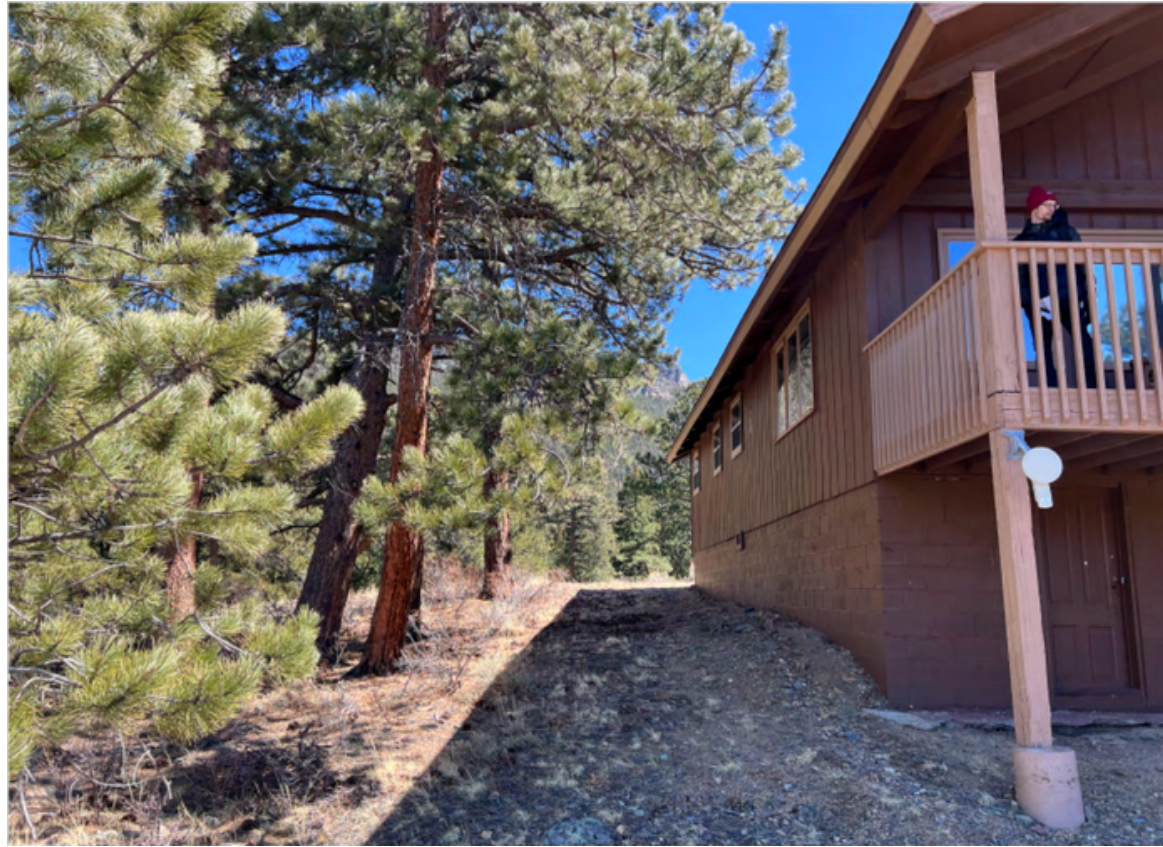
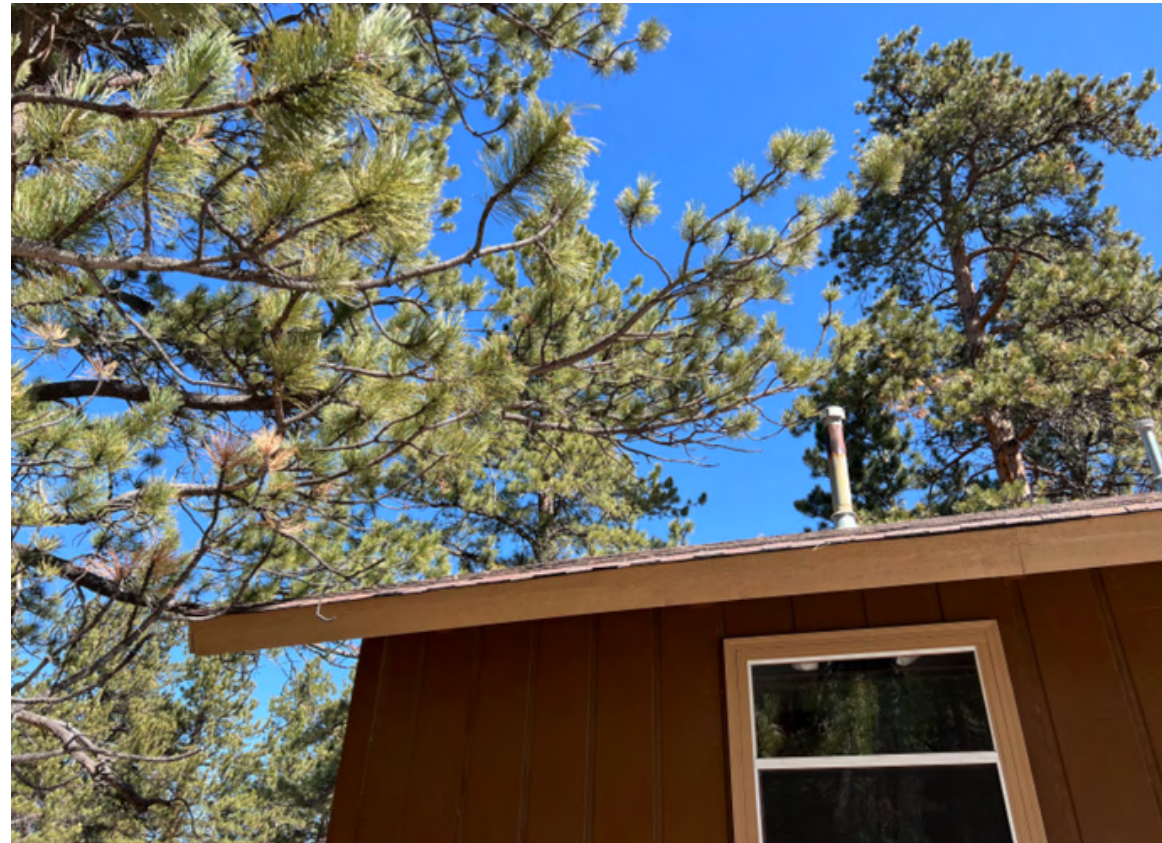
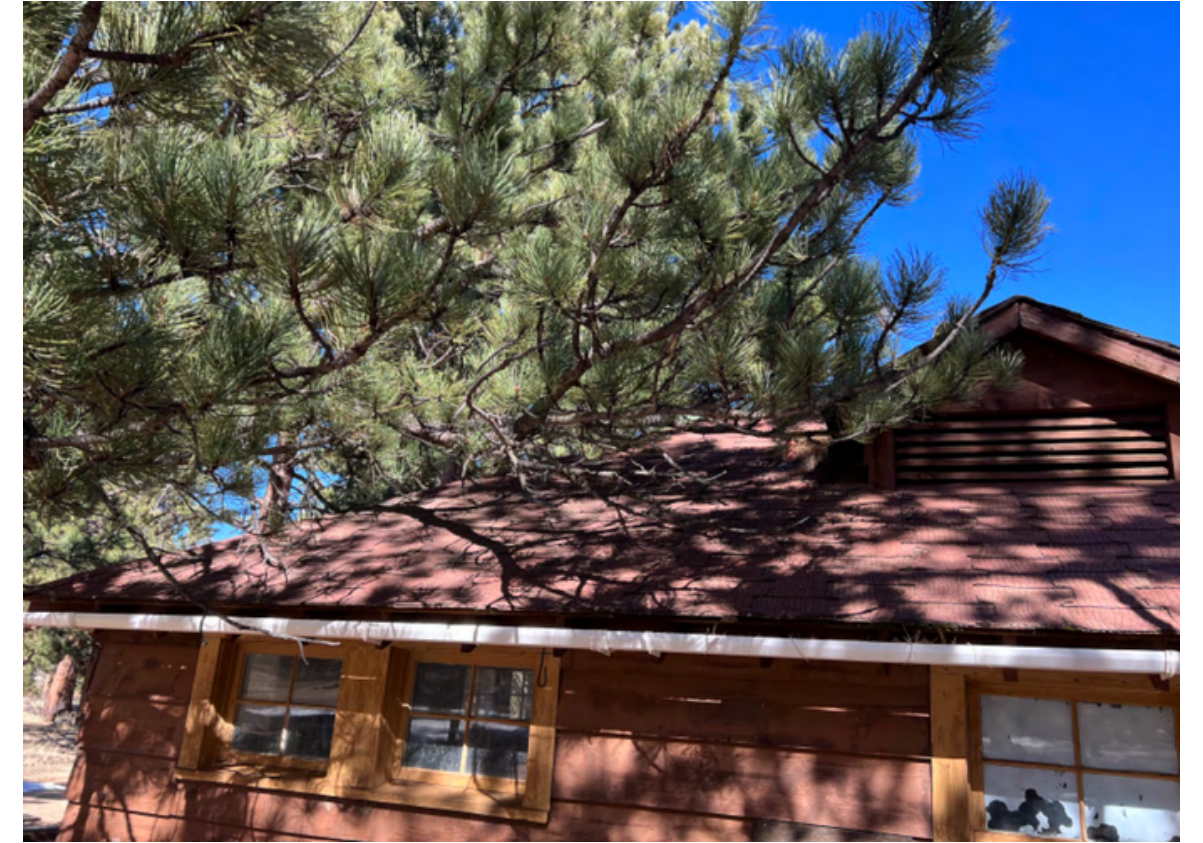
Overhang can be dangerous because it can increase the risk of flames from tree canopies spreading to buildings. When tree overhang is present, the branch above a roof provides a ladder-like bridge for the flames to spread to the building, providing an entirely new fuel source for the fire to burn. We rated the majority of overhang situations as either a 1, 2, or 3, which means that 10-30% of the roof was covered by trees. Examples of what we rated a 1, 3, and 7 can be found in figure 17 (see page 29).

Figure 17: Examples of assessed Overhang Ratings of 1 (Left), 3 (Middle), and 7 (Right).

We recommend that tree overhangs should have limbs removed to around 10 feet above the roof. Vegetation within 5 feet of the building or under porches, should be removed altogether. Finally, all types of debris should be removed: branches, logs, duff, and any dead standing or fallen trees found around the

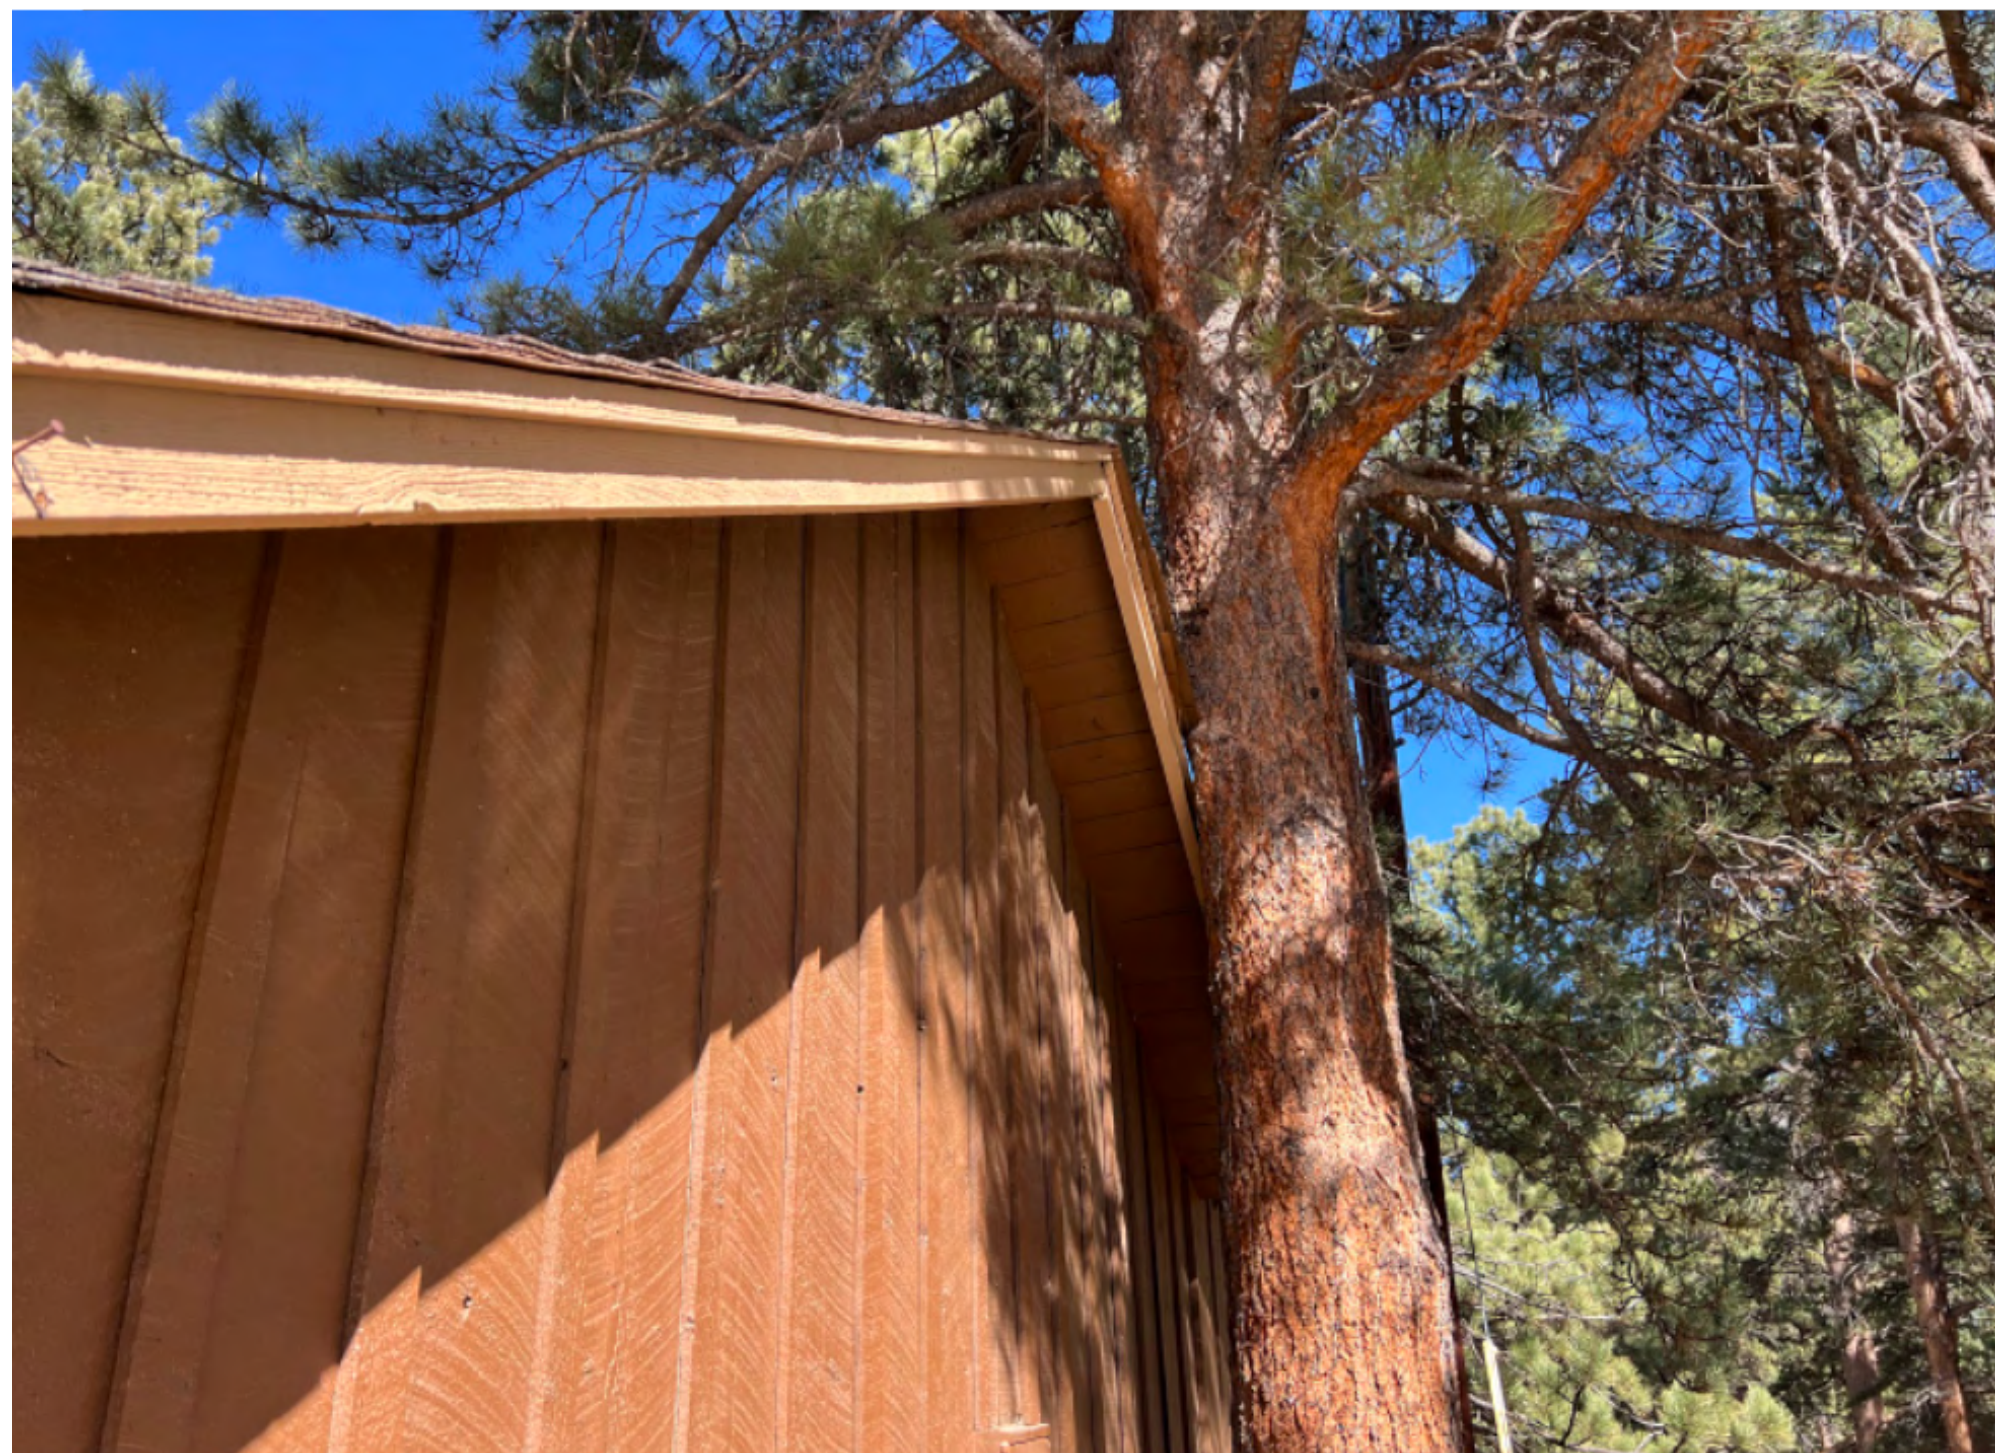
Figure 18: Image of a tree in direct contact with the cabin.

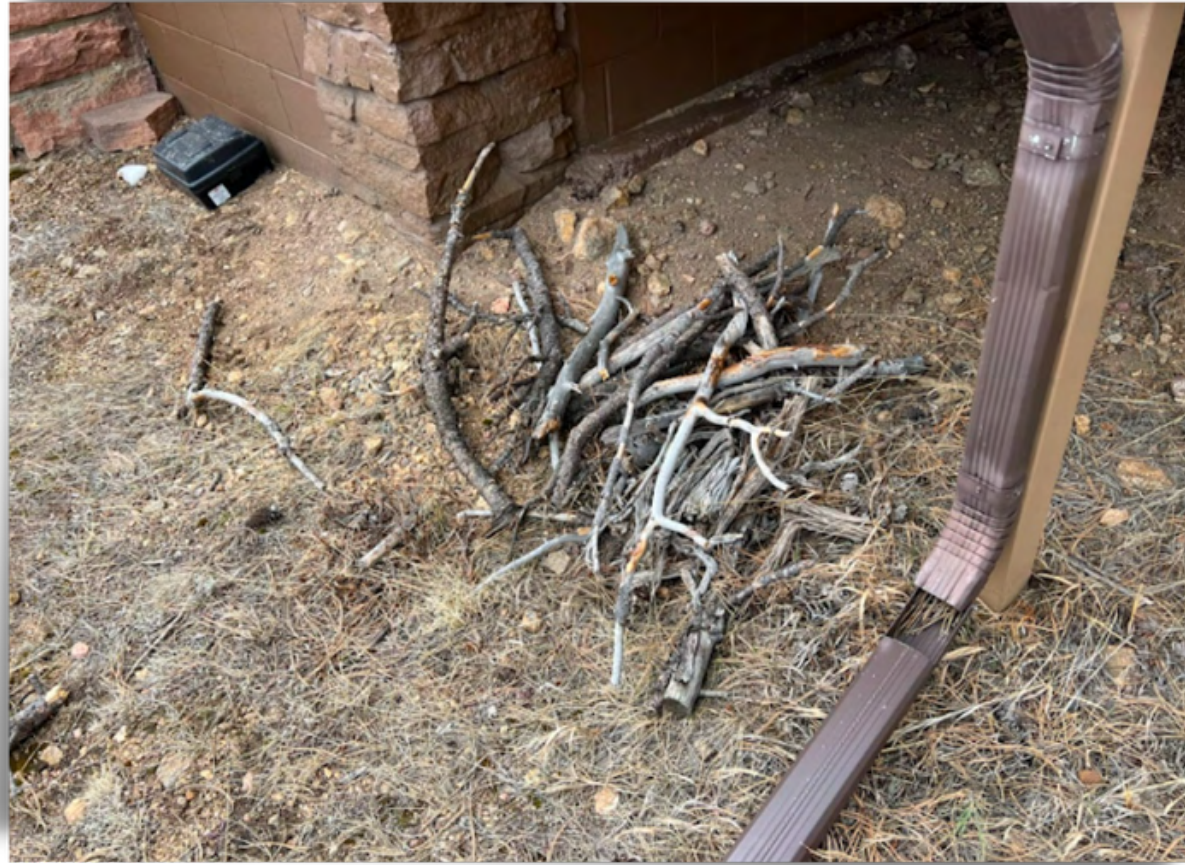
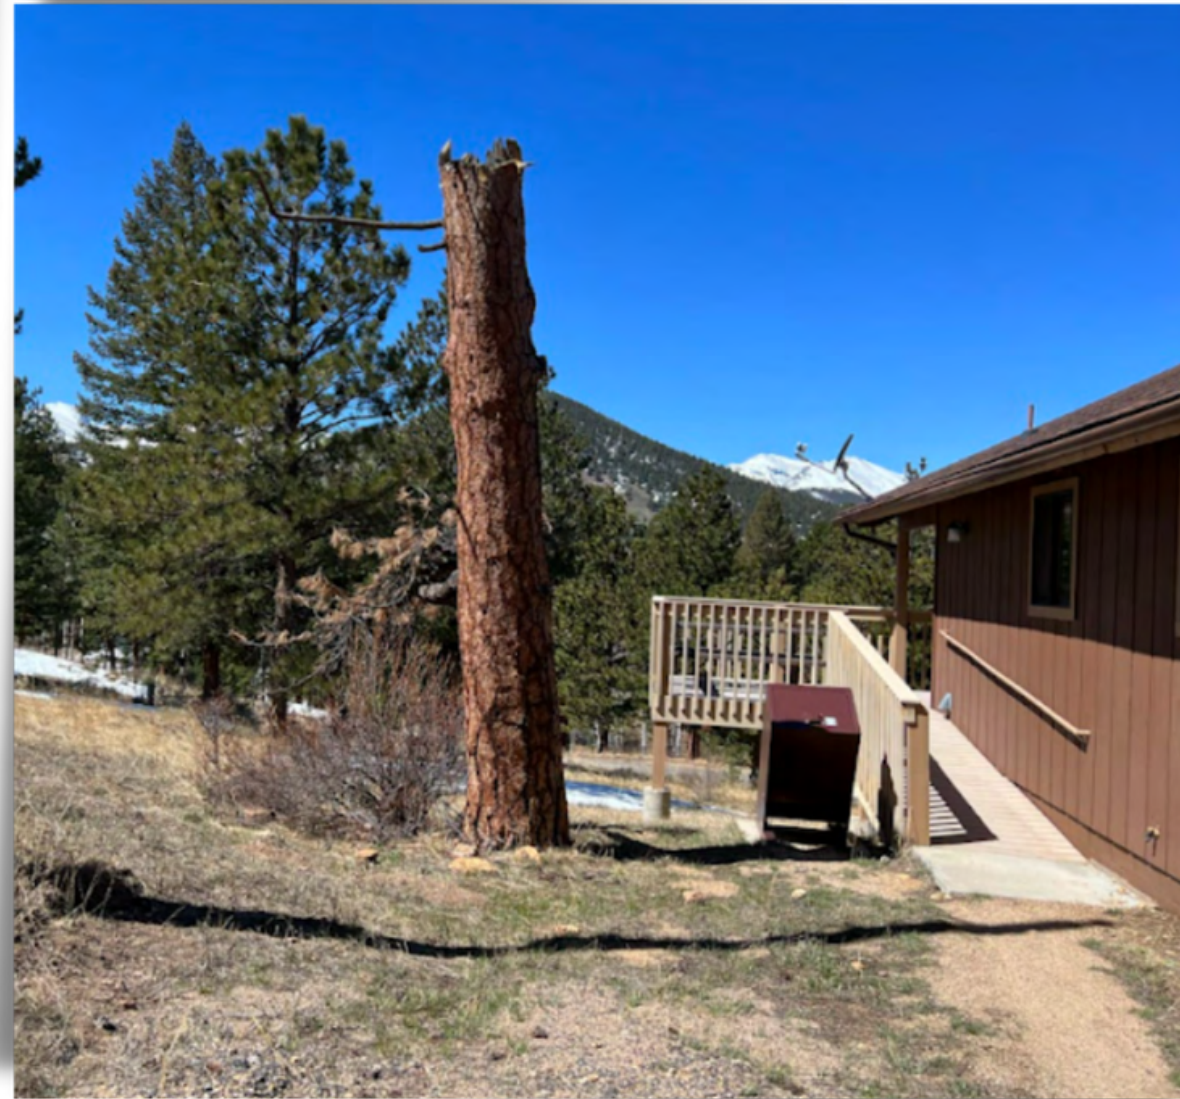
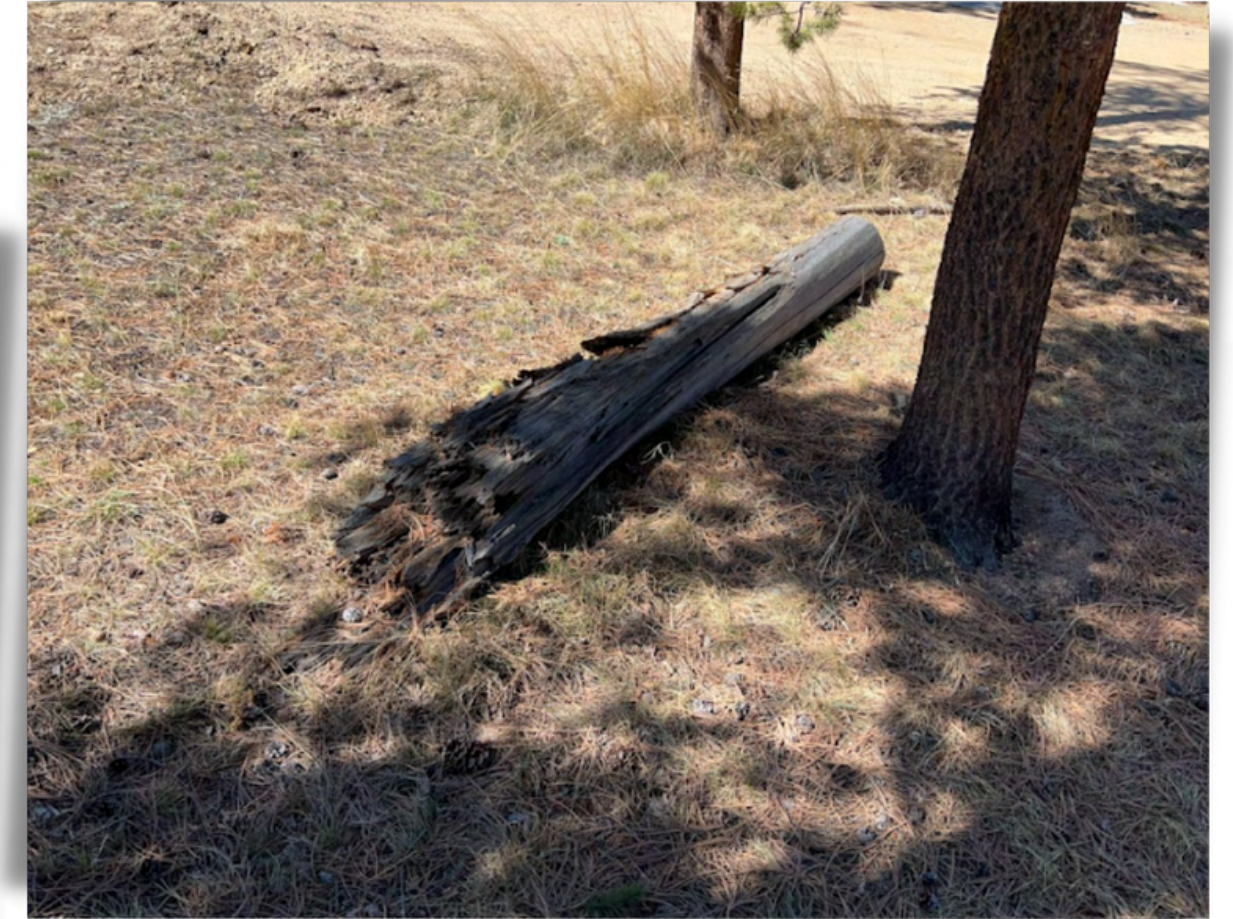
Figure 19: Different forms of debris around cabins. Branches (Left), dead standing tree (Middle), and a log (Right).

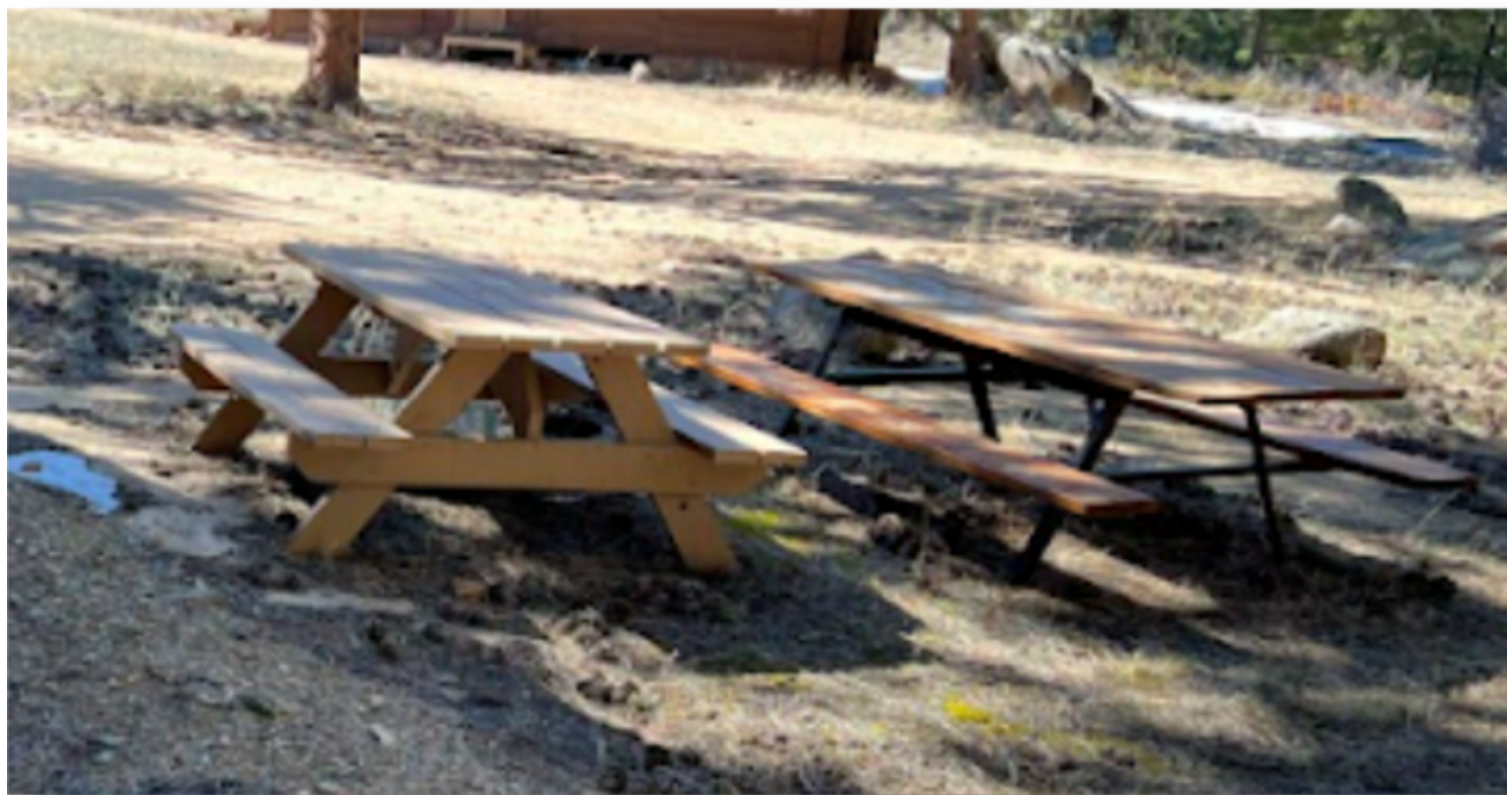
Figure 20: Two wooden tables in close proximity to a cabin.

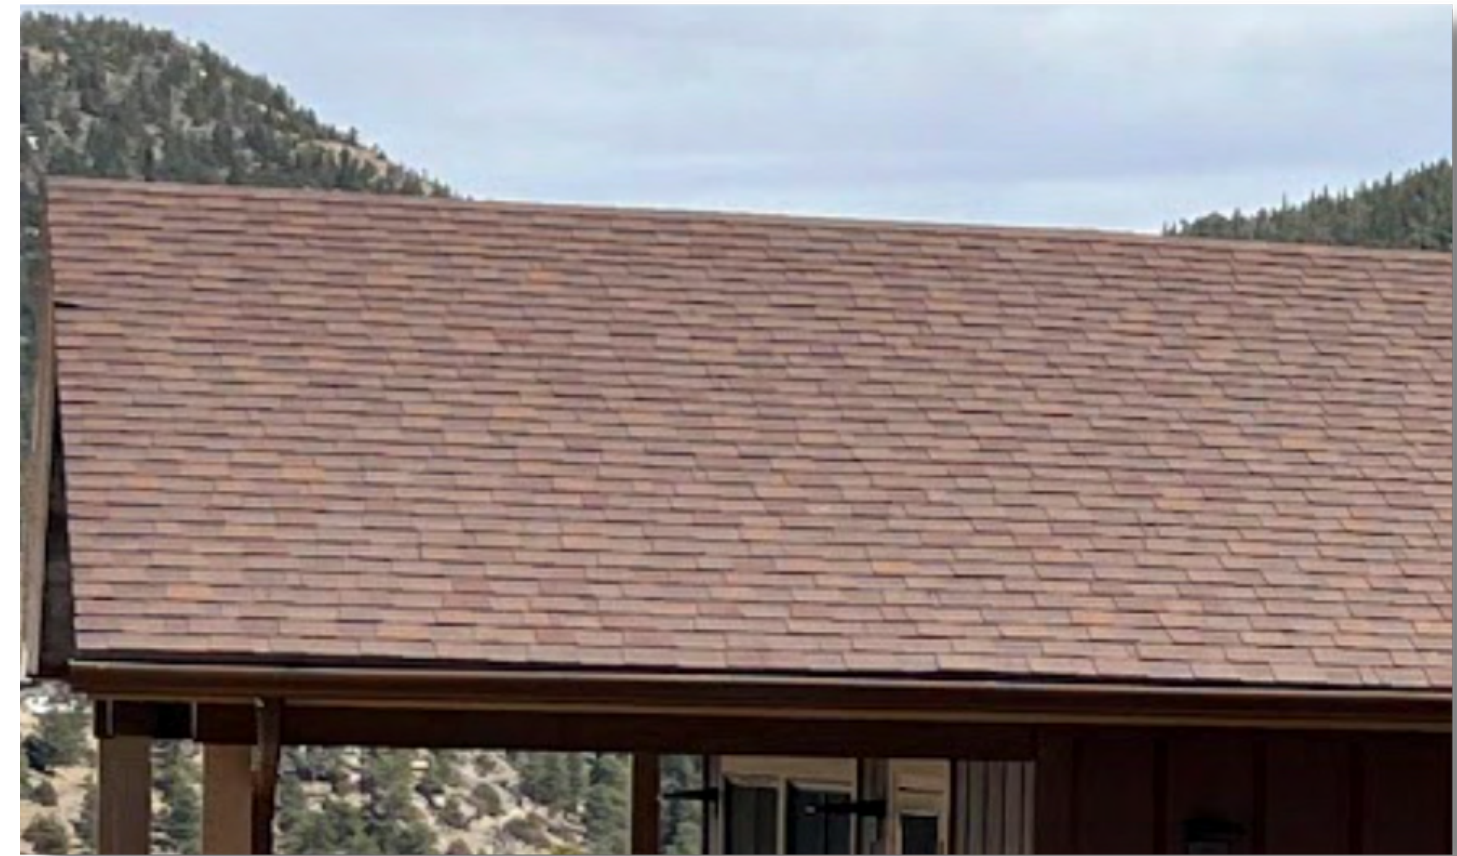
All of the cabins at the YMCA used asphalt shingles for roofing. These composite shingles found across campus have a high fire-resistive rating, with asphalt composite

Figure 21: Image of Architectural Asphalt Shingles at the YMCA.

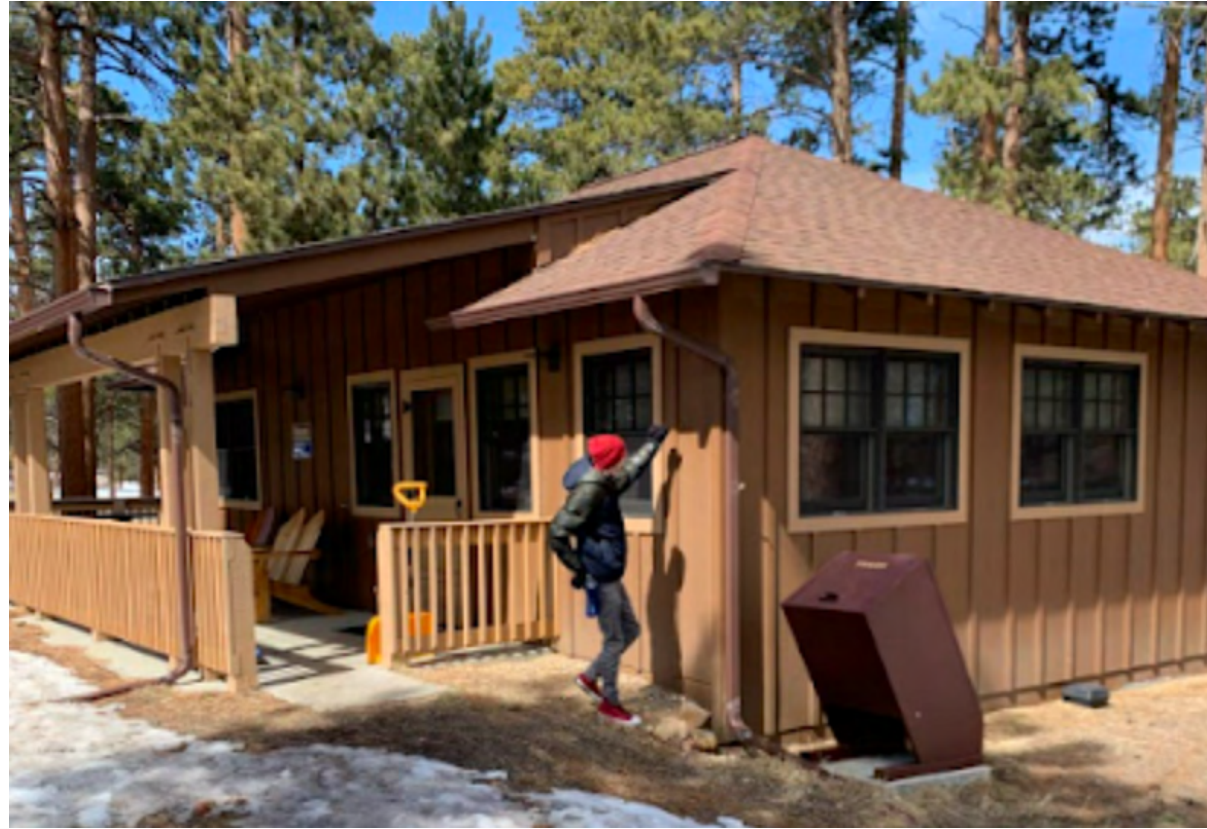
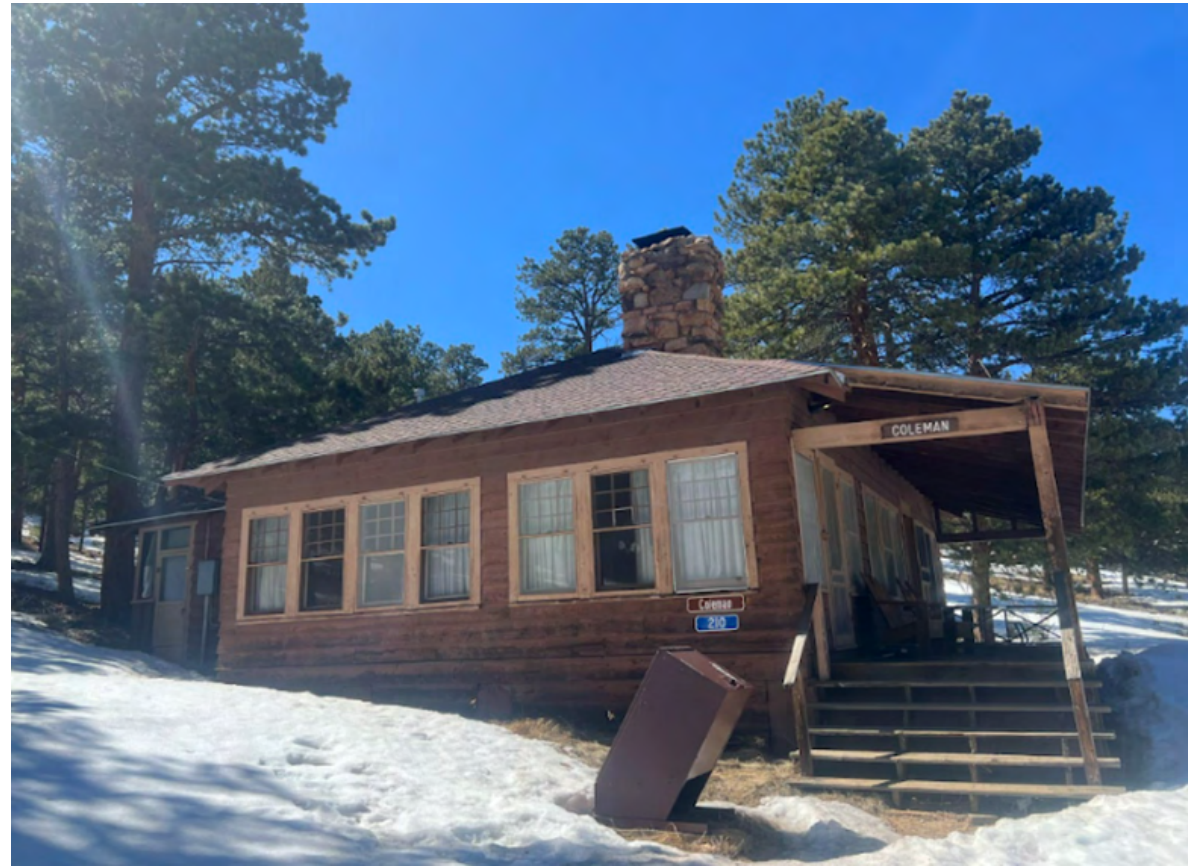
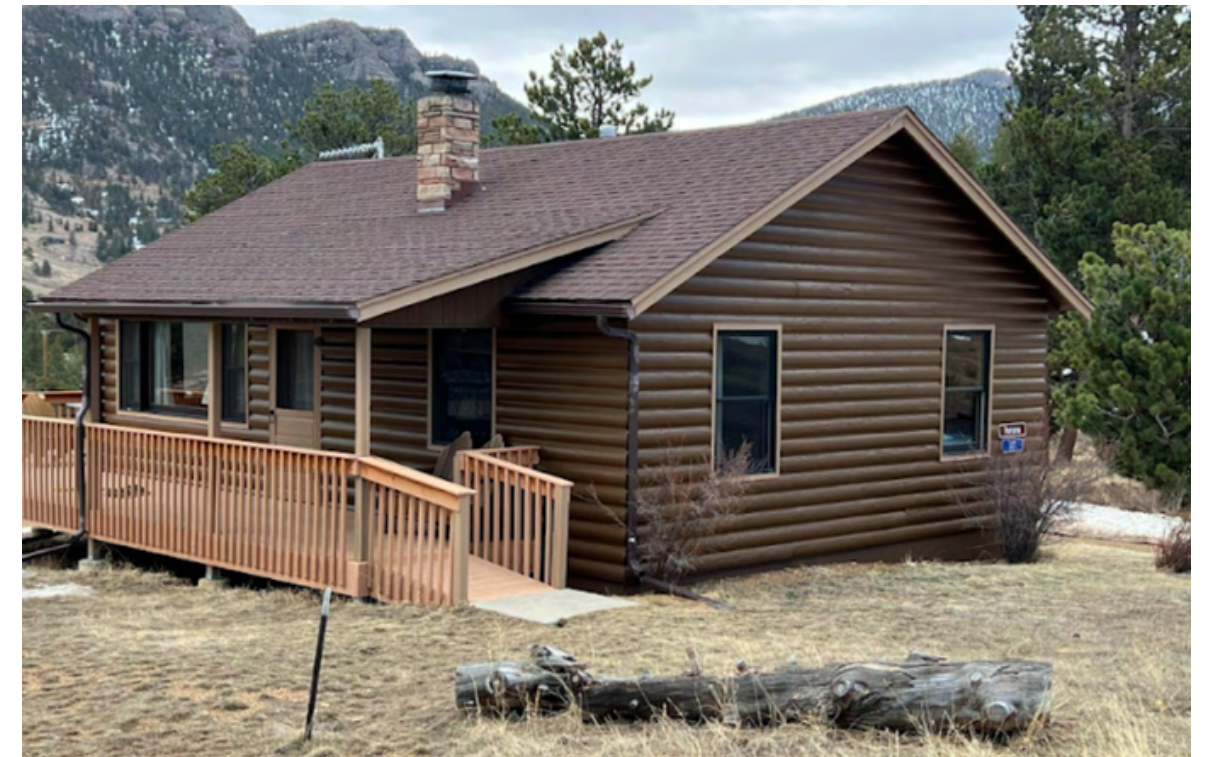
Figure 23 (see page 36) shows that 26.4% of the cabin sidings were constructed of fire-resistant fiber-cement boards, which have a Class A Fire rating according to the Flame Spread Index. The 33.1% of cabins with eastern white pine log siding are less fire-resistant, with a Class B Fire rating, while the other 39.7% of cabins have plank plywood siding with a Class C Fire rating. This means that only around a quarter of the cabins on campus are as well protected as they can be in terms of fire-resistant siding.

Figure 22: Cabins with fiber cement (left), wooden plank (Middle), and pine log (Right) sidings
