ASSESSING WILDFIRE RISK TO THE BUILT ENVIRONMENT AT THE ESTES PARK YMCA

Sponsor:
The Young Men's Christian Association (YMCA) of the Rockies

May 3, 2022

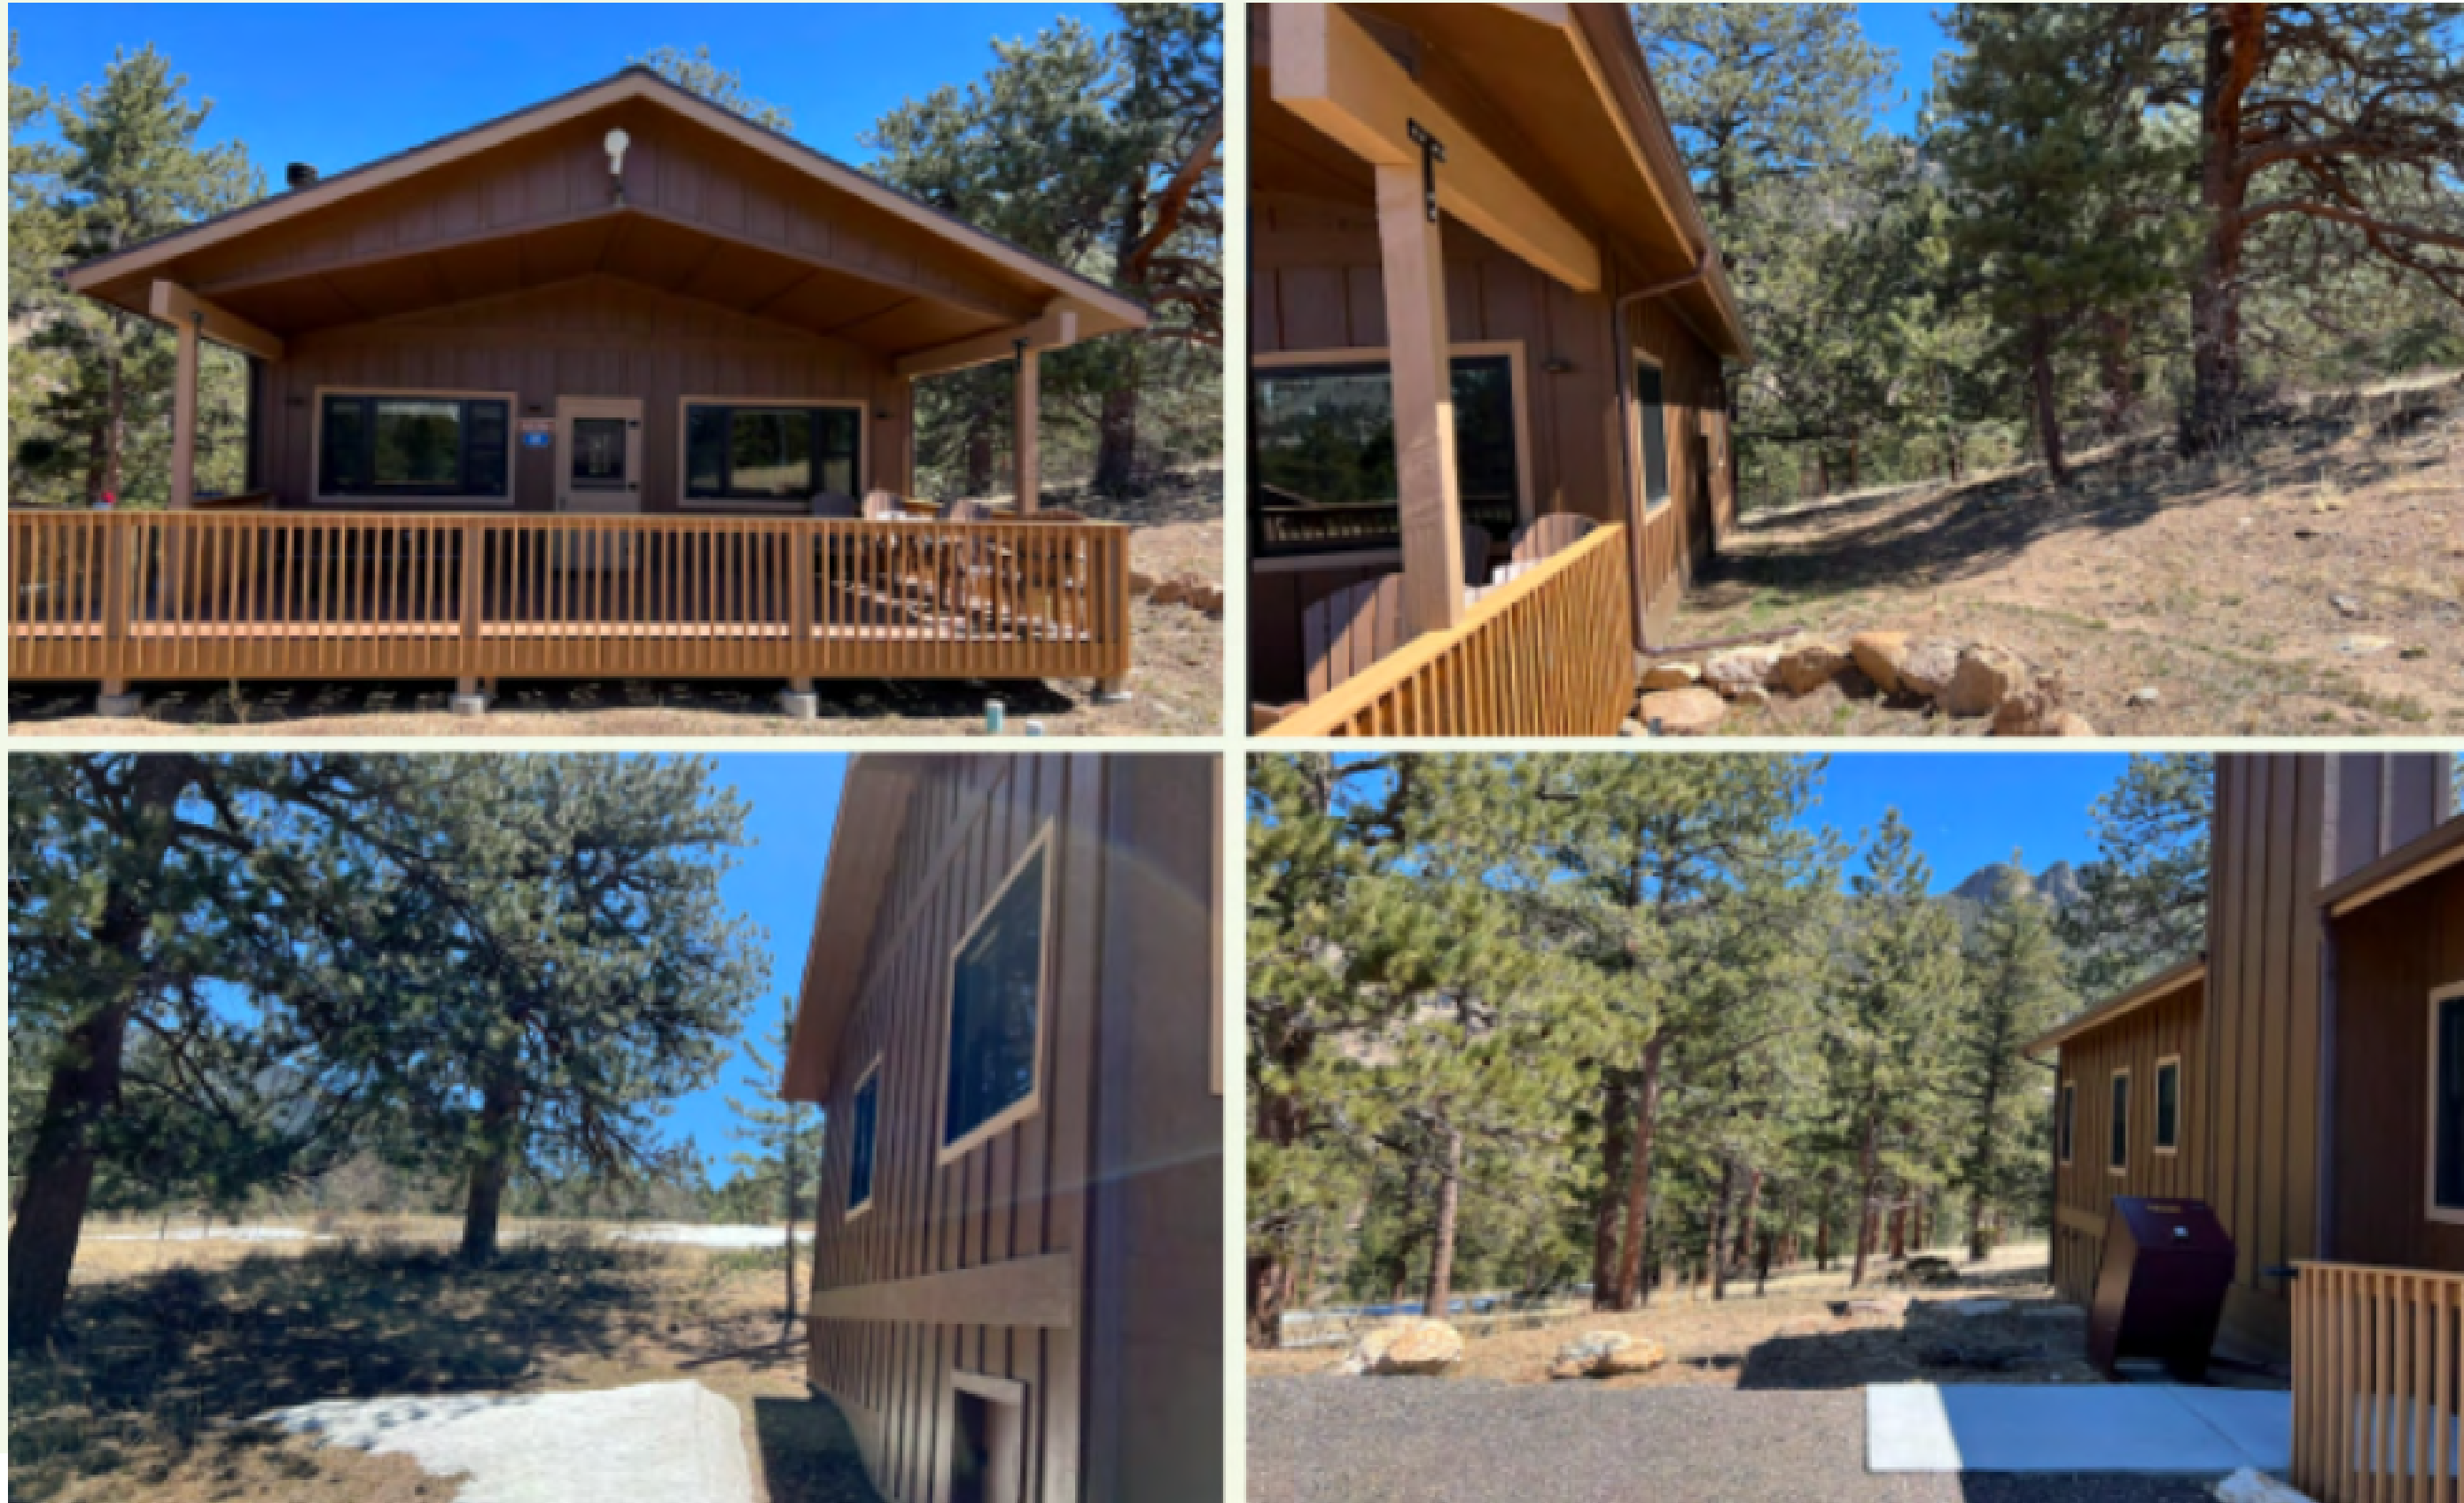
Figure 28: Images of Black Bear, a low risk cabin. Note how there is no vegetation surrounding the cabin within 5 feet, no gutter debris, and no overhang.

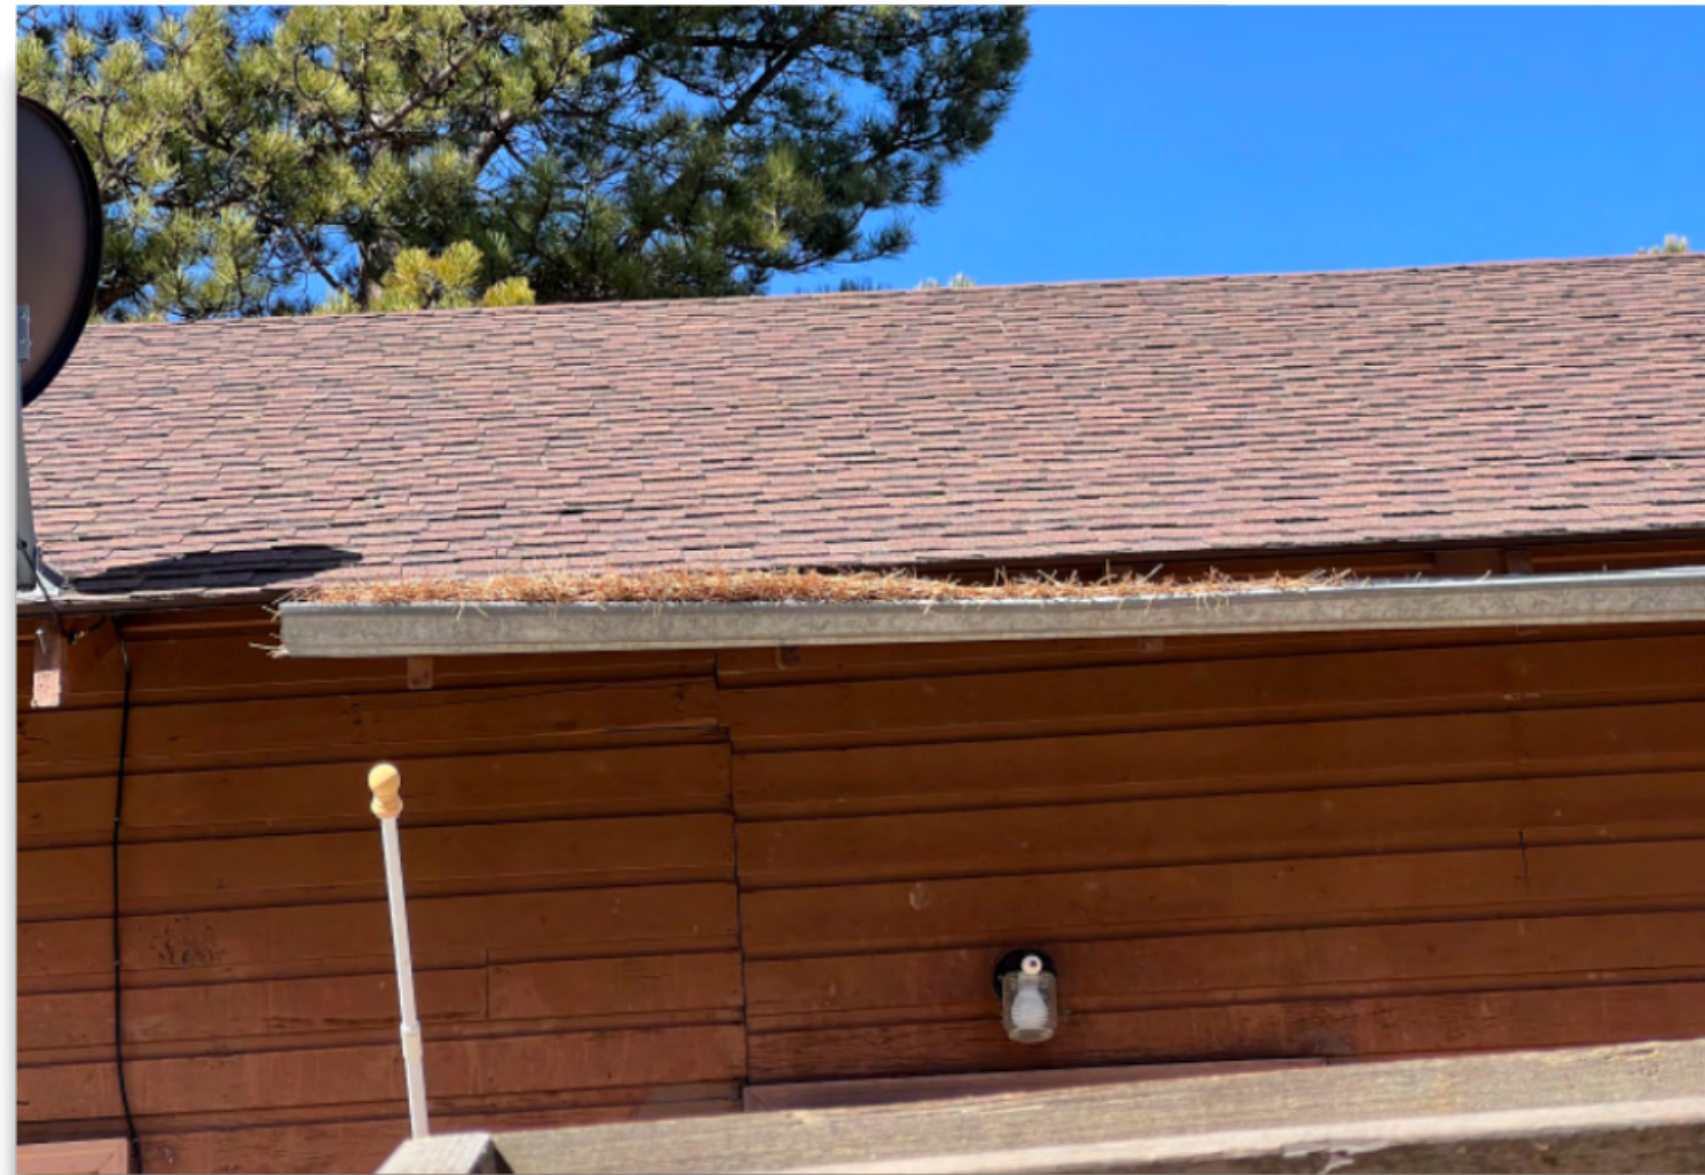
Figure 32: Photograph of cabin with filled gutters

The smaller-scale factors to consider mainly consist of maintenance tasks. Any gutters that are filled should be cleaned out at least twice a year, as many are filled with pine needles. Any holes in siding should be repaired or filled using caulking if they will not be renovated soon through the cabin adoption program. All branches resting on power lines should be removed, and all miscellaneous surrounding items should be removed so they are at least 30 ft away from the building. We suggest the costs of these tasks be covered by the Buildings and Grounds' operating budget.
