Products Liability

An Interactive Qualifying Project

WORCESTER POLYTECHNIC INSTITUTE

Date: May 6, 1997

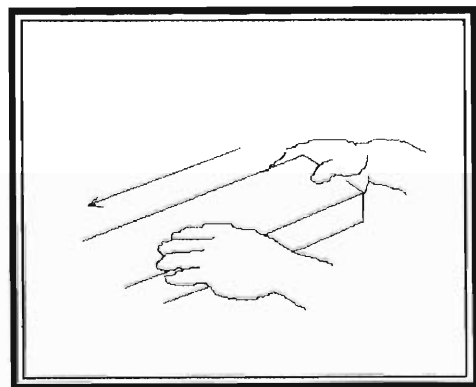
Figure 1

In his statement, Mr. Frazier claimed that the accident occurred as a result of a defective anti-kickback device, and a loose blade guard which he implies caused a kickback. Mr. Frazier stated that he was preparing to rip the workpiece and place the wood on the work bench. He had prepared a home-made push stick for the completion of the operation and cut. After setting the tool to its proper dimensions for the cut, he pushed the workpiece as to make the cut. He had his left hand in front and flat on the top of the workpiece. His right hand was placed on the rear as depicted in Figure 1.

However, unlike usual, while pushing the workpiece, after ripping through 2 5/16" of wood, he experienced a kick back. He claimed that all guards were in place on that date and that no alterations had been made to the machine which he had bought at Home Depot several days prior. The push stick which he had prepared for the operation was in his back pocket. He was going to use it after some distance in the cut, he claimed. At the time of the kickback, Mr. Frazier said, that he had no recollection of the events that took place in the small elapse of time where he suffered his injuries except for some movement from the see through guard. All he recalls is that he suffered severe injuries to his left hand and ran for help where he got a ride from a passing driver and was rushed to the hospital.

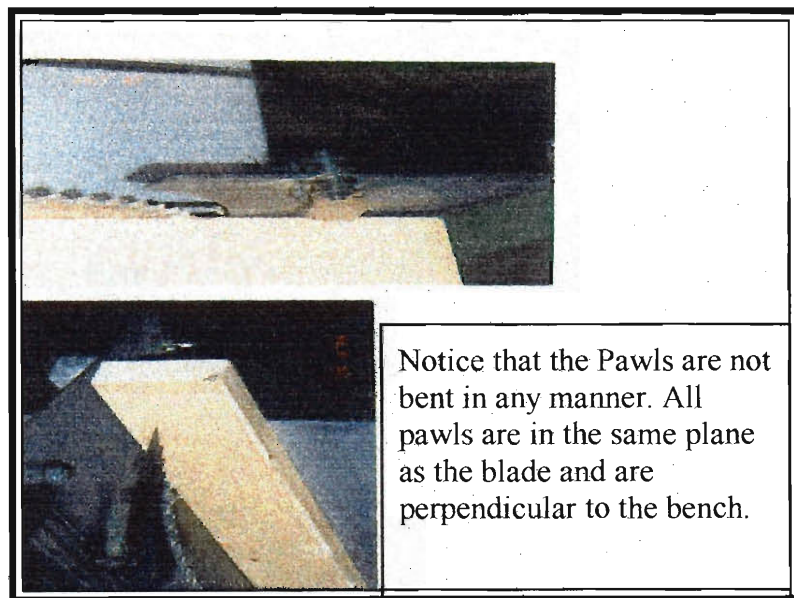
Picture 1.1

Also in place, as a safety guard, were the anti-kickback pawls which are intended to stop a workpiece from shooting back. Through his statements, Domeny further recognizes that kickbacks can occur and are not completely eliminated by following the manual, but also states that injury from such an occurrence is “practically eliminated” when read thoroughly. If Mr. Frazier had understood all the conditions that cause a kick-back and knew what happens while a kick-back occurs, Domeny believes, he would not have been injured. According to Domeny’s statement, the kick-back pawls when catching the piece of wood that gets kicked back would be bowed. In the case of Mr. Frazier’s they were not deformed. This would imply that they did not catch the wood or that the severity of the kickback was not extreme. Inspection of the workpiece shows that the pawls dug in like they should. However, there is no deformation to the pawls.

In the next picture set labeled Pictures1.1 you can see the set up of the pawl mechanism that helps protect from kick-backs.. It should be noted that they are in perfect condition and do not seem to show any evidence of bowed fingers. The springs that can be seen, were also in perfect condition and were operational when they were inspected.

- Based on analysis of the anti kick-back pawls shows that they did not engage during the kick-back. However, during inspection of the work-bench the anti kick-back springs were found to be in working condition. This indicates that the pawls were either blocked or prevented from working. This implies negligence on Mr. Frazier's part due to his failure to inspect the machine prior to use.

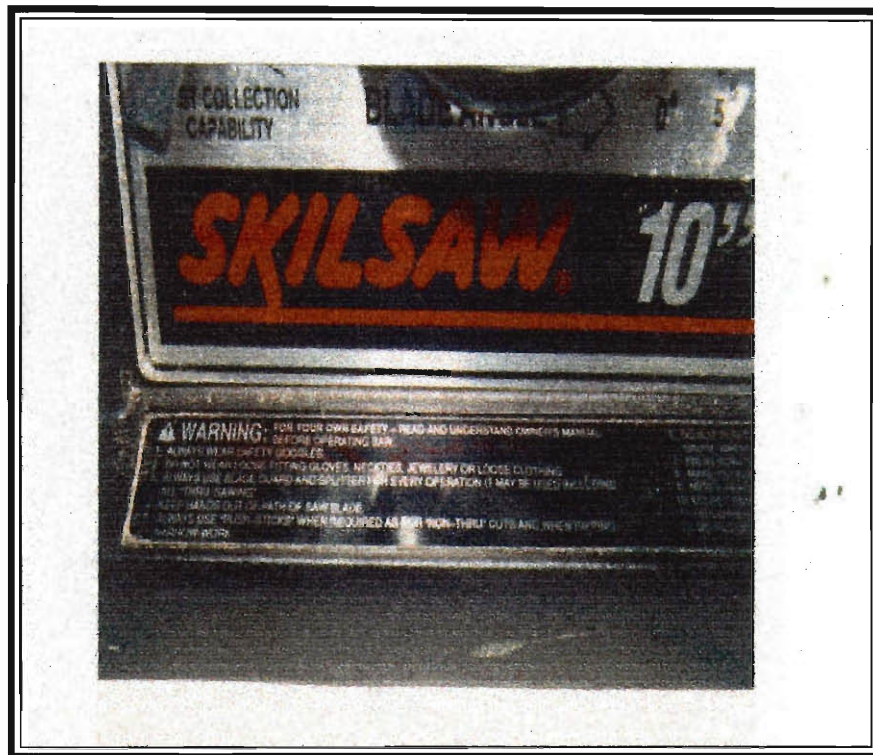
Notice how S-B Power Tool Company very clearly sets warnings for the user to view. The warnings are located underneath the Elevation Wheel where the operator can see them. If Mr. Frazier had fully understood these warnings, serious injury would have been prevented. These are the same warnings that are discussed in the operator's manual and are intended to help prevent against dangerous situations like kickbacks.

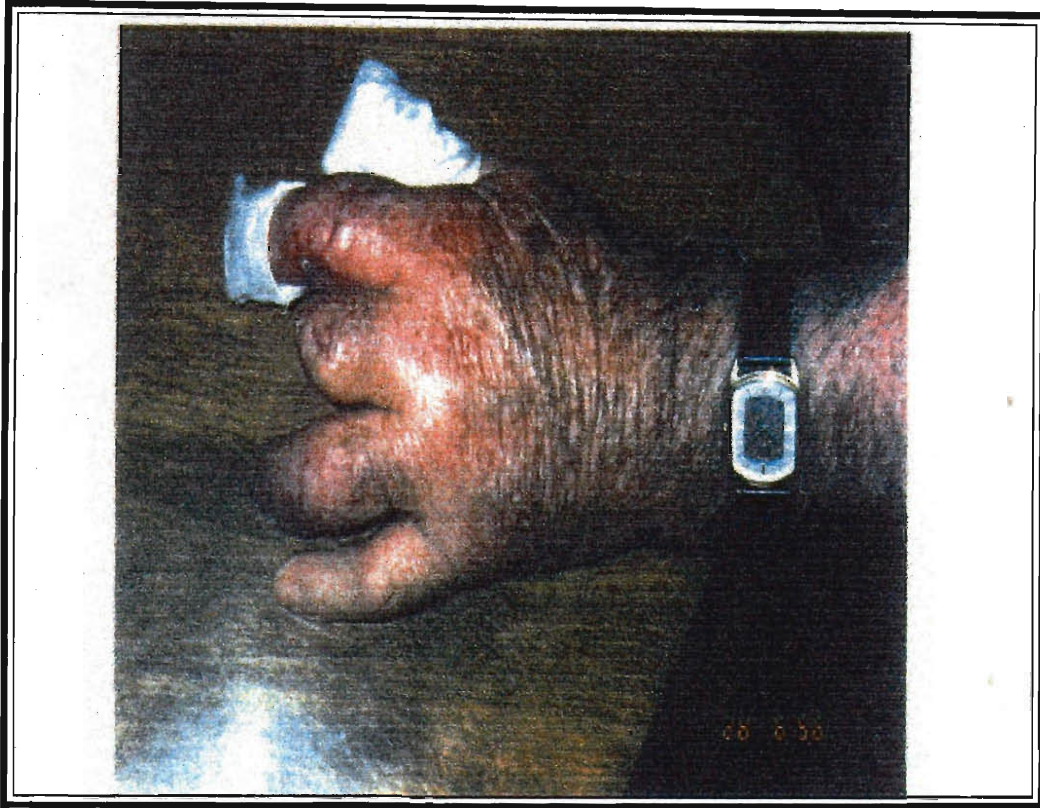
In this picture you can see the severity of Mr. Frazier's injury. Notice that the pinky finger did not suffer amputation though it was the first in line with the blade according to Mr. Frazier's deposition. It would not be possible to suffer the type of injury Mr. Frazier suffered if he had been holding the workpiece as he has stated.

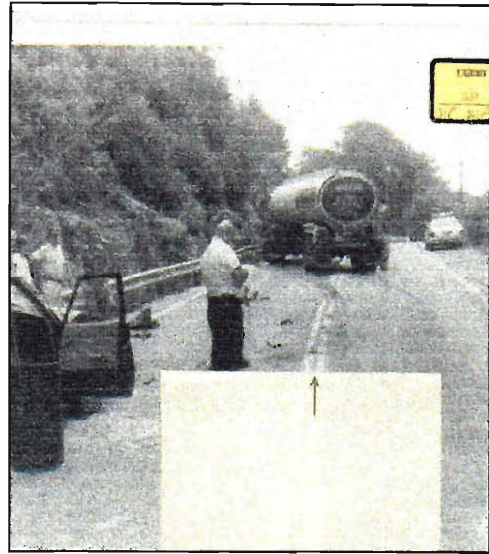
Photo 3.1 This picture illustrates the location of the accident. The arrow on the yellow box points to the point of collision.

As can be seen by the picture, the vehicle's left front quarter panel was ripped off and the front left tire axle was severely damaged. Inside the vehicle, the dashboard was pushed towards Ms. Hernandez and the steering wheel column also suffered damage.

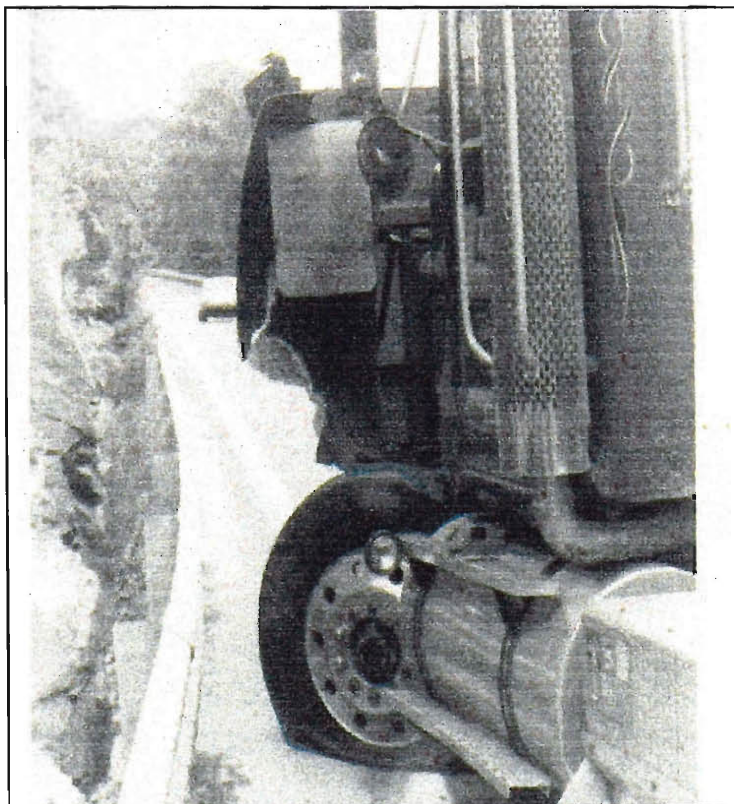
The truck did not suffer too much damage. Inspection of Photo 3.2 shows that the truck's fiber glass hood popped open and was cracked. The front left wheel was popped and the rim shows evidence of the impact with the Aries. Much of the damage to the hood occurred when the truck impacted the rock on the North bound lane. It is important to note that the truck's gasoline tank did not suffer any damage.

Photo 3.2 Picture of truck's damage.

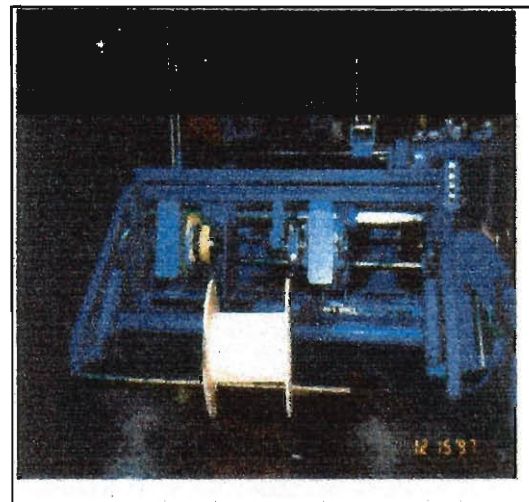
Picture of MGS take-up rewind machine five days after accident.

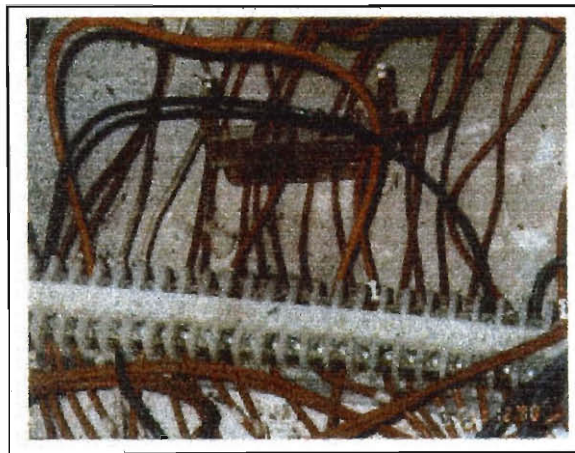
The machine was inspected two days after the accident and it was found that there was an alteration made to the machine by Encore wire. On the machine there is a device called the counter device. The purpose of the counter was to count the wire as it was spooled onto the reel. If there were no wire in the counter device the machine would not run. In order to use the scrapping method the counter would prohibit the reel from turning because wire would not be run through it. In the scrapping process wire is unspooled on the floor. Encore used a jumper wire to bypass the counter device so that the scrapping process would be possible (See fig 4.2.).

Jumper Wire on take-up rewind machine 62
