Brutalist Building Retrofit

A Major Qualifying Project
Submitted to the Faculty
of the
WORCESTER POLYTECHNIC INSTITUTE
in partial fulfillment of the requirements for the
Degrees of Bachelor of Science in Architectural Engineering

March 23, 2018

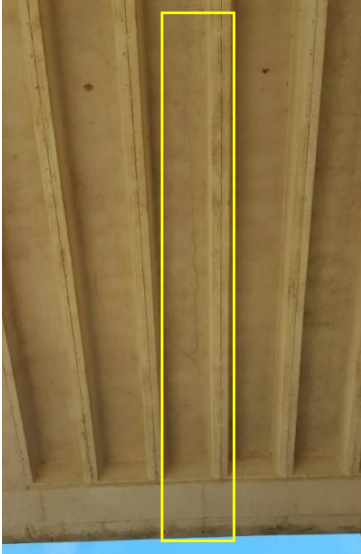
<i>Cracks</i>	
<u>Observation</u>	<u>Photo</u>
<p>A long horizontal exterior crack running North to South along the ribs on the underside of the Bridge outlined with a yellow box.</p>

We observed 18 horizontal cracks running North to South along the underside of the art studio bridge and along the interior of the art studio (Table 1 **Error! Reference source not found.**). The horizontal cracks observed on the interior and exterior are not the same crack due to the following reasons. First, we observed 5-10 interior cracks per art studio room as well as multiple long interior cracks running along the hallway as shown in Table 1.2. We observed and recorded 22 exterior cracks as shown in Appendix D. The exterior cracks were much more spread out along the 646 ft Art Studio Bridge and did not extend as long. Overall, we observed more interior cracks than exterior cracks. Second, according to the drawings, there is a layer of insulation between the exterior concrete ribs and the

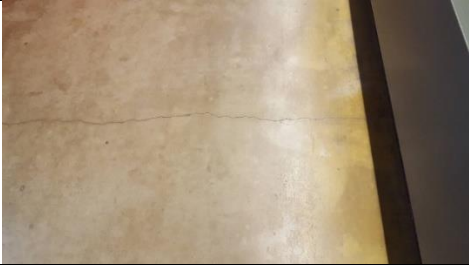
<p>A long horizontal interior crack running North to South along the hallway floor slab of the Bridge.</p>

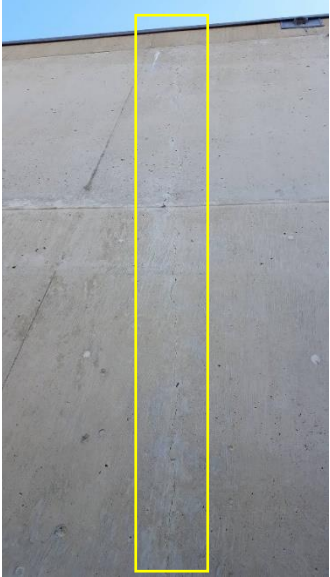
<p>A vertical long crack, outlined by the yellow box, running top to bottom located on the West Elevation of the Bridge</p>

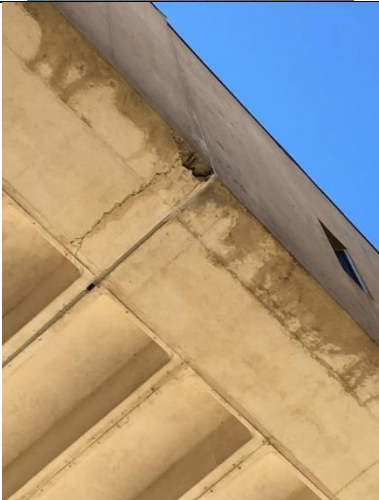
<p>A large crack and potential spall running North to South near an expansion joint on the underside of the Bridge.</p>

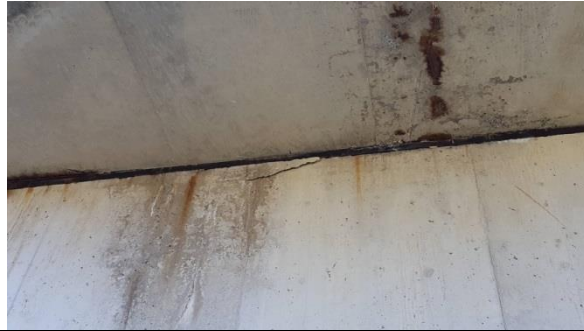
A second area of concrete beginning to spall underneath the Ramp leading to the Side door on **the East Elevation**

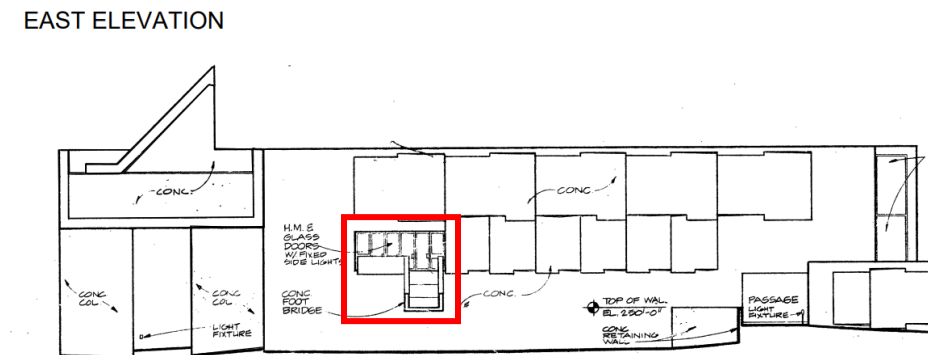
Figure 34: East elevation entrance ramp outlined by the red box.

One area of concentrated deterioration and a developing spall we found was located on the East Entrance Ramp leading up to Building B, outlined in a red box on Figure 34.

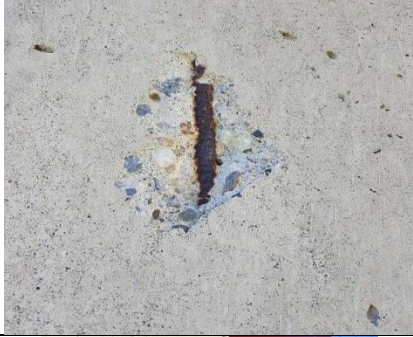
<u>Observation</u>	<u>Photo</u>
Exposed rebar and deterioration of the concrete on the East Elevation Wall

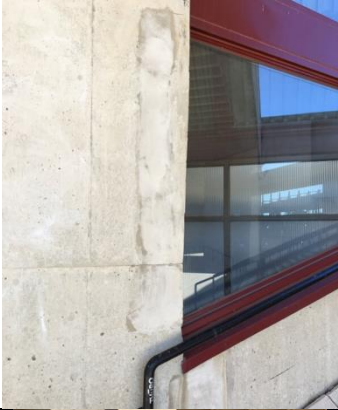
Evidence of previous spall repairs on South Elevation near entrance stairs.

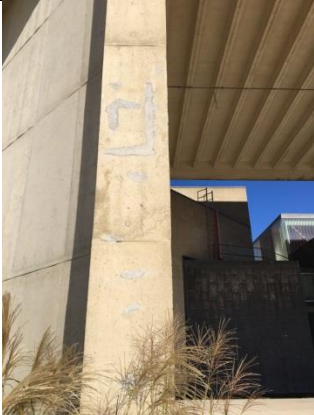
Evidence of previous spall repairs on the triangle supports under the Bridge.

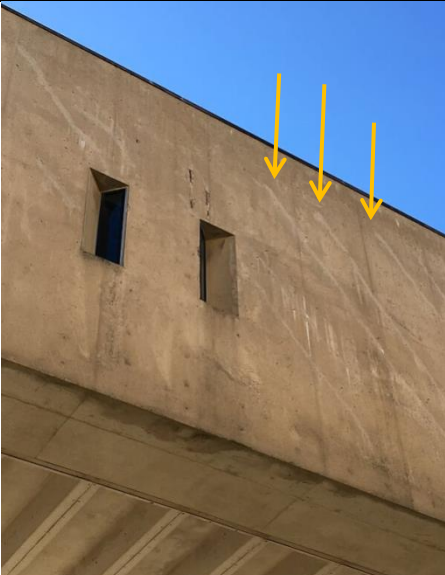
<u>Observation</u>	<u>Photo</u>
Efflorescence (indicated with yellow arrows) located on the North Elevation of the Bridge.

The Fine Arts Center has an abundance of efflorescence on all sides of the building. The white streaks are numerous, especially on the bridge. Efflorescence is caused by excess water soaking into the concrete structure. The water migrates to the surface collecting salt along the way. When the water evaporates, the crystalline salt brought to the surface stains the concrete white. Efflorescence itself is not a structural issue, but the excess water that causes it can also cause internal rebar and structural damage that does not always show on the exterior of the building. Noticing efflorescence in multiple places all along the wall is an aesthetic issue that creates an unclean visual. Beyond that, the walls showed generally staining with no signs of damage in those areas.

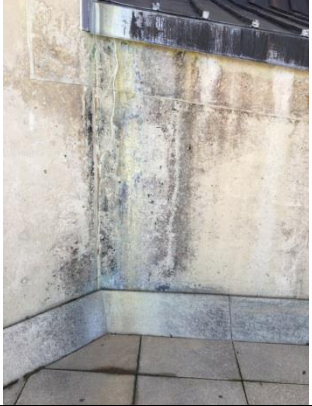
<p>Dark Staining on South Elevation under copper flashing</p>

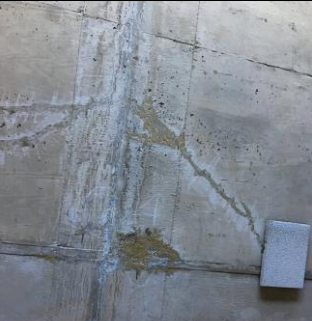
<p>Dark Staining on the interior ceiling of Art Studio 435</p>
