Rio Piedras Conservation Management Plan

Prepared for: The Conservation Trust of Puerto Rico

May
2009

Report Submitted to: Professor Ingrid Shockey and Professor Karen Lemone

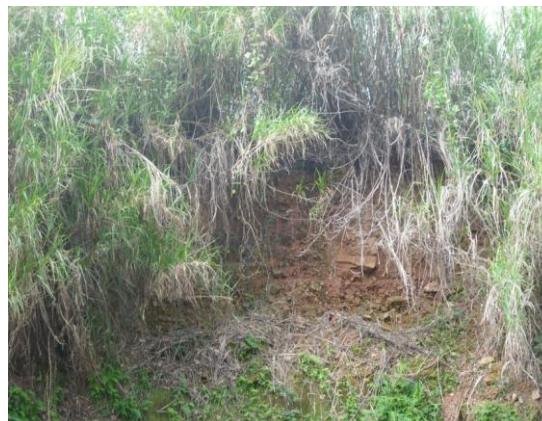
Our group found excessive erosion in a majority of the zones. Erosion is seen evident in the upper riparian zone sheer cliff faces (Figure 21), fallen trees, Bamboo, and bank edges. We recommend that The Trust remove the scattered fencing at the top of the riparian zone. We also suggest that the pavement surrounding the river be replaced by gravel or any other water permeable surface. This will allow proper water filtration and to improve ground run-off that sends sediments into the water.

Figure 21: Erosion in Zone 1

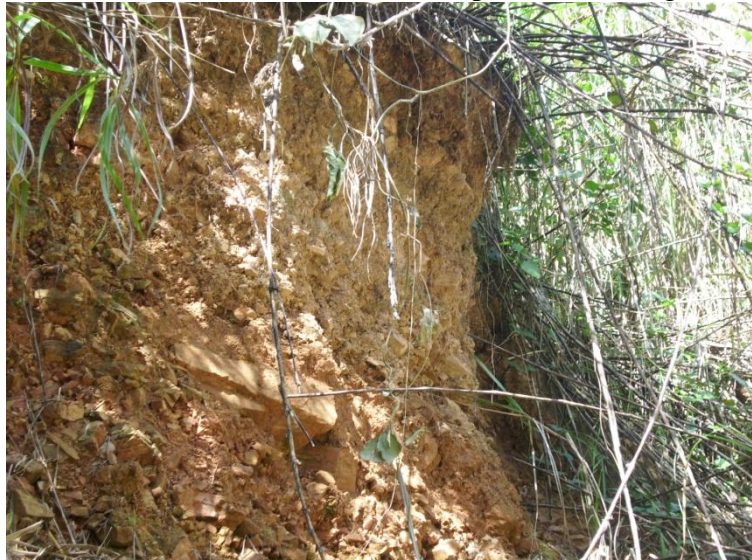
The urban development has also resulted in the down cutting of the Rio Piedras. Down cutting is the process of sediment removal by large amounts of water. A stream incision created in the river results in the lowering of the groundwater level. The entire ecology of the region is affected, including soil, plants, and microbial processes. The ground water level, which is a major factor in maintaining riparian zone stability, is also changed.

Figure 3: Erosion of the Rio Piedras

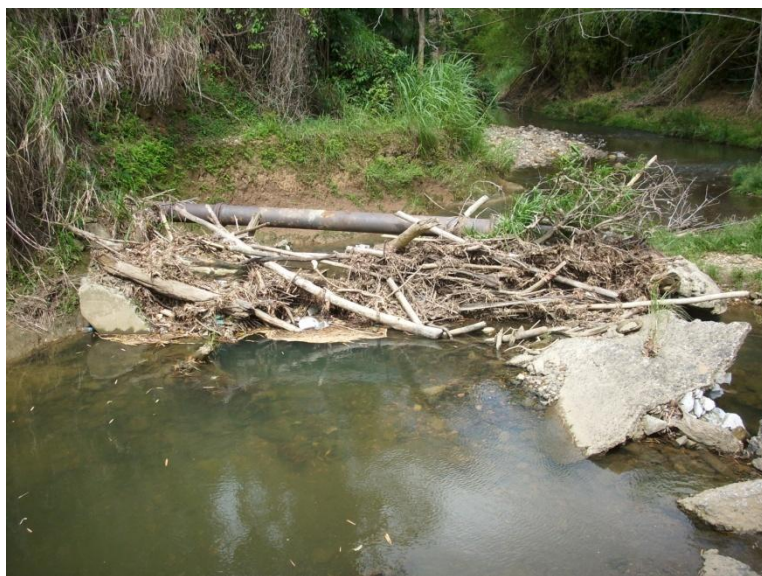
interval other than the debris collection in the water. In the water of Interval 1, a collection of natural debris has created a dam which diverted water flow from its normal path that can be seen in Figure 7.

Figure 7: Natural Dam of Zone 1

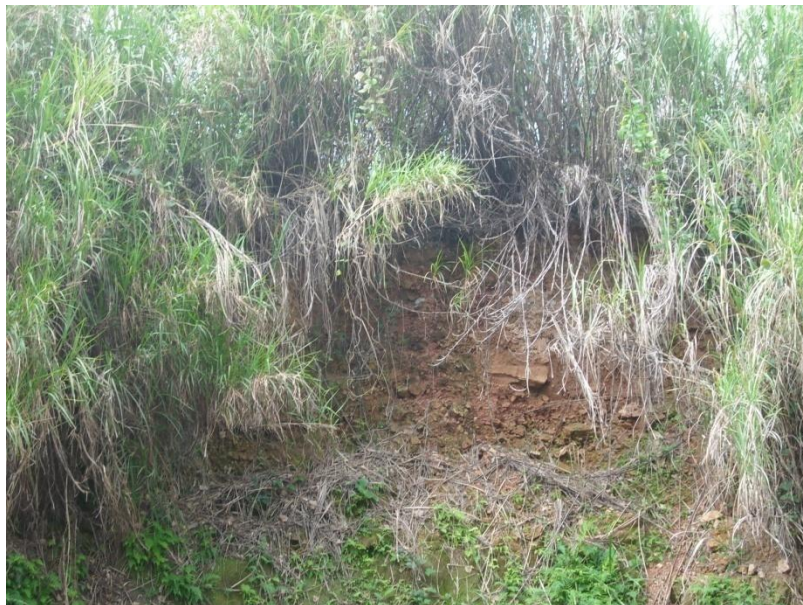
Figure 8: Erosion of Zone 1 and *Calopogonium coeruleum* Overhang

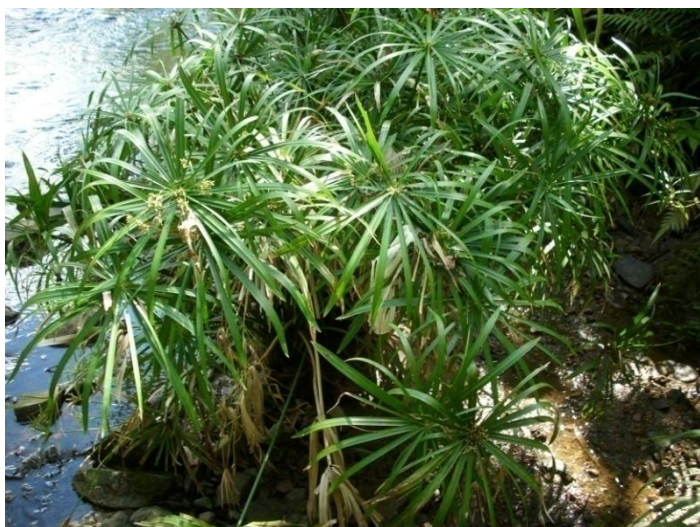
Figure 10: Invasive Papiro of Zone 2

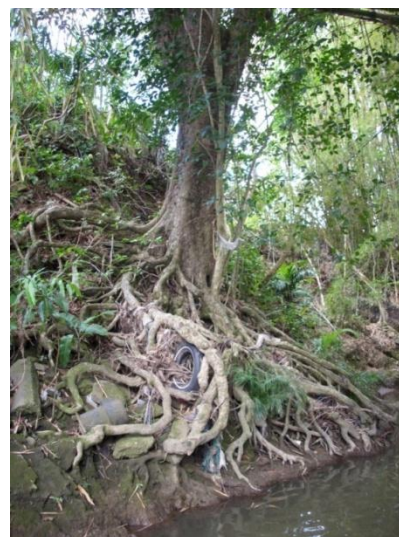
Figure 11: Indian Almond, Sparse Undergrowth, and Tire Debris of Zone 3

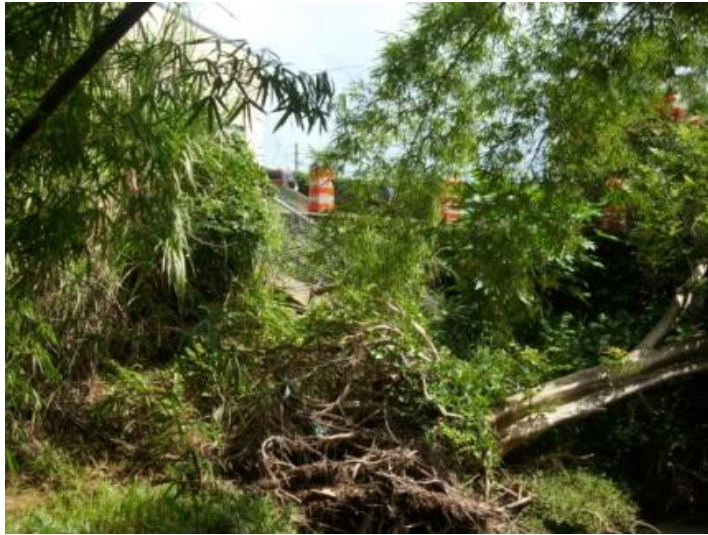
Figure 19: Parking Lot and Eroded Tree of Zone 6

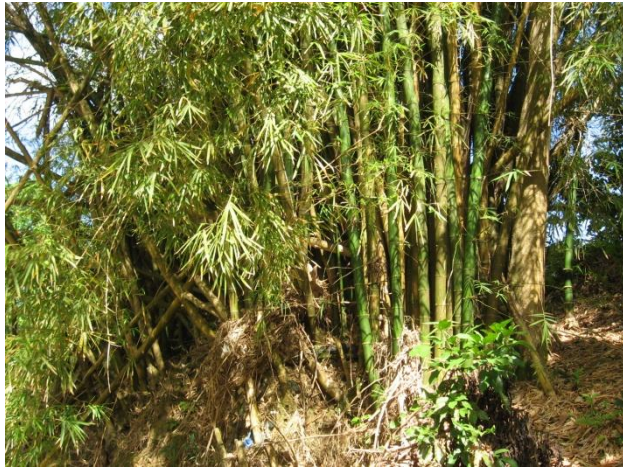
Figure 26: Bamboo Cluster and Erosion in Zone 9

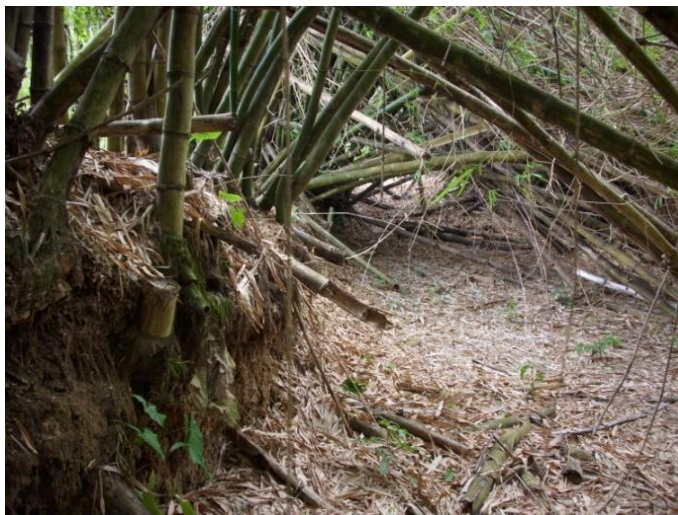
Figure 27: Falling, Dying, and Excessive Bamboo of Zone 10

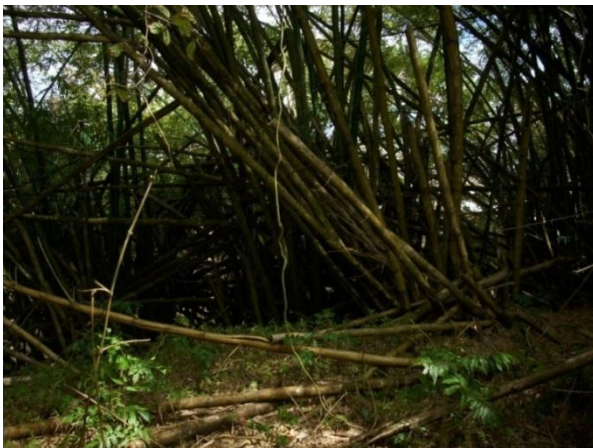
Figure 29: Bamboo Debris of Zone 11

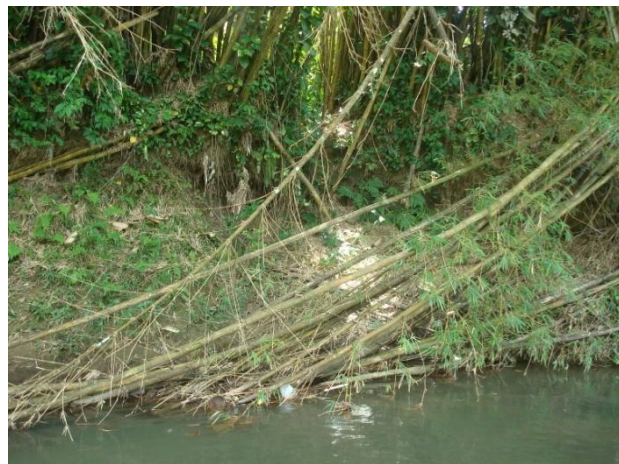
Figure 32: Fallen Debris of Zone 13
