Sudbury Renewable Renovations MQP

A Major Qualifying Project
Submitted to the Faculty of the
WORCESTER POLYTECHNIC INSTITUTE
in partial fulfillment of the requirements for the
Degree of Bachelor of Science

March 2023

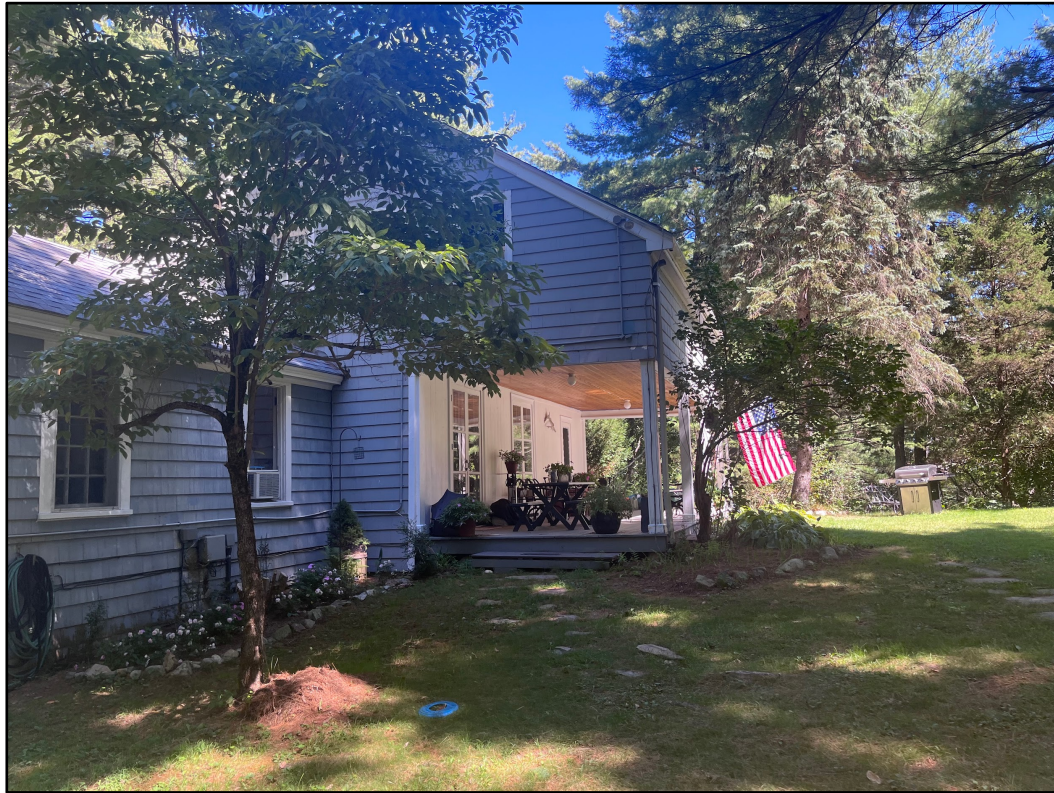
marked the building as having a fair building grade, and very poor building condition (Sudbury, MA, 2022b).

Figure 2.3 50 Wolbach Road, side (southwest); pictured: two levels, open roof porch

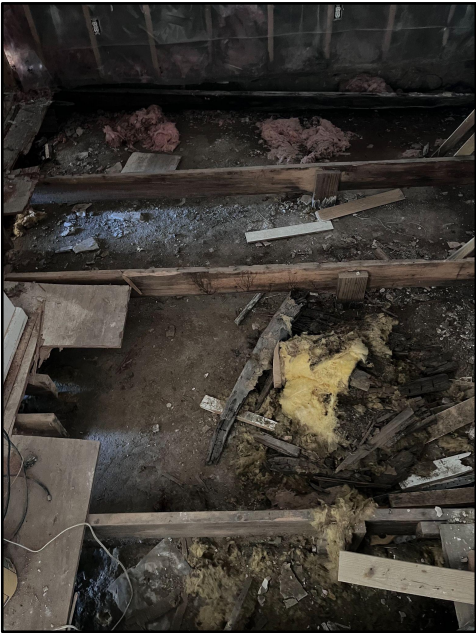
Existing: The basement of 42 Wolbach suffered extensive damage as a result of groundwater passing through the foundation. The water caused severe damage to the floor joists, necessitating their removal. In order to maintain the structural integrity of the building, the homeowner had to install a jack post to support a structural beam. The current state of the basement can be seen in *Figure 4.1*.

Figure 4.1 Basement floor flood damage in 42 Wolbach

Solution: The first step in refinishing the basement is to assess the damage caused by the flooding. This includes checking for any signs of mold, mildew, or structural damage. Any damaged items such as flooring, drywall, insulation, and other materials affected by the flood should be removed and disposed of and replaced properly. In case of any structural damage, it is advisable to hire a licensed professional to examine the space and recommend structural renovations. The groundwater flooding can be mitigated by the use of a french drain, which has been initiated by the owner already, and by grading the exterior ground to slope downhill, away from the home at one inch per foot for 10 feet.

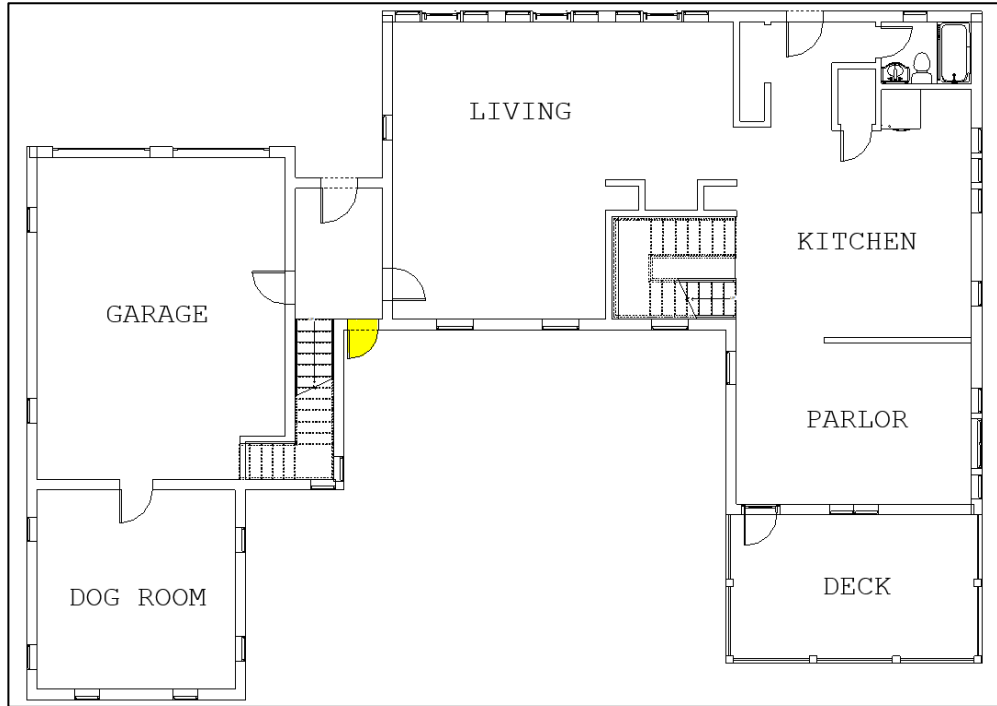
Existing: The current focal point of egress within the home is the foyer. It connects the original renovated barn space with the garage addition, where Dale End Dogs currently operates. In addition to this interior connection, there is a front door in the foyer facing the driveway which is adjacent to a back door. The back door is currently inoperable as it has no platform to walk outside onto, and the ground surface elevation is roughly 4 feet below that of the door. *Figures 4.2 and 4.3* depict the existing floor plan and highlights the inoperable back door.

Figure 4.2 Existing first floor plan. The highlighted door is inoperable.

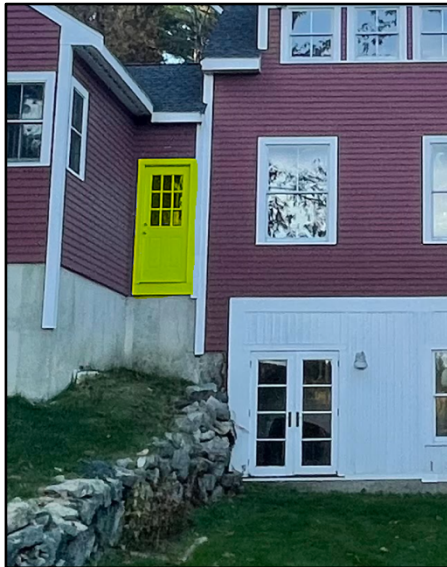
Figure 4.3 Inoperable back door

Solution: A quarter-turn stairwell descending from the back door to the exterior basement door would allow guests staying at the residence more privacy as they would not have to walk through the owner's current living space to use the interior stairwell. A new stairwell and patio

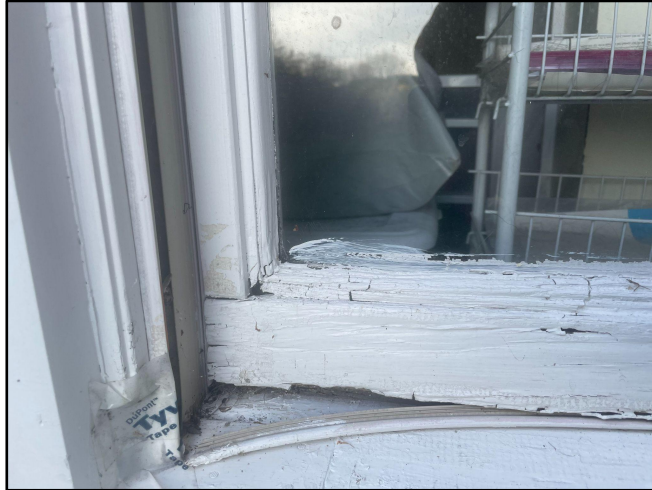
Existing: The current single-pane windows have not been replaced since the renovations that were completed over 25 years ago. They are outdated and drafty, allowing for a broader range of heat flux. To calculate the improvements that could be made by replacing the windows, the assumed insulation value for the existing windows was used to calculate heat loss, and then compared to the heat loss when using a high-efficiency window. All windows on the building appear similar to the window seen in *Figure 4.5*.

Figure 4.5 A deteriorated window is seen on the southern face of the basement-level facade at 42 Wolbach Road

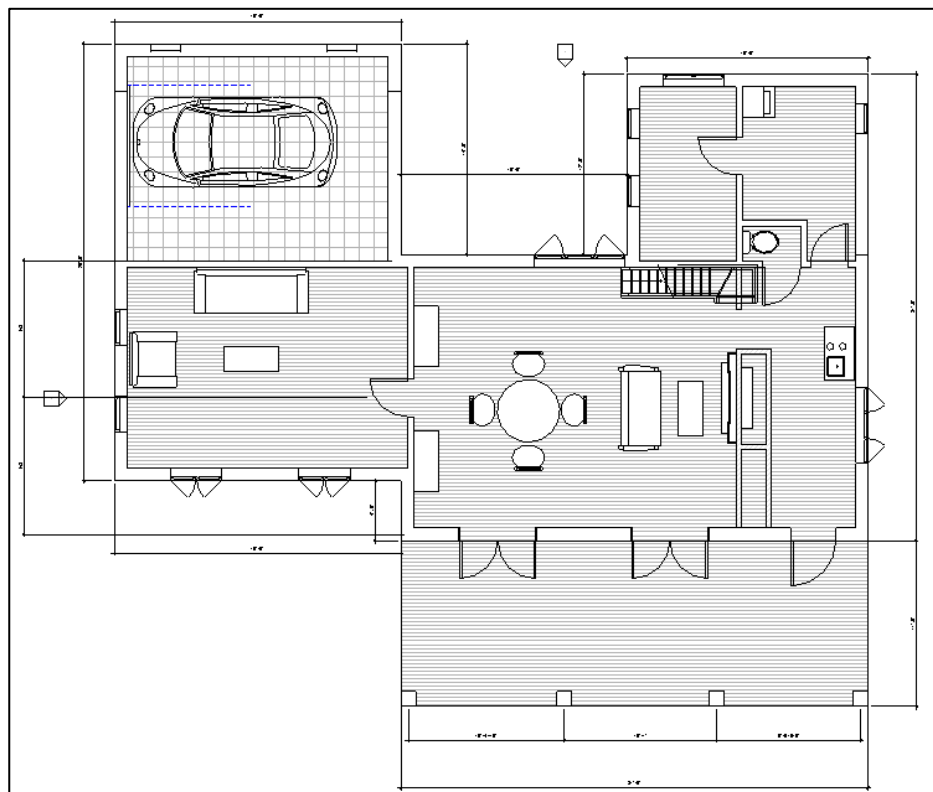
Existing: 50 Wolbach Road currently has three bedrooms and a full bathroom on the upper floor. On the ground floor is the galley-style kitchen with the refrigerator located down several steps towards the laundry room, open concept living and dining space, and an additional room currently used as a second living room. The ground floor restroom is very small, containing just a toilet, and is located off of the kitchen.

Figure 4.9 Existing 50 Wolbach Road Floor Plan
