Preserving Venetian Wellheads

An Interactive Qualifying Project Submitted to the
faculty of Worcester Polytechnic Institute in partial
fulfillment of the requirements for the degree of
Bachelor of Science

This project serves to aid and promote the preservation of Venetian wellheads by creating resources in the form of a comprehensive public Venetian wellhead catalog. This catalog may be used in building efficient restoration strategies. Through the creation of walking tours, an educational program, web pages, and promotional merchandise, we intend to help increase public awareness of these commonly overlooked pieces of art.

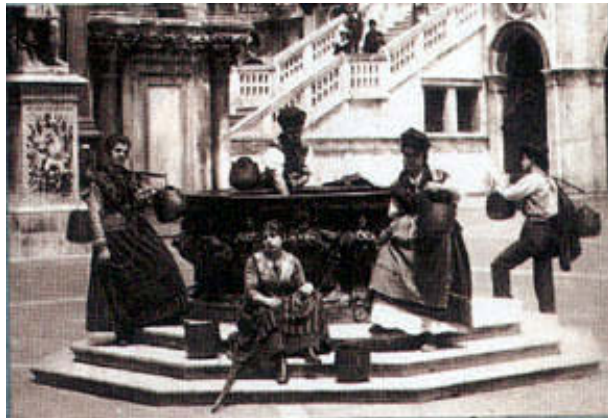
Figure 3-1 Activities Around a Wellhead

late as the nineteenth century, women washed clothes on the steps of the wellhead platforms, children played nearby, and men hauled up and carried water from its interior. ⁴ See Figure 3-1 for an illustration of a typical gathering around a wellhead located in the Doge's Palace. ⁵

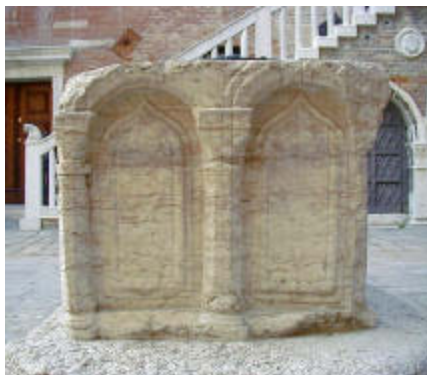
Figure 3-8 Byzantine Style Wellhead

The Byzantine era ranging from the 10th through 13th centuries was distinct in two ways. Firstly, this art style was based on Christianity. There was no longer the portrayal of many gods, but instead the theme was on one god, one faith, and one tradition. These became the standards for Byzantine art. Secondly, the Byzantine style is usually flat, with an emphasis on elaborate design instead of naturalistic depiction.²¹ Art all over Venice reflects this style due to the Venetian Republic's close contact with the Byzantine Empire throughout its history.

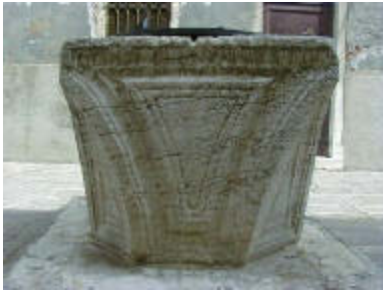
Figure 3-9 Gothic Style Wellhead

In time, the people of Venice prospered and dedicated more time to beautifying the city as a whole, including such commonplace objects as the tops of wells. Since most of the wellheads were privately owned and decorated, there was a need to bring the public wellheads to similar standards, considering the city's history of extravagance. The Gothic style dominated Venetian art from the 13th to mid-15th centuries and was characterized by a very pointed and intricate design in its arches and on each side.

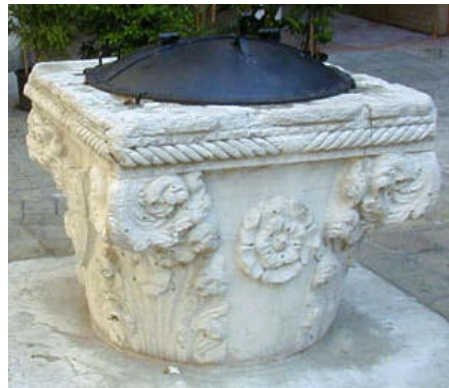
Figure 3-10 Renaissance Style

The Renaissance style was used primarily from the 14th to the 16th century. This style originated in Italy and was characterized by a renewed interest in classical art, specifically, classical Greek and Roman cultures. In the Renaissance style, features take on a more naturalistic form to simulate reality, as seen in Figure 3-10. At each corner, the sculptor has put a lot of effort into making the leaves and other plant forms as realistic as possible. The flower between the corners has a geometric appearance which could suggest the artist incorporated several styles.

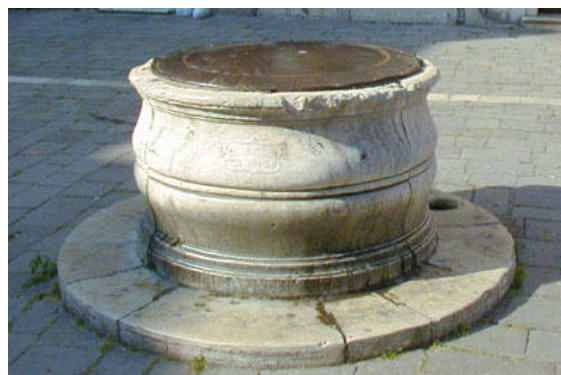
Figure 3-11 Baroque Style Wellhead

The 17th century marked the decline of the Venetian Republic and by the 18th century, the wellheads all but faded into the obscurity of apathy in the face of greater issues. Regarding its attention to art and architecture, the Baroque period was a slight twist on the Renaissance as a style characterized by a new simplicity. With a sprinkling of decoration and use of carvings to accent the edges of lines, mixed with a use of heavy spaces, gave a feeling of solidarity in tradition of the Gothic style.

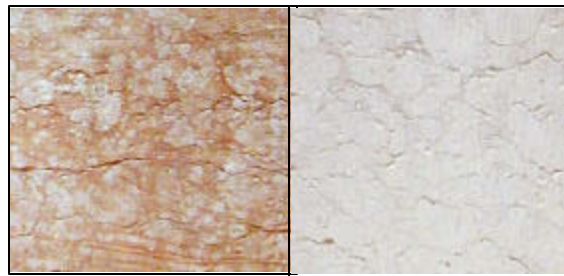
Figure 3-13 - Red and White Verona Marble

Verona Stone, often called Verona Marble, is not actually marble, but a sedimentary rock. It is composed of organic limestone and fossils.²² It has either a reddish or whitish color depending on the organisms it contains. Red Verona is easily distinguishable from Istria due to the hue.

heterogeneous appearance, and has small patches of slightly different colors located throughout the stone (See Figure 3-13).

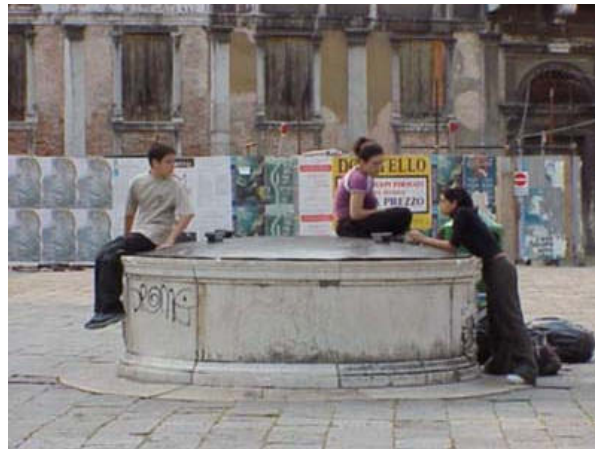
Figure 3-15- Unintentional Damage

Since the wellheads are located at a level in which people can easily interact with them, many wellheads are used by Venetians and tourists as meeting places or benches overlooking their artistic and historic significance. Although the platforms of the wellheads can tolerate constant human interaction, sitting on the lid can cause many problems. (See Figure 3-15) Sitting on the lid adds extra weight onto the wellhead that it is not designed to hold. Kicking feet against the side of the wellhead can cause the stone to flake or break off more rapidly than under normal conditions. This everyday interaction with the stone materials places them in a more urgent need of restoration.

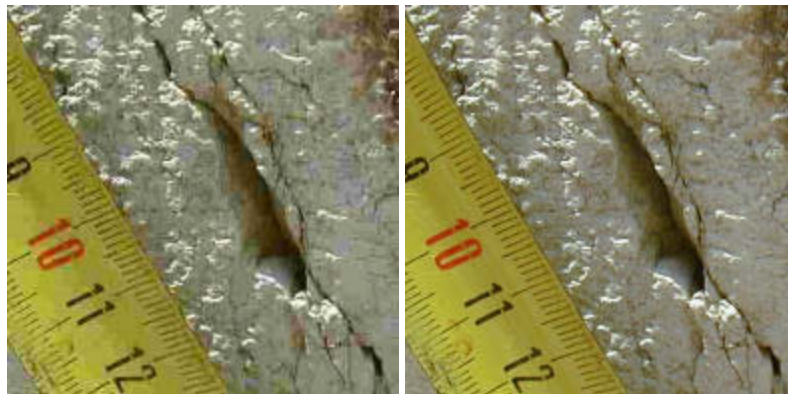
Figure 4-5 5640x480 versus 1280x960 pixel Resolution Comparison

Considering that all public wellheads could be visually broken into some combination of four to eight sides, four to eight corners, a lid and surrounding area photograph of the 232 remaining public wellheads, we took a grand total of around 2500 digital photographs. We decided to use the highest quality settings of the camera available, which set a resolution of 1280x960 pixels at about 20% compression in JPG format. See Figure 4-5 for a comparison of resolutions. Furthermore, to make the best use of the resolution, we filled the frame with as much of the surface as possible, by sometimes rotating the camera. In order to prevent confusion, we later rotated the photographs back to their appropriate orientations and resaved them at the same quality.

Each photograph required about 200 kilobytes of storage space, which would suggest that the total photographic archive would take up approximately five hundred megabytes, easily storable on a CD-ROM. We first created 232 directories in which to hold the photographs, then moved the appropriate directories into 7 folders labeled by *setiere* (including the Giudecca).

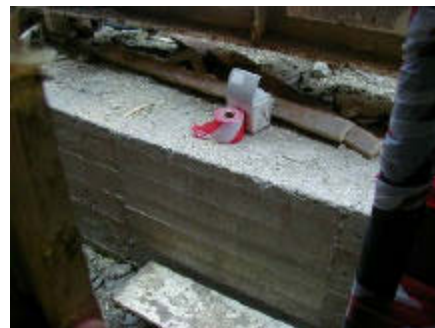
Figure 5-1 Inaccessible Wellhead (Rizzi #17)

We visually confirmed the existence and locations of 231 of the public Venetian wellheads, including 217 public and 15 privatized wellheads. We made it a point to confirm visually, wellheads that were located behind locked gates and within construction zones. Only one of the wellheads was completely inaccessible due to construction (See Figure 5-1). We obtained detailed information on the public wellheads and recorded only location and status for privatized wellheads.

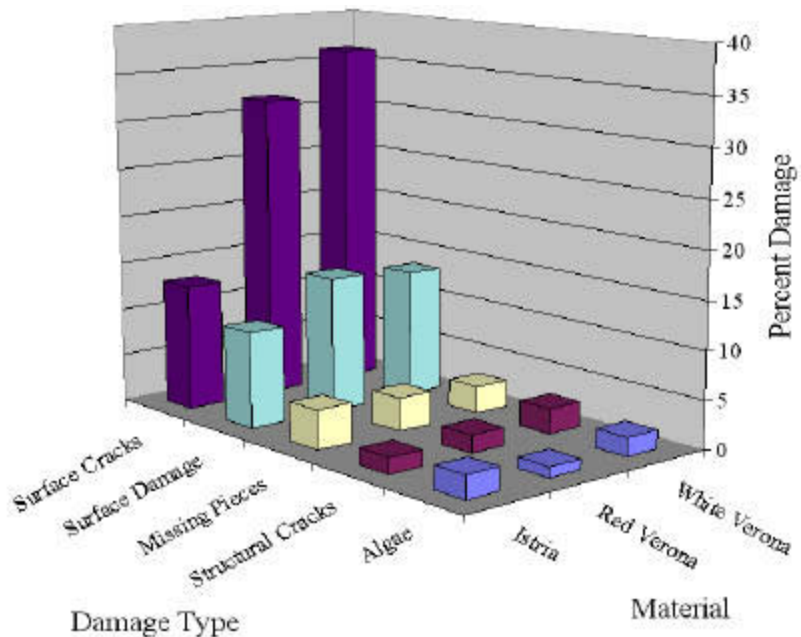
Figure 5-7 Deterioration by Material

We constructed Figure 5-7 by adding together the percentage coverage of specific damage types on every side assessment we recorded and dividing by the total number of equivalent type assessments. In this way, we created an average that gives a general impression of the state of each material on public wellheads. From this simple extraction, we can see that surface cracks are

certainly most prevalent in White and Red Verona. The coverage of surface damage is less on sides constructed from Istria, which may become important when taking into account the fact that the majority of the wellheads are made out of this material. Less obvious conclusions that can be made from the graph are that algae covers less of Red Verona than either White Verona or Istria, and White Verona was the least prone to missing pieces.

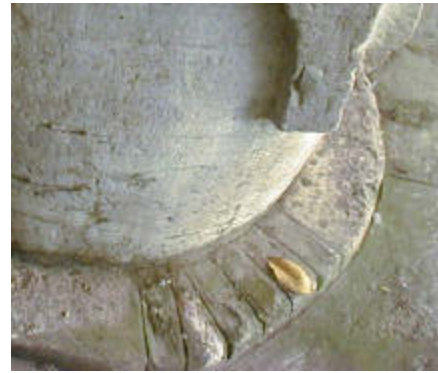
Figure 5-8 Istria Platform Repaired With Brick

The platforms cataloged were typically made of the same material as the wellhead itself with few exceptions. As pictured in Figure 5-8, Istria is the most common platform material. Aside from the seven percent without platforms, one percent had platform composed of materials other than Istria, Red Verona and White Verona.

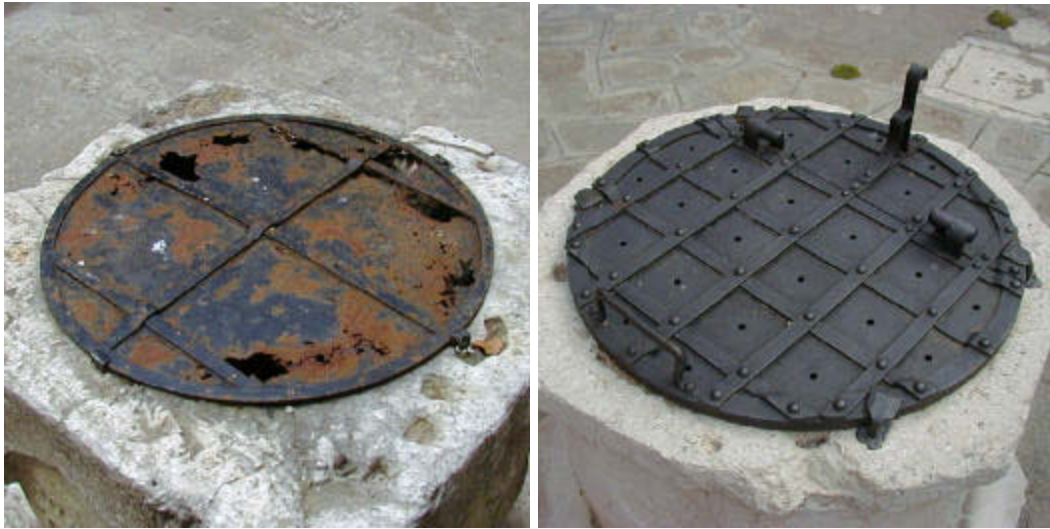
Figure 5-10 Lids in Bad and Good Condition

rust would severely eat away at the structure at a much faster rate than the rest of the lid. Even with the holes, flat lids tended to collect rainwater that would eat away at the surface in general.

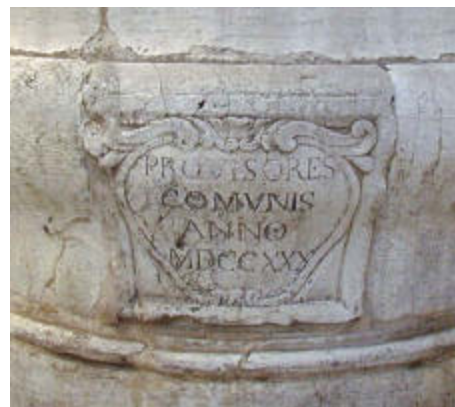
Figure 5-17 Partially Illegible Inscription

We found that forty-four wellheads had inscriptions

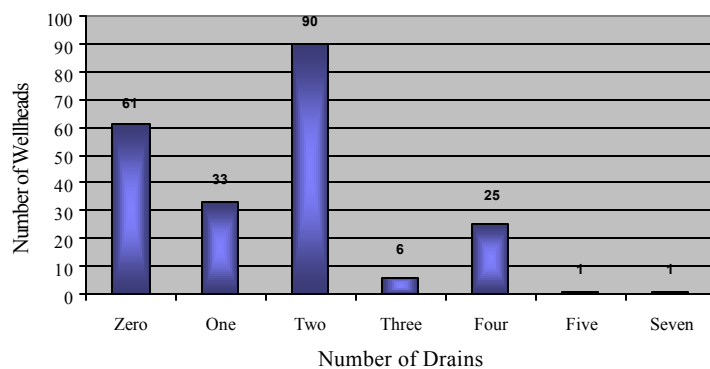
Figure 5-18 Number of Drains

Figure 5-18 displays the density of the number of drains per wellhead. Recording the number of wellhead drains serves to keep a record of another part of the original structure. We can assume that originally, every wellhead had at least one drain to allow water into the cistern. However, since a record of the number of original drains did not exist prior to the completion of our field work, there is no way to accurately tell how many drains have been destroyed or removed up until now. Future research teams have the benefit of referring to the data we collected to determine the number of drains lost from this point forward.

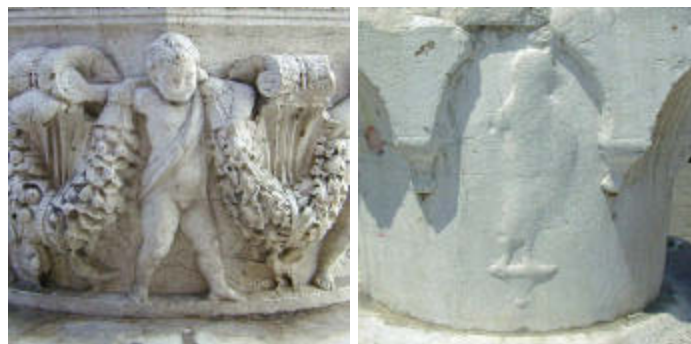
Figure 5-24 “Good” versus “Gone”

Another perfectly valid method of executing this would be to treat “gone” as a zero, thereby passing over pieces that are beyond help. See Figure 5-24 for a contrast between what should be focused on during restoration planning (left) and what should probably be passed over (right). The results of these rankings are located in Appendix R.

Considering this, we conducted a secondary prioritization solely among wellheads that displayed human figures. We simply translated the good, going, gone scale into a 1, 2, 3 scale, respectively, and added values together to get a state of conservation score for all human figures on a wellhead. A higher score suggests worse deterioration and thereby allows preservationists to focus on these wellheads separately in order of their deterioration severity.

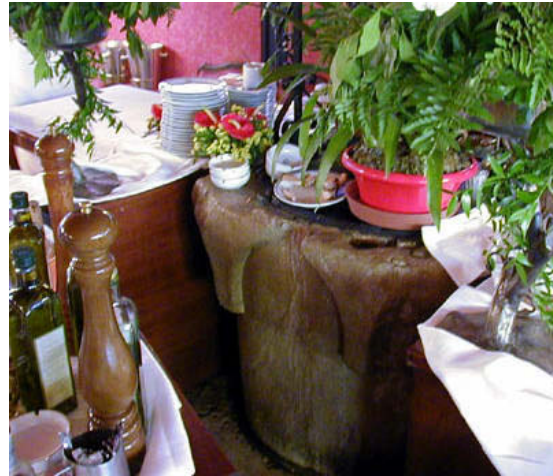
Figure 5-25 Example of Improper Use

We classified use of the wellheads as serving tables and inclusion in dining area arrangements as an improper use regardless of the actual threat restaurants pose. We focused on the cultural impact of covering a piece of art in a tablecloth and flower arrangement See Figure 5-25 for an example of a wellhead located in a restaurant (Rizzi #9). However, it is important to note that wellheads in such locations are likely the least prone to damage from weathering since awnings and other coverings, that serve to protect patrons from inclement weather, also protect wellheads.

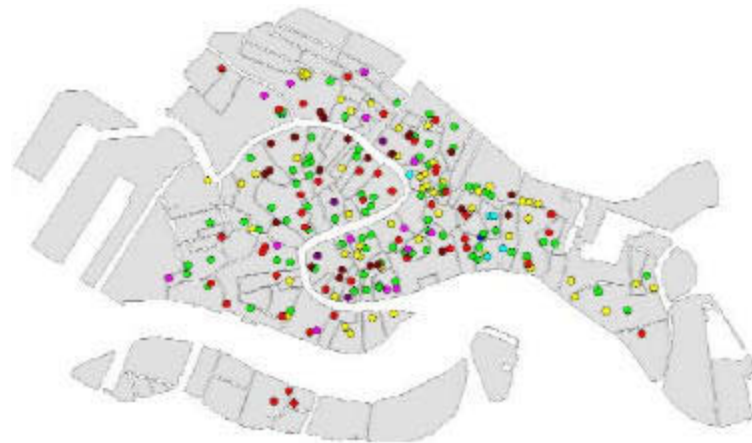
Figure 5-26 Wellheads by Approximate Date of Construction

Alberto Rizzi collected a great deal of information on wellheads that we found useful and would normally have been inaccessible. Aside from measurements of wellhead dimensions, we could not reproduce much of his collected data. In particular, information on the approximated building dates of individual wellheads was useful to us in determining the distribution of wellheads by date as illustrated by Figure

5-26. A more detailed comparison can be seen in Appendix S.

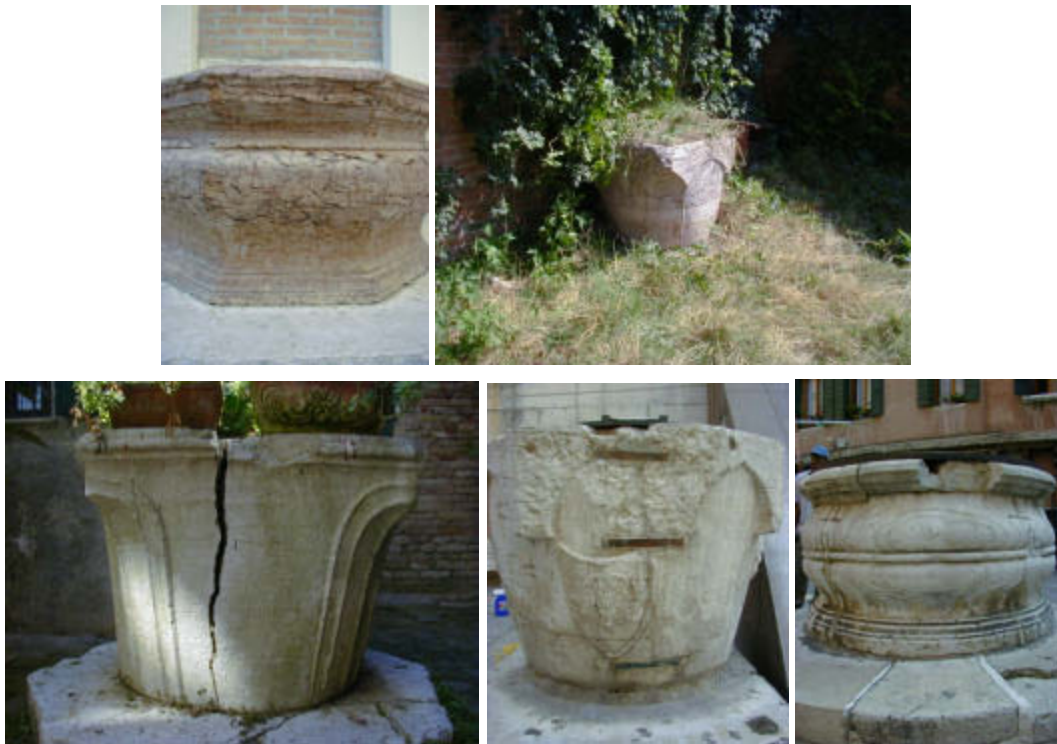
Figure 6-4 Five worst wellheads in prioritization list

Once again, the finalized ranking was checked against the photographs and we felt satisfied that the results were useful. The five wellheads most in need of restoration can be seen in Figure 6-5. Placing

217 wellheads in order of damage would have been nearly impossible to do without the aid of a computer, the numerically quantified data we collected, and the use of Microsoft Office Suite. It is also important to note that making progress on the prioritization would have been much more difficult without the previous work of the 1995 WPI Wellhead and 1995 Dorsoduro Public Art project teams. The final prioritization list can be found in Appendix J.

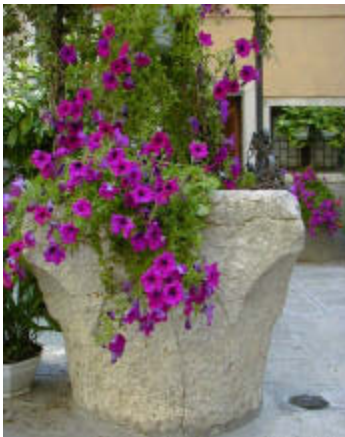
Figure 7-1 Wellhead with Flowers

In our fieldwork, we came across a few wellheads with flowers filling the top instead of having a solid lid. The presence of the flowers discouraged people from sitting on the wellhead and defacing it, which could help in preservation. We found through our fieldwork that not a single one of the twelve wellheads used as flower containers had graffiti. We strongly believe that if a wellhead is restored and transformed into a flower container, graffiti will not reappear.

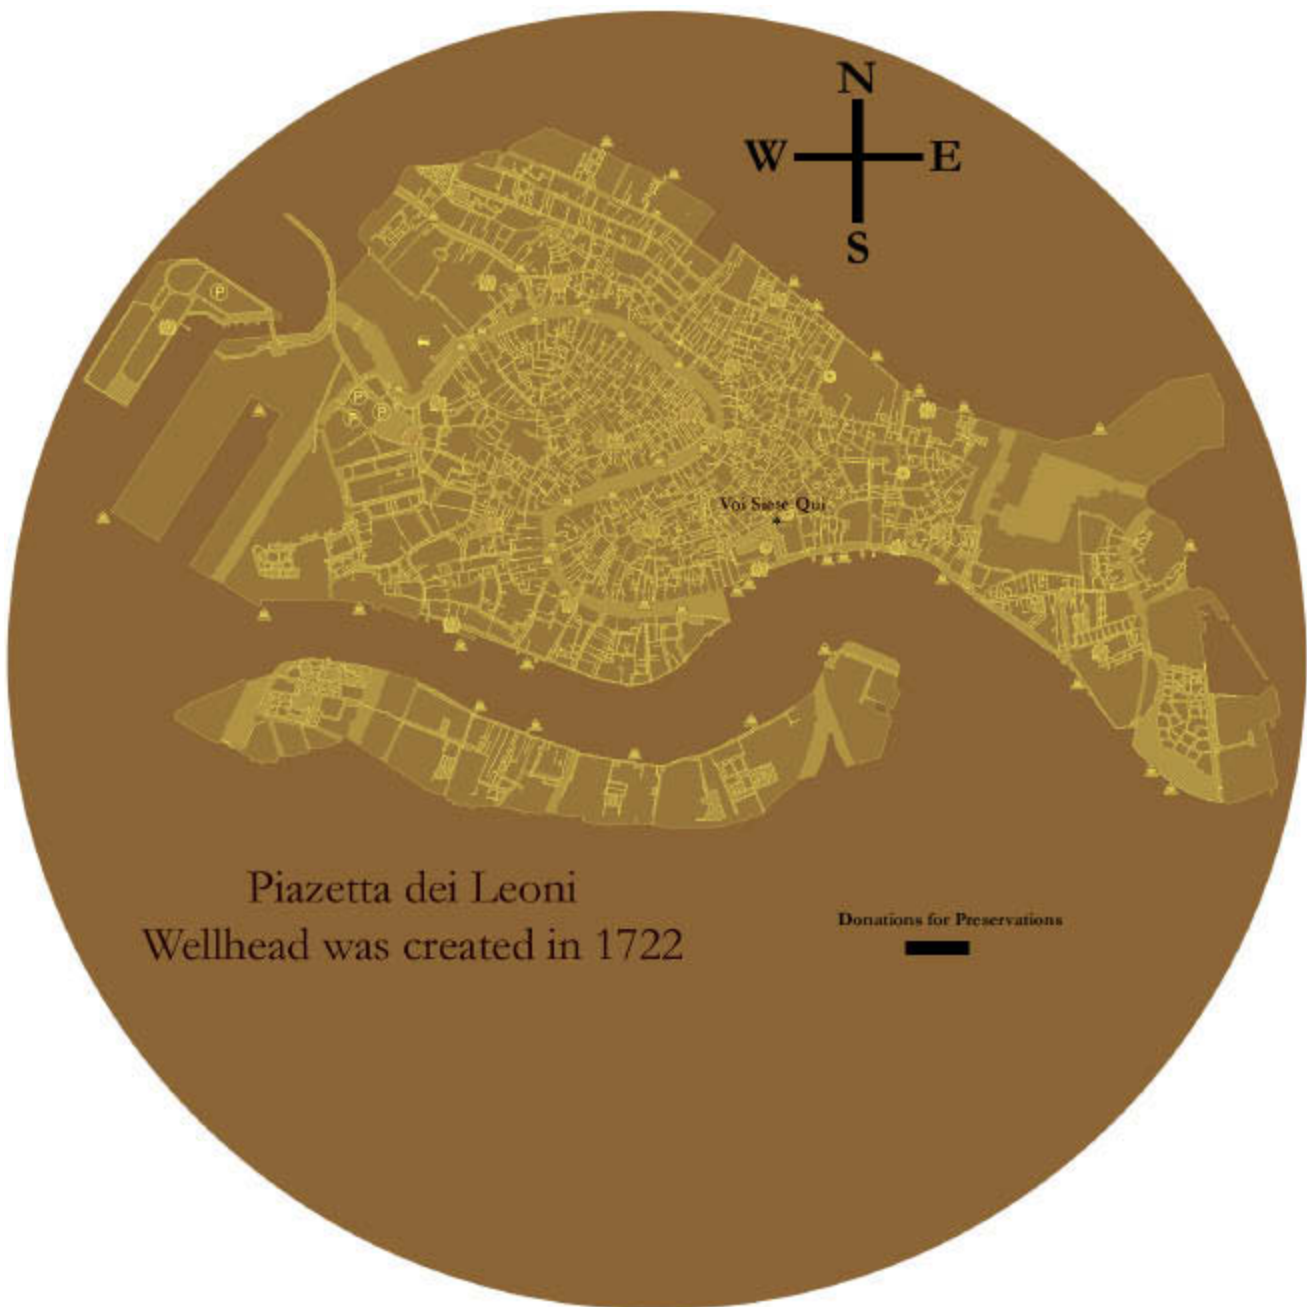
N.2 Example of Tourist Directory

This graphical representation is what we imagine our proposed wellhead tourist directories could look like.

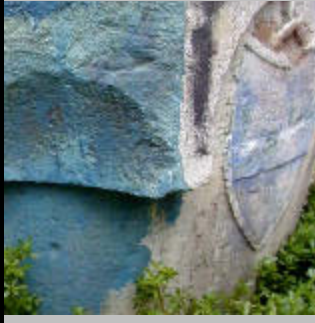
| | <p>Accretions2</p> | <p>Paint accumulations usually caused by graffiti that obscures the surface of the wellhead completely</p> |

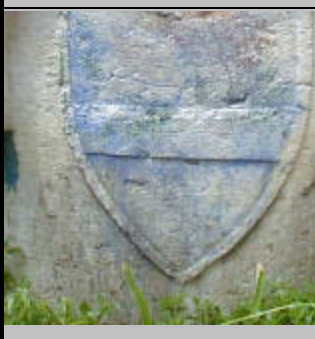
| | <p>Accretions1</p> | <p>Paint accumulations that are sporadic as in the edge of spray paint marks or tiny spattering that still allows the wellhead surface to be seen within it</p> |

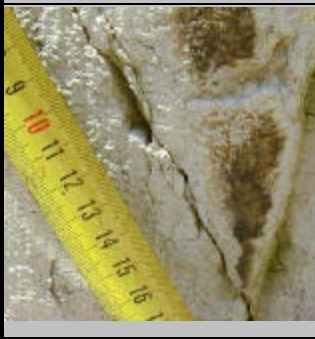
| | <p>StructuralCracks</p> | <p>Any cracks which are deep into, or all of the way through the wellhead wall; potentially causing severe structural damage</p> |

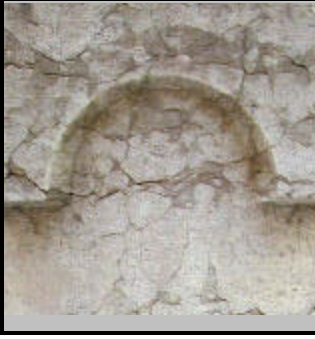
| | <p>SurfaceCracks</p> | <p>Minor cracks located on the outermost surface of the wall</p> |
