# Assessment and Catalogue of Puerto Rican Mooring Buoys

WORCESTER POLYTECHNIC INSTITUTE

May 5, 2009

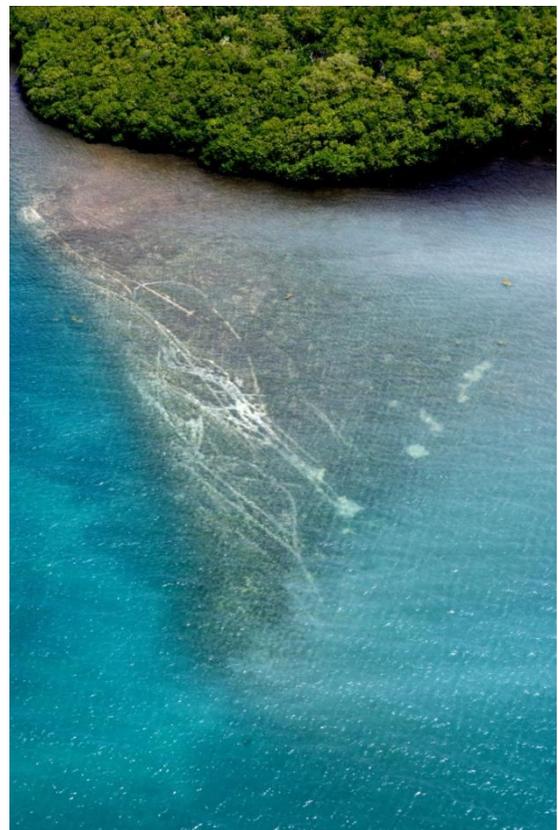
Figure 3: Scarring in a Seagrass Meadow

Seagrass beds are particularly susceptible to boating damages since they are often found in shallow coastal waters. People who use small boats often overestimate the depth of the water, or try to dock while in seagrass environments and run aground. The groundings carve long furrows into the seagrass, disrupting their root system, as shown in Figure 3. Even if the boat

does not run aground, the propellers rip the seagrass up by their roots, and it can take 2-5 years to recover (Dawes, Andorfer, Rose, Uranowski, & Ehringer, 1997; Hemminga & Duarte, 2000).

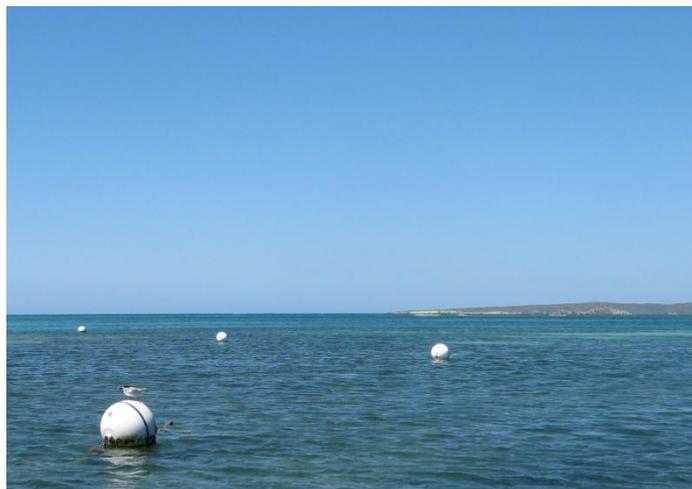
Figure 5: Mooring Buoys near Guánica

One of the main concerns of the DNER was that the exact locations of the buoys were unknown, more specifically, the exact location of the buoys' anchors. Knowing the anchor's exact location is important because if a buoy becomes detached, the anchor pin can be easily found by divers to facilitate replacement. Using a Trimble GPS transponder, we established each anchor's precise

geographic coordinates, which have been imported into a GIS database.

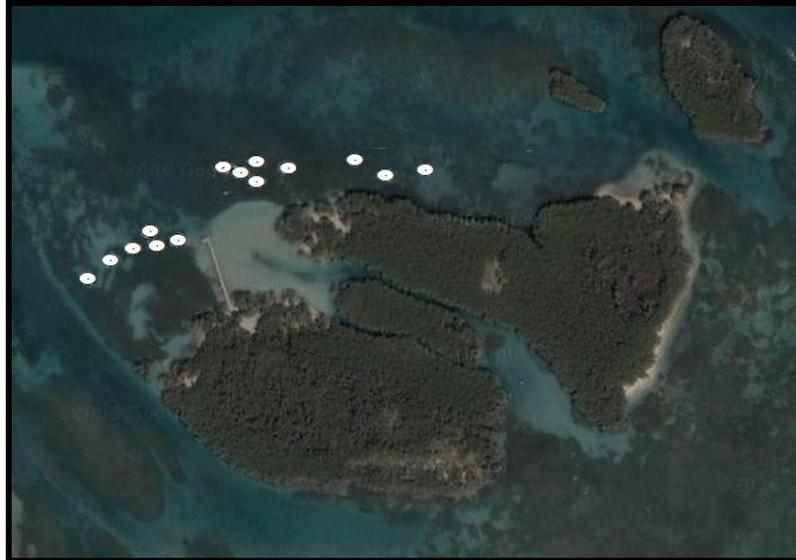
**Figure 10: Map of Guánica Mooring Buoys**

Figure 10 shows the 14 mooring buoys located off the coast of Guánica at the island of Cayo Aurora. These buoys were distributed in the area surrounding the island's sole pier, each approximately 54 feet from its closest neighbor. These relatively short distances are due to the shallow waters in which the buoys were installed. While at the site we discovered one buoy, not attached to an anchor, which the DNER brought back to the department for cleaning and reinstallation.

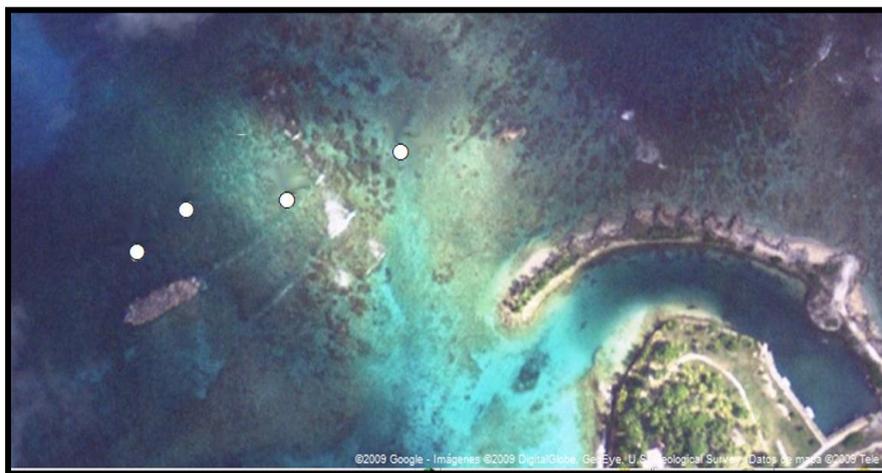
Figure 13: Map of Wolf's Den Mooring Buoys

Figure 13 shows four mooring buoys located around Wolf's Den Island. Each buoy was spaced 150 ft apart, similarly to Palomino, in order to prevent collisions between moored boats in the deep water.

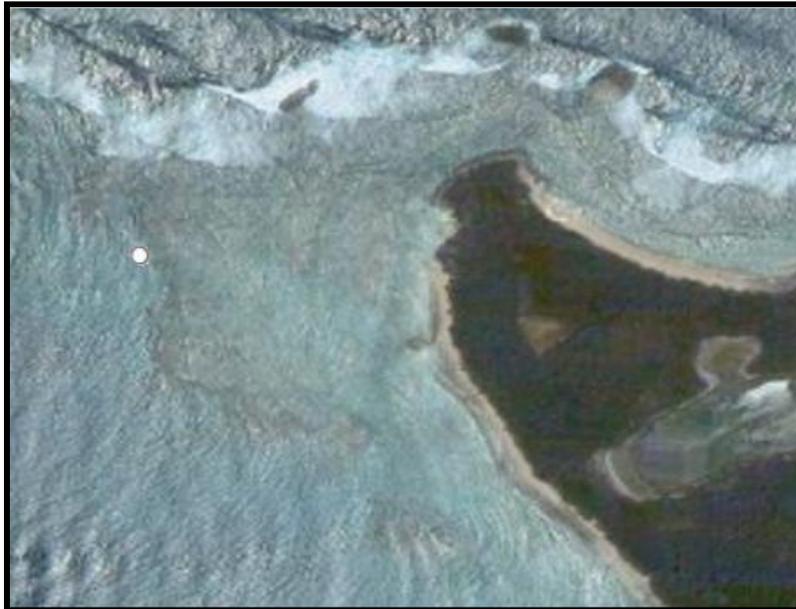
Figure 14: Map of Icacos Mooring Buoys

Figure 14 shows only one buoy located off the island of Icacos. This is because two buoys were missing at the time of our cataloguing. However, there were other mooring buoys in the area that did not belong to the DNER, one of which appeared to be the same model as the DNER buoys. The other buoys are in place at Icacos probably due to the fact that charter boats that wish to keep the surrounding ecosystems intact while still being able to moor frequently in this area.

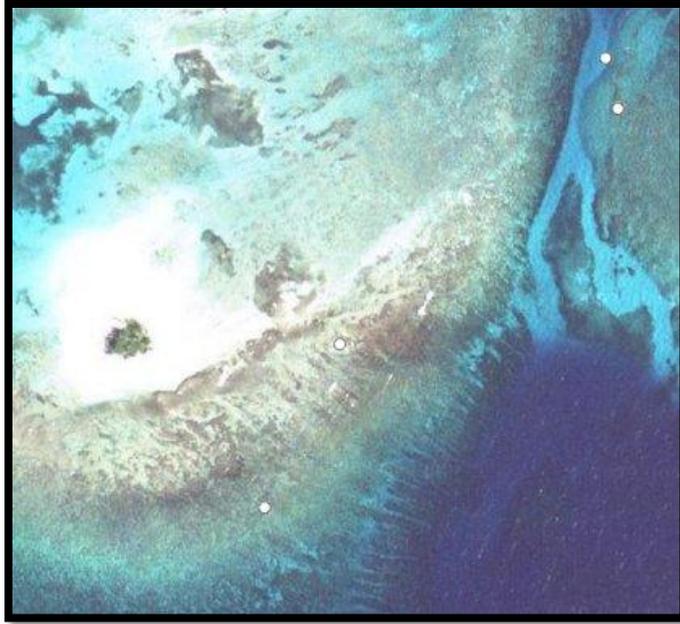
**Figure 15: Mooring Buoys at Palominto**

At the small island of Palominto, which is next to the island of Palomino, four buoys were catalogued ( Figure 15). These buoys were anchored at a depth of approximately 15 feet and were about 300 feet apart from one another. There were supposed to be six buoys in this area, but two were missing.

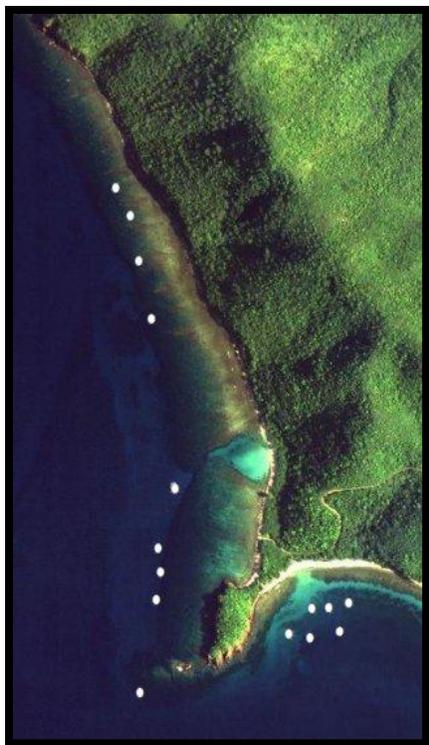
Figure 16: Mooring Buoys at Culebra

Figure 16 displays the mooring buoys off one of the coasts of Culebra. We catalogued only 15 mooring buoys, however, many more surround the island. There was not enough time during our fieldwork at Culebra to mark all of the buoys' locations. The depth of the water in this area ranged from 4-44 feet. These buoys had an average distance of 209 feet from each other; however we discovered an instance where two buoys were extremely close to one another. We only catalogued the buoy that was in better condition, and the other was marked for removal. The DNER will come back to this site to remove and relocate the second buoy at a later date.

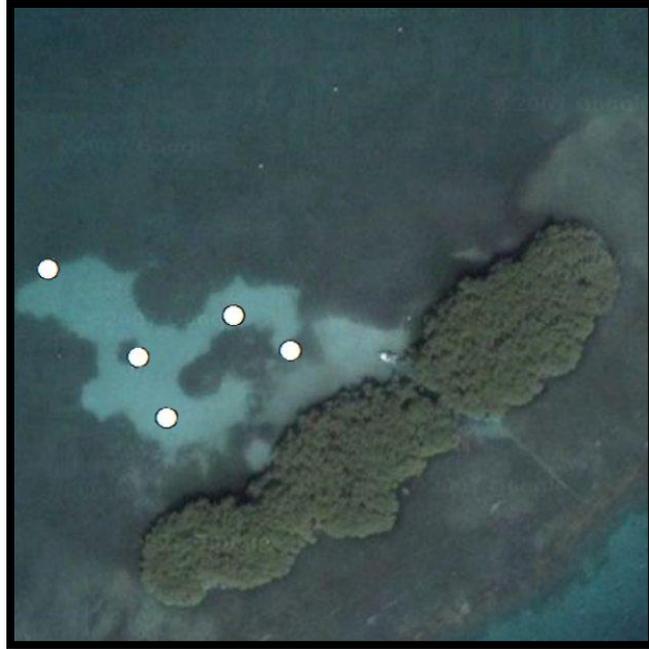
Figure 17: Mooring Buoys at the Cay of Collado at Parguera

Figure 17 shows Colloado, the first cay we visited off the coast of Parguera. With an average depth of three feet, and a range of depths from two to four feet, this area contained five mooring buoys that stood sentry over the seagrass below. The spacing between each buoy was common for shallow fields: approximately 75 feet.

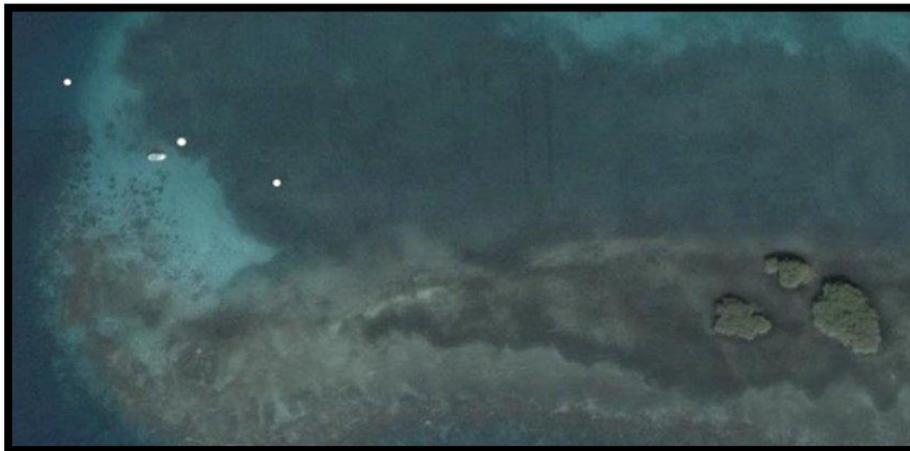
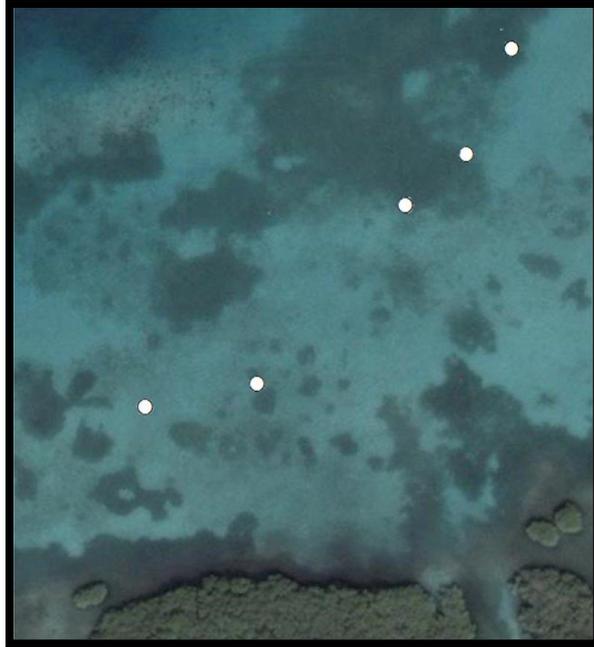
Figure 18: Mooring Buoys at the Cay of Enrique at Parguera

The cay of Enrique, shown in Figures 18 and 19, contains six mooring buoys in seagrass. The depths at the buoys are consistently four feet, except for one in 15 foot deep water. Arranged in a linear configuration, these buoys are spaced an average of 126 feet apart.

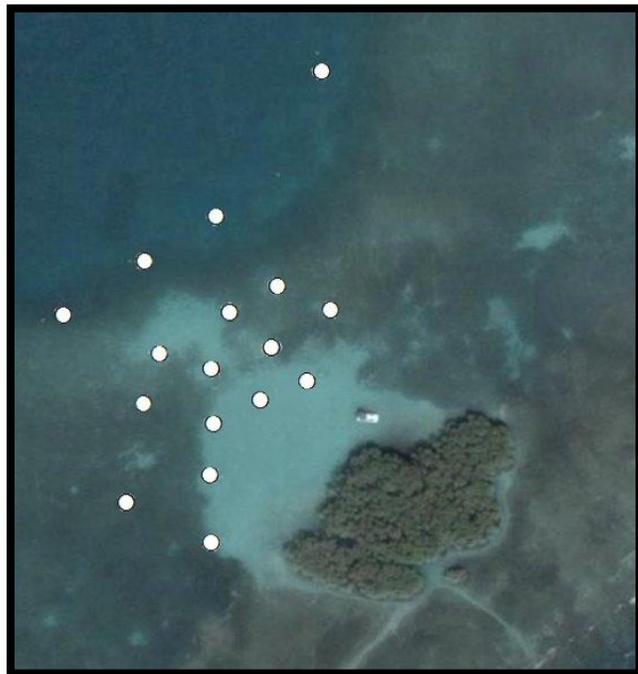
Figure 20: Mooring Buoys at the Cay of Caracoles at Parguera

Figure 20 shows Caracoles, the last cay we visited in Parguera. The 17 mooring buoys installed at this location sit in water with a range of depth from two to thirteen feet. The average spacing between buoys is 100 feet, which allows for larger boats to moor in this seagrass field.

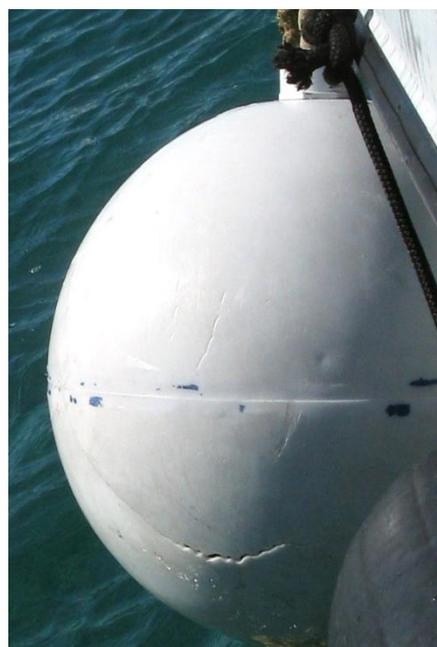
Figure 21: A Propeller Scar in the Buoy

The conditions of the buoys varied drastically between the sites we visited, with damage ranging from none to severe. Most of the buoys had microecosystems growing and flourishing on the downline and thru-line beneath the surface of the water. These microecosystems depend upon the buoys for the structural support provided as well as the freedom from competition with other denizens of the seafloor. They are capable of flourishing in calm shallow waters, but we did not observe any microecosystems in places where the water was rough. If the waters are too rough, as was the case at Fajardo and Culebra, there were no microecosystems on the lines. The DNER leaves these ecosystems on the buoys, and to our surprise, they also choose to leave bird feces on the buoys because the nitrates enrich the surrounding seagrass. Something to note is that our observations show the buoys with bird feces are the ones with the thickest algae on the bottom.

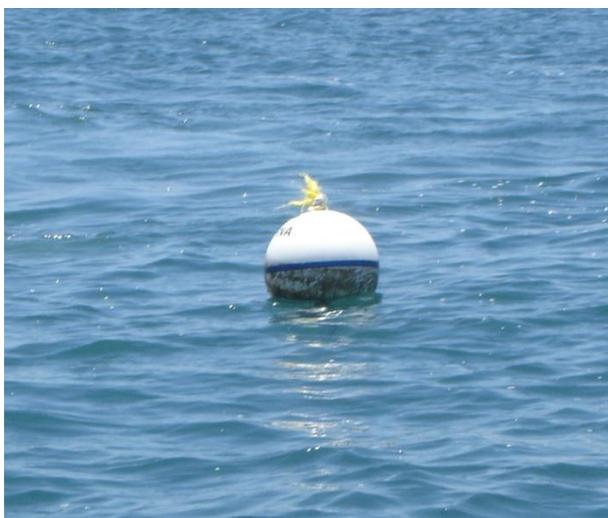
**Figure 22: A Mooring Buoy Missing Its Pickup Line**

While cataloguing the buoys around Salinas, we found them all to be in good working order. These mooring buoys were installed to protect mangroves from people tying up to them and damaging the root systems of the trees. Most of the buoys there were recently replaced and had new components with no prior damage. However, four of the other buoys needed to be cleaned of algae and other plant growth, which was done by DNER snorkelers with knives. The cleaning is required due to the fact that the buoys and lines become weighed down by the growth and will float lower in the water. When this happens it is hard for boaters to see the pickup lines and the buoys, which often leads to boaters driving

over the lines, cutting them with their propellers.

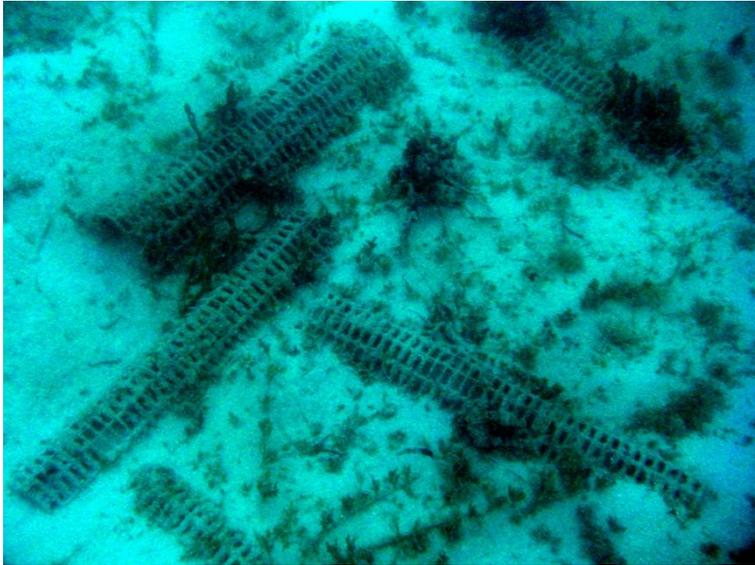
**Figure 24: Lost Traps Demonstrate the Negative Impact of Humans**

We also observed that trash and lost traps collect in the vicinity of mooring buoys, which was reiterated by the locals interviewed at Parguera. They blame the tourists and out-of-towners that arrive

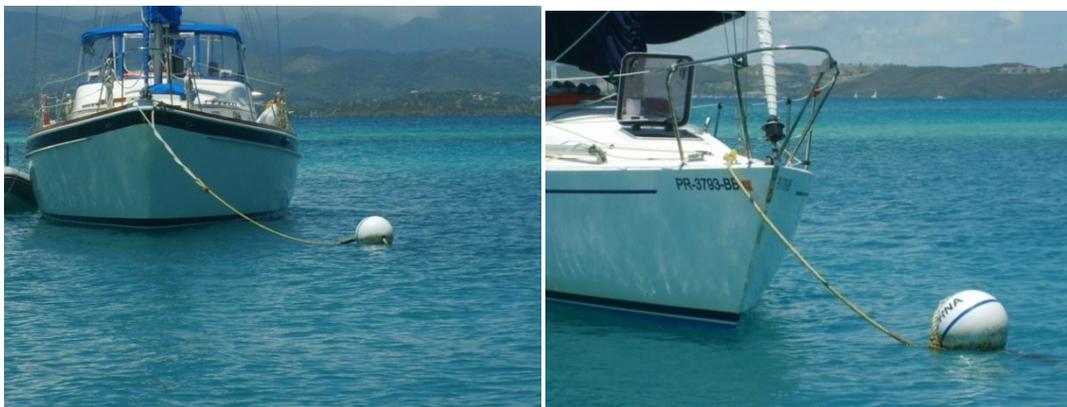
We returned to Palomino and visited its small neighbor, Palominto, on a weekend where more than twenty boats total were sighted anchoring very close to the beach. Many of these boats were also rafted together so that the boaters could better enjoy each other's company. Besides anchoring along the beach, other boats were using the mooring buoys, the majority of which were using the buoys correctly. Only two boats were seen using buoys incorrectly. One boat was tied up correctly, however it was too large a vessel to use the mooring buoy. It put so much strain on the lines that the buoy was completely submerged, which could cause the buoy to become detached from the anchor. The other boat tied the pickup line of the mooring buoy directly to its cleat, which also puts unnecessary strain on the lines (Figure 25).

**Figure 25: Two Boats Tied to Mooring Buoys. The first picture is the correct way to moor by tying a line from the boat to the pickup line. The second picture shows the incorrect way to moor by tying the pickup line directly to the boat.**

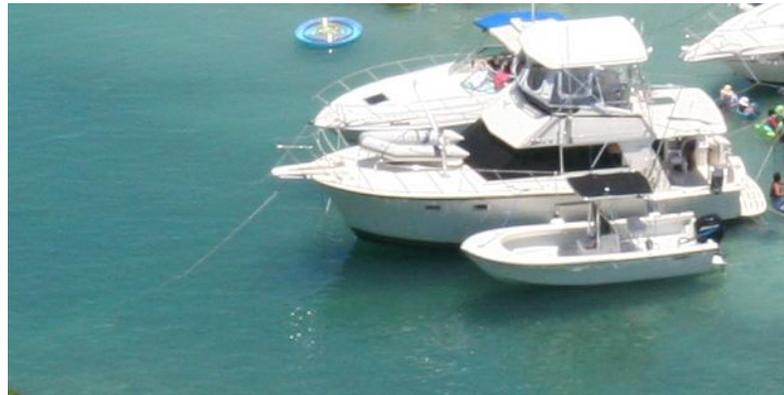
**Figure 27: Large Boat Anchored in Seagrass at Salinas**

Other bad practices observed were boats lining the beaches and mangroves. The boats dropped anchor along the sand, and with such a large number of boats, this can cause serious erosion to the beach. Along the mangrove channels in Salinas a long row of boats had tied their lines to the mangrove branches. This causes damage to the mangroves by breaking its branches and roots. If there was not enough room near the beach or next to the mangrove forest, the boaters proceeded to drop anchor wherever they wanted. At Salinas, a large boat deliberately dropped anchor upon the seagrass bed (Figure 27).

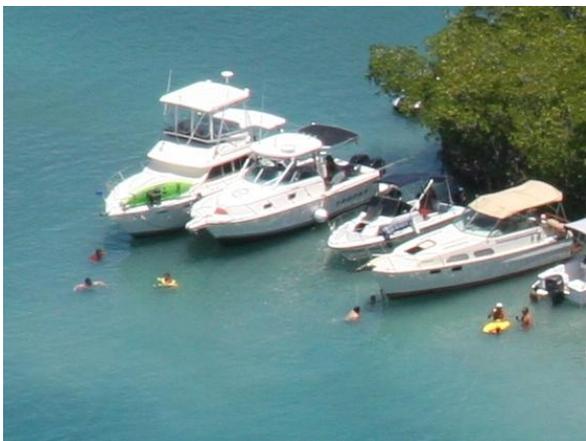
**Figure 28: Improper Mooring Buoy Use at Salinas**

Buoys can be seen used improperly in the aerial photography of Salinas, where a buoy can be

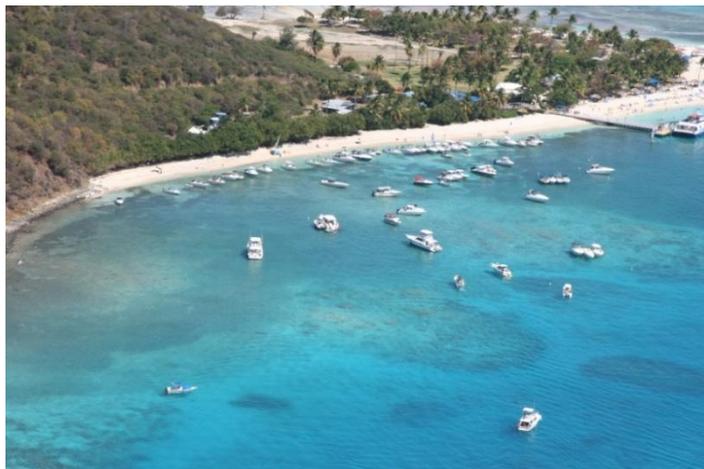
Figure 29: Boating Traffic at Palomino over Easter Weekend

There are a few possible reasons why boaters were not using the mooring buoys. The mooring buoys may have been in disrepair, rendering them unusable to boaters. Since the aerial surveys were collected on Sunday, at the end of Easter weekend, these buoys could have been damaged earlier in the weekend. Another reason is that the boaters decided to go wherever they desired rather than limiting themselves to locations with buoys. With the holiday festivities and the large number of other boats, a boater has more confidence to drop anchor in seagrass or coral environments if there are others doing the same. With this data and the aerial photography, it appears as if boaters go where they please with little regard to the environment.

When it comes to aquatic activities, people tend to go where they want. From our observations we witnessed that most boaters will go closer to shore and drop anchor in the sand. Although this practice is not illegal, it is discouraged by the DNER because it erodes the beaches. Boaters avoid fines for dropping anchor in seagrass or coral by getting close enough to shore that there is only sand. However, we observed that if their interest coincides with that of a mooring buoy location then some of the boaters will use the buoy instead of dropping anchor.

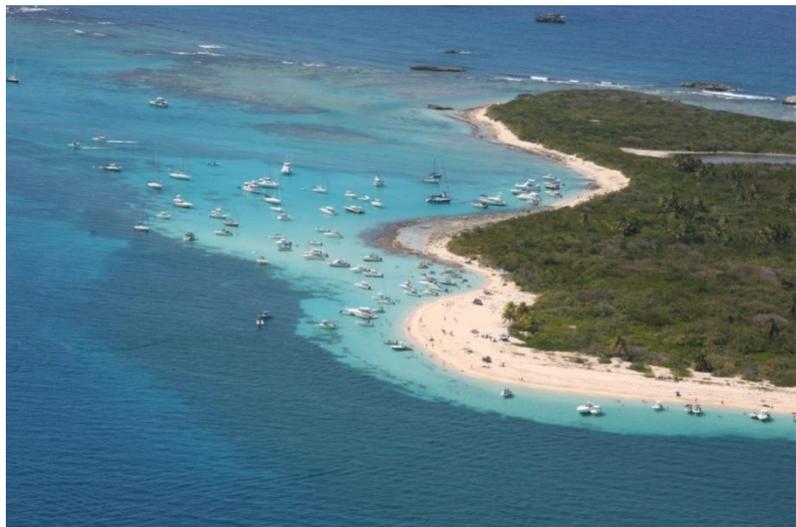
Figure 30: Boat Traffic at Icacos over Easter Weekend

To try to ascertain a better idea of the boat traffic during the weekend; another excursion was undertaken to Fajardo and Culebra on a Sunday. Compared to when we visited Palomino previously, there were over 49 boats present in this location and this was only at one of the many islands off the coast of Fajardo. Most of these boats were anchored next to shore, but the rest were using all of

the mooring buoys in that area. While at Culebra we counted 43 boats in different areas around the island. There were other parts of the island that were populated with many boats but we were unable to travel to them due to time constraints.

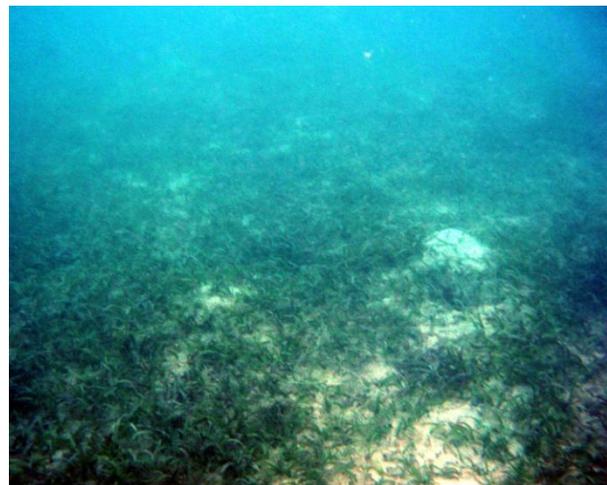
Figure 31: Bare Patches in a Seagrass Meadow

These popular areas contain the most damage to both buoys and ecosystems. The reason for the popularity is that these areas are close to major cities and large resorts, which allow tourists easy access. These places are also well known for their swimming and marine activities. Because they are used so frequently, the ecosystems have a hard time recovering from all the traffic. More remote places are allowed to recover because they only experience an influx of visitors during major holidays and weekends. The more popular the site, the more boats there are. These boats tend to crowd where there are not enough mooring buoys so they have to drop anchor, which damages the ecosystems. While the ecosystems are being damaged so too are the mooring buoys meant to protect them. Because of the sheer number of boats using these buoys, they sustain more damage from improper use and general wear, rendering them unusable. During the weekends and holidays, when there is an increase in boaters, damages to buoys are exasperated, diminishing the number of mooring buoys which leads to the deterioration of the surrounding ecosystems.

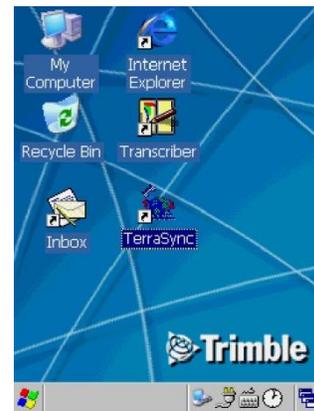
Figure 32: Trimble Desktop

On the Trimble desktop, double tap the TerraSync software icon to open the data collection program.

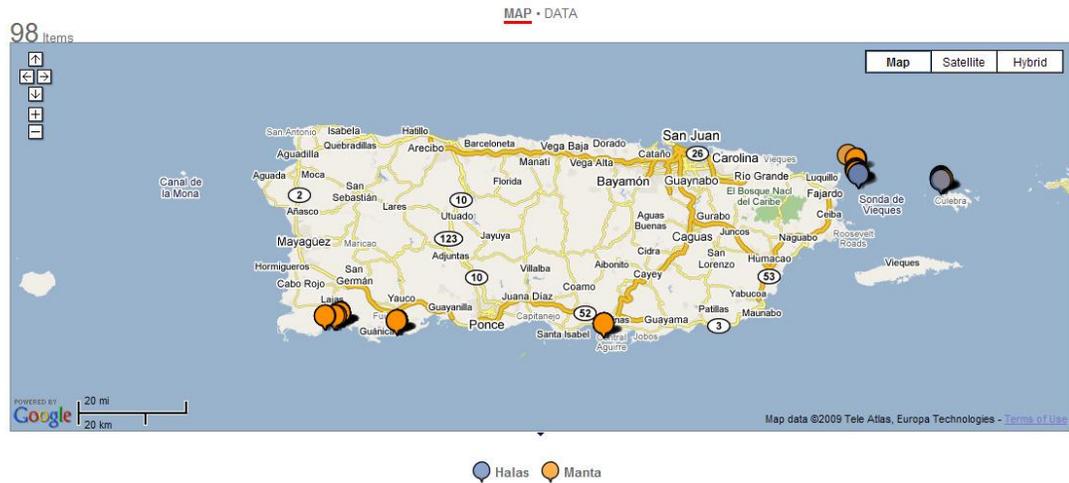
Figure 43: Database Website, Map

The user can read information about mooring buoys in two different ways: “MAP” and “DATA”. When the user is toggled to “MAP” (Figure 43) the mooring buoy locations are represented on a map of Puerto Rico that is powered by Google Earth. Each pin represents a mooring buoy. Using the key in the top left corner of the map, the user can pan up, down, right, or left and also zoom in or out. The type of

map can also be changed by clicking on the buttons that are in the top right hand corner of the map. The legend of the map indicates that each color of the pin represents a certain type of buoy.

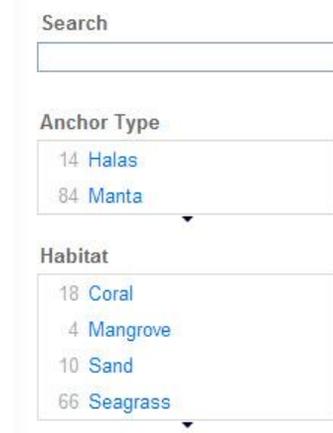
Figure 44: Database Website, Sidebar

Mooring buoys can be located in two different ways. The empty field titled “Search” allows the user to type in the type of anchor or what substrate the buoy is located in. This field is only useful when trying to locate buoys because it searches the database for any buoys that contain that value. For instance, typing in “pickup line” would not be helpful because it would not filter any buoys, since all include a pickup line.

Another way to filter buoys is by clicking on any of the hyperlinks located in the right hand column. When clicking on a value, only the buoys of that value will appear on the map. This is very useful because the user can click on multiple values, thus narrowing the search. The user can search for buoys according to anchor type, habitat, cleanliness, and types of damage to the buoy, and surrounding environment. For example, in clicking “Manta” for type of anchor and “Coral” for type of seafloor, the map will show three buoys in the Fajardo area. These buoys have a Manta-type anchor and are protecting corals.
