# Optimization of Tool Wear Versus Tool Change at Affordable

## Interior Systems

A Major Qualifying Project Submitted to the Faculty of  
WORCESTER POLYTECHNIC INSTITUTE  
In partial fulfillment of the requirements for the degree of  
Bachelor of Science

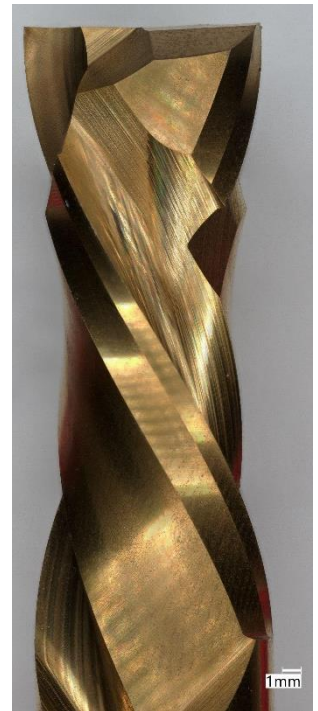
*Figure 1: New 1/2in compression endmill*

Currently, to do the majority of their cutting on work surfaces, AIS is using a 2 flute 1/2in diameter coated carbide compression end mill manufactured by FS-tool.

A compression end mill is different from a normal end mill in that it “has an up-cut flute geometry from the tip to usually about 1/3 of the cutter length at which point it converts into a down-cut flute.”<sup>2</sup> A down cut flute in short is a flute that twists in the opposite direction. This can be seen in figure 1. The utility of this is that it avoids the delamination of the laminate layers while cutting. With a regular twist end mill the cutting forces are trying to pull up the tool or positive Z direction due to the angle of the cutter. This helps with the evacuation of the chips out of the gullet or flute of the end mill. This works well with metals due to the homogenous or layer less composition of the material. When cutting laminate fiberboard on the other hand, the upward facing cutting forces will pull apart the laminate layers. The counter rotating flutes on compression end mills counteract this by adding an opposing force that prevents delamination as well as reducing the upward forces. The reduction of upward forces also means that a vacuum plate can be used to hold the workpiece down on the machine.<sup>3</sup> The boards are held down to the machine using a vacuum plate that uses a negative pressure pump and ports cut into a MDF board.

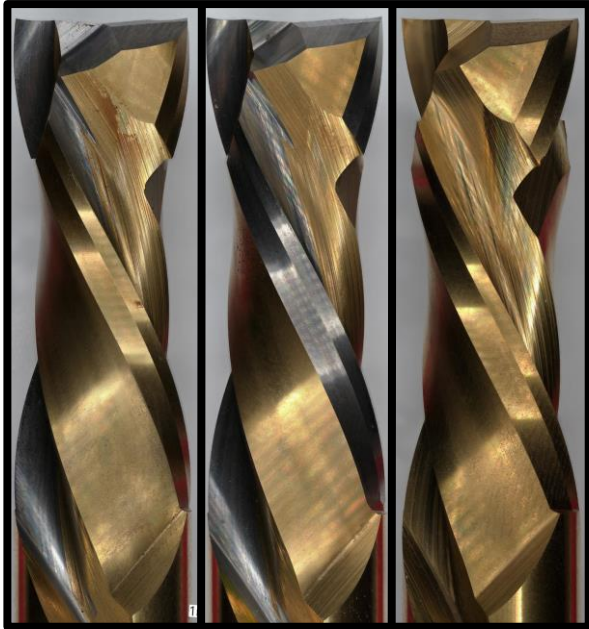
specifications. This produces a tool that dimensionally is the same except for the outside diameter (OD). An alternative resharpening design is the leftmost image shown in figure 3. This resharpen program only refinished the flute of the endmill, to keep the coating in-tact. This condition was not tested, as it is only feasible for the first resharpen and 50% of samples for the

second resharpen according to the tooling supplier.

Every resharpen results in a reduction of the outside diameter by roughly .01 in. This is not a specified value rather an average because each resharpen is based upon laser measurements done by the grinding machine. The middle and right most images in figure 3 show a reground tool and a brand-new tool.

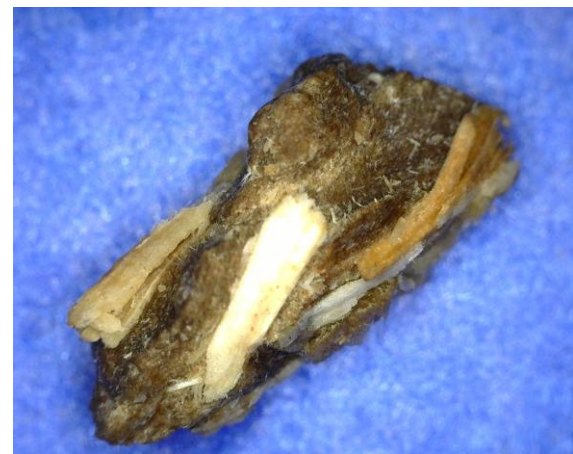
*Figure 5: Sample of non-homogeneous fiberboard material.*

Voids are also an issue that can occur, leading to poor quality of finished goods, whereas other inconsistencies can also create inconsistent wear on the endmill as well as affect the finished product. On top of consistency issues AIS engineers have also found foreign bodies such as fasteners, rocks, and staples. There are processes in place at fiberboard manufacturers to mitigate these quality issues, but historically AIS has seen a significant number of quality issues with incoming boards. Figure 5 shows magnified images of chunks of what is likely a non-homogeneous mixture of glue and wood.

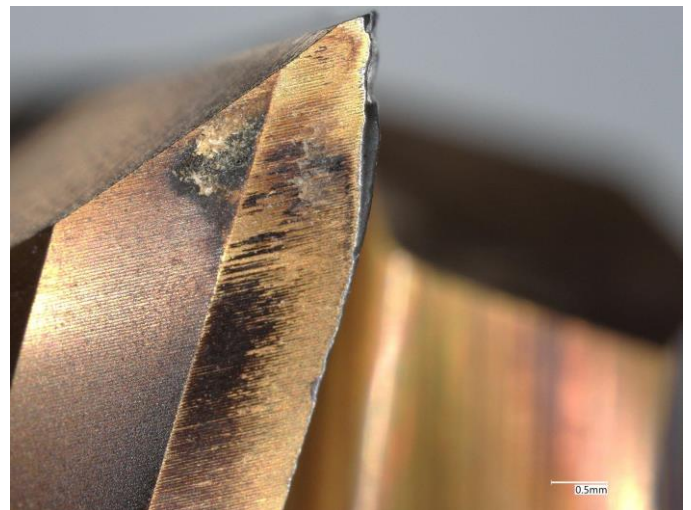
*Figure 12: Tip of HPL sensitivity analysis test tools*

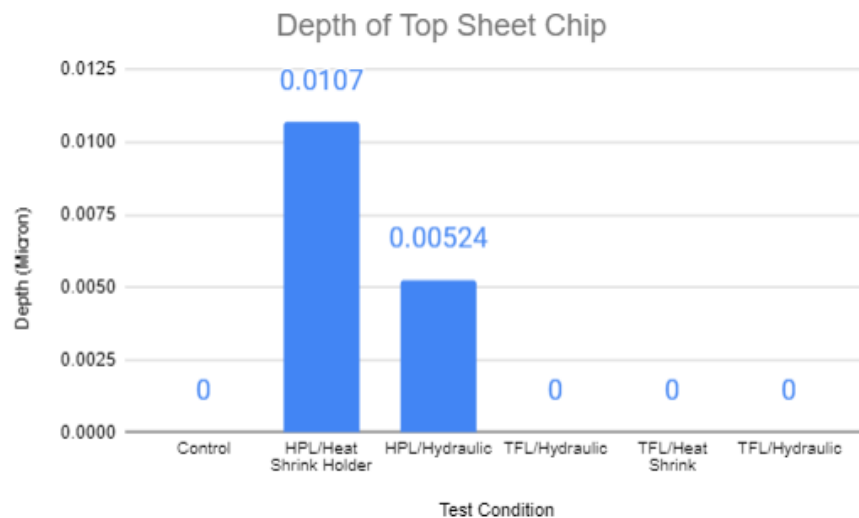
Figure 15: Depth of top sheet divot chart between tool holders

To compare the two holder types, below in figure 15 we can see that there is no significant difference between the two tool holder types on the TFL tools and the HPL tools. The only differences are seen when comparing HPL tools to TFL tools mainly in regard to the depth of the top sheet divot as seen in figure 15. This was expected due to the different material makeup between the two board types, and the different wear types that occur.

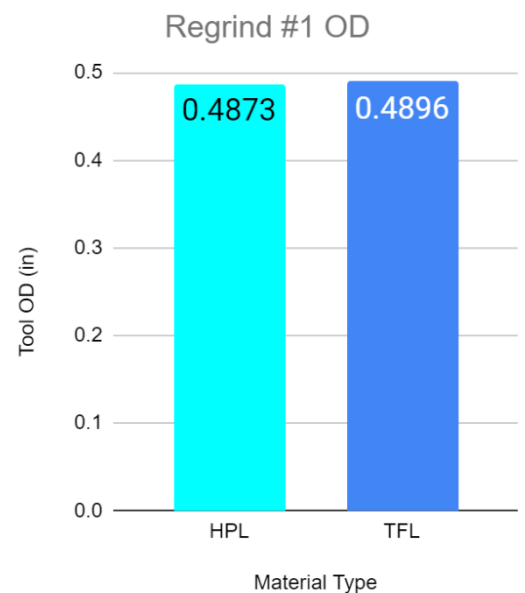
*Figure 21: Comparison of OD of post grind endmills.*

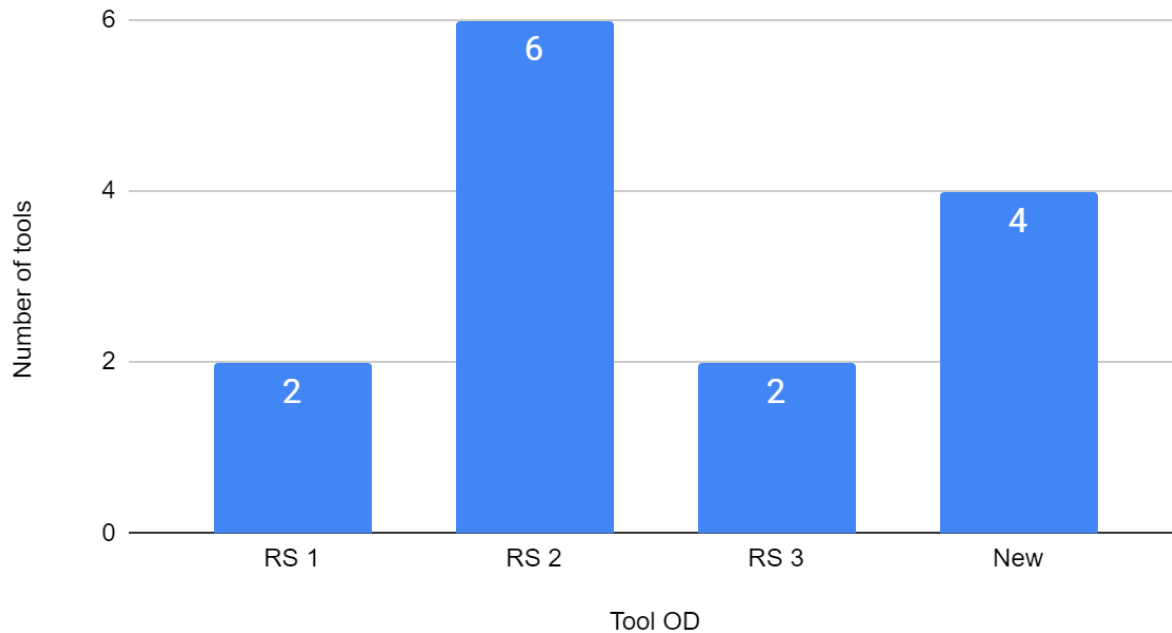
*Figure 25: Daily changeover rate from a sample of 111 days.*

As mentioned in the interview methods and results section, a large part of this project was to understand what is currently occurring on the shop floor and compare it to our test data. The goal of the interviews was to understand what the operators perceived the status quo to be. To understand what exactly was going, we pulled production data that kept track of each tool changeover and its associated router and diameter. The results of this analysis are as follows in figure 25.

In order to understand what is currently happening on the floor in regards to tool changeovers, we analyzed historic data the AIS has on the tool changeovers over 111 days. Operators are required to report when an endmill is changed, with reference to the time, date, and machine number. We used pivot tables as well as countif excel functions to average number of tool changes over first and second shift. We also recorded the distribution of size of tool to help refine our predictive changeover calculator. The results from this analysis are shown in figure 26 below. We also averaged the changeovers over 2 shifts across 4 machines.

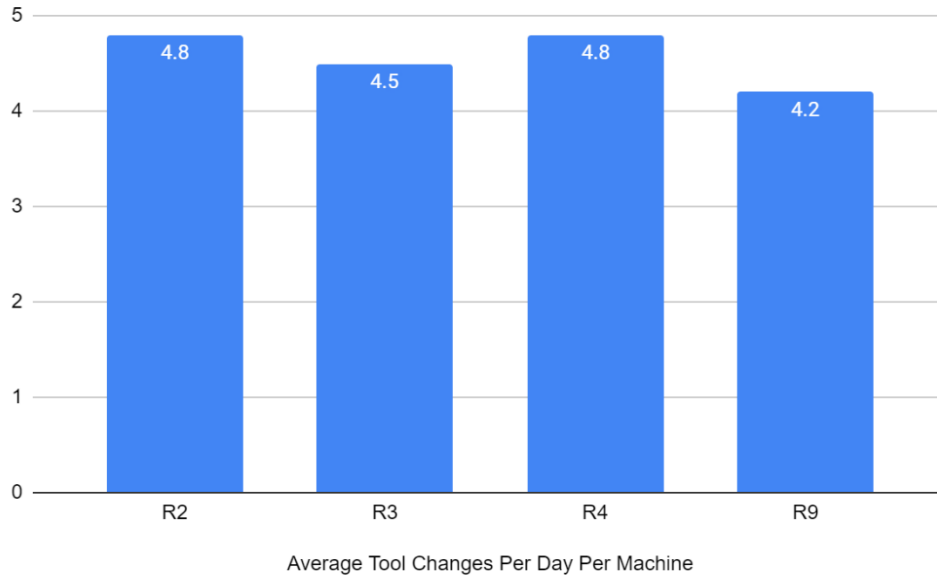
*Figure 28: Average tool changes over 1st and 2nd shift.*

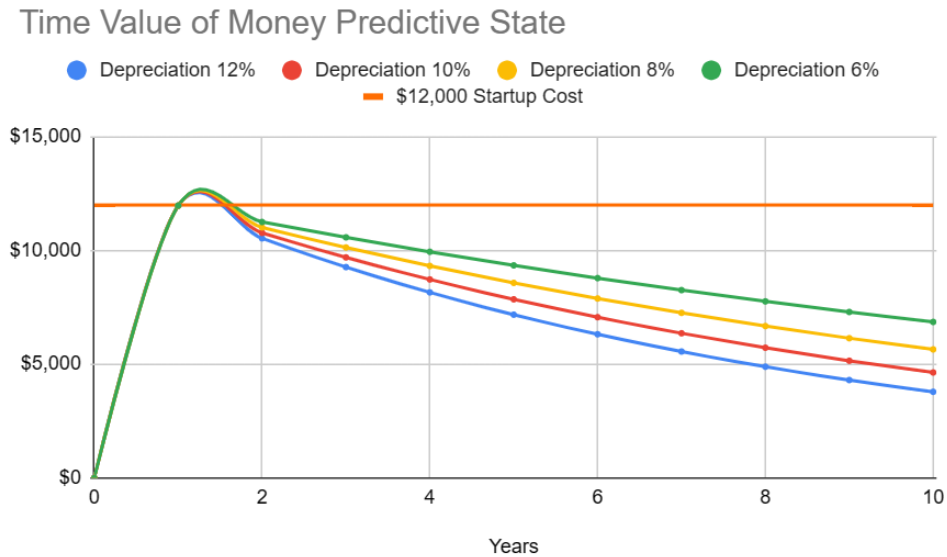
*Figure 29: Time Value of Money with distance trackers installed in 4 CNC routing machines.*

To quantify the financial benefits that AIS could achieve from implementing our recommendations. Focusing specifically on the tool changeover rate standardization, as mentioned earlier if AIS implements that footage limits as defined earlier, there will be a 4.3% decrease in changeovers over 2 shifts per machine daily. To quantify this in conjunction with our partnered process team, we wanted to do a time value of money analysis of this improvements. Our analysis only looked at the cost of a tool due to the amount of variability in the cost of machine time due to the variability in AIS' process. Using FV calculations and the 41\$ cost per use of a tool we got a yearly return of roughly \$12,000. This is all based upon calculations shown in the analysis done by our partner team in their paper titled "Tool Change Process Improvement at AIS". The takeaway from this are that the cost of the distance measurement system on the machines are worth it, and with no other improvements, the software will pay for itself within the

first year. A composite graph showing the FV and different depreciation rates of the savings resulting from our improvements is shown below in figure 29.<sup>13</sup>
