## Community Clean Water Access

An Interactive Qualifying Project

The project studied water quality and supply in Cerrito, Paraguay. The study included three groups: the Junta de Saneamiento, the local water board, Qom communities, and the Escuela Agrícola. Home test kits assessed water quality in ten wells managed by these groups. The team produced schematics of the water pipelines systems of both the Junta de Saneamiento and the Escuela Agrícola, a maintenance guide for the Junta de Saneamiento, and provided new pump equipment for two Qom communities. Recommendations include: retest water quality at three sites, conduct periodic water system cleaning, and modernize the Junta de Saneamiento system through the addition of water meters and the development of a centralized system.

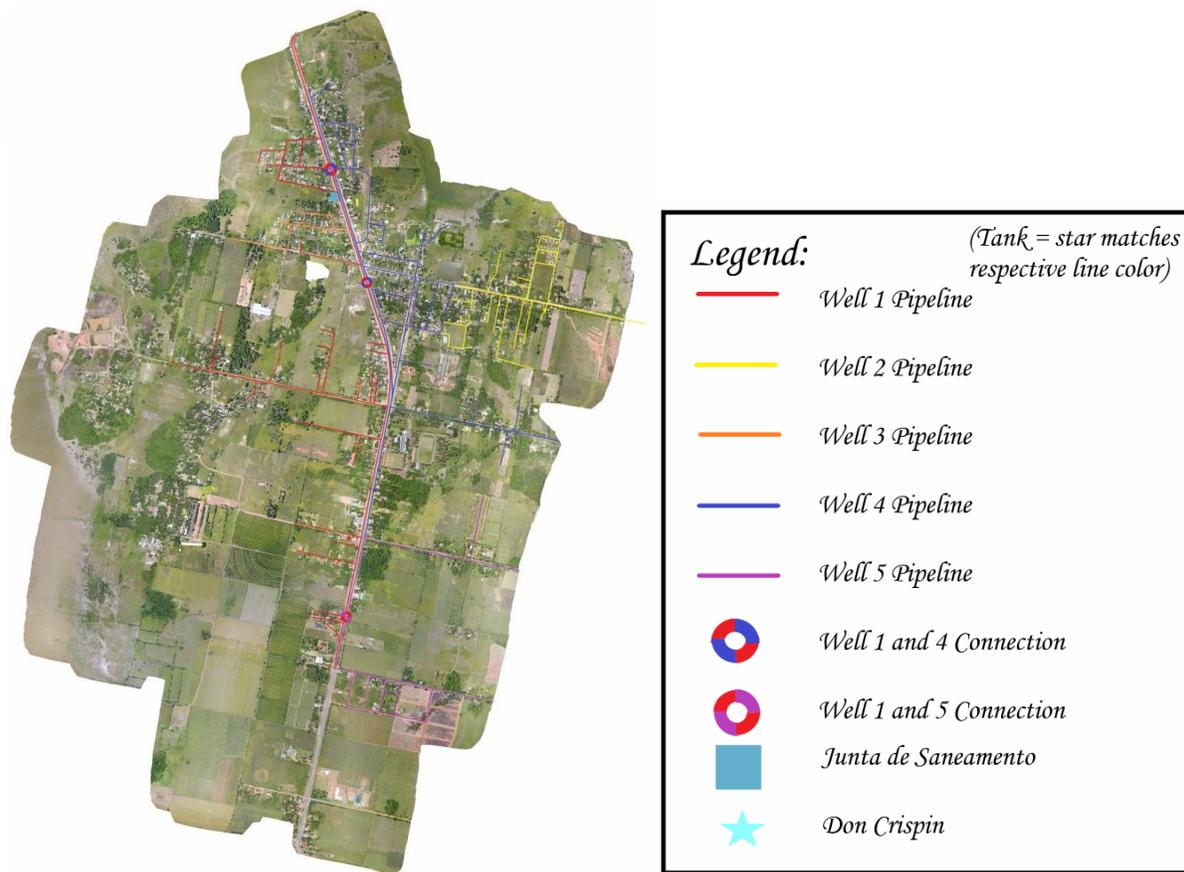
Figure 2: Schematic of pipelines for the Junta de Saneamiento.

A digital version of the water distribution systems of the Junta de Saneamiento can be seen in Figure 2. Pipelines, wells, connections, and important locations are color coded, as indicated in the legend. This schematic was printed on plastic and given to Sr. Llanes for the office of the Junta de Saneamiento. The Escuela Agrícola schematic of wells and spigots can be seen in Figure 3. A digital copy of the schematic was sent to advisor Jose Luis Salomon to give to the school.

recommendation of adding water meters to Junta wells is a relatively small investment that will allow a better understanding of water supply, demand, and loss. The recommendation of updating the pipeline schematic would allow workers to better locate all pipelines.

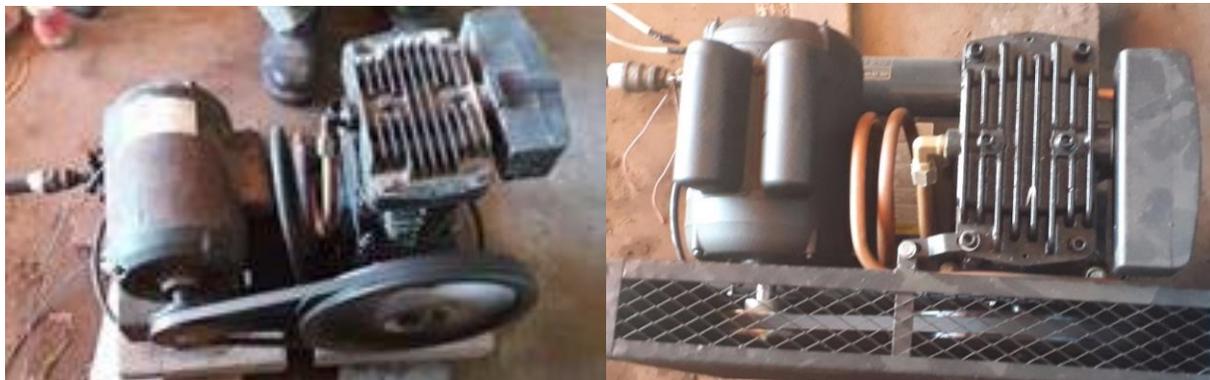
*Figure 4: Previous air compressor (left) and new air compressor (right)*

The main improvement made was the instillation of a new airlift pump. In the past, a 1.5 horsepower air pump was used to push water into the water tower that became very inefficient over time, limiting water within the community. The team suggested that the community may benefit from a more efficient 2 horsepower air pump. With aid from the mayor and WPI students, the community purchased a 2-horsepower air compressor. The new compressor increased water accessibility to the community.

The Paraguayan general elections may have had some influence on aspects of the project, particularly the replacement air pump for the Cerriteno Kael Sat Lecpi Qom community. In the past, the community asked for close to \$1,500 USD for a replacement pump, but the mayor declined. When the project team discovered that the community used a cheaper air lift system, it was determined that the cost of a new air lift pump was only \$550 USD. The community

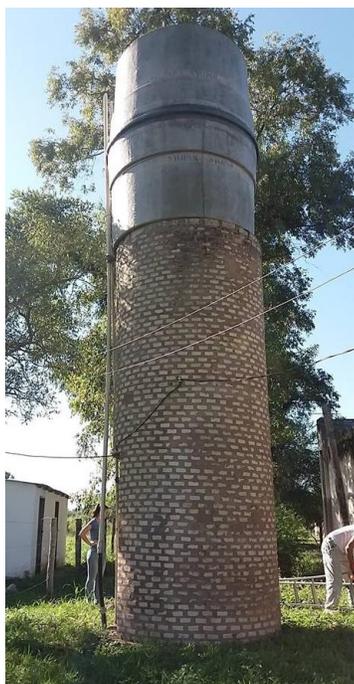
The water tower is made of a brick and mortar base and fiberglass water tank. The current system shows no leaks. The base of the tower is about 4.5 m high. The water tank itself is cylindrical. It is 3 meters high and 1.9 m in diameter, so the volume was calculated to be around 8510 L. The top of the tank was covered, but there was a square opening at the top that was about 30 x 30 cm. The water

appeared to be relatively clear inside the tank, although there was some algae growth that seemed to be near the opening in the lid shown by the second photo. The water tank is supported by a hollow cylinder made of brick and mortar,

The well of this community showed a positive result for bacteria, so it is recommended that the tank is cleaned, a tank cover installed, and the water is retested. A picture of the water flowing into the tank that shows some algae growth can be seen in Appendix 7.5.1. It may be beneficial to repair cracks in the tower with mortar. A mason can usually tell what type of mortar to use based on appearance (Sullivan, 2018).

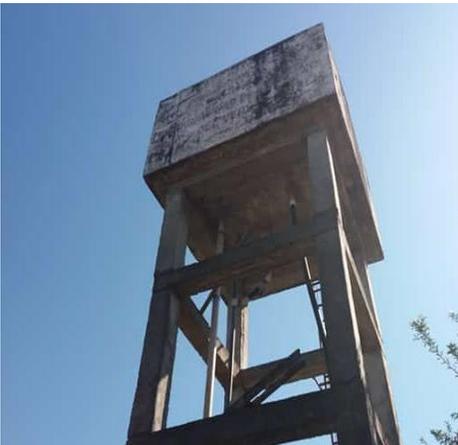
with a wall width of 23.5 cm. The base was about 6.3 m in circumference, so the diameter was calculated to be 2.0 m. Upon observation, the tower appeared to be structurally solid. The brick and mortar did appear to be dry and cracked in some areas, although cracks appeared to be minor and did not go through the tower wall.

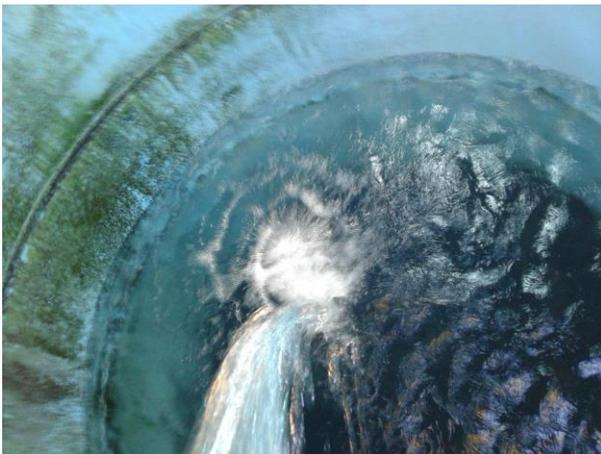
*Figure 6: Water tank in the community of Don Francisco.*

The water tower currently in place is approximately 11 m tall and made of cement. The water collection basin at the top of the tower is about 9900 L, although it has not filled recently. A 1.5 horsepower air pump is currently used to pump water from the 60-70 m deep drilled well to the tower.

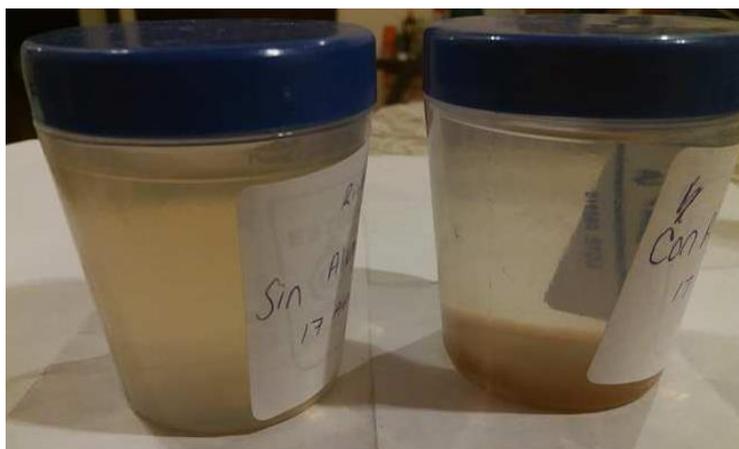
*Figure 4: Water from Río Verde without aluminum sulfate (left) and with aluminum sulfate (right) after settling for less than 30 minutes.*

The Río Verde Qom community led by Don Crispín Amarilla has used the water from the Junta de Saneamiento for about a year due to reasons that are not completely clear to the project team. The well pump has not been used in at four months, a value given to the team by the community leader. The water that comes from the well is turbid and may be undesirable to drink. It is assumed that there is no water being stored in the water tank. However, the WPI team met with a member of the Junta de Saneamiento to access the system. The Junta de Saneamiento contacted their electricians and together made an assessment. A replacement motor owned by the community was installed and water was able to be accessed from the well. The team was able to test the water and determine the flow rate of water from the well to be around 0.86 L/s. The quality test results were all within normal range, although turbidity was apparent, shown in Appendix A. Water was also tested for flocculation with aluminum sulfate. The particles did flocculate to the bottom when treated with aluminum sulfate, indicating a colloid suspension, shown below in Figure 4.

A proposed compromise was for the Junta to incorporate the water from Río Verde into their grid as a form of repayment for the debt. However, the Junta de Saneamiento has not pursued this solution for two main reasons: the water is turbid, and the functionality of the system is unclear. When the project team first visited Río Verde, the pump did not work. When the motor was replaced, water was pumped out, but the rate was not steady, potentially due to an electrical problem.
