Cooking Oil Based Asphalt  
A Major Qualifying Project Report:  
Submitted to the Faculty  
of the  
WORCESTER POLYTECHNIC INSTITUTE  
in partial fulfillment of the requirements for the  
Degree of Bachelor of Science  
by

## **Abstract**

This study looks at determining the suitability of waste cooking oil-based asphalt for making Hot Mix Asphalt (HMA), through structural strength testing – rutting and fatigue properties, using the South African Model Mobile Load Tester (MMLS3). Slabs of conventional and waste cooking oil asphalt mixes were tested for fatigue and rutting properties. These results showed that there was no statistical difference in rutting between the two slabs and a significant difference in fatigue testing.

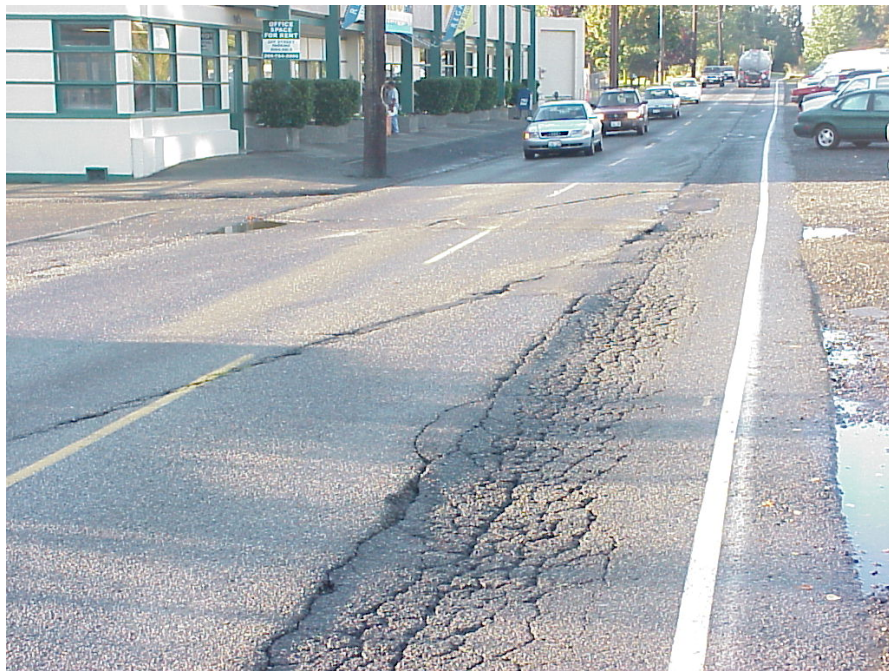
**Figure 1: Rutting**

When a pavement is said to “rut” it is subject to a permanent deformation from a load of a wheel path over the asphalt. Asphalt can be subject to two basic types of rutting; mix rutting and subgrade rutting. “Mix rutting occurs when the subgrade does not rut yet the pavement surface exhibits wheel path depressions as a result of mixing/compaction problems. Subgrade rutting occurs when the subgrade exhibits wheel path depressions due

to loading. In this case, the pavement settles into the subgrade ruts causing surface depressions in the wheel path” (6). Mix design rutting can be caused by unstable mix design, heavy vehicle traffic, and/or high pavement temperatures. The most common places that these ruts can be seen are at intersections, or places that have continuously heavy loading, such as bus stations. A mix rut can be seen in Figure 2 below. Subgrade rutting is caused by an overstressing of the layers beneath the asphalt surface, or subgrade. It can be due to insufficient thickness for the areas traffic conditions or insufficient strength in the underlying materials. Moisture which finds its way into the subgrade can have a weakening effect on the pavements material make-up and applied loading from traffic can inflict permanent deformation (7). An example of subgrade rutting can be seen in Figure 1.

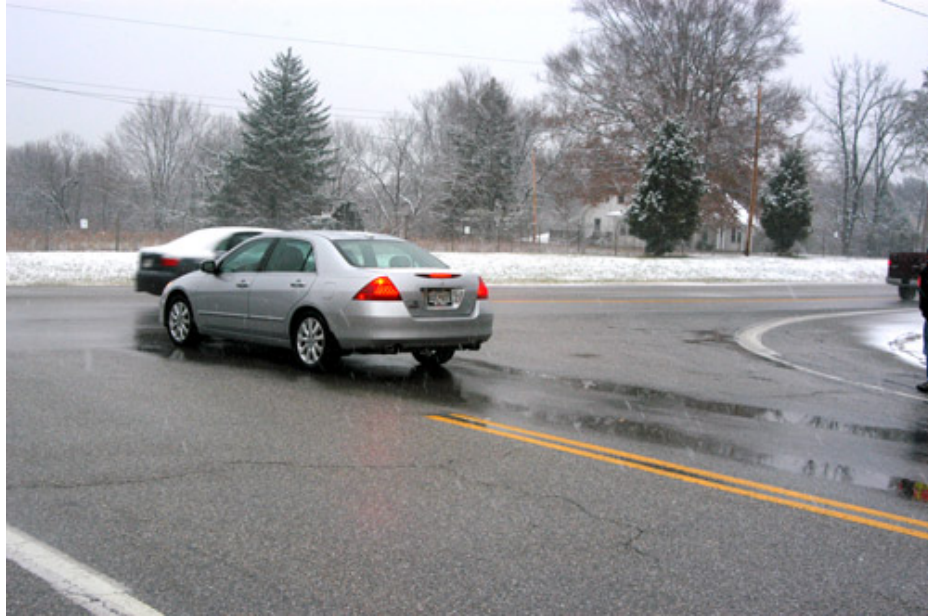
**Figure 2: Water collecting in ruts**

A pavements ability to withstand loads and not let rutting occur is very important as it increases its lifetime and increases traffic safety. When a rut occurs it forms a trough like structure and when filled with water can increase the likelihood of hydroplaning.

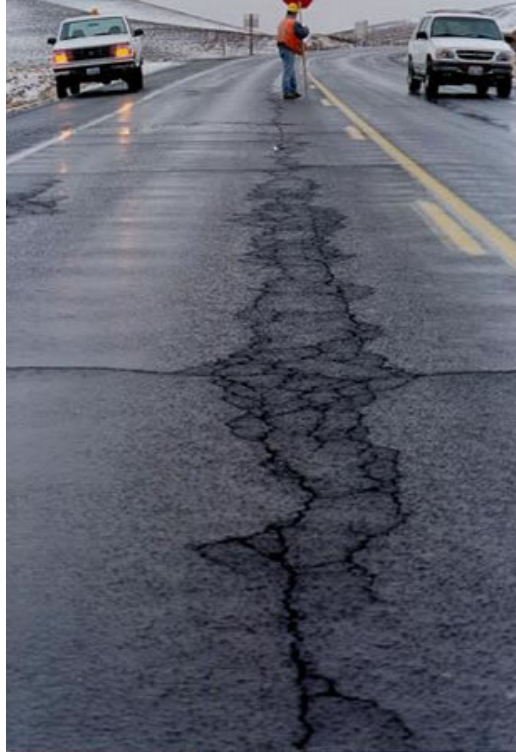
**Figure 3: Fatigue cracking**

Testing for pavement fatigue can be very useful in determining the life span of designed hot mix asphalt. When a load is placed on a pavement it experiences strain, or a tensile force, which usually occurs on the bottom of the grade. If the pavement experiences a low strain then it may not experience fatigue but if the strain is high enough, depending on a given mix design and loading, fatigue failure may occur. When the pavement fails it will result in fatigue cracking, which can lead to deterioration of the materials (10). An example of fatigue cracking can be seen in Figure 3.

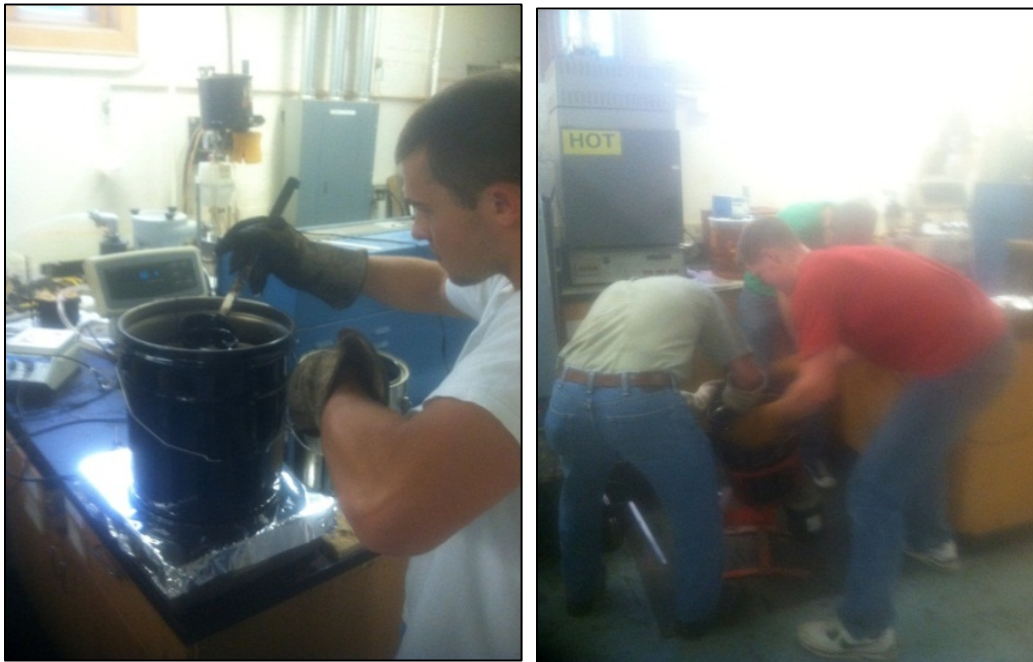
The aggregates and binder were heated up in the oven to reach a temperature of 150 C. The project team also heated up the mixing blade and the roller to allow smooth mixing and compacting. The correct calculated weight of binder was added to each bucket of aggregate. This occurred one bucket at a time to keep the other buckets warm in the oven. Once the correct amount of binder was added to the aggregate the project team started to mix the bucket using the motorized rotational bucket mixer. Once the bucket was mixed it was placed back into the oven and a new bucket of aggregate was removed from the oven. The process was repeated until all buckets were properly mixed, and they were left in the oven for about 10 minutes to allow them to heat up one last time before pouring. Photos from this process can be seen in Figures 7 and 8 below.

Figure 7: Left: Binder being added to aggregate; Right: Mixing the binder and aggregate

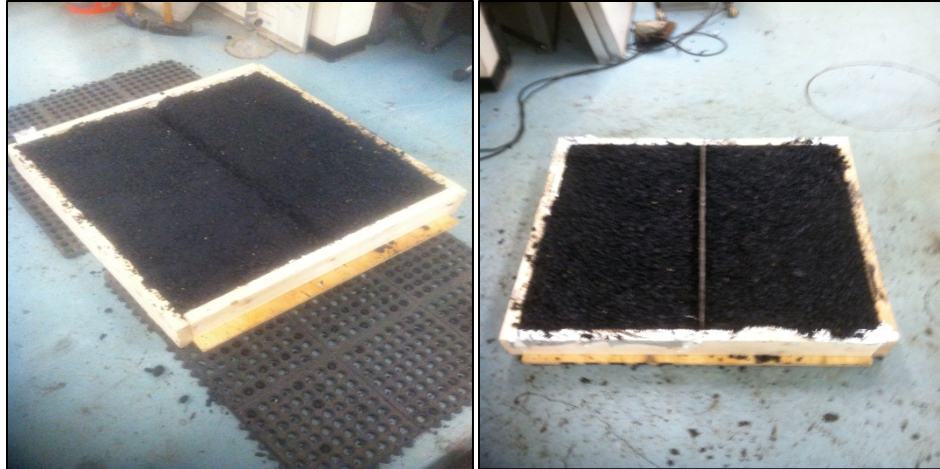
After pouring was complete, a blade was hammered into the middle of the asphalt using two sledgehammers to split the slab in half. This allowed the group to acquire its rutting and fatigue slabs. The final product can be seen in the Figure 9 below.

**Figure 9: Left: Conventional asphalt slab; Right: Bio-asphalt slab**

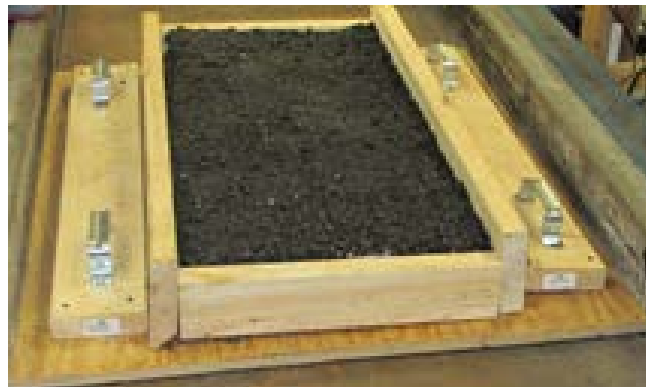
**Figure 10: Mold for conventional slab**

Once the HMA was properly cooled the project team moved onto the rutting test. After separating the slab, the team created a new mold, with dimensions 3'x1.5'x4", to fit the rutting slab in. Using the overhead crane the slab was moved to the Model Mobile Load Simulator (MMLS) mold. The slab was placed in the direct center of the mold so an even load distribution occurred across the entire slab. In order to accomplish this, the project team first modified the original slab mold so that it would be able to contain the control slab; this can be seen in Figure 10 below.

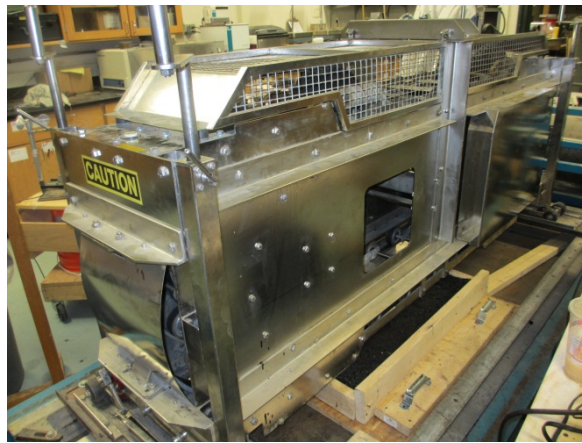
**Figure 11: MMLS machine positioned over control slab**

Once the mold control slab was placed in the correct spot, reinforcements were placed in the four corners of the mold to ensure the mold was stabilized during testing. To accomplish this task, four 2”x 6” pieces of lumber were wedged from the end of the pathway to the separate corners of the mold. After this step was complete, the MMLS3 was placed over the center of the mold. To do this the project team used the overhead winch to lift the machine over the mold and then locked it into place with its built in frame. An image of this process can be seen in Figure 11 below.

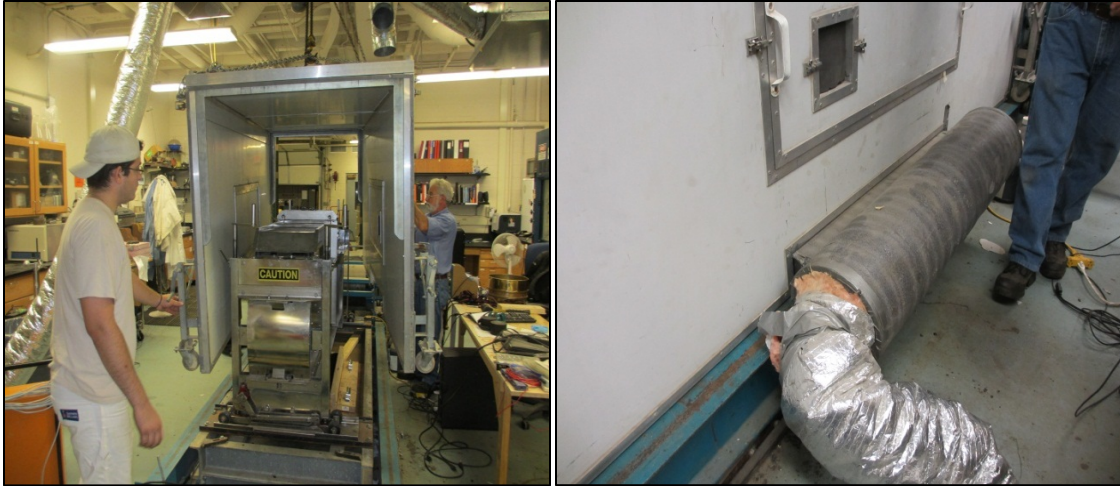
When the MMLS was secured to the frame, the tire pressure along the surface of the slab was checked to make sure that it was between 90-100 psi. The environmental chamber was then placed over the MMLS machine to encase the whole slab. The environmental allows heat vents to be placed through slits on the two sides. The entire procedure of this can be seen in Figure 12 below.

**Figure 12: Left: Environmental Chamber being lowered over slab; Right: Heating vents**

The heating vents were secured by use of zip ties around the pipes where they were attached to prevent any heat from escaping. The temperature of the ventilation system was set to 50 °C and the slab was heated up for approximately twelve hours before testing begun.

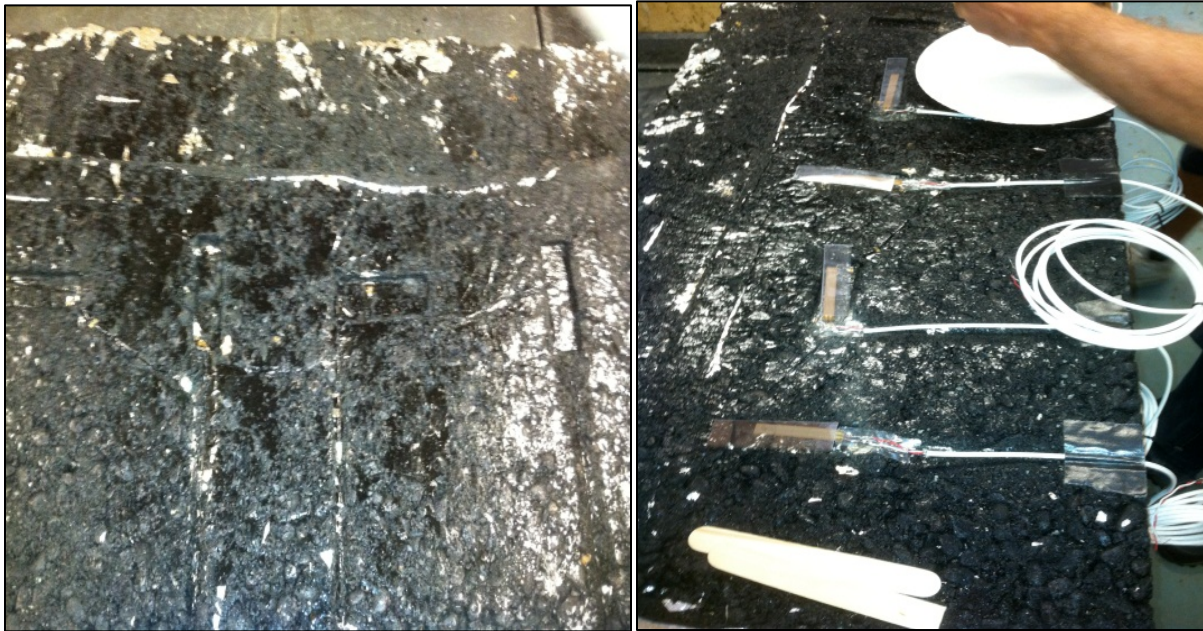
First, the strain gages were attached at the bottom of the slab using epoxy. As the epoxy cured the other parts of the new mold were put together. Using the results of the analysis and design  $\frac{3}{4}$  of an inch of plywood made the base and four inches of Neoprene D60 were placed on top of that. Once the epoxy cured, the slab was carefully placed on top of the neoprene, and with

all edges flush, the 3' x 1.5' x 9" wooden border was added. The nine inch sides were needed to enclose the five inches of wood and neoprene and the four inch slab. Before securing the sides, holes were drilled in one side to allow for the wires of the strain gages to come through. Figure 15 below illustrates the fatigue slab preparation.

**Figure 15: Left: Imprints in slab for strain gages; Right: Strain gages epoxied onto slab**

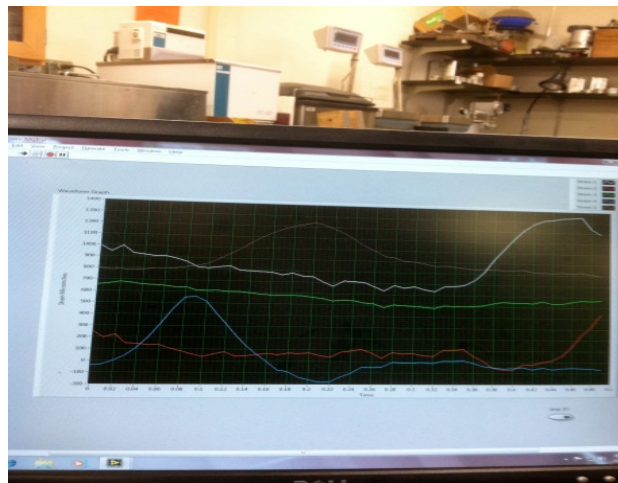
**Figure 17: LabView reading data from strain gages**

When the MMLS was secured to the frame, the tire pressure along the surface of the slab was checked to make sure that it was approximately 690 KPa. The strain gage wires were then inserted into the computer and LabView software was started to read the data from the gages. Figure 17 shows an example of the strain data being collected in LabView.

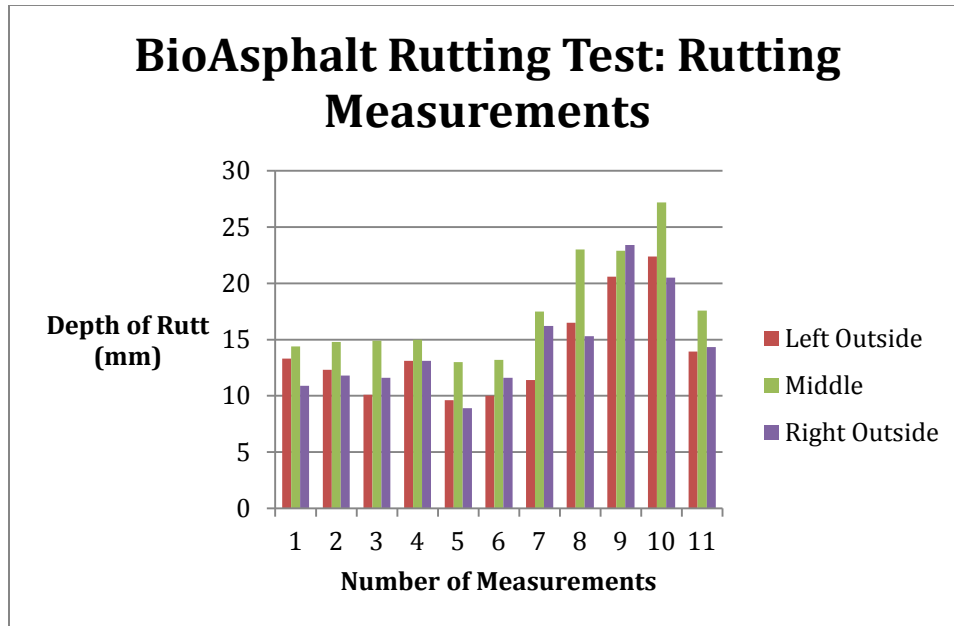
Figure 19: Bio-asphalt rutting measurements graph

The Bio Asphalt slab was under the MMLS machine for 8 hours while running at a speed of approximately 286 revolutions/hour when the project team noticed a rut of approximately 12.5 mm, seen in section 9.2 of the Appendix. Table 4 shows the rut depth data. Figure 19 is a graph of the rutting measurements.

The average for the left outside was 13.93 mm, the middle 17.59, and the right outside 14.33. The total average depth was 15.283 mm, just about 3mm deeper than the target. As expected the measurements in the middle of the rutting were larger than the measurements taken from the outsides for all increments. The Bio Asphalt slab was tested 4 hours less than the Control slab and had more rutting.

After completing the statistical analysis it was found that the mean rut depth for the middle of the tire path for the control slab was 16.88mm and 17.59mm for the bio asphalt slab. The standard deviation for the control slab was 3.41mm and 4.97mm for the bio asphalt slab.

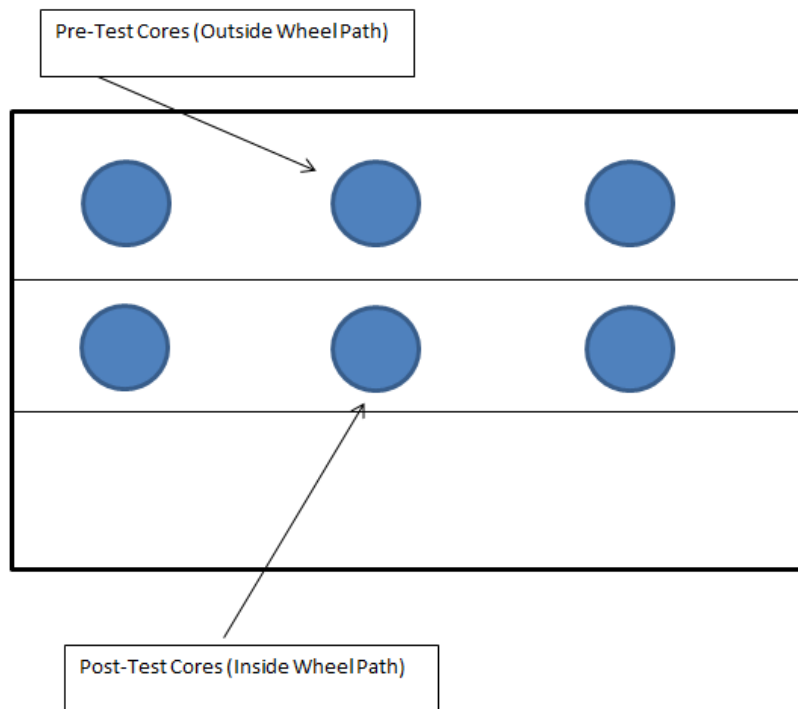
Figure 20: Locations of Cores on Slab

Post- testing voids refer to voids from the cores that were taken from the wheel path. The average post-testing voids from the control slab was found to be 5.55 with the standard deviation of 2.175. For the bio asphalt slab the average post-testing voids was 12 with the standard deviation of 0.83. Figure 20 shows a diagram of the pre and post-test core locations.
