Planning Tools for the Santo Domingo Pueblo

Guidelines for Future Housing Rehabilitation

An Interactive Qualifying Proposal submitted to the faculty of Worcester Polytechnic Institute in partial fulfillment of the requirements for the Degree of the Bachelor of Science.

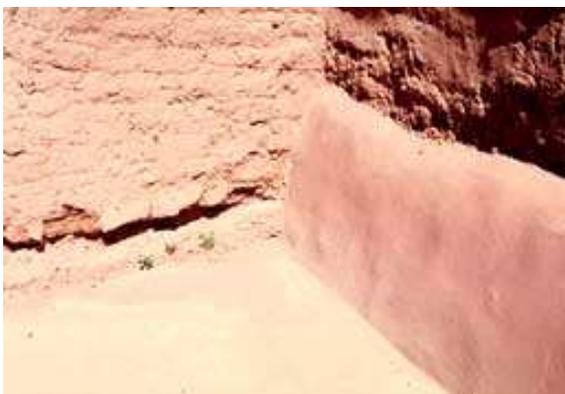
Figure 7: Evidence of Coving in Adobe Building⁴⁶

Common sources of deterioration include water, wind, and material incompatibilities. Since traditional adobe structures are made from earth, rain and groundwater can do significant damage. Roofs and walls are easily eroded by rainfall, and when they dry after a storm, they can develop cracks and pitted surfaces. The adobe bricks themselves can also be damaged by repeated soaking and drying, often losing integrity and crumbling. In addition, if the foundation of the building is not properly drained, any standing water that gathers at the base of the structure will cause coving (a hollow space underneath the bottom of a wall). In extreme cases, the adobe will be saturated by water and will start to behave more like a liquid than a solid. Wind erosion is less prevalent than water damage, but it is possible for sand lifted by the wind to furrow the walls, and can be differentiated from water erosion by its visibility on the upper part of the walls and near the corners of the roof. Another common source of damage arises from repair attempts. Some techniques used to maintain and preserve adobe buildings in the past are no longer recommended because of the incompatibility of the materials. For example, some of the weaker materials, such as the mud mortar, were replaced by stronger ones, such as cement mortar. This may seem like an improvement at first, but the adobe ends up falling apart under the pressure caused by the different rates of expansion of the two materials⁴⁵.

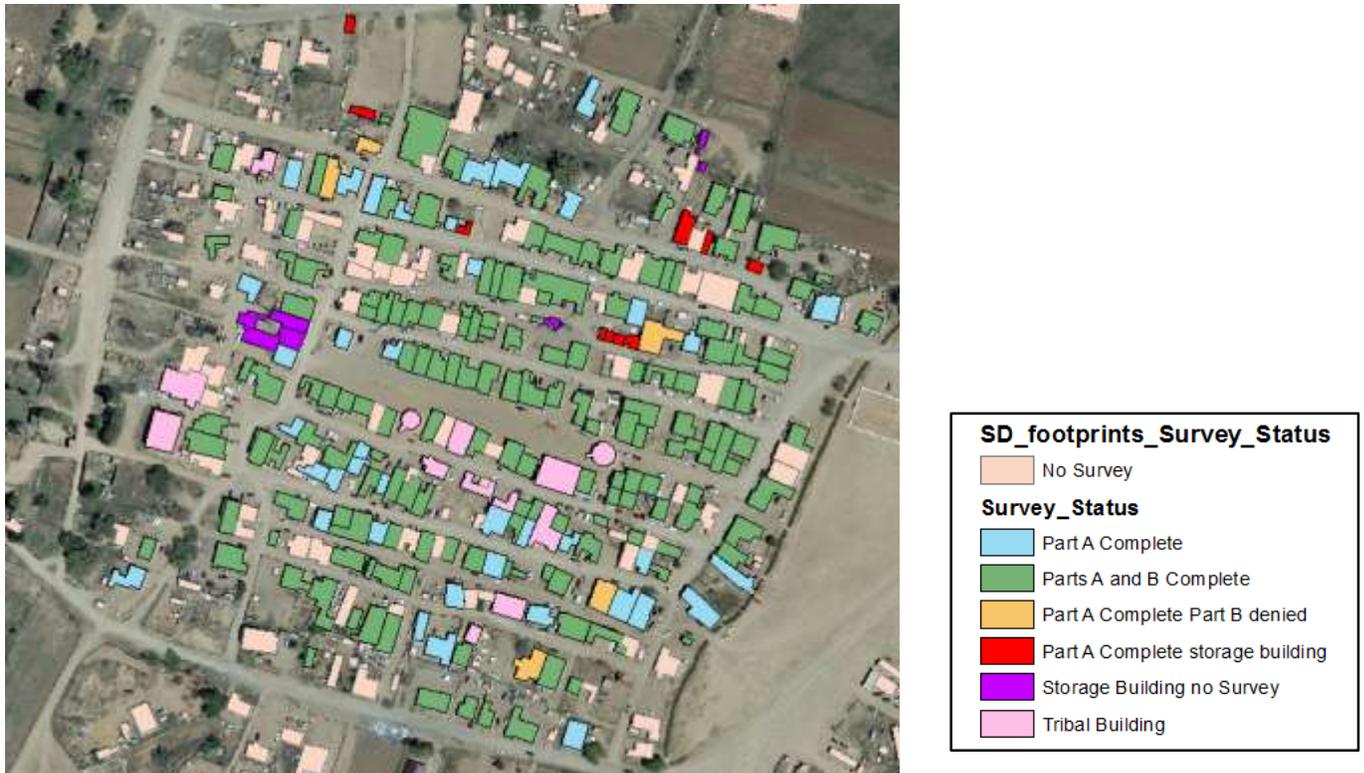
Figure 15: GIS Map of Building Survey Completion Status

Using GIS, we created a color-coded map to display the survey status of each building. This helped us determine which buildings still needed both sections or Section B only. It also displays if they did not require any further surveying due to prior denial to participate in Section B of the survey or if the Santo Domingo Pueblo deemed the building culturally significant and therefore did not want it to be surveyed by outsiders of the tribe. This initial map, shown in Figure 15, was created before we performed any building surveys and displays the completion status for building surveys. The surveys were scanned in digitally and organized in the network drive, indicating the family's name, if the home was inhabited, and if the family refused to complete Section B of the survey.

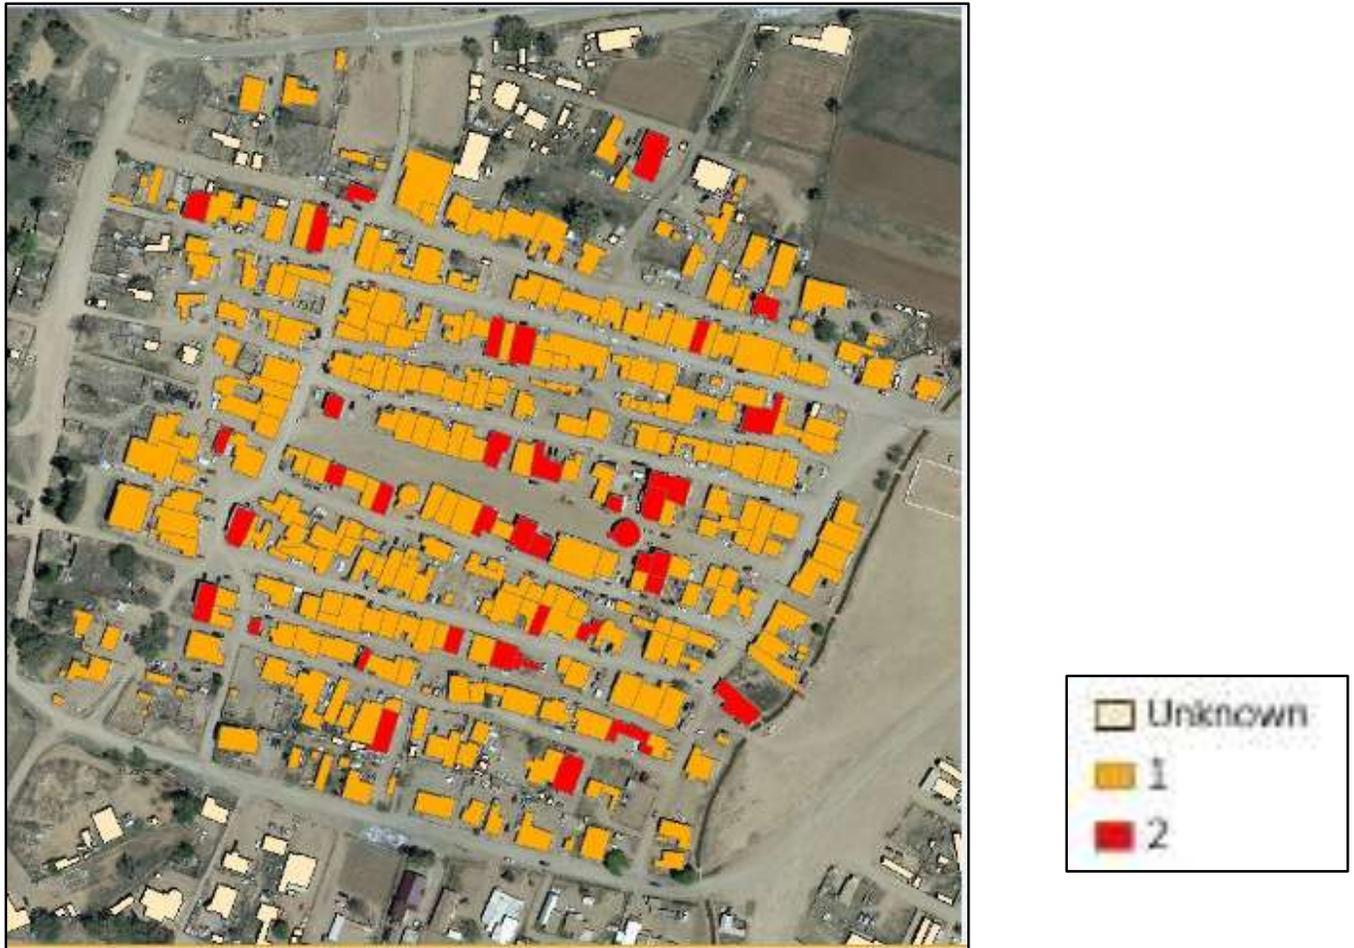
Figure 23: Number of Stories for Buildings in the Historic Village

Since buildings with two stories will cost more to rehabilitate, it is important to keep track of how many stories each building has. Two story buildings also pose a bigger threat as they deteriorate, causing more damage if they collapse.

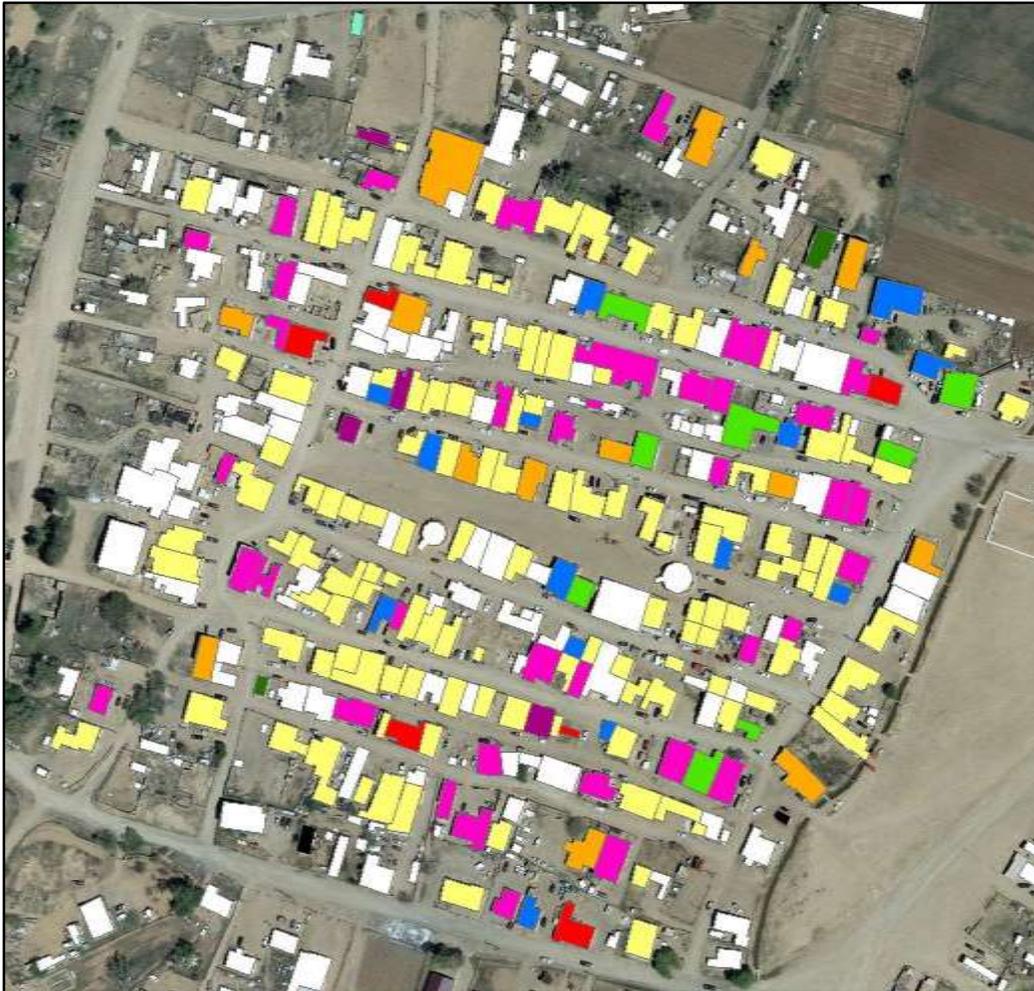
Figure 25: Wall Construction

stored inside the walls. This figure shows that even if some of the cement stucco buildings are in good or fair condition now, they could deteriorate in the future, making the situation in the village even worse.

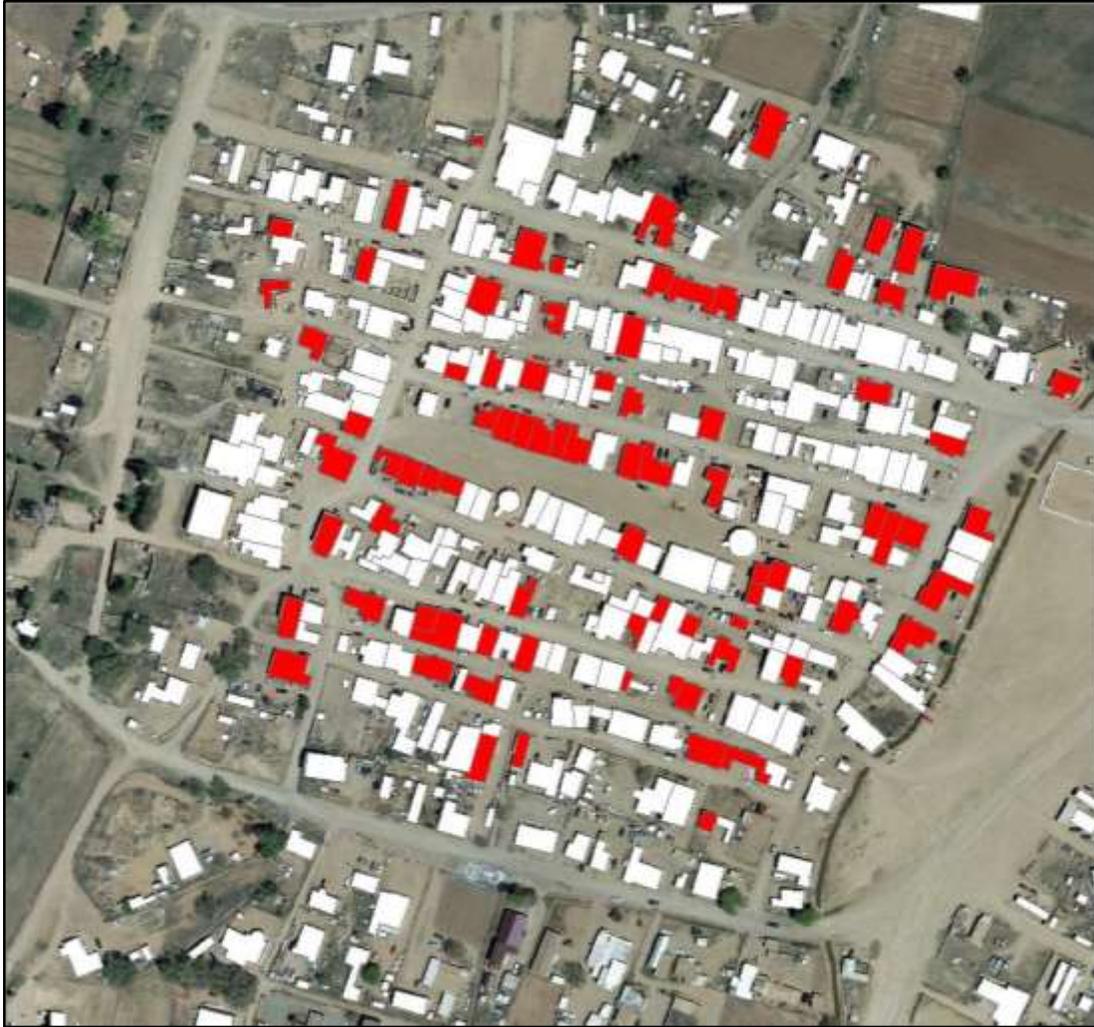
Figure 27: Mold Presence

If the surveys are extended in the future to catalog the health issues that each household has, such as asthma, Figure 27 could be used to prove the the mold has had serious health impacts on the residents. It could then be used to apply for more funding to help fix the mold issue in the Village.

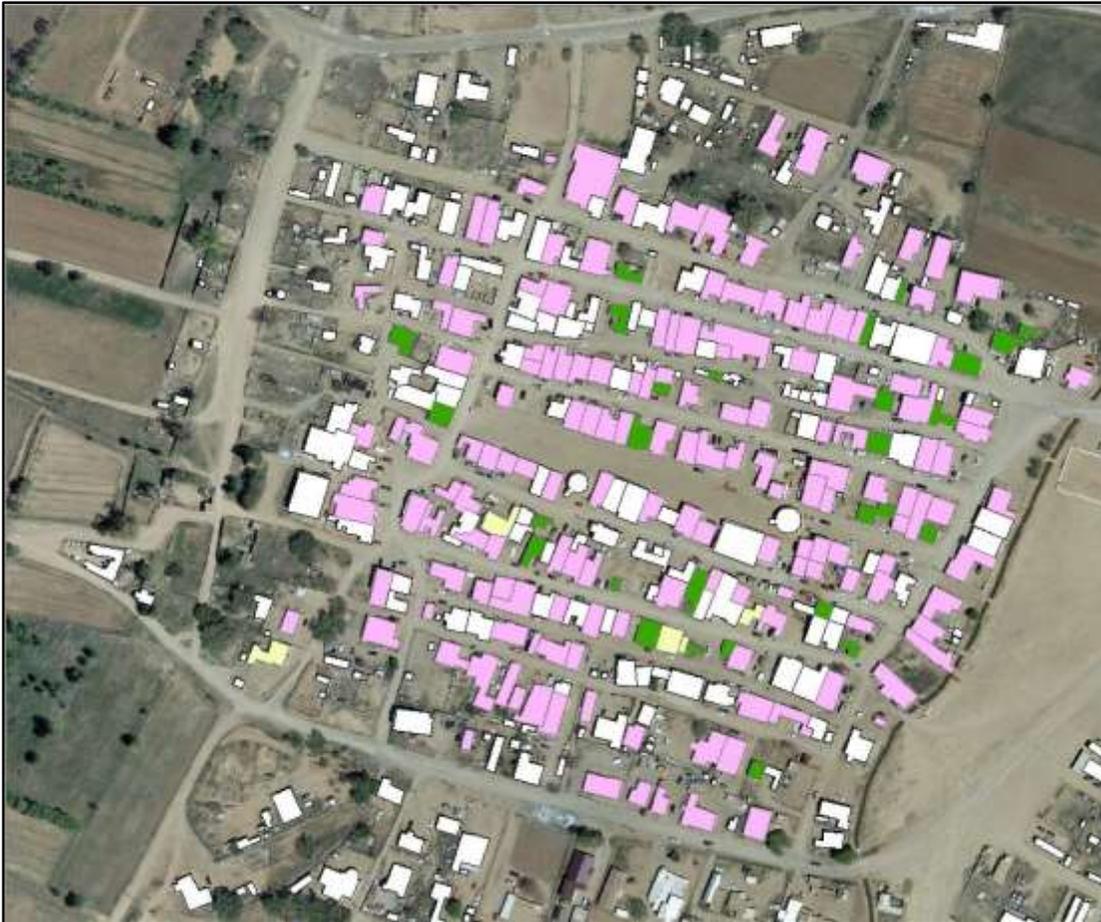
Figure 28: Residency

Figure 28 shows that unlike most other historic pueblos, the Santo Domingo pueblo use their Historic Village as a permanent housing district. It is important to rehabilitate the buildings that are a primary residency first.

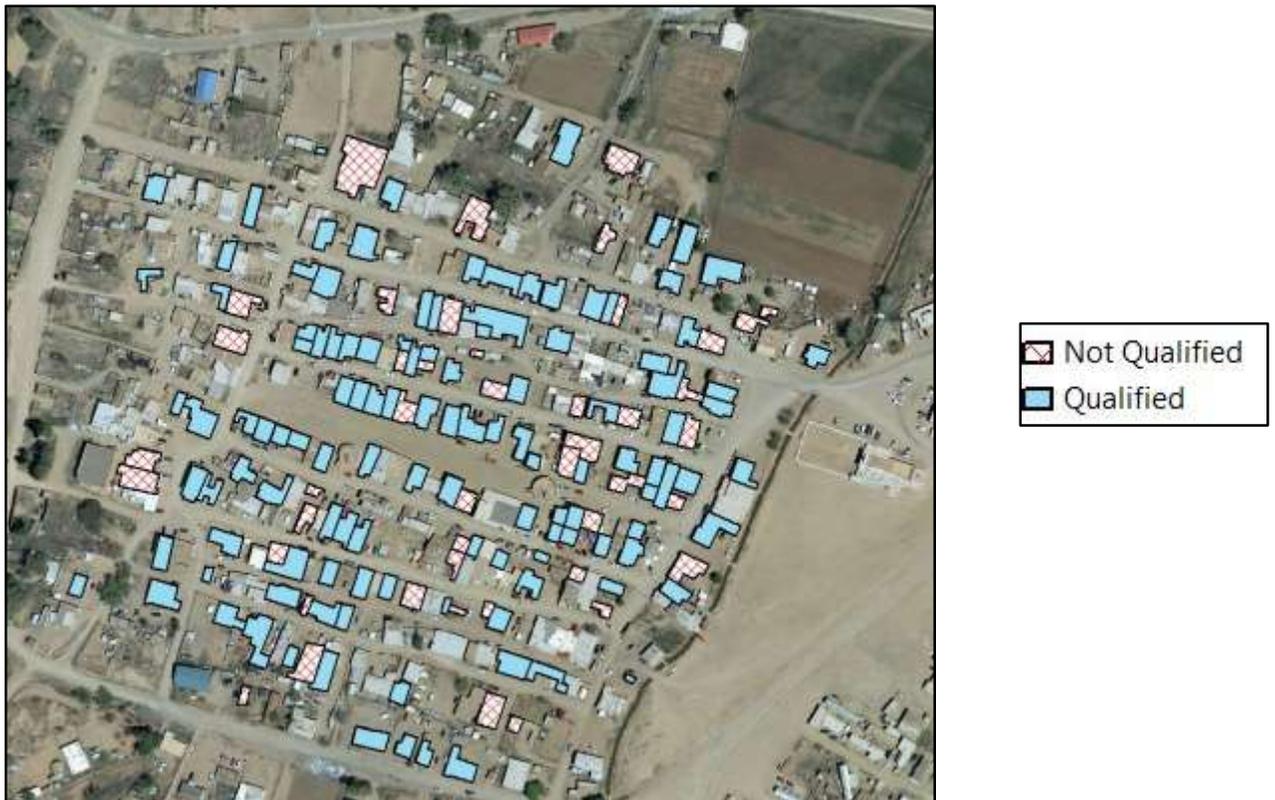
Figure 32: Qualified Homes

In order to select which houses were to be rehabilitated first, we used the unweighted points system we had created. The units highlighted in red denote failure to qualify for rehabilitation due to being in good condition or uninhabited. The map shown in Figure 32 geographically displays which buildings were assessed for the proposed structural and building use criteria based on the qualifications for rehabilitation, which entailed being inhabited and assessed for an overall condition less than good.

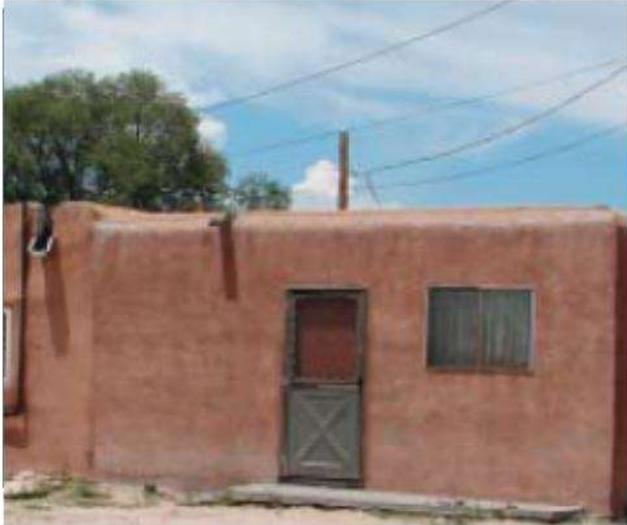
Good Condition

- No significant display of wall deterioration
- Building components (window and door) in good condition

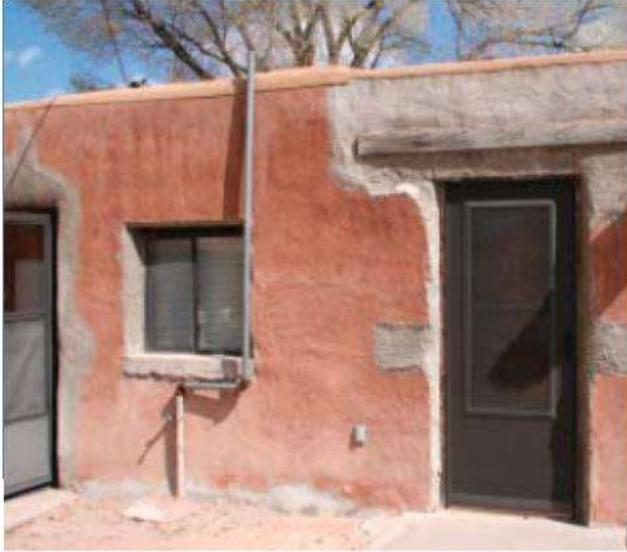
Fair Condition

- Spalling looks present toward top of building
- Wall has minor visible deterioration

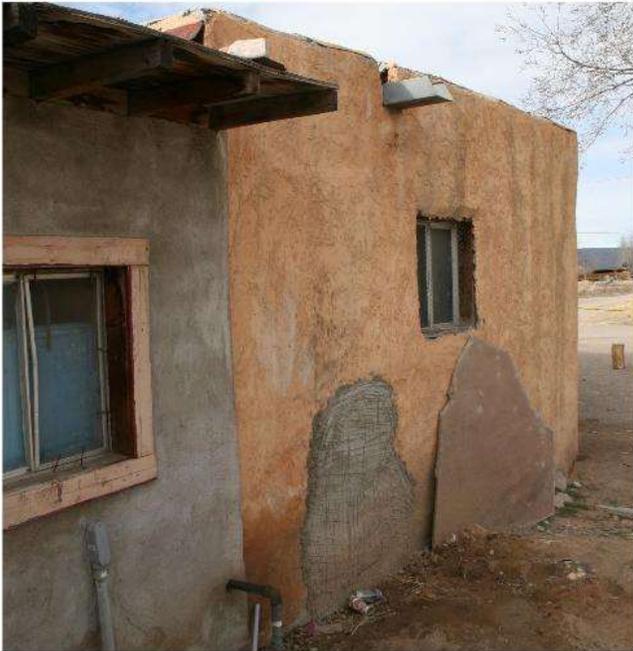
Poor Condition

- Different surface coatings
- Windows in poor condition
- Roof deterioration is visible

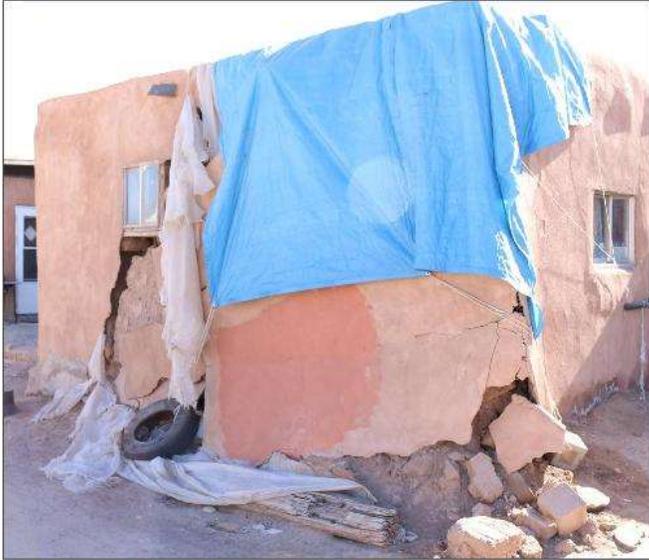
Severe Condition

- Total Collapse of wall

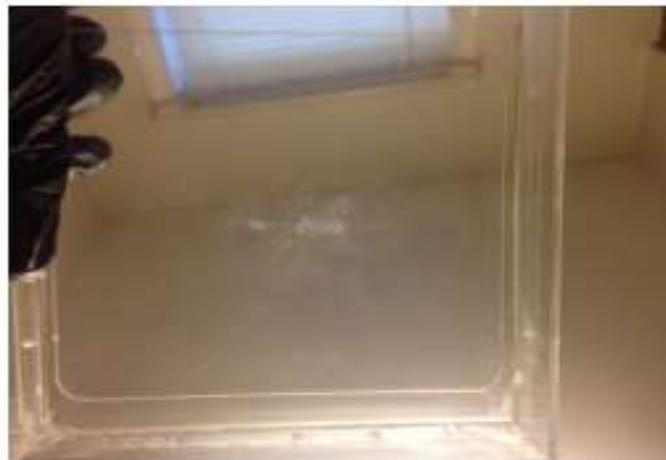
When printing the buildings for the Historic Village, the success rate was incredibly low, around 30%. After studying the failed prints, four main causes were found. The first cause of failure was that digital model was put over a damaged part of the tray in Preform. The image below shows a tray with a damaged section.

The cloudy part in the middle of the tray is the damaged section. The trays cloud over time from repeated printing in the same area. A failed print also causes significantly more damage to the tray. When a print fails, resin sticks to the bottom of the tray. That already hardened resin is hit repeatedly with the laser, damaging the tray more than it usually would be damaged. It is important to check the tray after each print to see if any new damaged areas have appeared. Printing over a clouded area greatly reduces the probability of getting a successful print. Damage to the tray can also occur from removing excess print residue from the tray. This residue sticks to the bottom of the tray and must be carefully removed. If this is done incorrectly, the pieces of the bottom of the tray, which is made of silicon, can be torn off the tray. When this happens, that portion of the tray can no longer be used again. Proper removal of residue will be discussed in the section describing steps for after a print has finished.

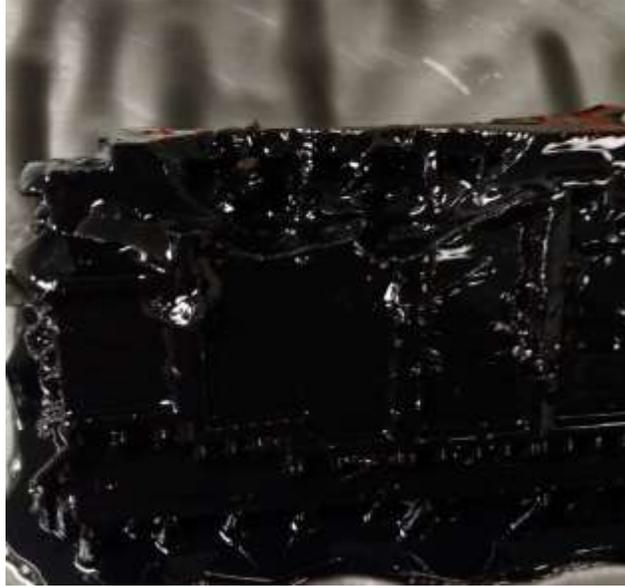
The last main cause of failure was the orientation of the models. After many print failures, it was determined that the building parts of the models were causing air pockets to form around them. Because the buildings stick out from the rest of the model, when the printer moved up a layer, the fluid would sometimes not fill in around the buildings. This caused print failures because with no resin to harden over the model, that part of the layer would be incomplete, causing every layer after it to fail as well. The picture below is a print that failed for this reason:

The print appears to have failed at one small point, which caused the failure to spread over a larger area as the more layers were added.
