Walk Newton

A Study of Pedestrian Mobility in Newton, MA

AN INTERACTIVE QUALIFYING PROJECT SUBMITTED TO THE FACULTY OF
WORCESTER POLYTECHNIC INSTITUTE
IN PARTIAL FULFILLMENT OF THE REQUIREMENTS FOR THE DEGREE OF BACHELOR OF SCIENCE BY

Date: May 4, 2010

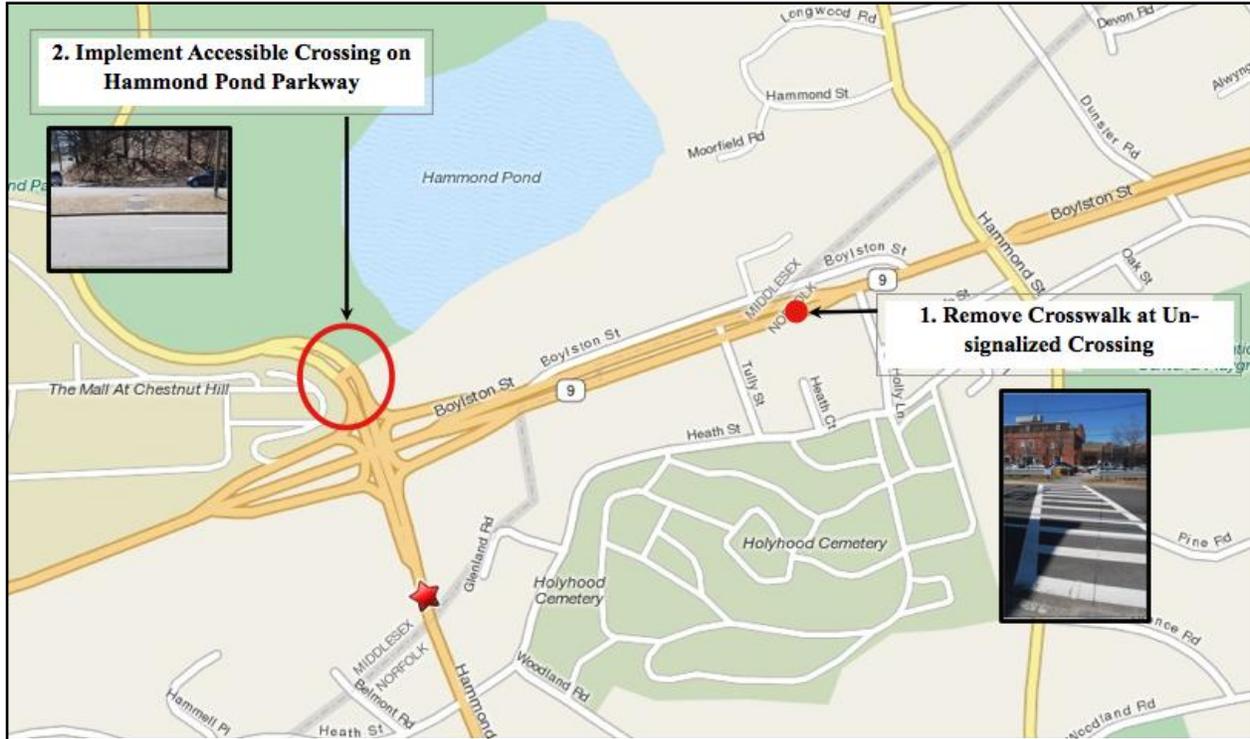
Figure 4: Chestnut Hill Short-Term Recommendations

- 1. Remove un-signalized crossing on Route 9.** Located on Route 9, roughly 80 meters east of Tully Street, is a crosswalk that has no traffic light or walking light. By removing the crosswalk, it would prevent pedestrians from putting themselves in harm's way when trying to cross this dangerous state road.
- 2. Implement accessible crossing on Hammond Pond Parkway.** Crossing this road is unsafe and implementing a crosswalk would increase driver awareness here.

- 1. Install a traffic signal and walking light at un-signalized crossing on Route 9.** Installing a traffic signal and walking light will increase the safety of pedestrians wishing to cross Route 9. This recommendation will require cooperation from Brookline.
- 2. Redesign pedestrian facilities along Hammond Pond Parkway.** Redesigning pedestrian facilities at the intersection of Hammond Pond Parkway and Route 9 would make this area much safer for pedestrians by providing means of travel that avoid interactions between pedestrians and motorists.

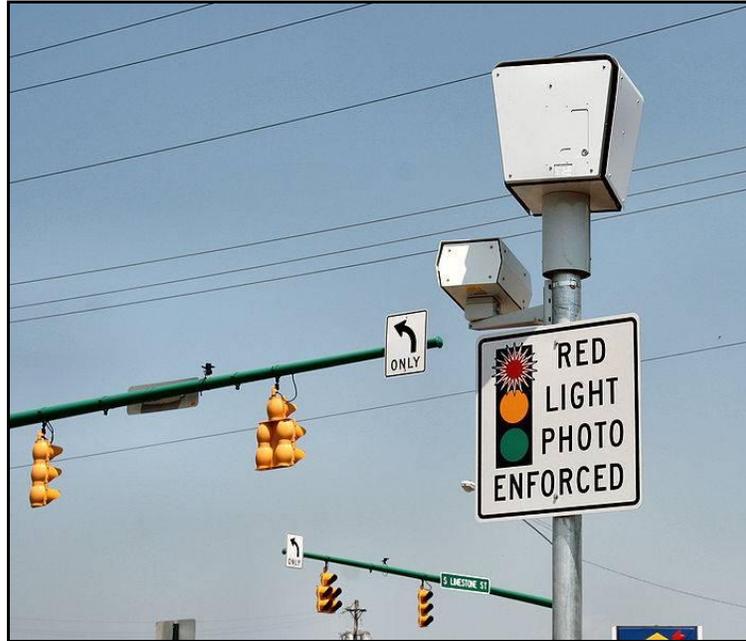
Figure 5: Automatic Camera Enforcement

- 2. Automatic Camera Enforcement (Figure 9):** Mounted mainly at intersections, automatic cameras photograph vehicles violating traffic laws, such as running red lights and traveling above the posted speed limit. Once the camera takes a photograph of the offending vehicle's license plate, a ticket is issued to the driver through the mail. This supplements the local police presence and makes drivers more aware of their surroundings (International Scan Summary Report..., 2009).

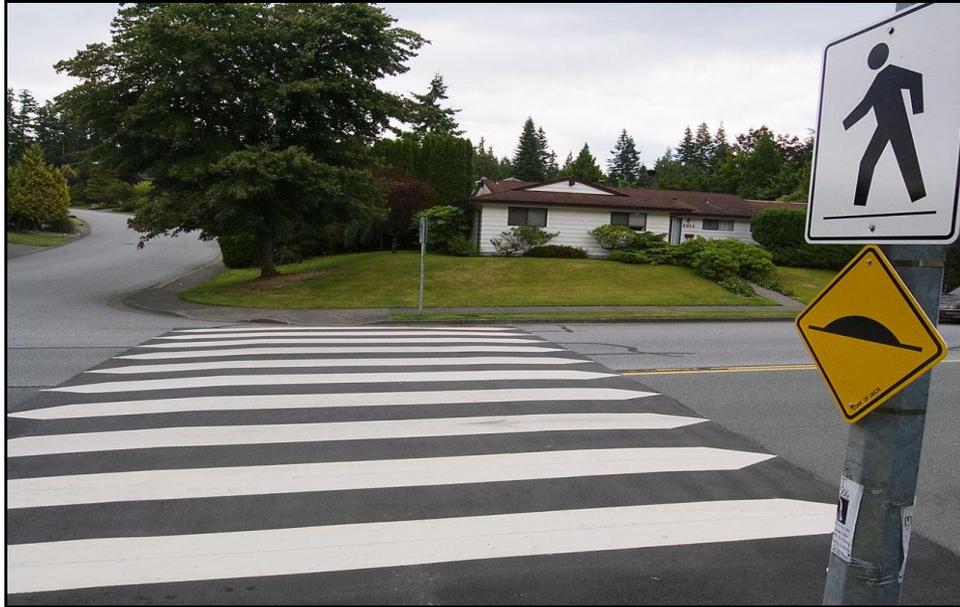
Figure 6: Raised Crosswalk

- 3. Raised Crosswalks (Figure 10):** Raised crosswalks are sections of raised pavement, similar to a speed bump, with crosswalk markings that allow pedestrians to cross a street. These provide a level street crossing for pedestrians, allowing them to be more visible to motorists. They also force motorists to slow their vehicle, which makes the motorist and pedestrian more aware of traffic laws (FHWA, 1998).

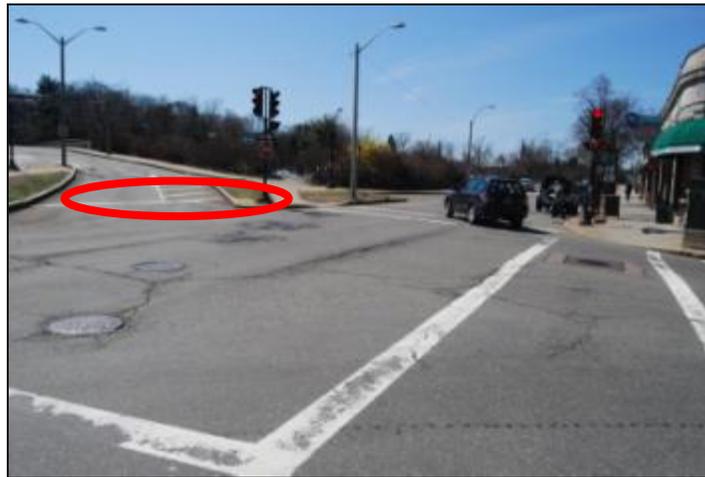
Figure 9: Potential New Crosswalk Location

Recommendation: Implement a new crosswalk. We recommend implementing a new crosswalk across from Elm Street at the north side of the intersection with Washington Street. This was a common path along one lane of traffic and would provide a safe place to cross.

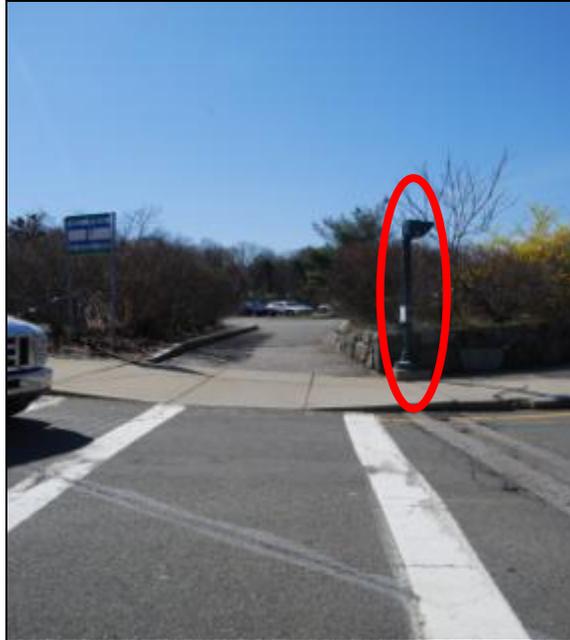
Figure 10: Walking Light Not Visible

- 2. Walking Light Not Visible:** As shown in Figure 10, the walking light is turned away from the crosswalk, making it impossible for a pedestrian to determine when the light indicates it is safe to cross.

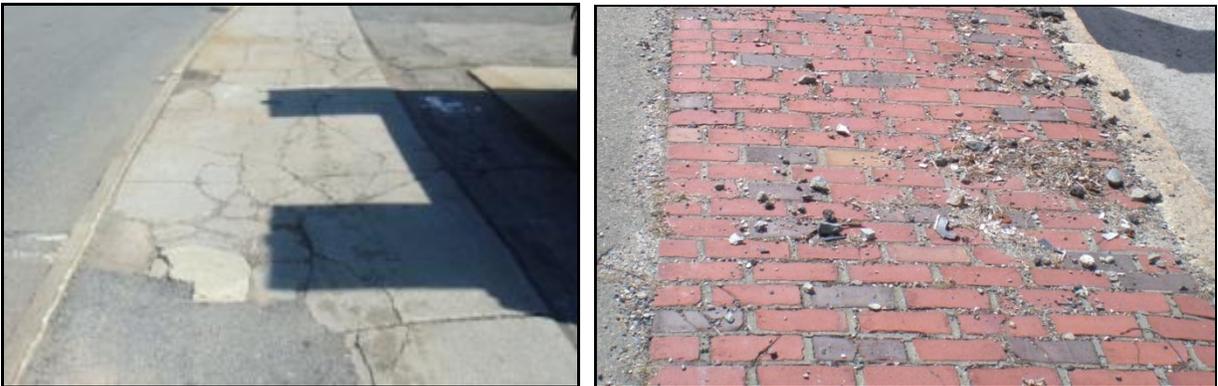
Figure 12: Cracked Sidewalk (left); Poorly maintained brick (right)

- 8. Sidewalks in Poor Condition:** The sidewalks in West Newton are generally in good condition; however, some areas feature cracked and broken sidewalks, as shown in Figure 12, creating tripping hazards that are particularly dangerous to the elderly and the disabled. At the same time, many sidewalks are lined with brick buffers and brick curb cuts.

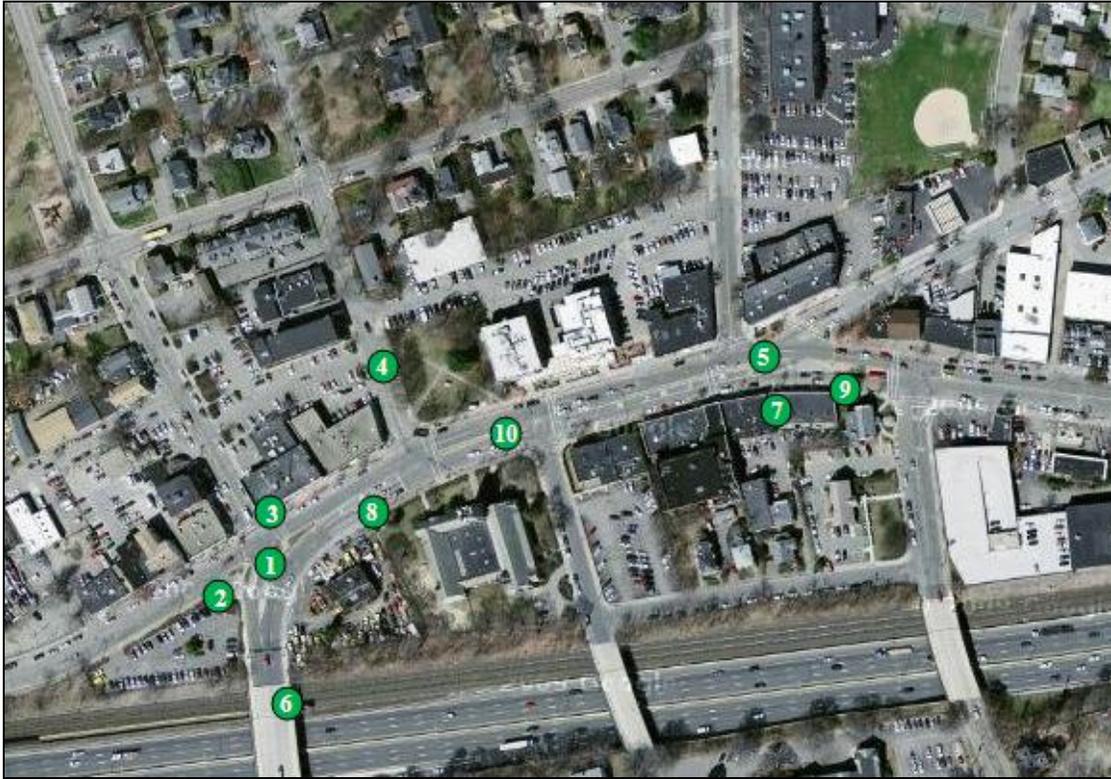
Figure 14: West Newton Recommendations Map

Location on Fig. X	Recommendation	Cost	Impact
1	Implement a new crosswalk	Low	Low
2	Rotate the walking light	Low	Low
3	Fix the walking light	Low	Low
4	Implement a crosswalk	Low	Low
5	Move the crosswalk to east side of Waltham Street	Low	High
6	Construct a ramp to Commuter Rail platform	High	High
7	Make the alleyway more appealing to pedestrians	Low	High
8	Repair sidewalks	Low	Low

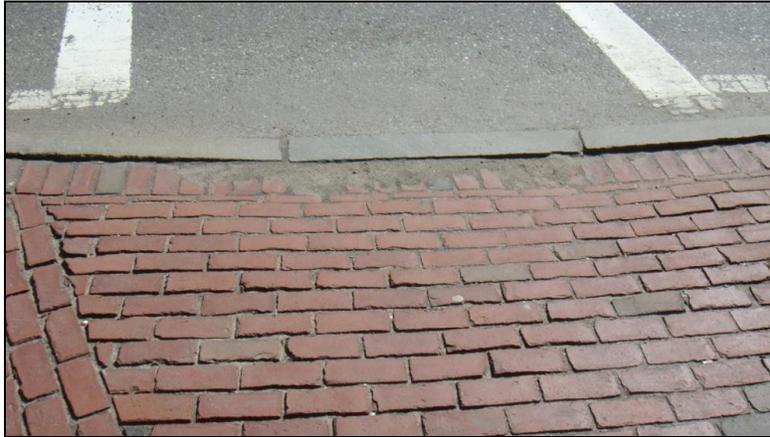
Figure 16: Brick Surface along Washington Street

- 2. Hazardous Brick Surfaces:** Washington Street, for example, has a partial brick surface, as shown in Figure 16. Brick surfaces are extremely difficult to maintain and can be hazardous. The ADA suggests uneven surfaces such as bricks should be avoided.

Recommendation: Replace with pressed concrete. We recommend replacing the brick surfaces with pressed concrete. Pressed concrete maintains some of the aesthetic appeal of brick while providing a safer traveling surface. This can be implemented systematically over time. As the brick degrades, pressed concrete could be used as a replacement. An example of pressed concrete is shown below in Figure 17.

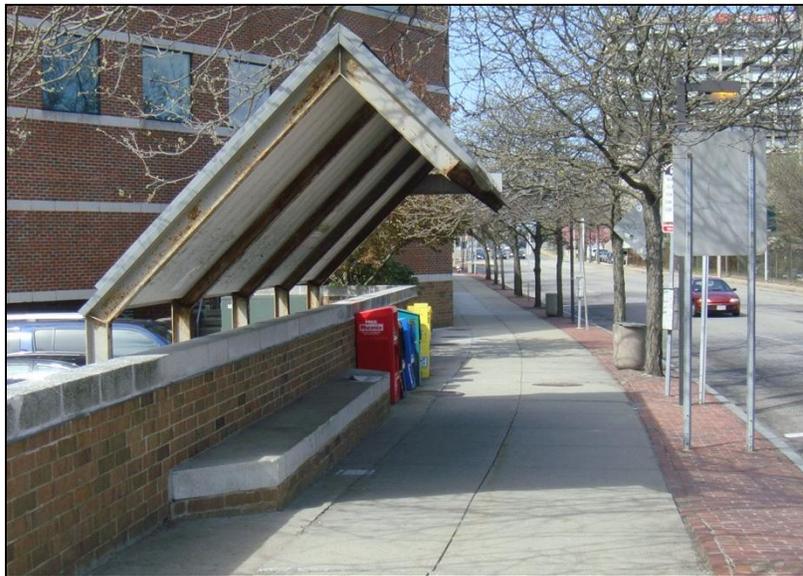
Figure 18: Newton Corner south bus stop

- 4. Lack of Proper Bus Stop:** At the south side stop, we found that the bus shelter was open and unattractive. This current shelter does not protect the bus users from the elements, as displayed in Figure 18. Another challenge at this bus stop was a lack of bicycle racks. There currently are no outside bike racks in the vicinity of the bus stop.

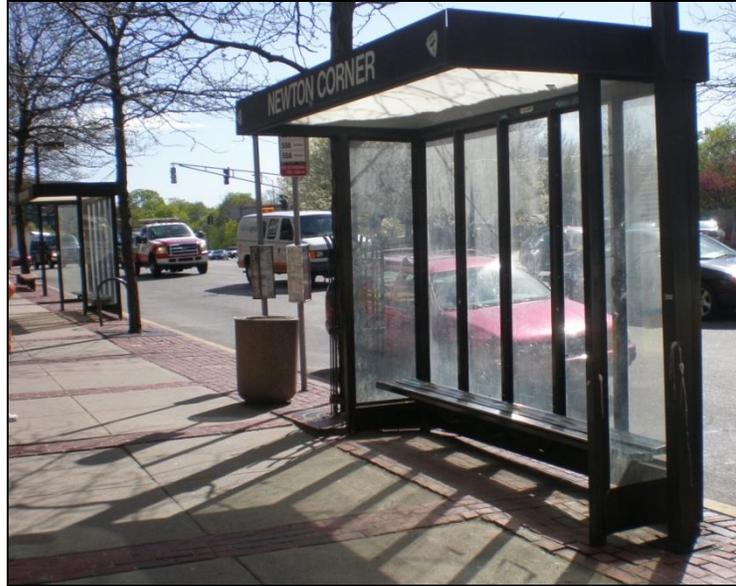
Figure 19: Newton Corner north bus stop

- 5. Lack of Proper Bike Racks:** Specifically at the north side stop, an additional problem could be the lack of knowledge of existing bike racks. We noticed that a person had locked their bike to a trash can at this stop, shown in Figure 19. Here we found that there are bike racks in a nearby public parking garage that could be used by bus patrons. Another challenge at this bus stop was a lack of bicycle racks. There currently are no outside bike racks in the vicinity of the bus stop.

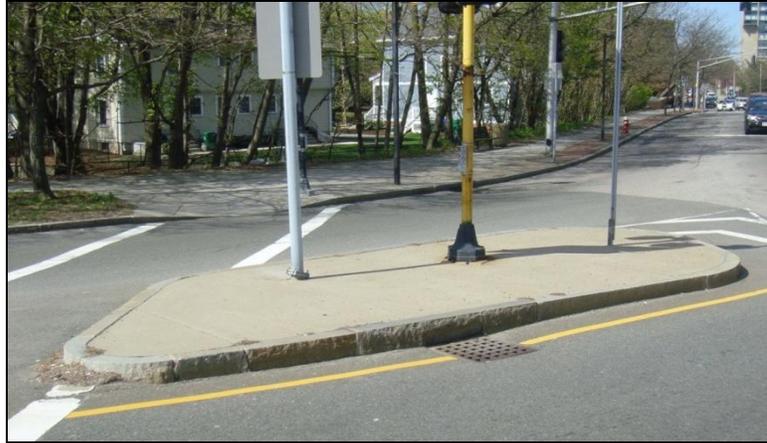
Figure 20: Inaccessible Walking button at Centre Avenue and Park Street

- 6. Inaccessible Walking Button:** A walking light at Park St and Centre Ave also presents a challenge. Here, we found that the walking button is in the center of a raised median thus making it inaccessible to the disabled and elderly, seen in Figure 20. Also, this walking button was not functional. This walking button presents a safety concern as well as violating the ADA regulations on its accessibility. Below are two options for improving the accessibility of the walking light.

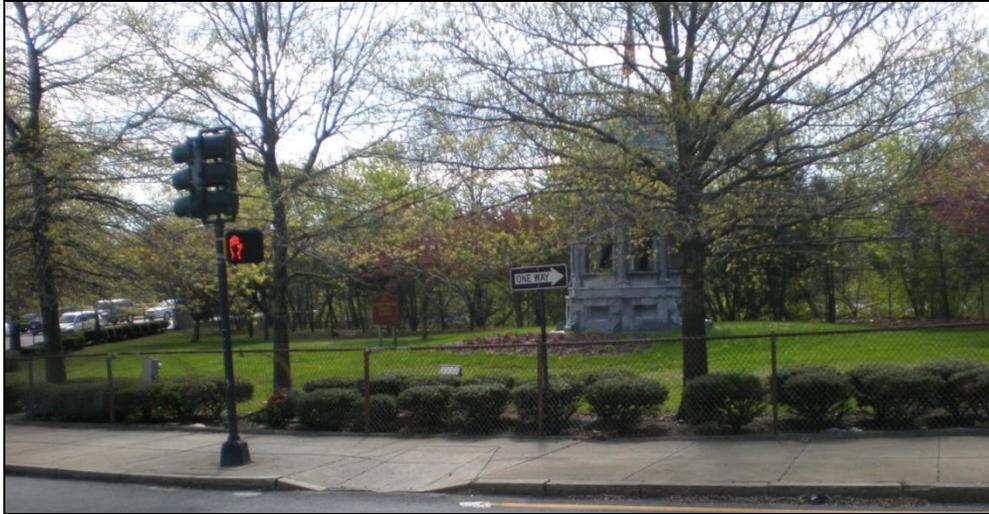
Figure 21: Bell Park on the north side of Newton Circle Rotary

- 7. Closed Green Space:** In Newton Corner, there are not many green open spaces. Therefore, an area for improvement could be the Memorial Bell Park that is currently completely enclosed by a fence, as evident in Figure 21. This area has the potential to be a public area that would attract pedestrians and also offer them a safer path to travel.

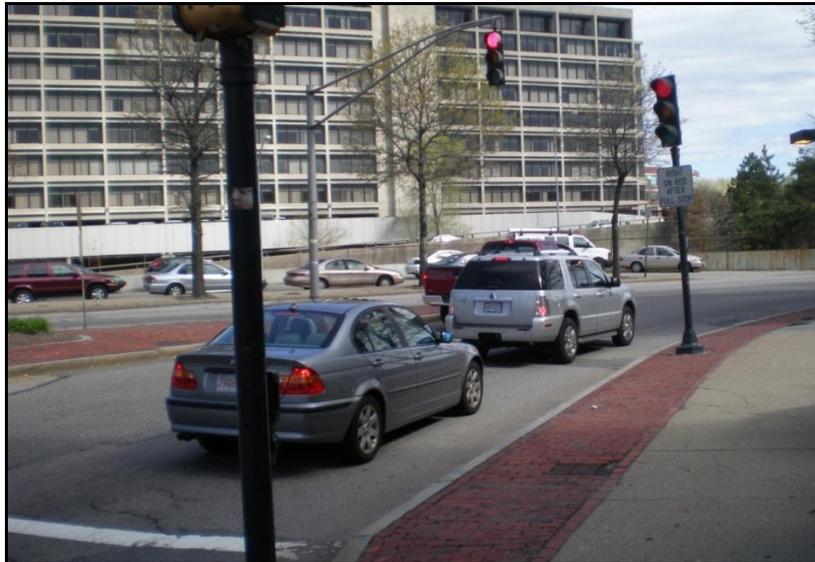
Figure 23: Traffic signals at Centre Street and Centre Avenue

- 9. Improper Placement of Traffic Signals:** The traffic signals for the right turn on Centre Street at the intersection of Centre Avenue are located after the crosswalk, as shown in Figure 23. This causes cars stopped at the light to block the crosswalk and cause a hazard for pedestrians.

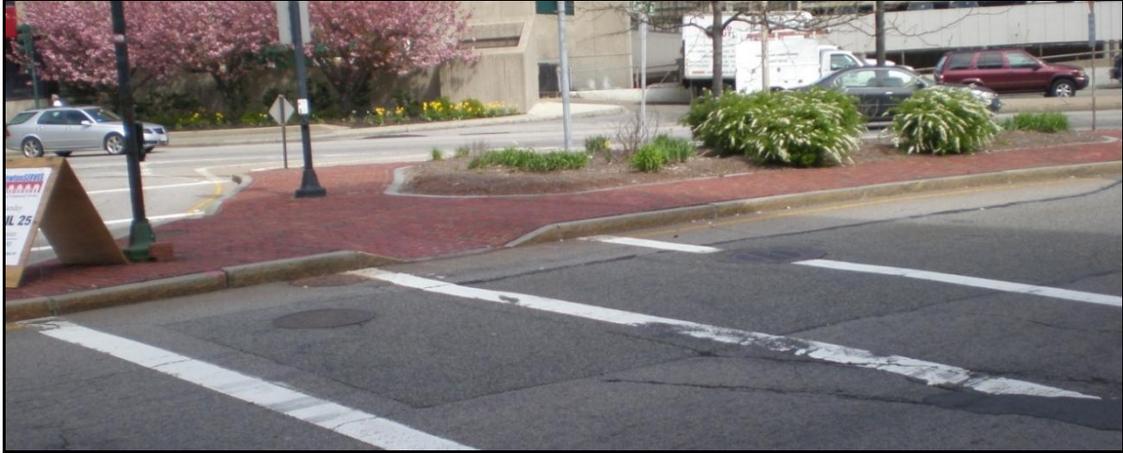
Figure 24: Median at Centre Street and Centre Avenue

- 11. Uneven Median:** The median on Centre Street at the intersection with Centre Avenue is not a level surface and may cause some difficulties for disabled pedestrians, as shown in Figure 24.

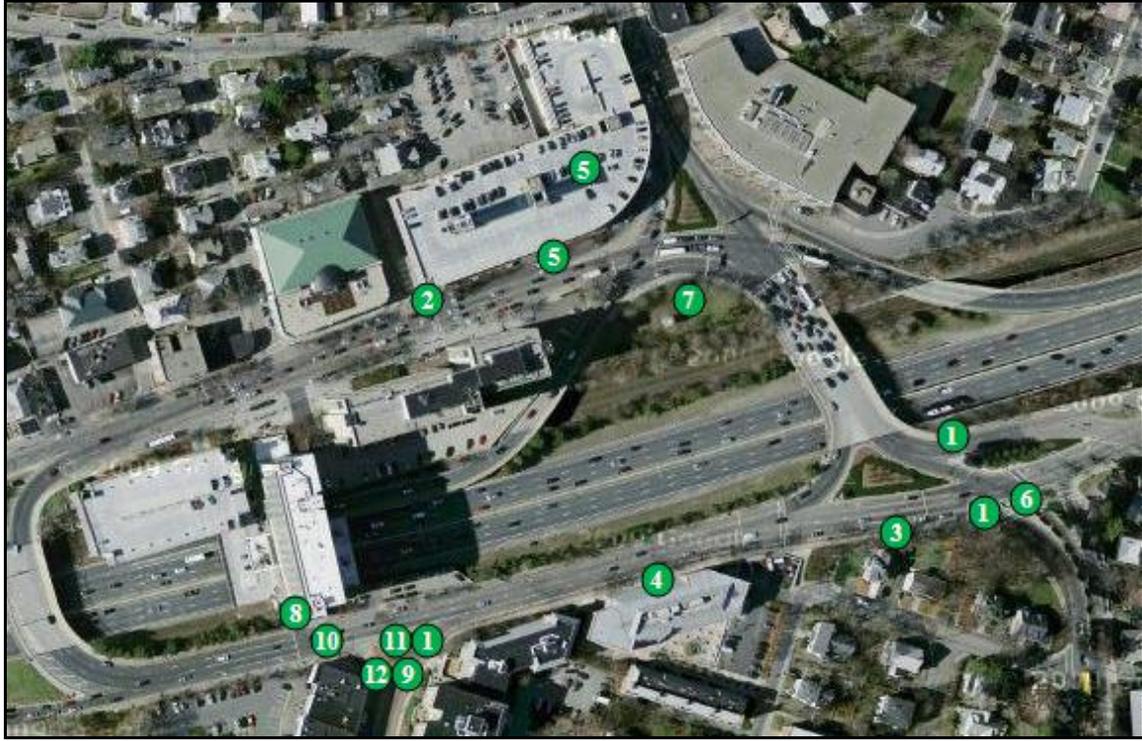
Figure 25: Newton Corner Recommendations Map

Location on Fig. X	Recommendation	Cost	Impact
1	Prohibit right turns on red	Low	High
	Install a “No Turn on Red” signal	Low	High
2	Replace with pressed concrete	Low	Low
3	Clean sidewalks seasonally	Low	Low
4	Implement a full bus shelter and bike racks	High	High
5	Implement bike racks or install informative signage	Low	Low
6	Create curb cuts on and off median	Low	High
	Relocate the walking button	Low	High
7	Open Bell Park	Low	Low
8	Implement a ramp	High	High

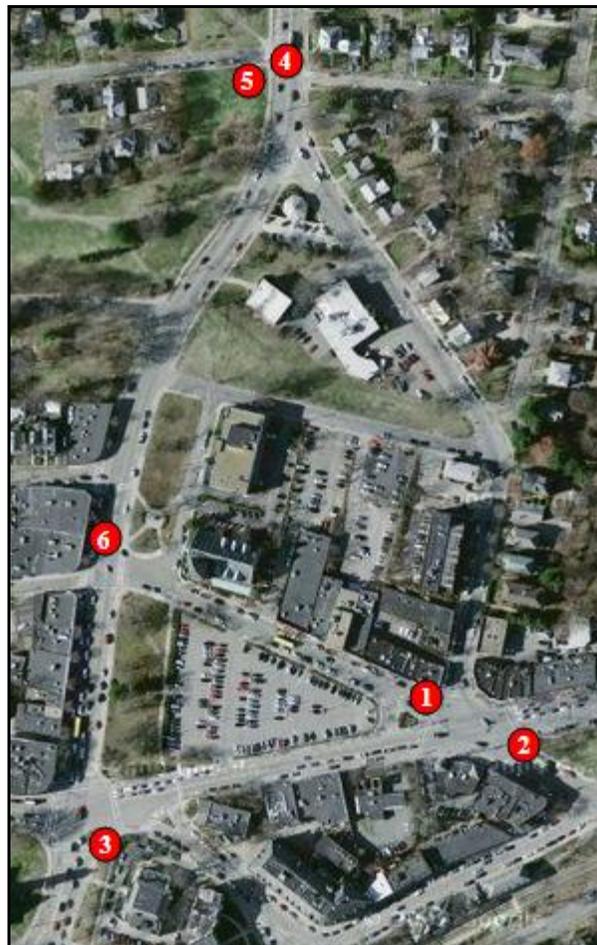
Figure 26: Newton Centre Problems and Opportunities Map

Newton Centre, one of Newton's foremost pedestrian areas, presents many challenges present many challenges that impact pedestrian traffic due to the number of shops, cafes, restaurants, and small businesses in the village. We studied the following intersections: Langley Road and Beacon Street, Beacon Street and Centre Street, and Centre Street and Bowen Street. Below, we discuss the challenges that we found and our recommendations for these intersections. A map outlining these challenges is shown in Figure 26.

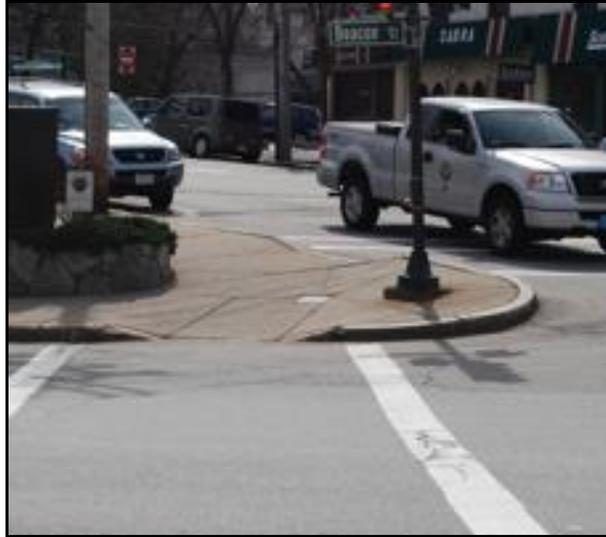
Figure 28: Steep curb cut located at the intersection of Langley Road and Beacon Street

- 2. Steep Slope of Curb Cut and Long Crosswalk:** When traveling east through this intersection, where Langley Road and Beacon Street begin to separate, there is a curb cut that has a sharp slope, shown in Figure 28. This impedes those with walking disabilities from accessing the sidewalks located on the respective streets, forcing many people to walk in the street instead of utilizing the crosswalk. At this intersection, we observed many people avoiding this curb cut. This is extremely unsafe as it is forcing pedestrians to interact with vehicles. Also located at the steep curb cut is a long crosswalk crossing Beacon Street on the east side. Long crosswalks present the challenge of crossing the street in enough time to avoid vehicular traffic.

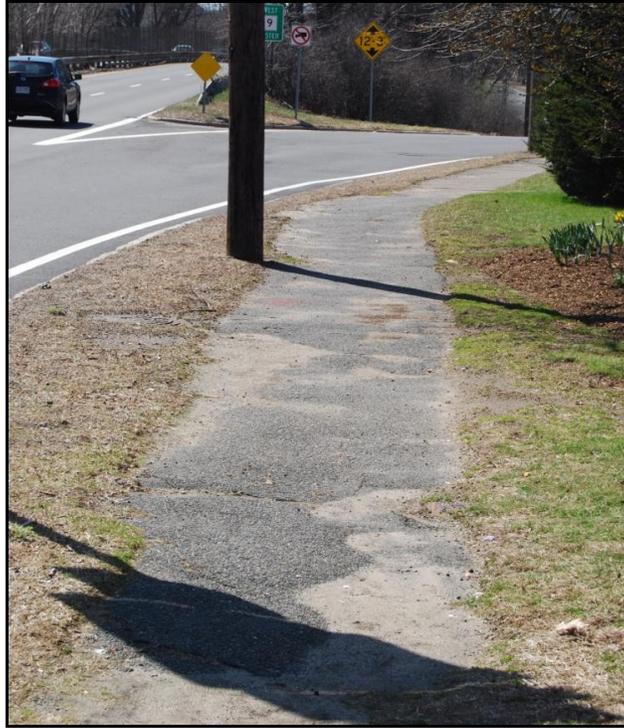
Figure 35: Poorly maintained sidewalk along Route 9 leading to Hammond Pond Parkway

- 3. Inaccessible Sidewalk:** The sidewalk leading from Route 9 onto Hammond Pond Parkway on the westbound side is inaccessible, presents dangerous conditions for the elderly and disabled, and is not aesthetically pleasing. Where the off-ramp extends towards Hammond Pond Parkway, a sidewalk also begins. However, there are no crosswalks leading to this crosswalk and no curb cuts allowing those in wheel chairs access to this. Even when a pedestrian reaches this sidewalk, it is broken and covered in debris, which can present many tripping hazards to the elderly and disabled. The sidewalk looks as though it is not meant to be used. The beginning of this sidewalk is shown in Figure 36.

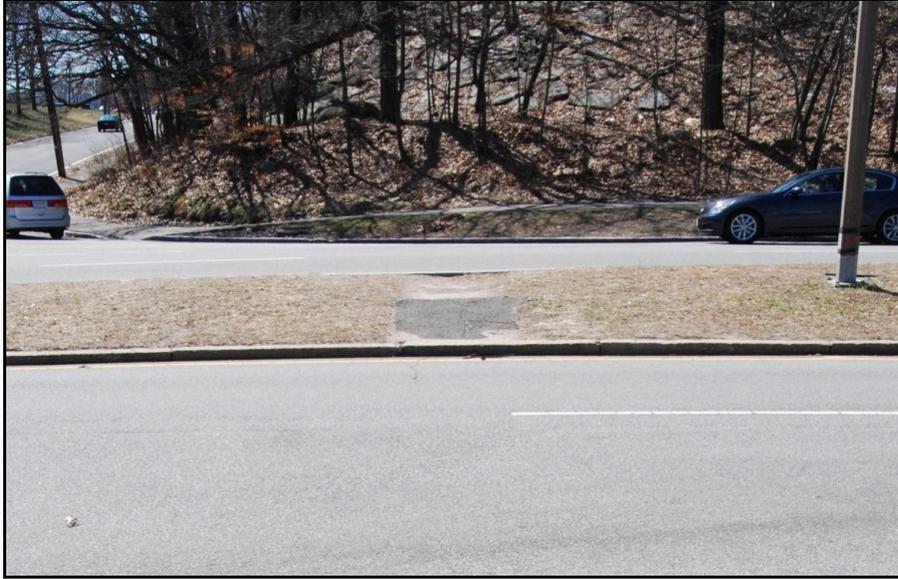
Figure 36: Potential crossing across Hammond Pond Parkway

- 4. Hazardous Facilities along Hammond Pond Parkway:** The conditions of the sidewalk and facilities associated with it continue to be a problem along Hammond Pond Parkway.
 - a. Hazardous Pedestrian Crossing without Proper Facilities:** Cars traveling southbound on Hammond Pond Parkway approach the intersection of Route 9 right after they take a sharp turn down a steep hill. Pedestrians do cross here; the facilities seem to suggest a designated crosswalk because of a median with a paved patch of sidewalk. However, there are no crosswalks and no curb cuts leading to the median. This median is shown in Figure 37. As pedestrians cross here, they are presented with fast-moving traffic with poor visibility, putting them in danger.

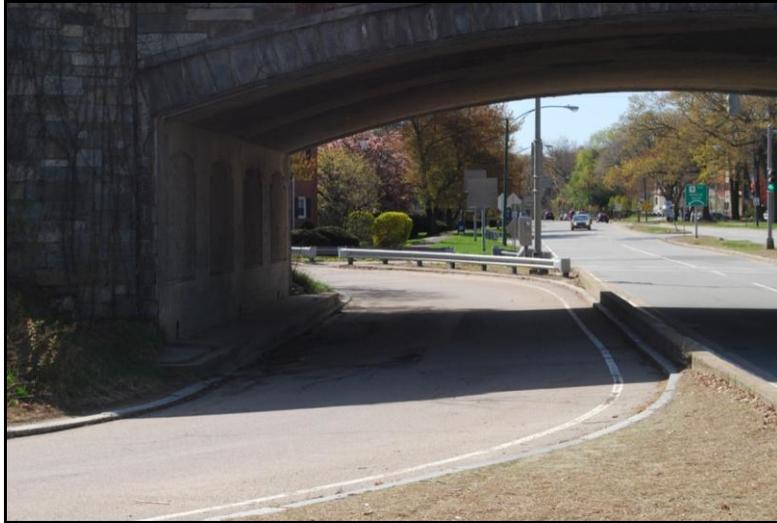
Figure 37: Route 9 Underpass

- 5. Pedestrians Use Underpass to Cross Route 9 without Facilities:** During our observations, many pedestrians were walking through the underpass without any designated facilities. The underpass is shown in Figure 38. To identify the reason for this, we observed where they were traveling. Some were walking through the underpass to use the crosswalks on the other side of Route 9 to cross Hammond Pond Parkway. Others were using the underpass to get from one side of Route 9 to the other. These paths are shown in Figure 39. Regardless of where they were traveling, using this underpass is extremely hazardous because it only provides a very narrow place to walk with cars traveling quickly around a sharp corner from Route 9. This area is likely to cause an accident between motorists and pedestrians.

Recommendation: Install pedestrian facilities along the underpass of Route 9. To solve this safety issue, new facilities need to be built to accommodate the pedestrians crossing through this underpass. In order to fit in new sidewalks and other facilities, the lanes through the underpass need to be narrowed. Narrowing street lanes is considered a method of traffic calming, which slows down traffic, also benefiting pedestrian safety.

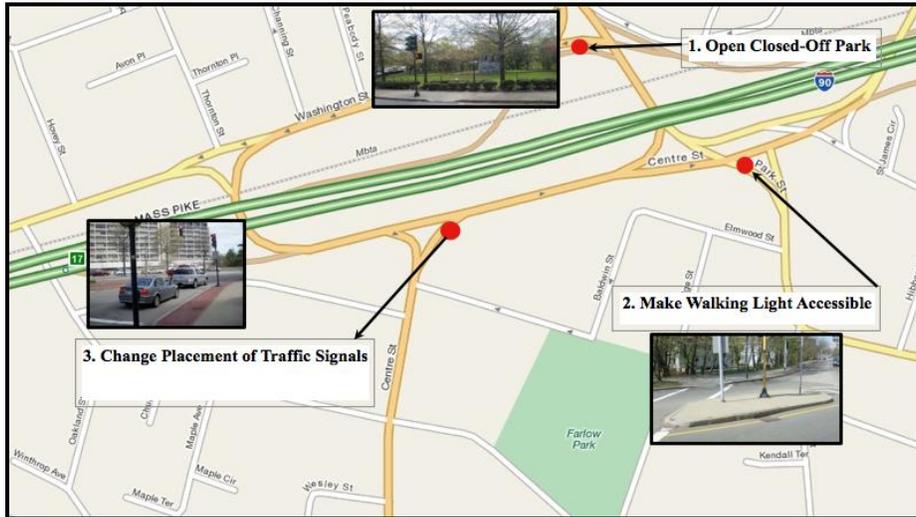
Figure 41: Map of Newton Corner Short-Term Recommendations

- 1. Open Closed-Off Park:** On the north side of Newton Corner, there is a green, open space that is closed off by a fence. This park is a memorial containing a bell from a former fire station. Opening this park would provide a safe and inviting destination for pedestrians.
