# REFURBISHING THE CAROUSEL IRRIGATION SYSTEM

Marcello Nicoletti, Christina Steele,  
Mason Kolb

February 24, 2019

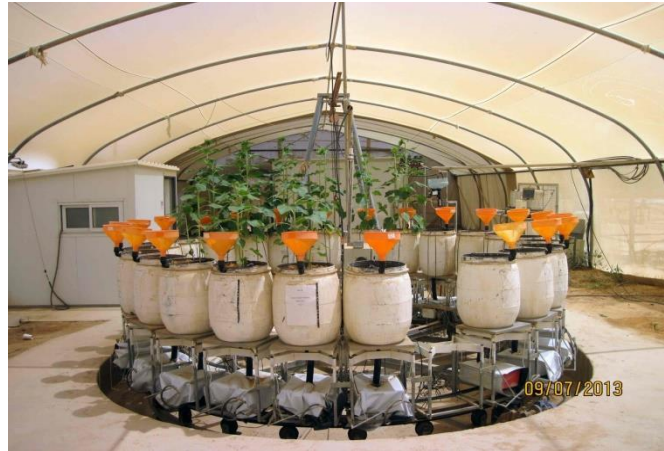
**Figure 2: Working Carousel (2013)**

The Arava R&D's Carousel Irrigation system (CIS), shown below in Figure 2, is a computer controlled agricultural research system that was constructed 25 years ago. The CIS is designed for small-scale experiments, utilizing data collection devices and sensors to operate automatically. The system is located in a greenhouse to maximize the control of outside parameters. Arava R&D prefers

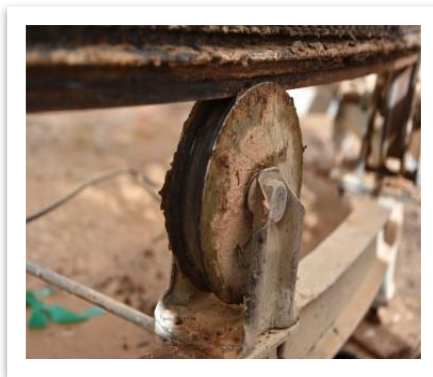
**Figure 3: Before Cleaning**

The last experiment run in the CIS was over three years ago, resulting in a large buildup of sand, grease, dirt shown in Figure 3 and 4. Cleaning the carousel consisted of power washing, scrubbing, and vacuuming to later assess the status of each component. Inventory records were divided into three major subsystems and parts were labeled based on functionality. These records allowed for a complete system-analysis that identified all problem areas of the machine to repair or replace.

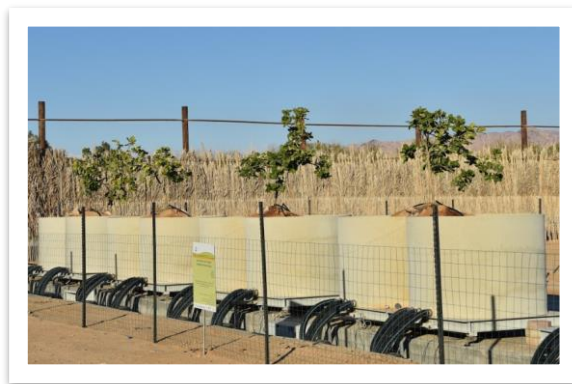
**Figure 9: Pomelos trees with a split root**

plant's water absorption and evapotranspiration (the plants' transpiration and evaporation). Large-scale lysimeters, with a 25-ton max load capacity, are used to identify the unique environmental stresses to the root system of a pomelo tree, shown in Figure 9. The root system has been divided, one half receiving freshwater while the other receives hypersaline water. Just like the Mango experiment, the irrigation is controlled automatically. Researchers want to understand how the tree will react, and if it will choose a dominant side and a water quality.

Figure 9: Pomelos trees with a split root system [Personal photograph taken in Arava R&D]. (2019, February)

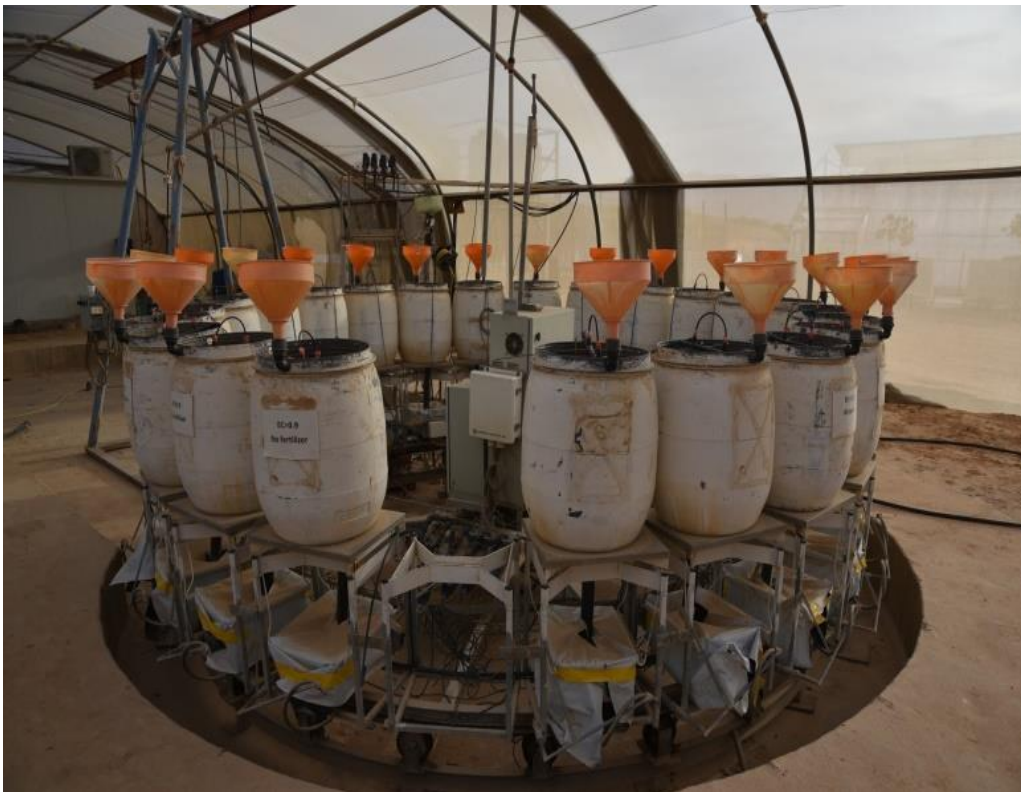
**Figure 10: Carousel Irrigation System overview**

The Arava R&D's Carousel Irrigation System (CIS), shown in Figure 10 below, is a computer controlled automated research system that was constructed 25 years ago. The CIS is designed for small-scale agricultural experiments, utilizing sensors, lysimeters, and a salinity probe for accurate data collection. The system is in a greenhouse to maximize the control of outside parameters, limiting these as a source of error on the results. A greenhouse provides consistent humidity and temperature as well as shelter from the wind and bugs. The carousel mechanism rotates continuously to cycle the barrels for specified irrigation and drainage while equally distributing each of the plants' light exposure, mimicking conditions out in the field. This uniform environment increases control of independent variables, improving the accuracy of the results and ultimately bolstering the relevance of the results for farming in the future.

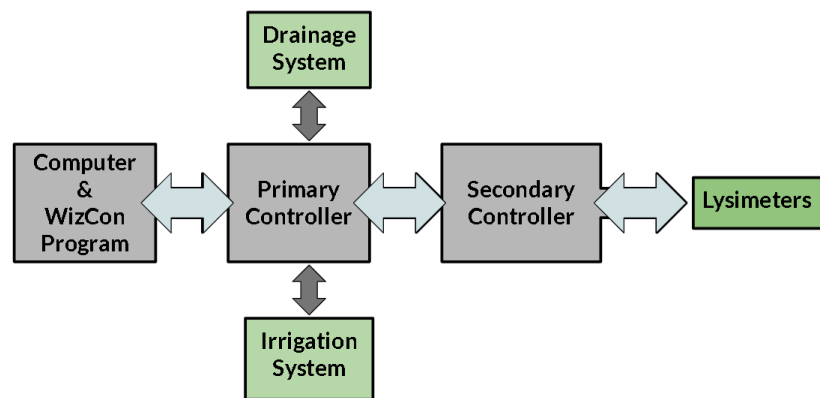
Figure 12: Communication flow of automation

The functions of the experiment, like irrigation and drainage, operate directly according to the parameters specified within the time schedule. Figure 12 demonstrates the flow of communication that allows for automatic operations. Instructions from the time schedule are sent to the primary controller housed in the control room of the greenhouse, outside the carousel. The primary controller organizes and stores these specific instructions and distributes commands to the correlating subsystems, including the irrigation, the drainage, and the secondary controller.

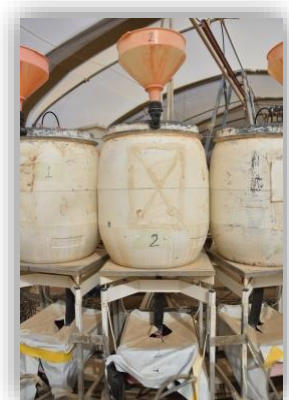
**Figure 14: Section of the experimental system**

Experiments are conducted in the barrel where the plant are housed, pictured in Figure 14, and use the orange secondary funnel and drip irrigation hoses for irrigation. The 75-liter barrel allows for experimentation with a variety of sized root systems for different plants. The data collection equipment includes separate lysimeters directly located under each barrel to collect the total barrel’s weight to be compared to the amount of water drained into the primary drainage bin.

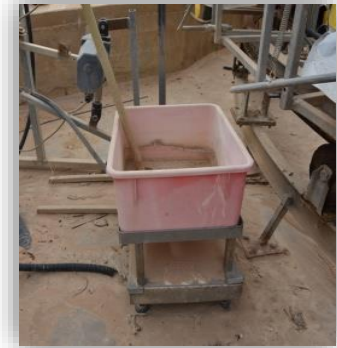
**Figure 15: Secondary drainage bin**

Another lysimeter, located outside of the carousel and pictured in Figure 15, records the weight of sediment left behind in the secondary drainage bin after the water is disposed of. The weight of the sediment is omitted from the final drainage amount to distinguish the accurate amount of output water. The weights of the irrigation, the barrel, and the final drainage are used to calculate the water balance equation, referenced in Appendix A. This equation determines the plant's desired amount of water by comparing the waters' input and output weights. This calculation is used to improve the plant's growth by observing its reaction to different salinities or amounts and adjusting these parameters accordingly (Elsevier, 2015).

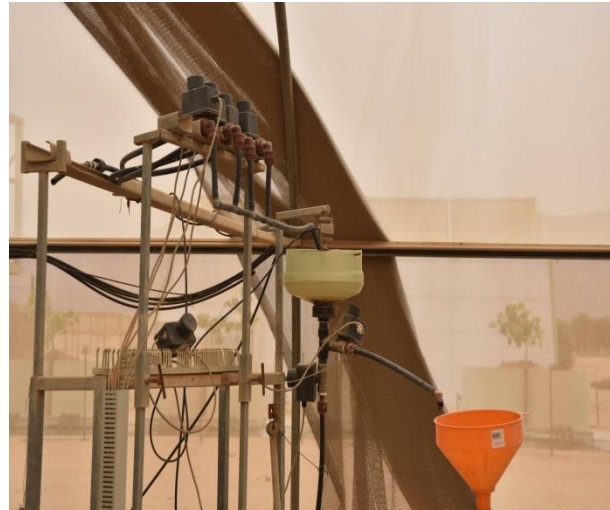
**Figure 16: Irrigation subsystem**

component, water storage, stocks three different salinities, 0.9, 1.4, and 3.2, separated into three 1000-liter water drums. The second component consists of a filter that removes large sediments from the water before being pumped into the greenhouse using underground piping. The potential energy of the raised water stored at height of roughly 10 feet, 3.1 meters, forces the

flow water from the drums to the equally raised irrigation delivery system. Motorized ball valves (MBV) use an electrically powered actuator to open and close a valve, controlling the flow of water into the primary funnel, shown in Figure 16 (“Sagiv: Motorized Ball Valve”). Attached to the support frame of the primary funnel, a scale measures the primary funnel’s weight which is transmitted back to the WizCon program to close the valve once the desired irrigation amount has been reached. A second MBV is opened, and the water flows from the primary funnel into the secondary funnel of the designated barrel specified within the time schedule. This time schedule consists of set parameters on irrigation amounts, requiring the rotary system to align and halt the designated barrel with the water delivery hose and drainage mechanism. The program uses radio frequency identification (RFID) to determine the position of the RFID tag attached to each barrel.

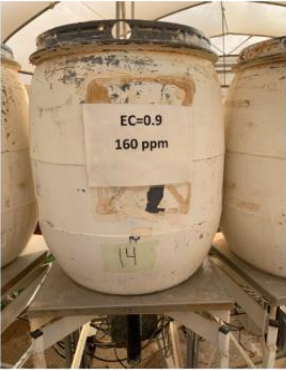
<p>The Barrel acts as a container for the experiments (soil, plants, water). The attached exit pipe allows excess water to trail into the bucket below and be disposed of. The large Barrel is coated in a white paint, while the Exit tube for trailing water has a black plastic appearance.</p>	<b>BP</b>	<b>Barrel and Exit Pipe</b>			The Barrel is located at the top of this system on the Scale Platform. The Exit tube is located directly under the Barrel towards its back and runs through a hole in the Scale Platform to the top of the box collecting the buckets excess water.
	BP-1	Barrel and Exit Pipe 1	Drains slower	Chipped paint, - dirt, pipe intact	
	BP-2	Barrel and Exit Pipe 2		CP, +dirt, pipe intact, foam present.	
	BP-3	Barrel and Exit Pipe 3		CP, +dirt, pipe intact, foam present.

BP-4	Barrel and Exit Pipe 4		CP, +dirt, pipe intact, foam present.	
	BP-5	Barrel and Exit Pipe 5		CP, +dirt, pipe intact, foam present.	
	BP-6	Barrel and Exit Pipe 6		CP, +dirt, pipe intact, foam present.	
	BP-7	Barrel and Exit Pipe 7		CP, +dirt, pipe intact, foam present.	
	BP-8	Barrel and Exit Pipe 8		CP, +dirt, pipe intact, foam present.	
	BP-9	Barrel and Exit Pipe 9		CP, +dirt, pipe intact, foam present.	
	BP-10	Barrel and Exit Pipe 10		CP, +dirt, pipe intact, foam present, metal staple in dirt.	
	BP-11	Barrel and Exit Pipe 11		CP, +dirt, pipe intact, foam present.	
	BP-12	Barrel and Exit Pipe 12		CP, +dirt, pipe intact, foam present.	
	BP-13	Barrel and Exit Pipe 13		CP, +dirt, pipe intact, foam present.	
	BP-14	Barrel and Exit Pipe 14		CP, +dirt, pipe intact, foam present.	
	BP-15	Barrel and Exit Pipe 15		CP, +dirt, pipe intact, foam present.	
	BP-16	Barrel and Exit Pipe 16		CP, +dirt, pipe intact, foam present.

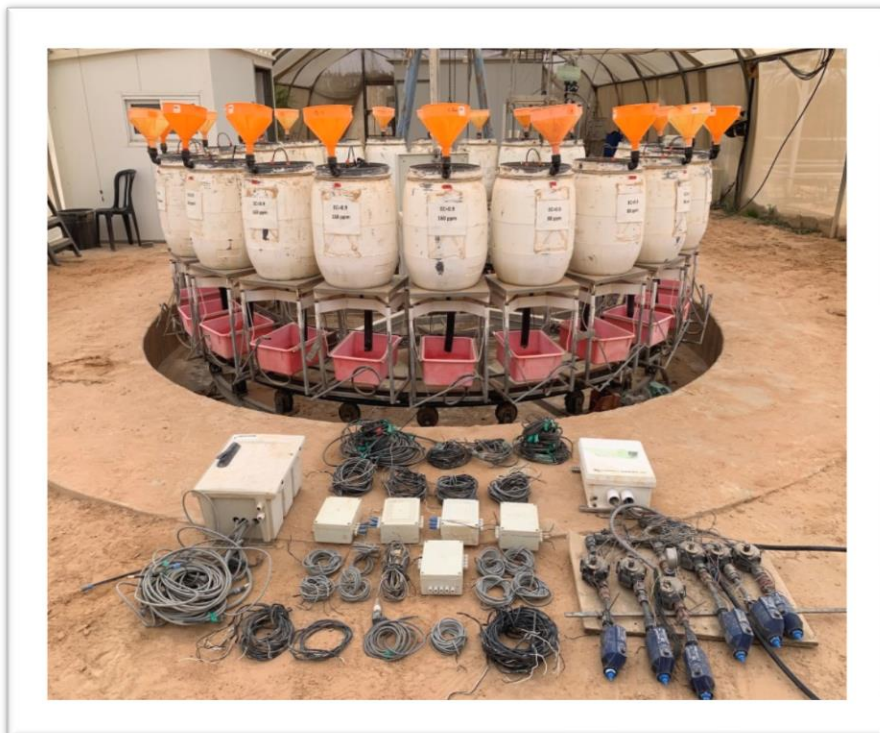
Figure 18: Cleaned CIS system

The cleaning process consisted of power washing, dusting and sweeping to remove the dirt, dust, and grease covering the CIS. Power washing was effective for removing the thick layers of grease and sand that covered the frame. Water was flushed through the irrigation pipes, drainage bins, and hoses to remove dust, sand, and dried salt. In addition, the control room and more sensitive electronics were swept and vacuumed for dust and sand. Cleaning revealed a significant amount of parts to repair, which were organized in the inventory.

All unnecessary equipment from past experiments was removed from the CIS. This was accomplished by following each wire, hose, and piping from start to end, separating unnecessary components from the rest of the system. The equipment included negative pressure sensors, wires, broken piping, pumps, and controllers. Figure 18 shows the excess equipment that was removed. This improved the accessibility to components that needed repair or further assessment.

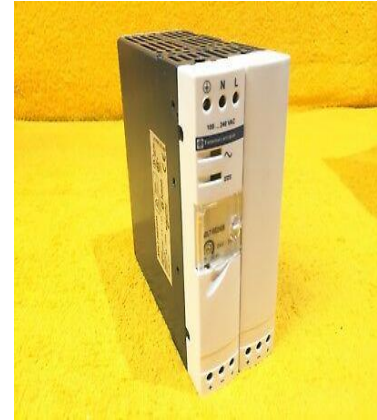
**Figure 19: Transducer**

The lack of power stemmed from no amperage at the source of the secondary controller caused by a faulty transducer, shown in Figure 19. Power was returned to the system after this transducer was replaced along with multiple repaired short-circuits within the secondary controller. The repairs allowed for the assessment of

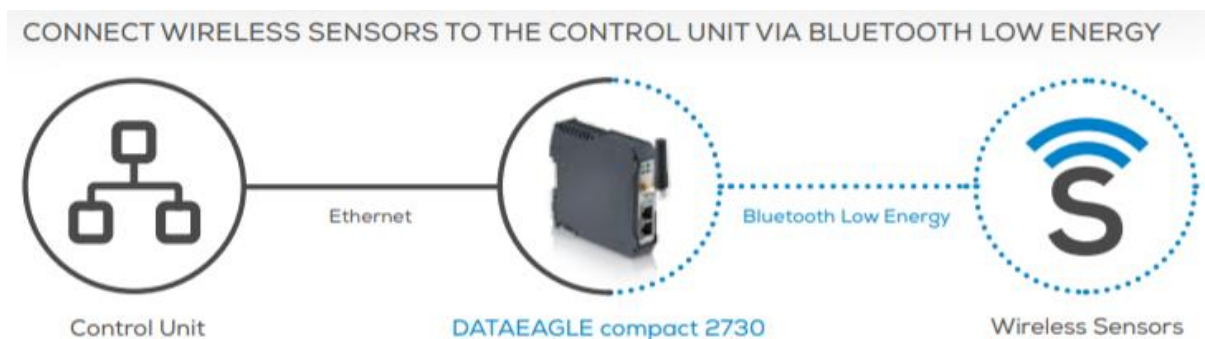
**Figure 22: Connect Wireless Sensors to the Control Unit via Bluetooth Low Energy**

Many technological improvements have been implemented to the controller systems in industries with needs for complete automation. With the help of Compost Equipment Manager, Richard Nicoletti, our team researched an updated Programmable Logic Controller (PLC) system for its easy installation, cost, and a wide range of applications. This system utilizes Bluetooth technology, demonstrated below, to communicate between a PLC and the sensors which serve many functions. The DATAEAGLE compact 2730 is an example of the products that act as the “gateway” between the signals of the blue-tooth and the control unit. The PLC system would bypass the need for major rewiring, allowing for quick initial installation. Also, the lack of wires would allow the R&D center to add or remove sensors in future experiments, easily adjusting the system to the needs of the experiment. Depending on the experiment’s specifications, the PLC can be setup with virtually an unlimited number of sensors which are small and can be easily attached to the desired system with ease. These sensors can be used to detect temperature, infrared light, touch, proximity, pressure, level and many more forms of data. The array of available sensors would allow Arava R&D to continue experimentation in a similar process used currently.

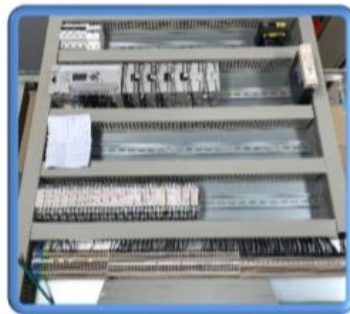
2. Organized

#### Organize Wiring

Improves accessibility for repairs and add-ons
