**AIDS PROJECT WORCESTER:
REDUCING ENERGY COSTS, GIVING BACK TO THE COMMUNITY**

Interactive Qualifying Project submitted completed in partial fulfillment
of the Bachelor of Science degree at
Worcester Polytechnic Institute, Worcester, MA

March 5, 2010

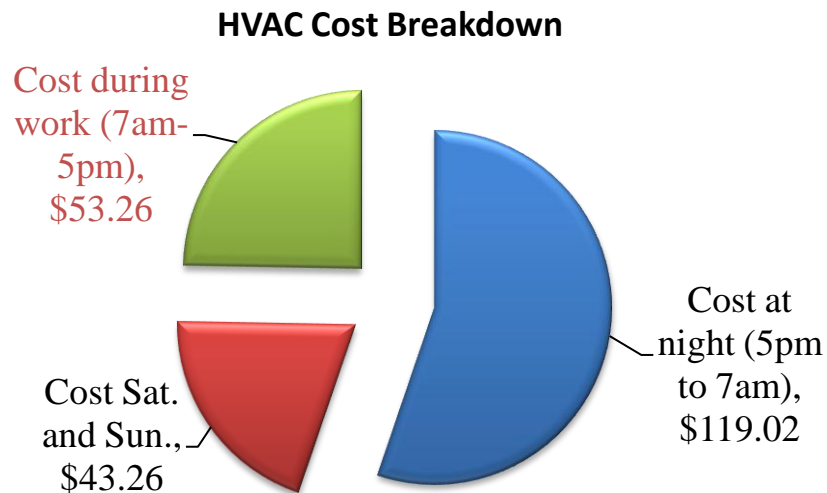
We found that the HVAC systems were operating inefficiently. The HVAC systems were also working more often at night when the building was not being used than they were during the day. They were using energy that was not needed as there were no staff members in the building.

The four rooftop units were found to use roughly 75% of their energy during non-working hours and weekends.

We found that by upgrading to programmable thermostats APW can reduce energy costs by roughly 60% and save approximately \$1800 annually. This estimate could prove to be low because our projection did not include air-conditioning operation in the summer. If the AC operated in similar fashion to the heating units, estimated savings would conceivably double.

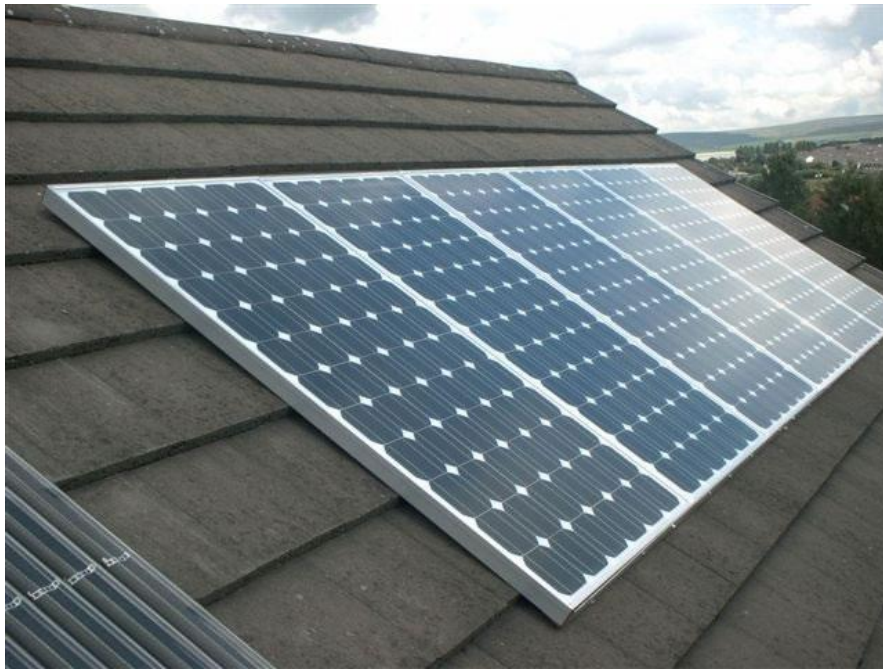
Figure 4: Solar Panels on a House

Another green technology is a photovoltaic (PV) system, which is a group of solar cells (or panels) that convert solar energy to electricity. This is possible due to the photovoltaic effect. The photovoltaic effect is when sunlight (photons) collides with the electrons in the solar cells. The electrons of the solar cells gain energy from the collision with the photons and are able to move more freely, and this creates a direct current (DC). Buildings run off of alternating current (AC) electricity so power inverters are used to convert the power type.

There are two main types of building materials for solar panels: crystalline silicon and thin-film. Crystalline silicon has been the established technology for solar panels. There are two main types of crystalline silicon, single and polysilicon. Single silicon has a low cost at \$4/Watt, and a conversion efficiency of 10-15% (Solar Electricity). Polysilicon has a faster growth and cheaper materials, but due to the structure of polysilicon, the module cost is roughly the same (Handbook of PV). Also, the efficiency of polysilicon compared to single silicon is lower by a few percent (Handbook of PV). The three main types of thin-film building materials are amorphous silicon, copper indium diselenide (CuInSe_2), and cadmium telluride (CaTe). Thin film materials have conversion efficiencies similar to the crystalline silicon. The costs of the materials for thin-film are higher than crystalline silicon, because silicon is widely available and only needs to be purified and the thin-film materials are rarer than silicon. The main advantage that thin-film materials have is that they lower the module cost of the solar cells (Solar Electricity). This is possible because thin-film modules can be manufactured in larger volumes and lower costs than the crystalline silicon modules (Solar Electricity).

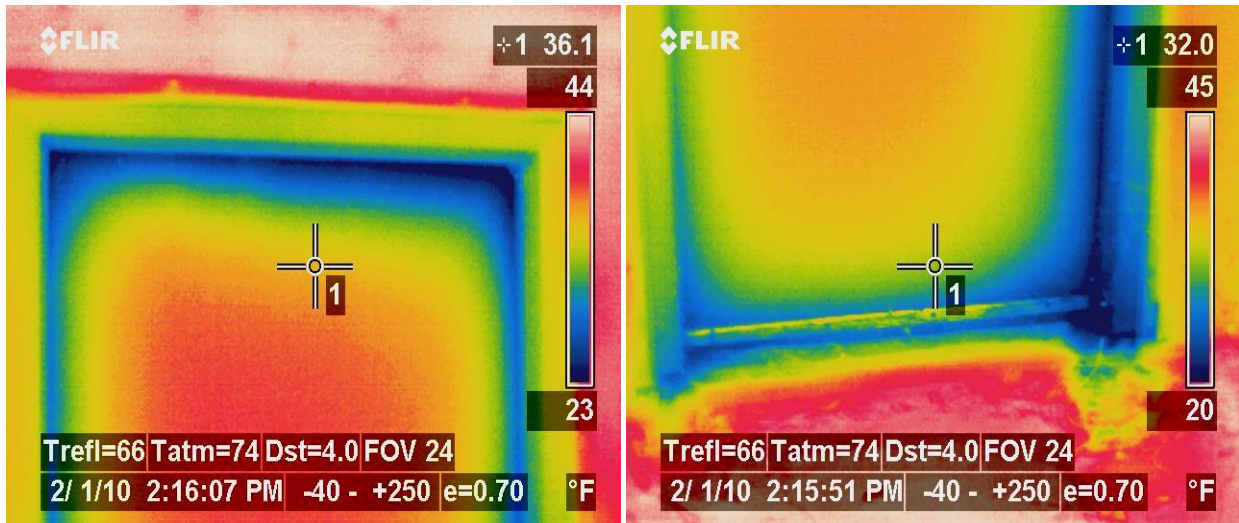
Figure 7: Thermal Images of Emergency Exit Door

The shots in Figure 7 were taken in the emergency exit stairwell, which leads outside. Of note are the thermal patterns visible around the door frame on the exterior door leading to the street. The dark blue areas are the areas where the coldest spots are. This is especially evident at the bottom of the door, because the door is not sealed properly. Looking at the warmer center of this door shows that the door itself is not in bad condition; however, it is severely lacking around the edges. If this door was re-hung correctly and weather-stripped (which involves placing rubber strips around the edges of the door) to make proper contact around the door frame, the thermal efficiency of the door would greatly increase.

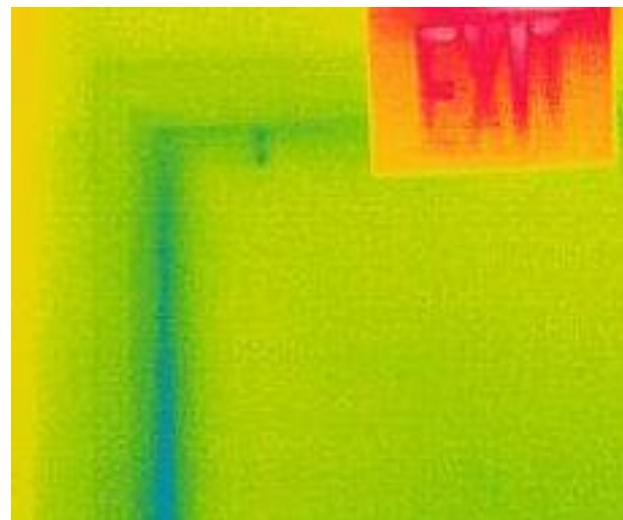
Figure 8: Properly Sealed Door

Figure 8 depicts a properly-sealed door. This door leads to the emergency exit corridor. The color is much more uniform throughout the door, meaning that there is minimal thermal “leakage.” In addition, the frame and walls around are very similar in color, meaning they are the same temperature. This is an ideal model of what the doors throughout the building should look like. Replacing, repairing, re-hanging, and weatherstripping doors to model this one will

greatly improve the thermal efficiency of the building by reducing costly thermal leakage and allowing for a more consistent ambient temperature throughout the building.

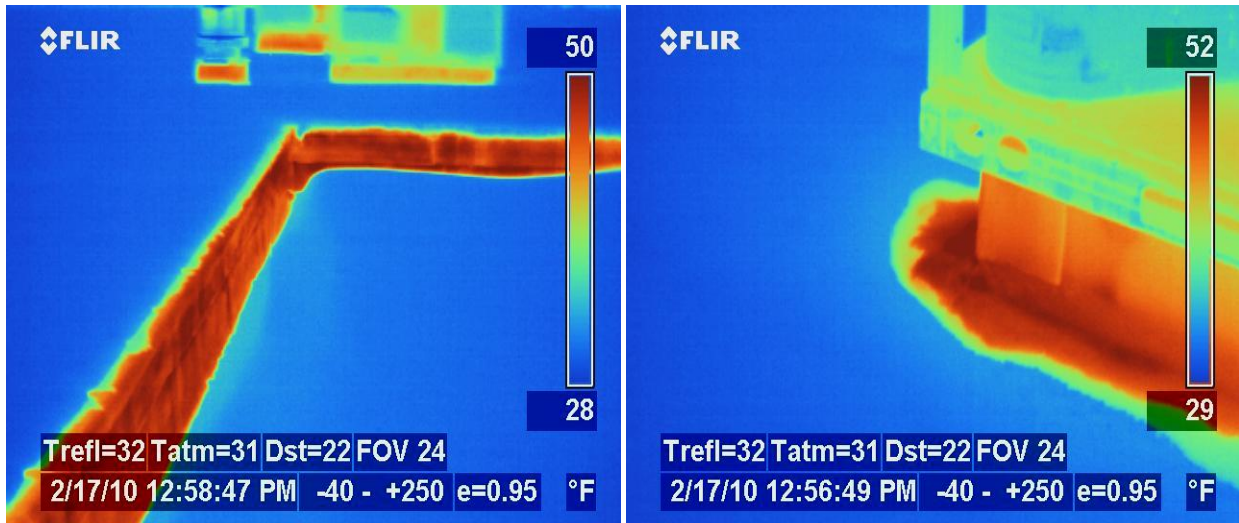
Figure 10: Specific Thermal Leaks on APW Roof

Photographs in Figure 10 were also taken on the roof of the APW building. The left depicts a 1-foot drop to a lower section of the roof directly over the APW offices. The measured temperature of this particular area was $\sim 50^{\circ}\text{F}$. That is a 20°F difference between the snow on the roof and this exposed surface. The picture on the right shows the area surrounding one of the HVAC units. The difference in temperature here is even greater. In addition to thermal leakage,

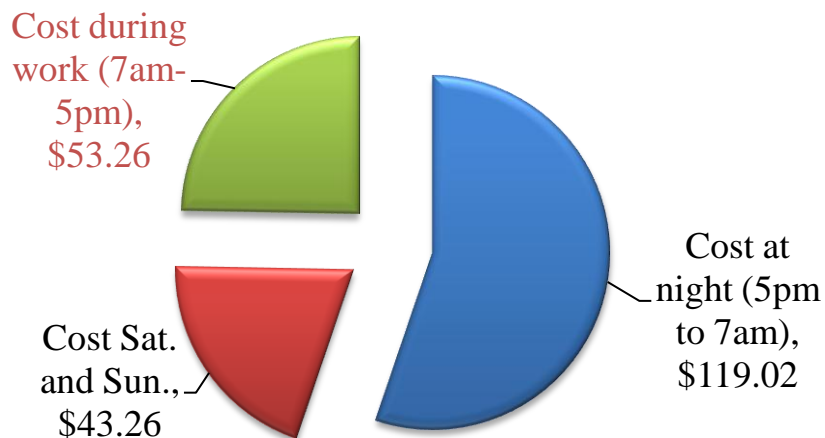
Figure 15: Cost Breakdown for HVAC Operation Over an 8-day Period

Discrepancies like this appear very frequently in the data that we collected. In fact, using our temperature-to-energy-cost algorithm, we determined and estimate of the cost breakdown of the HVAC system, found in Fig. 15.

We estimate, as shown above, that only \$53.26 or ~25% of the total heating cost incurred over the 8-day recording period was used to heat the building during normal working hours. Not only is that a small portion of the total cost, but also we estimate that it is insufficient to effectively heat the building.

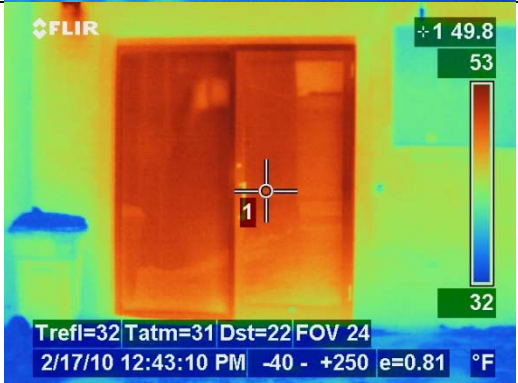
<p>2/17/2010</p> <p>APW Front Entrance from Outside</p>

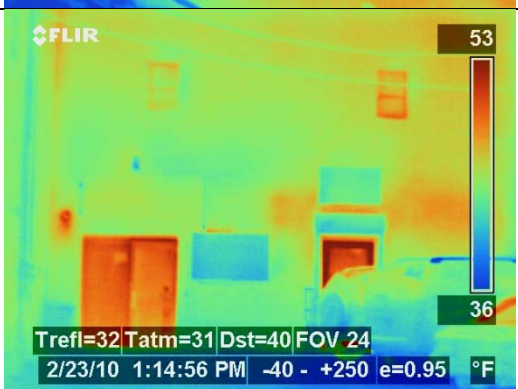
<p>2/23/2010</p> <p>APW Front Entrance from Outside</p>

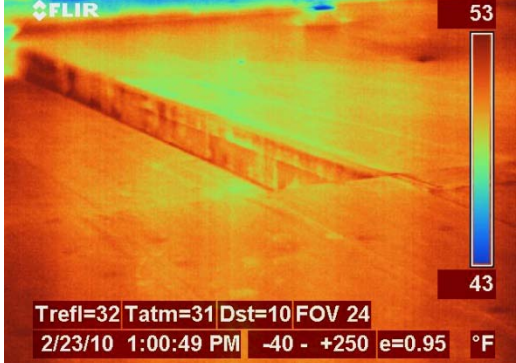
<p>FLIR</p> <p>53</p> <p>43</p> <p>Trefl=32 Tatm=31 Dst=10 FOV 24</p> <p>2/23/10 1:00:49 PM -40 - +250 e=0.95 °F</p>	<p>2/23/2010</p> <p>Roof 1ft Drop No Snow</p>

The photographs in Figure 9 were taken on the roof over APW's office space. These pictures were taken February 17, 2010 at 1:00pm. The mean temperature that day was 27°F with overcast conditions. In addition, it had snowed the previous day. These pictures show a very clear 12°F difference in temperature between the snow covering the roof (blue) and the roof itself (red), where snow had already been melted by the heat leaking through the insulation. The roof was observed to have no snow left less than a week later on February 23, 2010. In many buildings, there are policies prohibiting roof access during the winter months due to the danger of the ice that remains atop a properly insulated roof though the season. We observed at APW that, because of the roof's poor insulation, no such policy is needed.

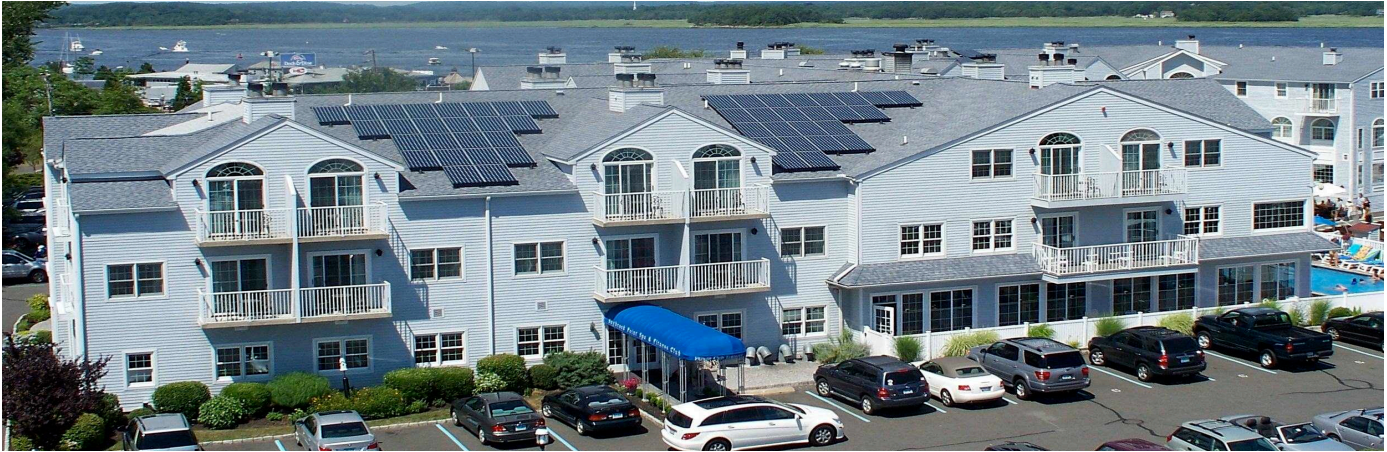
How Solar Works

Solar Panels (Photovoltaic cells) convert the sunlight into electricity. The cells are grouped together to create solar panels. A series of panels are linked together to create an array. The panels are mounted to your roof with a racking system which makes sure your panels stay in place during high winds or heavy snow loads. The inverter takes DC power (solar panels generate DC power) and converts it into AC or household power for running appliances, TVs, computers, etc. The electric panel distributes the electricity throughout your home's wiring and outlets. The utility grid is basically your local utility department. It allows you to store excess electricity on it during the day, then draw upon that power in the evenings. In essence, the grid is like a 100% efficient battery backup.

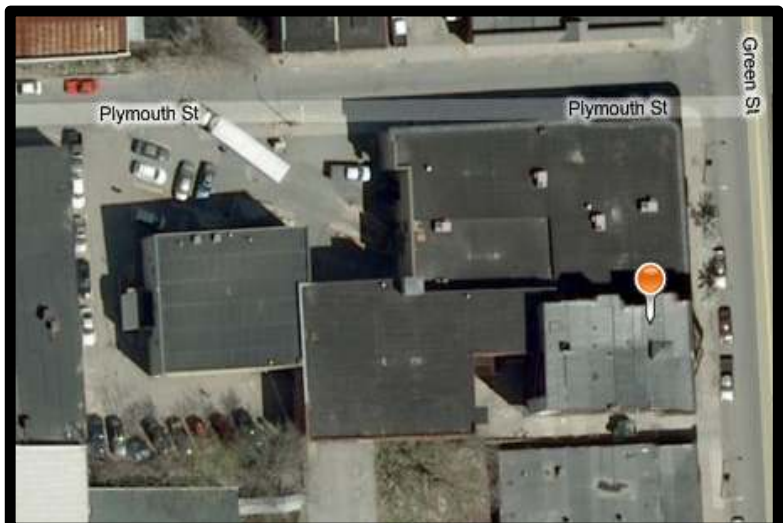
VIEW	PANEL ORIENTATION (TRUE)	ROOF PITCH (DEGREES)
AERIAL - OVERHEAD	180	0

Sunpower racking: T-5
 Modules: SPR-305
 # of panels: 42
