Bus Stop Assessment: Bringing Worcester to Code

An Interactive Qualifying Project Report
Submitted to the Faculty of
WORCESTER POLYTECHNIC INSTITUTE
in partial fulfillment of the requirements for the
Degree of Bachelor of Science

Date: 1 March 2007

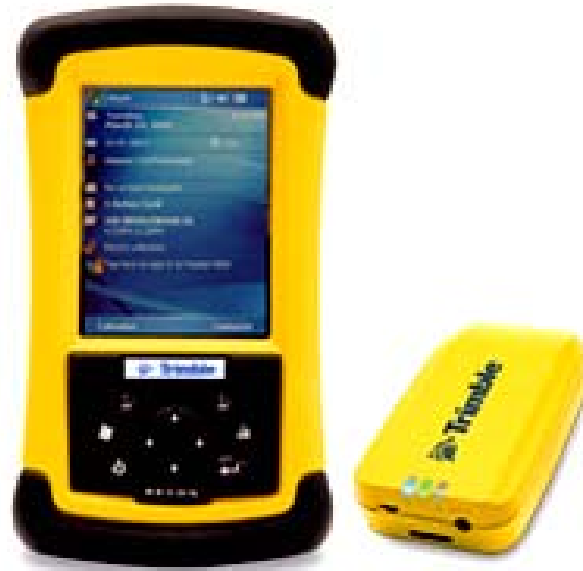
Figure 1 - Trimble Recon

The Trimble Recon handheld provides us with the impact proof, weatherproof handheld that we needed for this project. It also has Microsoft® Windows Mobile® version 5.0 software, as well as built-in Bluetooth wireless technology which make it a valuable asset because of the compatibility it has with our PC's. (Trimble Navigation Limited, 2006)

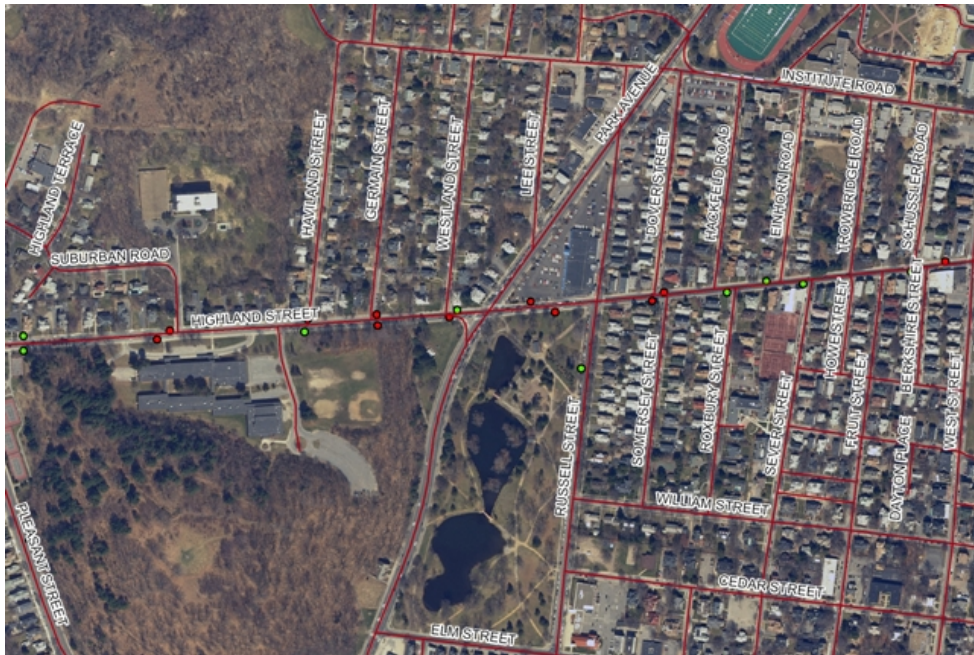
Figure 2 - Aerial view of Worcester, MA seen from PDA

Once the CMRPC received the PDA and GIS system they bought for use in this project. They brought us in to do a small half hour training session. We worked with Matthew Franz, who is the CMRPC GIS Analyst, and he assisted us in learning how the PDA operated. The software provided with the PDA is called *Arc Pad Mobile GIS* software. This software was used to give an aerial view of Worcester and most of the bus stops in the city. You can see from Figure 2 we were able to view streets and buildings clearly, and each bus stop was identified with a red or green dot.

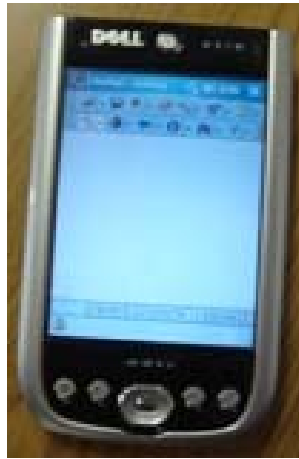
Figure 3 - PDA with GIS Software

In a meeting between representatives from the CMRPC, WRTA, and the DPW, it was agreed upon that a Tablet PC, that the City already had from a previous project, with GPS/GIS capabilities would be an optimal choice for our project. To be cost effective, it was agreed upon that in addition to the Tablet PC, a Personal Digital Assistant (PDA) (See figure 3) with GPS/GIS capabilities (See Figure 4) would also be purchased (See Appendix B for product matrix).

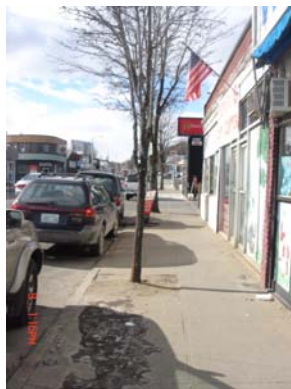
Figure 5 - Parking on street

Figure 5 is a prime example of what happens when there is only one or no signs indicating “No Parking.” This picture was taken directly under a bus stop sign and there was no room for a bus to pull over. Therefore when picking up passengers, the bus would block traffic and create an unsafe environment.

Prior to starting the project, our sponsors were very clear in communicating to us that many approved stops were missing signs. After collecting all the data it was shown that 4% of the stops inventoried were in fact unlabeled. As such, our first recommendation to the City of Worcester is to locate those stops without signs and replace them. This is inarguably one of the first things the City should concentrate on. After labeling all the stops the next step would be to put route numbers on the signs. This will make for a much more efficient transportation system if the riders know what routes go to which stop. The final recommendation for the inventory portion would be to add multiple “No Parking” signs to each stop. One sign does not seem to suffice in creating a wide enough lane for a bus to pull over. In numerous streets in Worcester there is no designated place for the bus to pull off if cars are parked in the way.

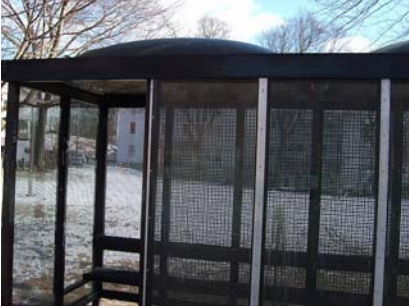
Shelter Condition	Figure
1) Hazardous – Broken glass or material, many cracks in structure, vandalized	
2) Poor – Cracks in structure, broken material	
3) Fair – Slight cracks, overall structure is good

<p data-bbox="943 835 1268 867">Figure 16 - Fair Shelter</p>
4) Good – Not new but in almost new condition, no cracks or broken parts

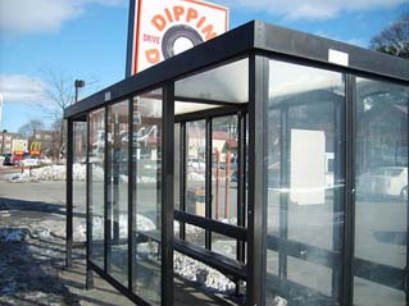
<p data-bbox="935 1213 1276 1245">Figure 17 - Good Shelter</p>
5) Excellent – New, perfect condition

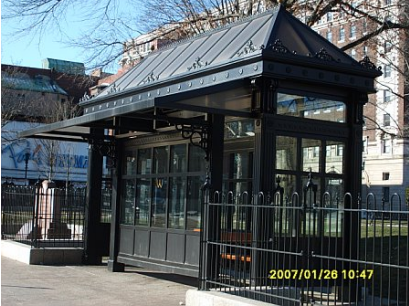
<p data-bbox="911 1591 1300 1623">Figure 18 - Excellent Shelter</p>

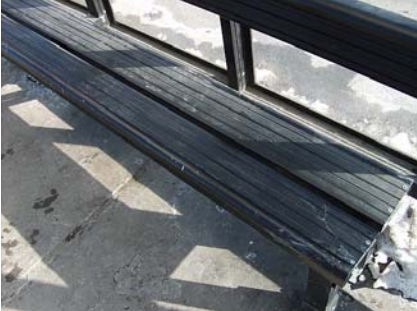
Bench Condition	Figure
1) Hazardous – Many breaks and cracks in material, vandalized	
2) Poor – Cracks in structure, broken material

<p data-bbox="943 726 1266 762">Figure 19 - Poor Bench</p>
3) Fair – Slight cracks, overall structure is good

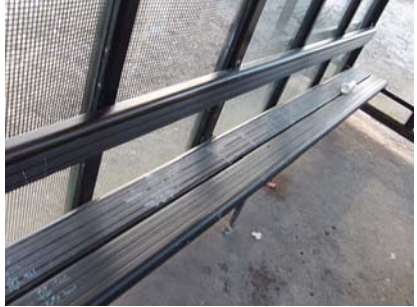
<p data-bbox="943 1106 1261 1142">Figure 20 - Fair Bench</p>
4) Good – No cracks, good structure

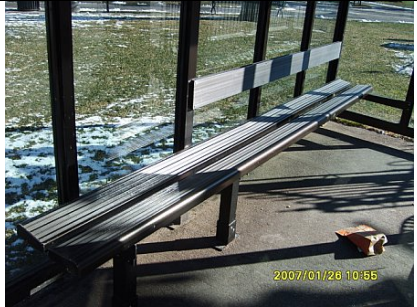
<p data-bbox="943 1484 1268 1520">Figure 21 - Good Bench</p>
5) Excellent – Clean, upkeep is good, no cracks

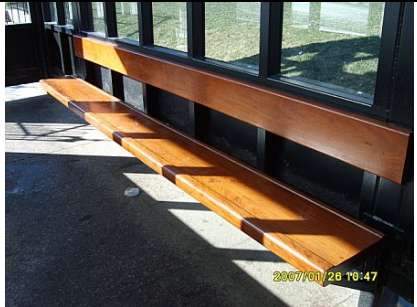
<p data-bbox="914 1862 1295 1898">Figure 22 - Excellent Bench</p>

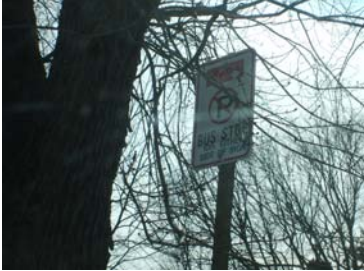
Degree of Vegetation	Figure
<p>1) Hazardous - Completely over grown, can not see the sign for the stop, covering the sidewalk, low hanging branches, branches in danger of hitting pedestrian or bus.</p>

<p>Figure 22 - Hazardous Vegetation</p>
<p>2) Poor - Slightly over grown, growth is starting to cover the pedestrian waiting area, some low hanging branches on trees, potential of obstruction to stop if not trimmed.</p>

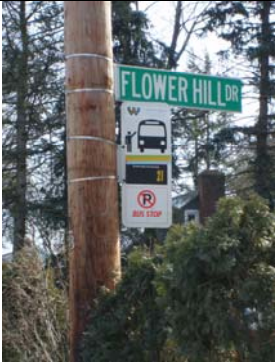
<p>Figure 23 - Poor Vegetation</p>
<p>3) Fair – Light vegetation, is not covering or blocking anything, but without maintenance in the future could be hazardous.</p>

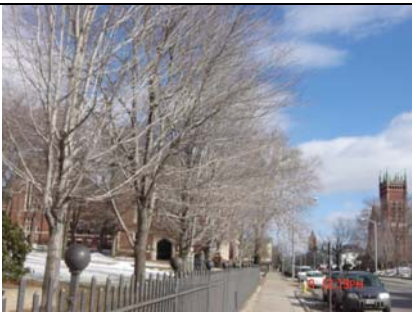
<p>Figure 24 - Fair Vegetation</p>
<p>4) Good - The vegetation is not covering or over hanging at all on the sidewalk, sign is clearly visible. It will not affect pedestrians, the bus stop sign or the bus.</p>

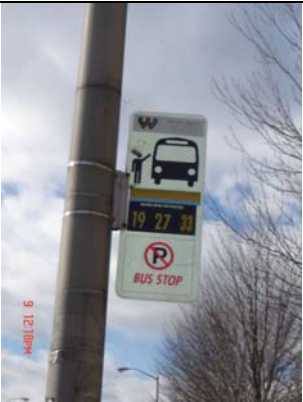
<p>Figure 25 - Good Vegetation</p>

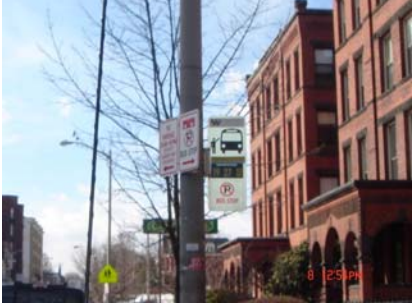
<p>Figure 26 - Excellent Vegetation</p>

Degree of Vegetation	Figure
<p>5) Excellent - There is no risk that if/when the vegetation is not maintained that it will cause a potential problem for the stop.</p>
