Renovation of Alumni Gymnasium

A Major Qualifying Project

Worcester Polytechnic Institute

29 April 2014

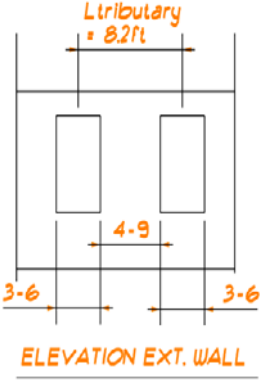
13.00	Check Flexure at Piers

<p style="text-align: center;">ELEVATION EXT. WALL</p>					
Shear per ft of wall		=	95738/87.4		
			1095	lbs/ft	
Shear to Pier		=	1095*8.2		
		=	8979	lbs	
Shear Stress in Pier					
fv		=	8979/(4.75*12*29)		
		=	5.4	lbs/in ²	
Moment Distribution by I (stiffness fraction)					
% to each Pier		=	$(L \text{ Pier}^3)/(\Sigma(L \text{ Pier}^3))$		
L Pier ³		=	318.6		
L Pier ³		=	1157.6		
L Pier ³		=	166.4		
L Pier ³		=	107.2		
L Pier ³		=	107.2		
L Pier ³		=	107.2		
L Pier ³		=	166.4		
L Pier ³		=	1157.6		
L Pier ³		=	318.6		
$\Sigma(L \text{ Pier}^3)$		=	3606.7

% to 4-9 Pier	=	$(4.75^3)/(3606.7)$		
		=	0.030		
	M to 4-9 pier	=	$.03*2908914.6$		
		=	87267.4	ft-lbs	
	S of 4-9 pier	=	$29*((4.75*12)^2)/6$		
			15703.5	in ³	
	fb	=	$87267.4*12/15703.5$		
		=	66.7	lbs/in ²	T or C
	% to 10-6 Pier	=	$(10.5^3)/(3606.7)$		
		=	0.32		
	M to 10-6 pier	=	$.32*2908914.6$		
		=	930,852.7	ft-lbs	
	S of 10-6 pier	=	$29*((10.5*12)^2)/6$		
			76734	in ³	
	fb	=	$930852.7*12/76734$		
		=	145.6	lbs/in ²	T or C
	Add Gravity Load to 4-9 pier				
	Brick Unit wt for 12" wall	=	120	lb/ft ³	
	Brick Wall wt	=	$1.75*120*49*8.2$		
		=	84378	lbs	
	fc	=	$84378/(4.75*12*29)$		
		=	51.0	lb/in ²	C

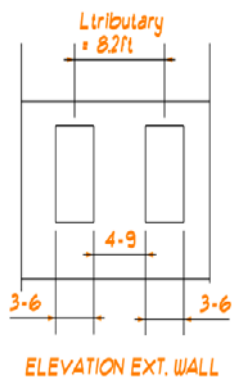
Check Flexure at Piers

Shear per ft of wall	=	182680/87.4	
		2090	lbs/ft
Shear to Pier	=	2090*8.2	
	=	17138	lbs
Shear Stress in Pier			
f_v	=	17138/(4.75*12*29)	
	=	10.4	lbs/in ²
Moment Distribution by I (stiffness fraction)			
% to each Pier	=	$(L \text{ Pier}^3)/(\Sigma(L \text{ Pier}^3))$	
L Pier ³	=	318.6	
L Pier ³	=	1157.6	
L Pier ³	=	166.4	
L Pier ³	=	107.2	
L Pier ³	=	107.2	
L Pier ³	=	107.2	
L Pier ³	=	166.4	
L Pier ³	=	1157.6	
L Pier ³	=	318.6	
$\Sigma(L \text{ Pier}^3)$	=	3606.7
