Conflict Resolution of Urban River Restoration, Kikuhama

**Urban River Restoration in Kikuhama:
Memory, Community and Landscape Change of the Takase River**

An Interactive Qualifying Project submitted to
the faculty of Worcester Polytechnic Institute in partial fulfillment of
the requirements for the Degree of Bachelor of Science

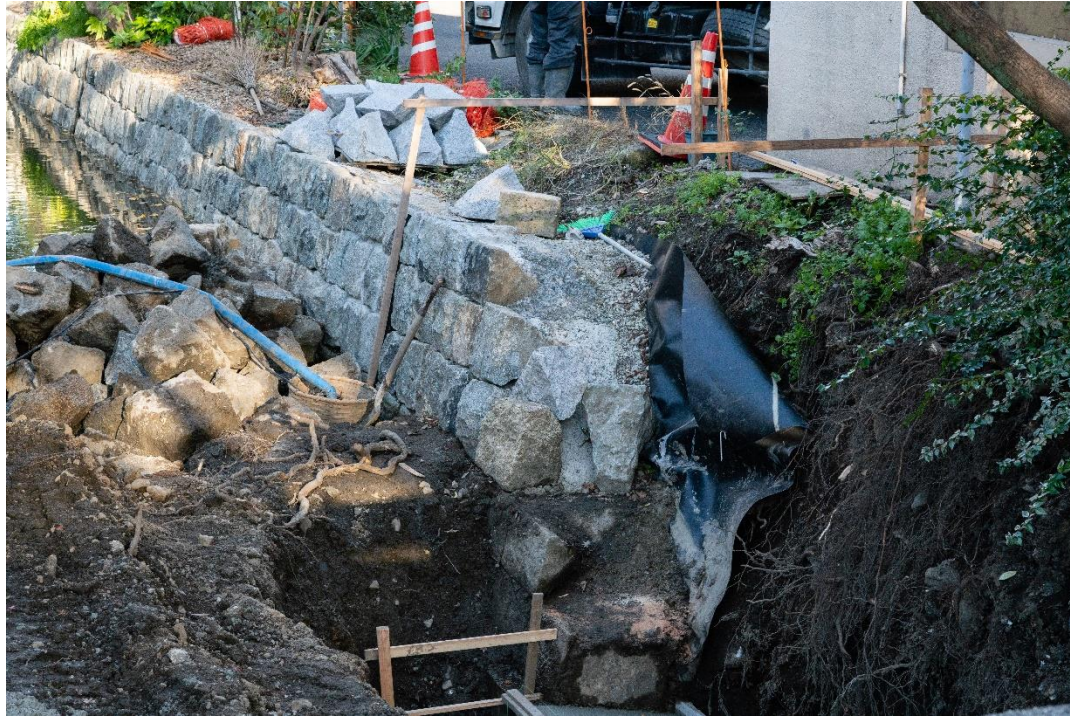
Figure 4: Waterproof sheets being placed behind rocks

It has been known that the canal leaks water through the rocks since the original construction finished. After 300 years of use, age and damage to the canal bed have worsened these leaks. In 2010, a local Kyoto project aimed at repairing such leaks by relaying stones over a series of waterproof sheets. Work on the canal began in 2010 and around 1.8 km of the canal was finished by 2020 (Murakami, 2022). The rest of the canal was not restored due to budget limitations, but in 2022 a foundation led by an heir of Nintendo founder Fusajiro Yamauchi committed to donating 530 million yen - roughly 3.7 million dollars - to finish the repairs (Murakami, 2022).

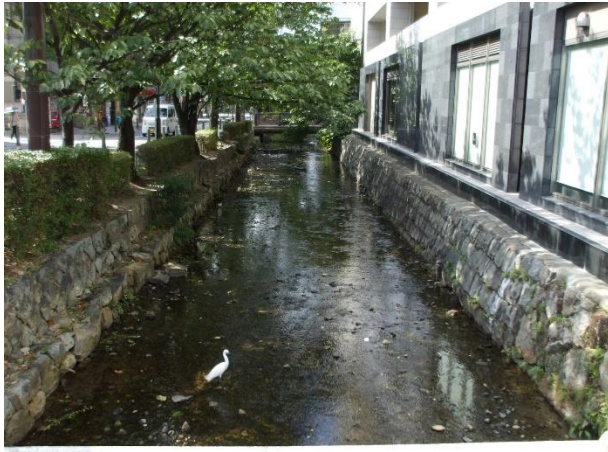
Figure 5: Oike-dori before repairs

Work on the canal that began in 2010 was halted during the Covid-19 pandemic in 2020 (Murakami, 2022). Below you can see a section of the canal, in the downstream area of Oike-dori, before and after the restoration.

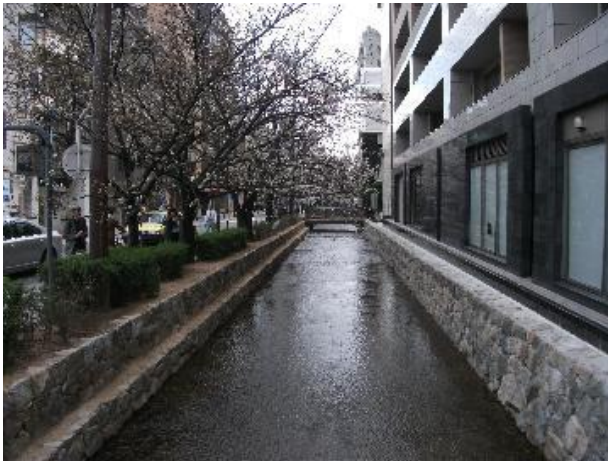
Figure 6: Oike-dori after repairs

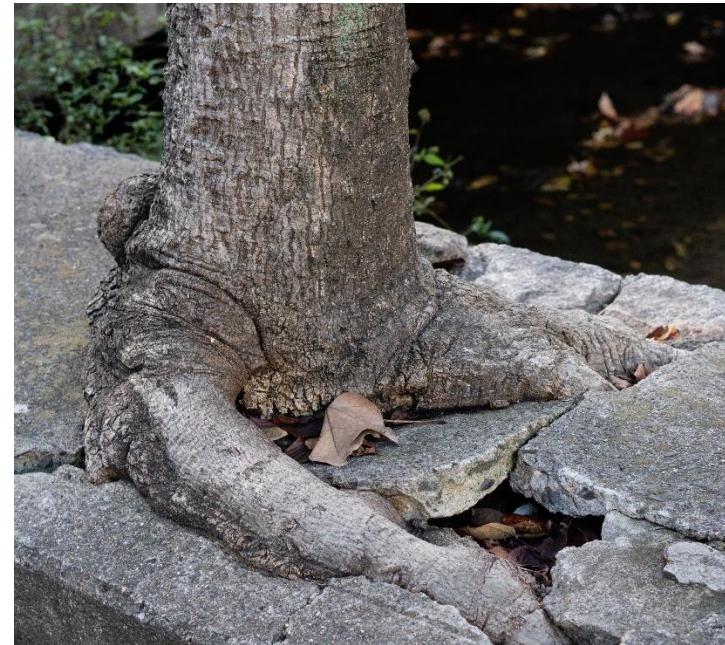
Figure 9: Example of root damage to the canal

vehicular traffic. The dense soil compaction alongside the impermeable surfaces creates the perfect environment for shallow and destructive root growth (Lucke & Beecham, 2019).

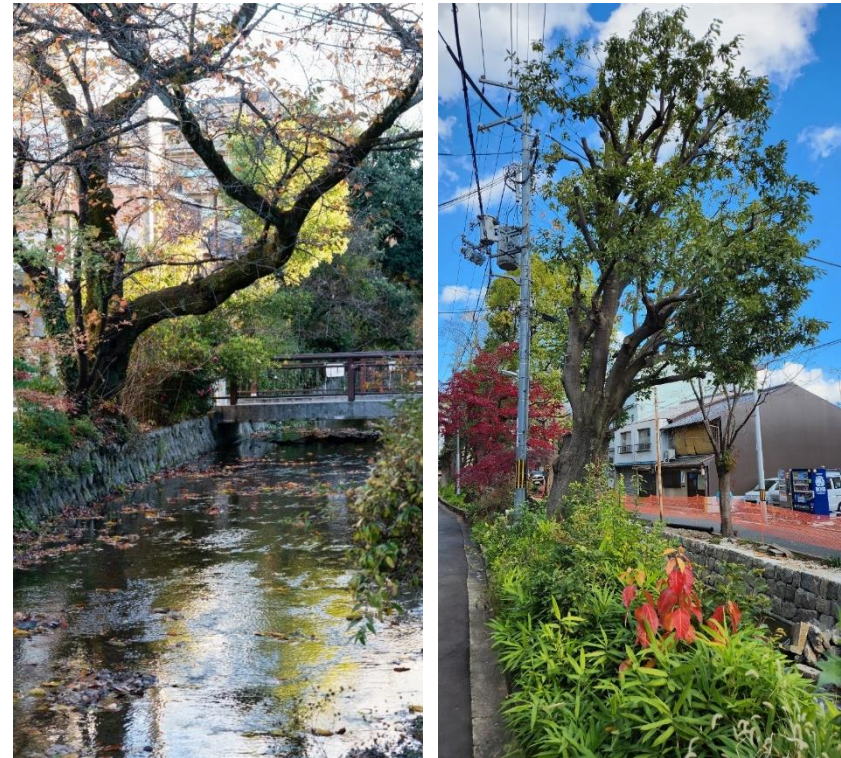
Figure 13: Example of a Fixable Tree (Left) & a Non-Fixable Tree (Right)

were to be stabilized, the tree itself would still be hazardous as the majority of its mass would not be vertically above its base. This uneven force will still classify the tree to be a danger to the environment around it which would classify it as “non-fixable”. See figure 13 below for examples of fixable and non-fixable trees.

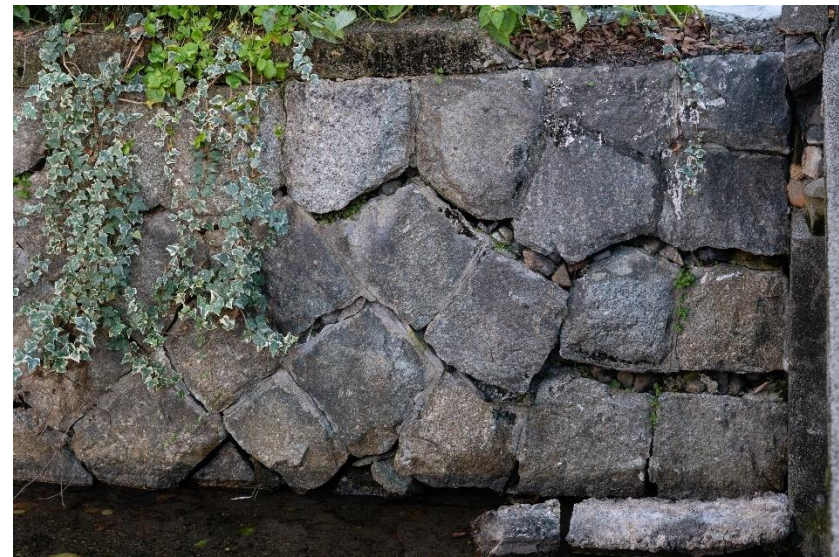
Figure 14: Example of Crack Damage

These types of damages were used to identify areas of the canal where trees may need to be removed for repair. Trees that cause significant root damage will need to be taken out for the repairs to occur. Areas with foliage damage will need to be completely cleared of said foliage to be repaired. Locations with excessive cracking and erosion damage will likely result in the removal of some trees, along that section of the canal wall, for repair.

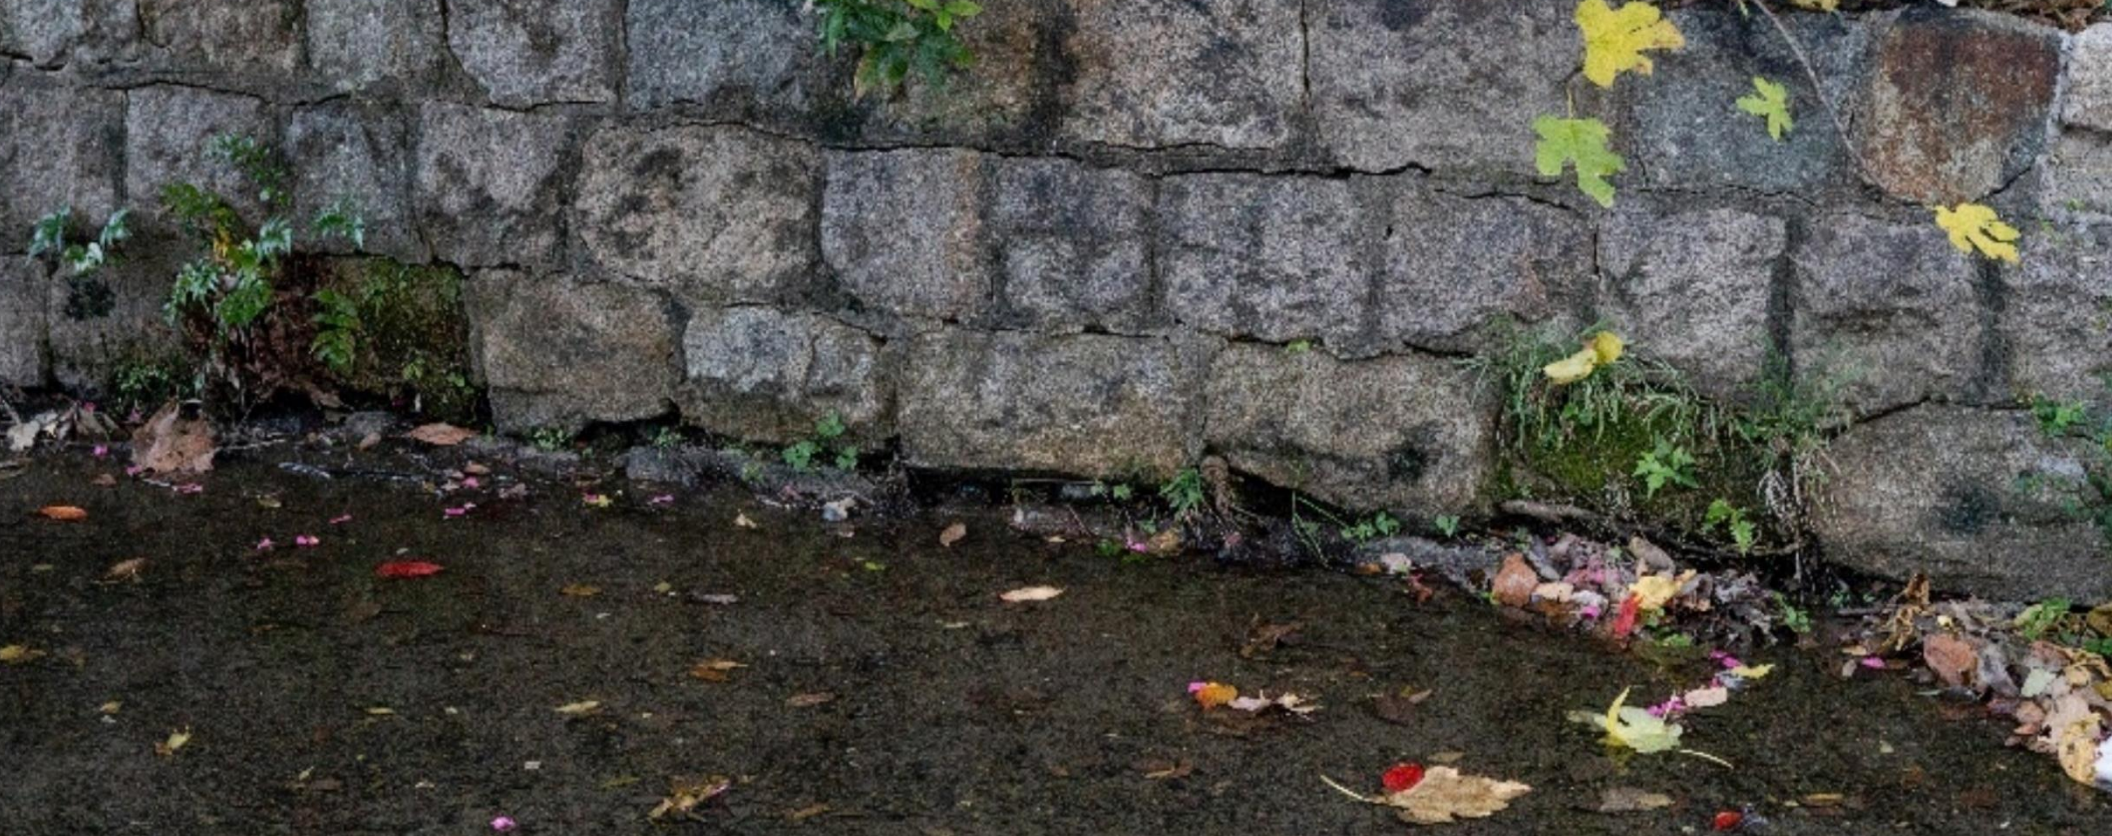
Figure 15: Example of Erosion Damage

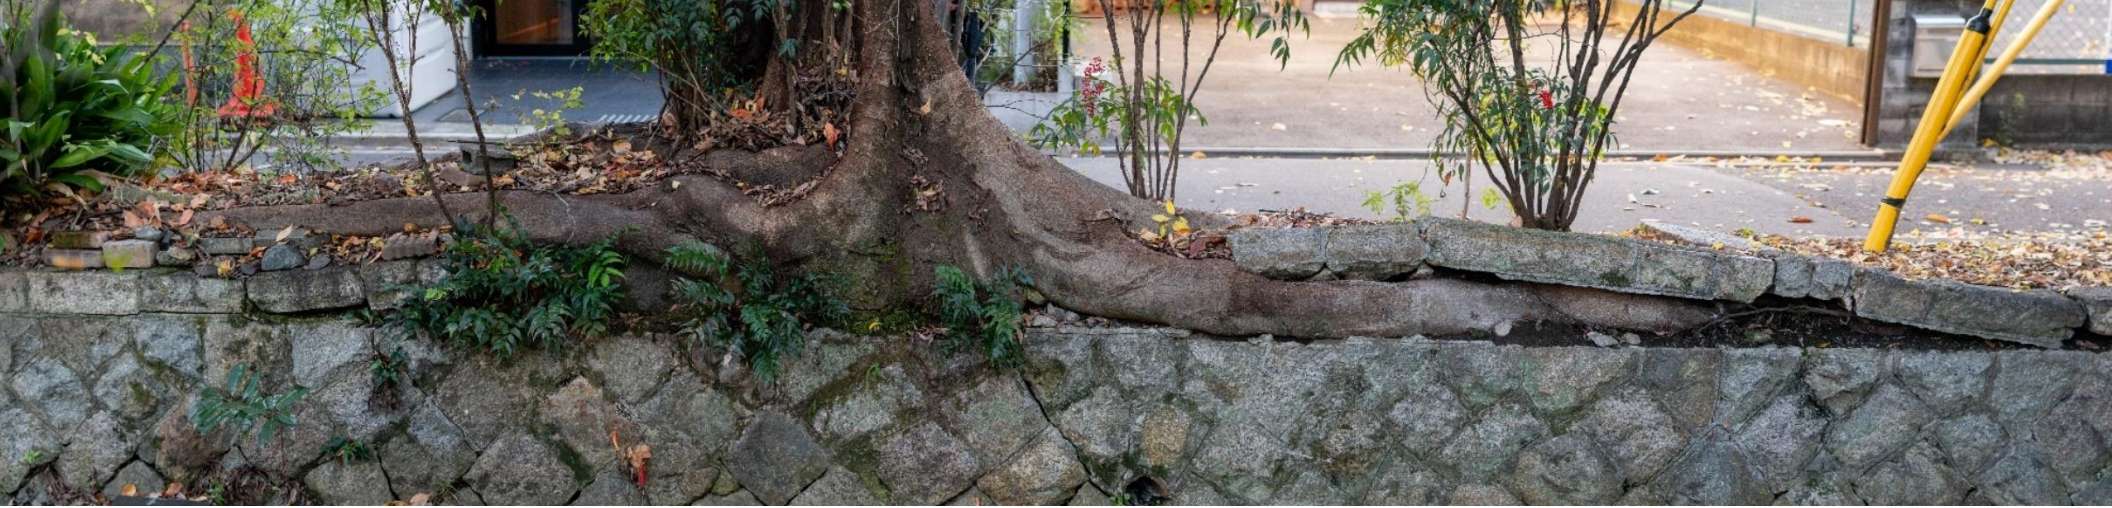
Figure 17: Example of Root Damage

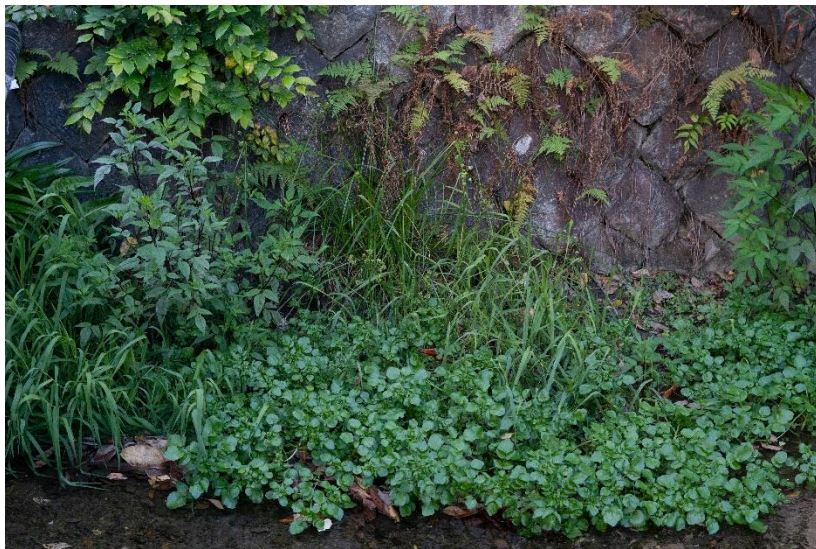
Figure 18: Example of Foliage Damage

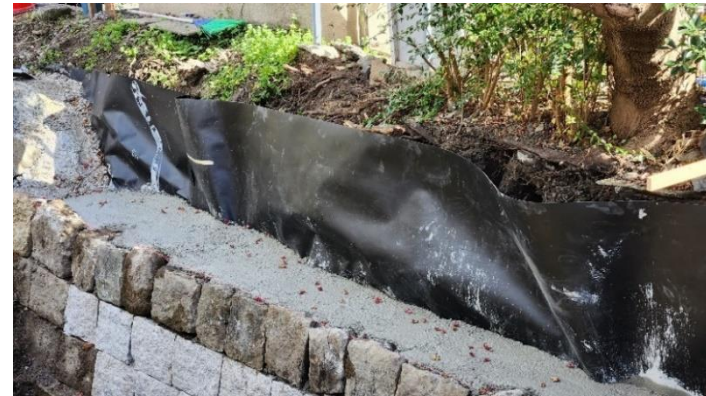
Figure 22: Face Rock Repair Without the Removal of Vegetation

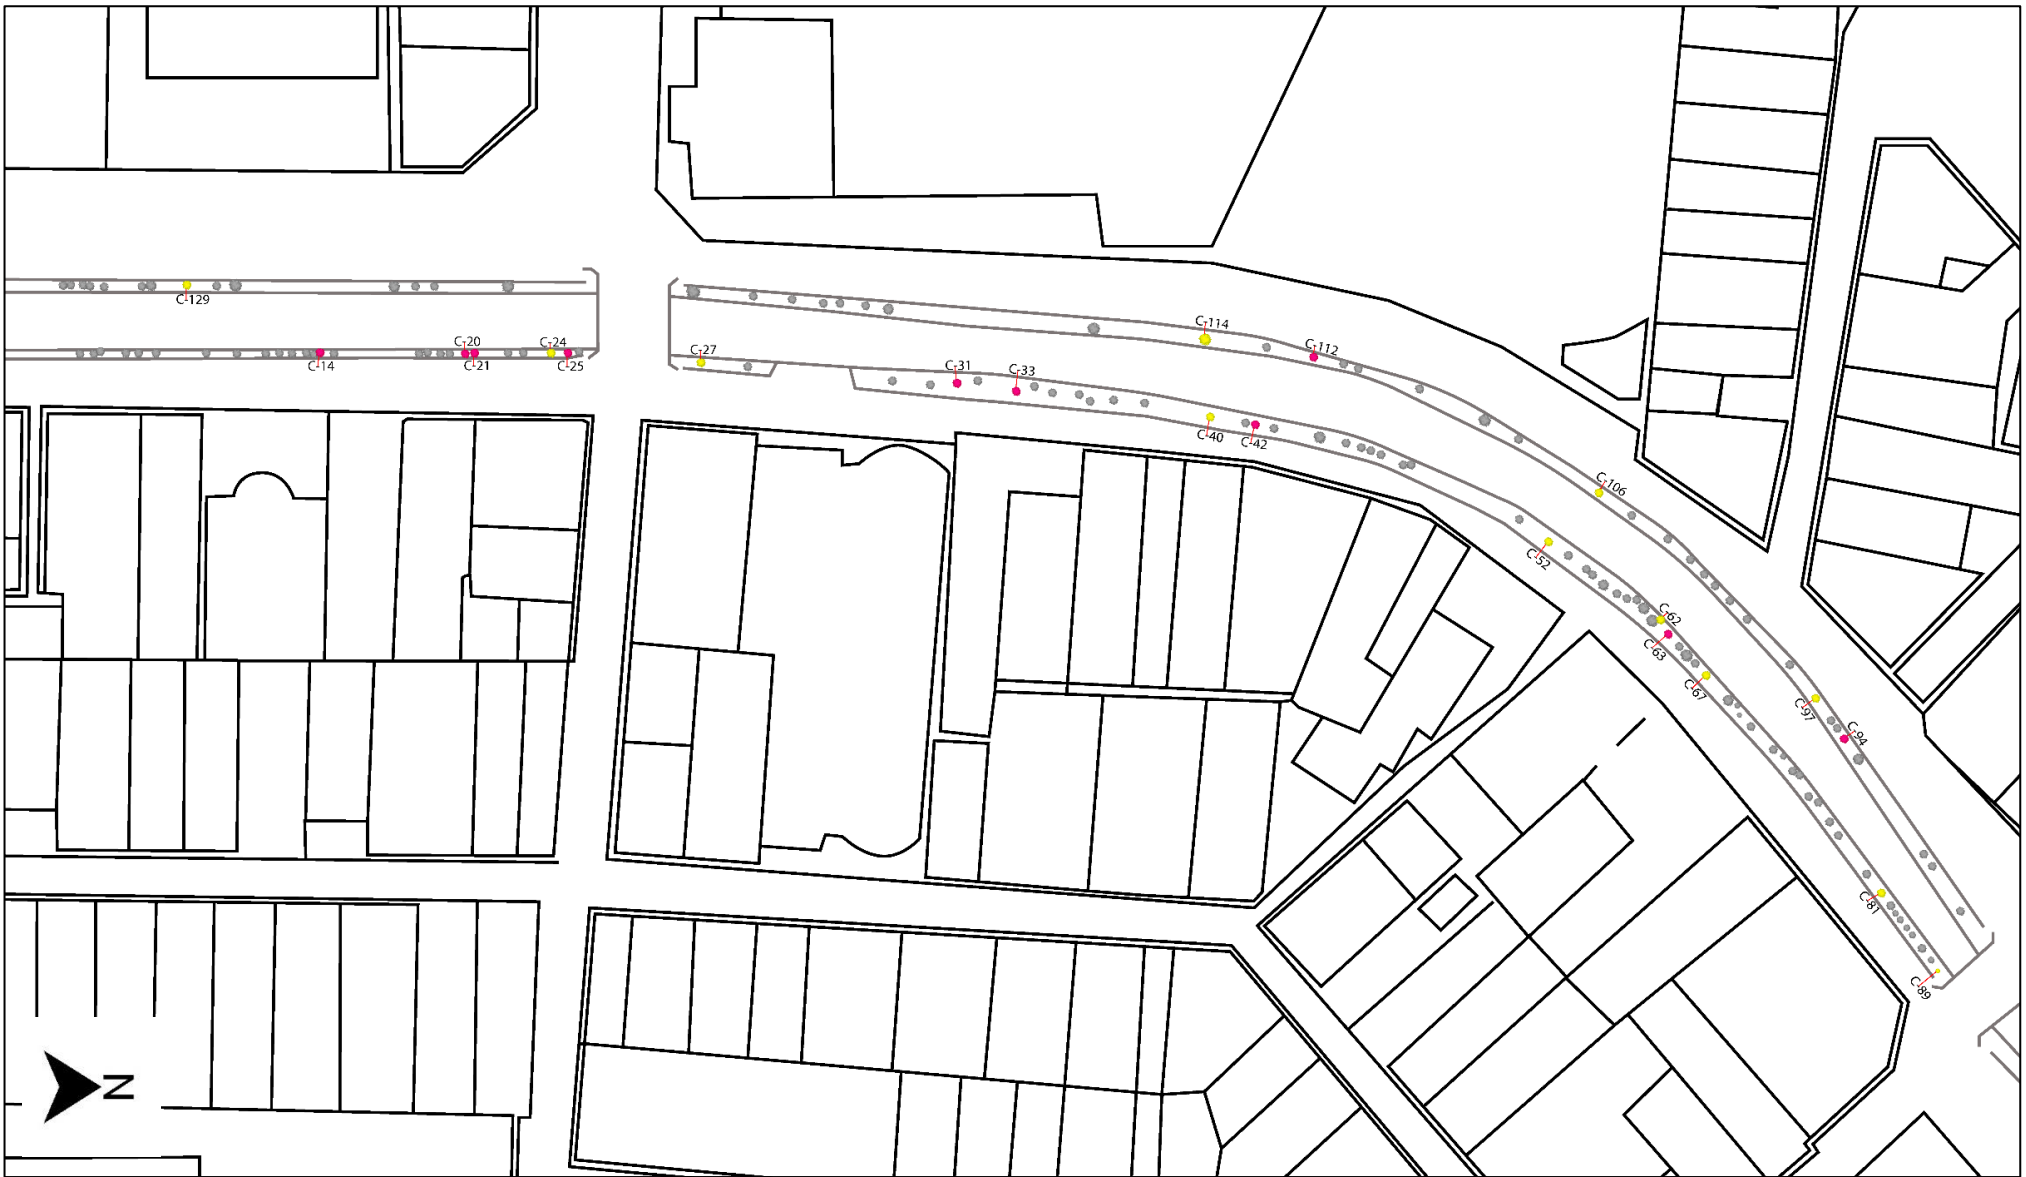
Figure 43: Remaining Trees Section C

We then used this data to create a map of how the local vegetation would look like if all the non-marked trees were to be cut (figure 41-43). In this map, trees that would be theoretically saved are colored green and the trees that would be cut are colored gray. Again, if this were to happen, it would mean that only 25.6% of the plants would remain. See maps below. Section D is not included due to the restoration already being seen in this area.

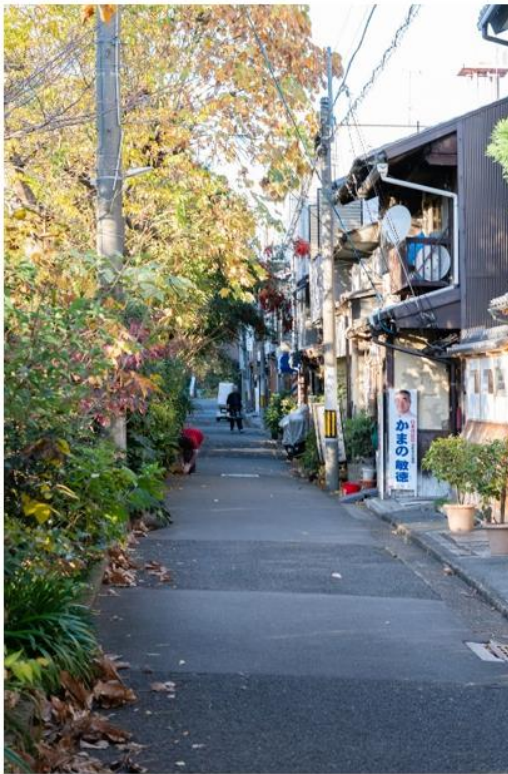
Trees Touching Power Lines

The majority of the trees analyzed intersect the power lines, posing an extreme electrical risk during storms and high winds (“TREES AND POWER LINES,” n.d.). Many other trees have other hazardous elements, some of the trees are in contact with houses or have cavities in the trunk. These cavities remove from the stability of the tree, meaning that they are more likely to fall over in the presence of strong winds or other natural disasters. See figure 51 for example.

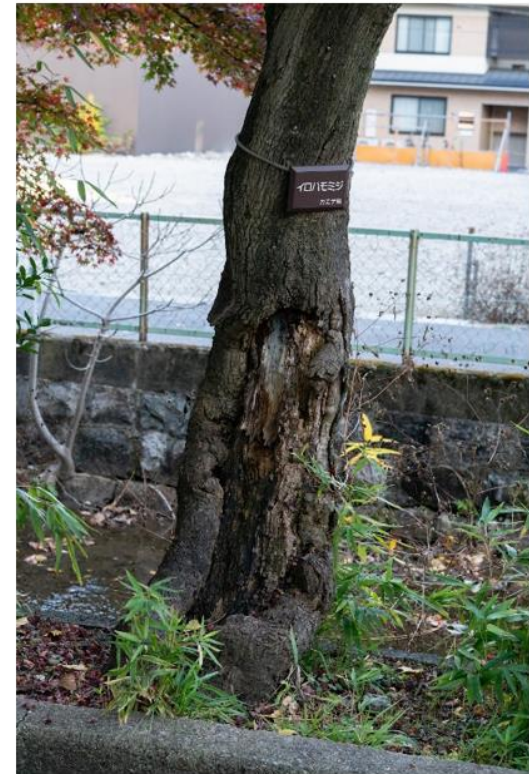
Tree with a Cavity in The Trunk

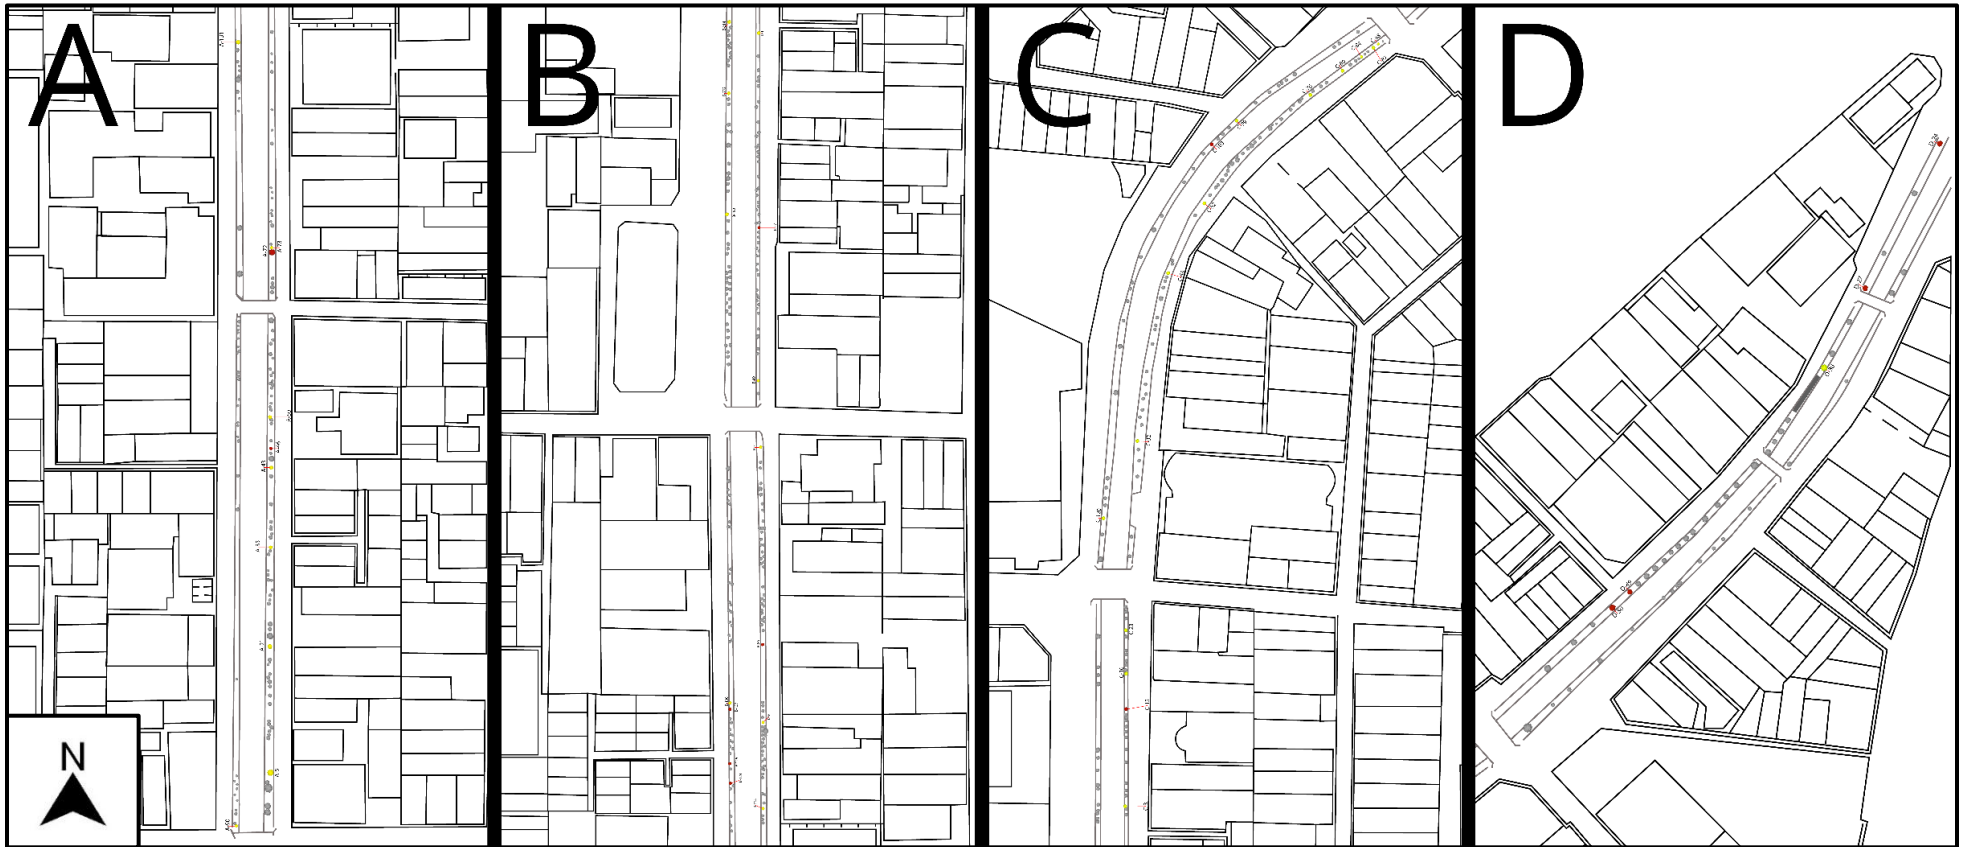
Figure 52: Tree Risk Assessment Map Section A-D

This data was then plotted on a map of the canal. The trees that are placed as risky are colored either yellow or red, in accordance with the same spreadsheet mentioned above, table 7. The trees that did not receive the risk assessment are in greyscale. See figure 52 below for the map, a more detailed version of each map is available in the *appendix L*.

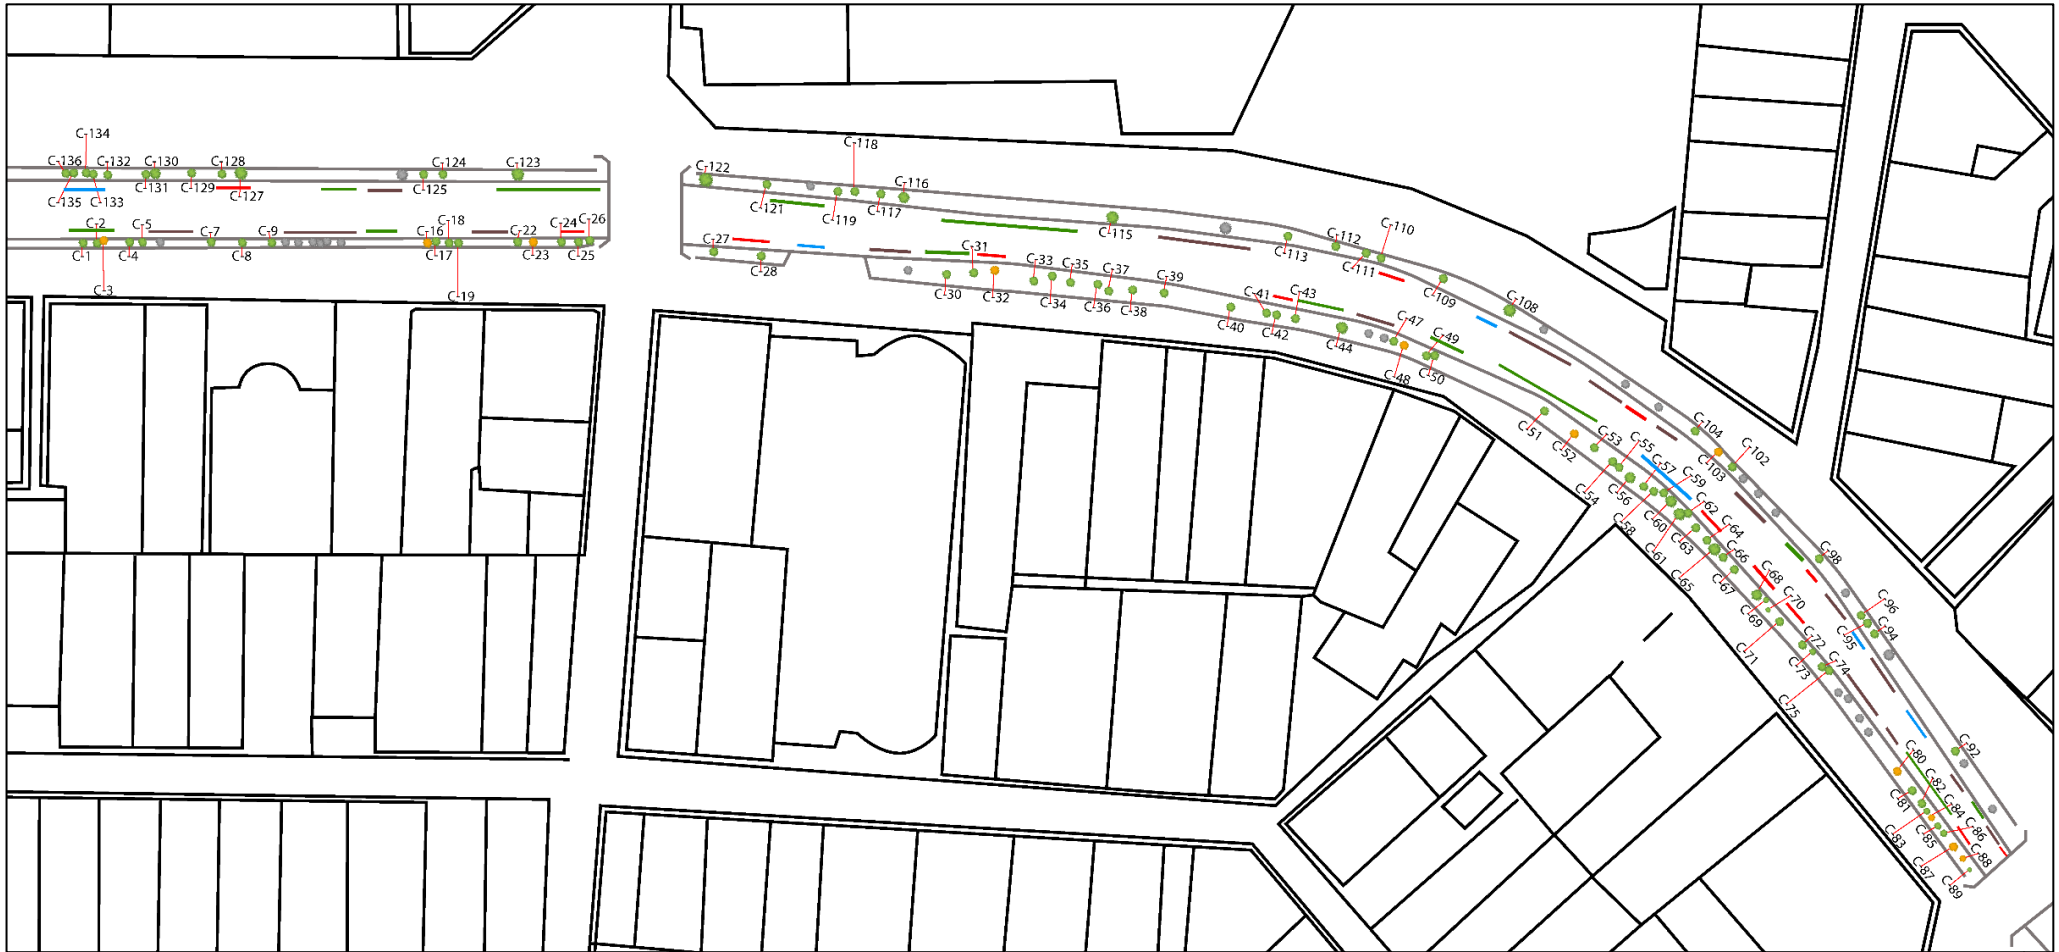
Figure 69: Recommended Trees to Save on Section C
