MANAGEMENT OF THE RÍO GUAYNABO CONSERVATION EASEMENT

April 28, 2008

Management Plan
For the
Río Guaynabo Conservation Easement
Guaynabo, Puerto Rico

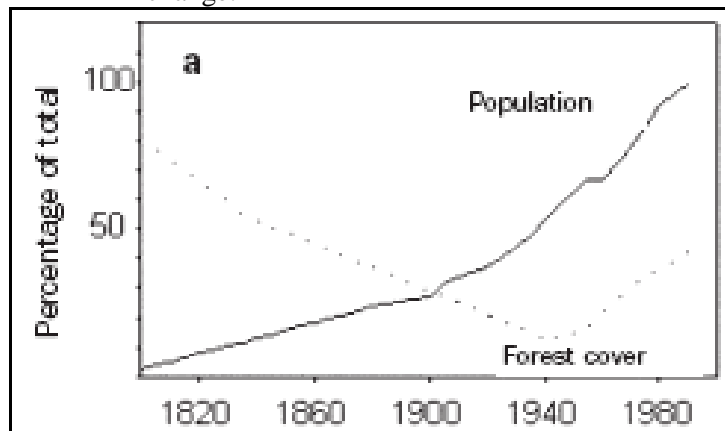
Figure 2: Puerto Rico's population growth and forest cover change.

According to Houghton (2003) deforestation causes over use of land, and therefore, causes a reduction in the earth's capacity to support human populations. This "over use of land" is caused by forests which are cut down and then allowed to re-grow repeatedly resulting in inferior second generation forests, soil erosion, and declining soil fertility. Deforestation in the tropics is caused by the need of lumber, fuel wood, and cropland (Copper and Griffiths, 1994). The need for these resources is caused by population growth. Puerto Rico's population density is already 1,100 people per square mile and its population has been steadily increasing since the 1800's as shown in Figure 2.
