# **A Survey of Macrophytes at Indian Lake and Little Indian Lake in Worcester, Massachusetts**

An Interactive Qualifying Project Report:

Sponsored by the Indian Lake Watershed Association and  
submitted on: March 1, 2016

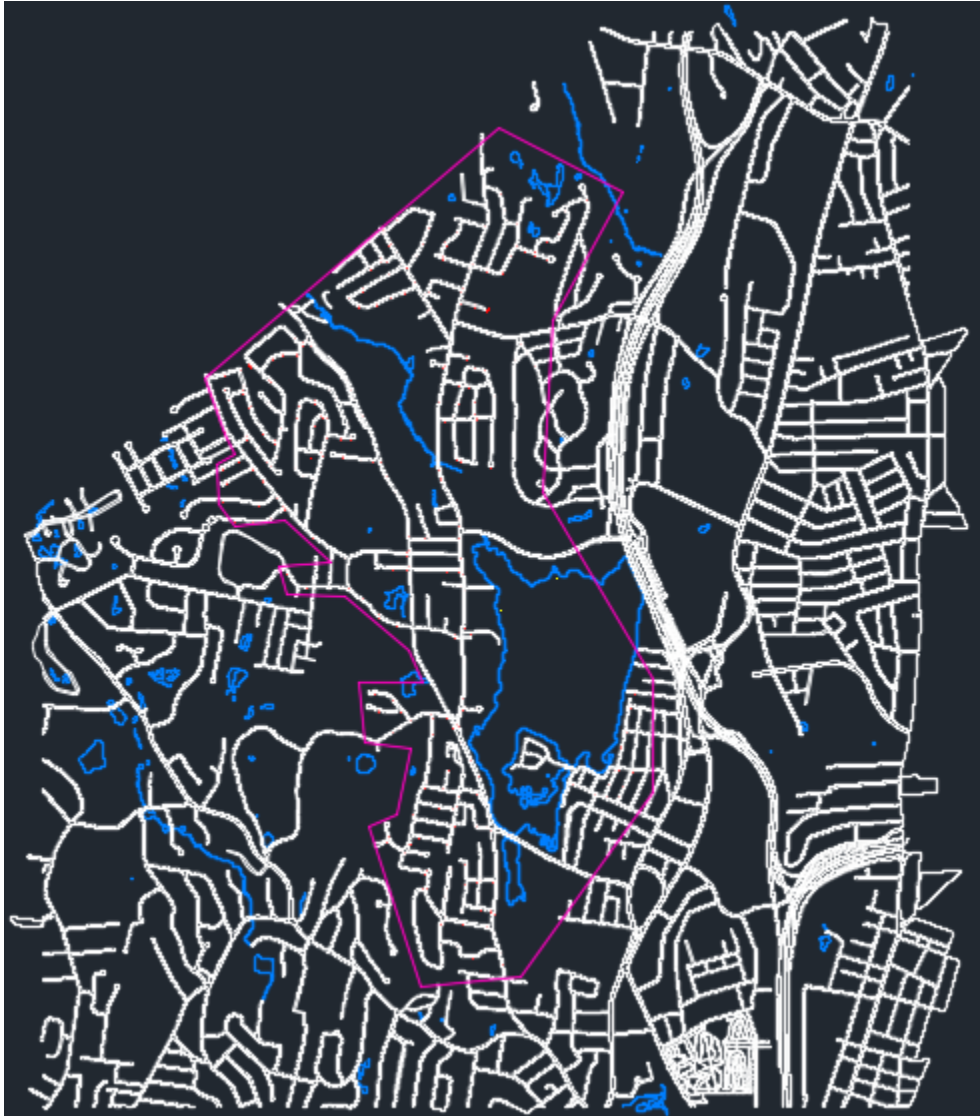
Figure 11 Indian Lake Watershed (Center) modeled in Civil 3d LTTM with respect to road systems

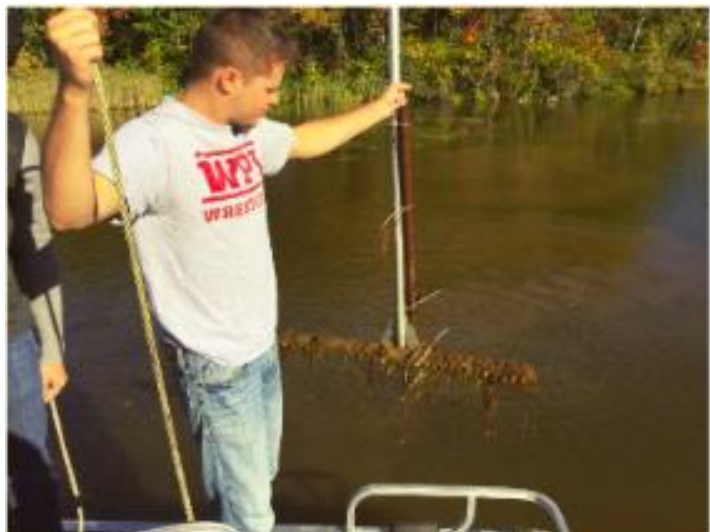
Figure 14 Picture of Rake after Dredging

we had to determine the amount and type of plants found. In order to determine the density of the amount of plants found, we divided the collection into five separate categories shown below, as developed by the U.S. Army Corps of Engineers. Sequential numbers starting at 0 were also assigned to their respective notation in order to average the density among collected points. High density yielded a higher number.

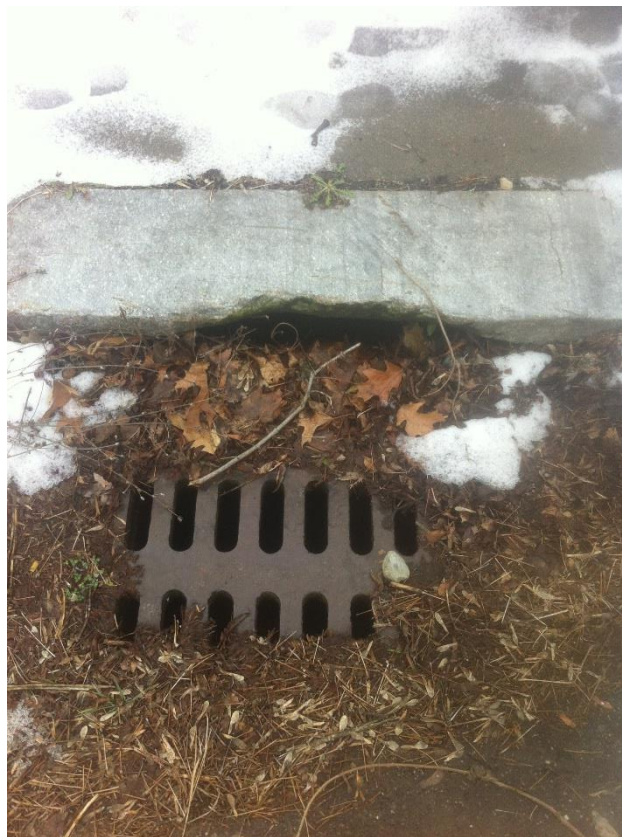
Figure 16 Storm drain with no Stenciling

Each storm drain was a different size, had different surroundings, and were in different conditions which forced us to assess each storm. If it was determined that stenciling was needed, we would check if the stencil fit on the stone easily. If the stencil fit, we used the white spray paint to stencil the drain. If the stencil would not fit directly, we would paint each word at different times so that we could adjust the stencil. The City of Worcester also provided stickers for us to put on the stone if we could not stencil the storm drain due to the size.

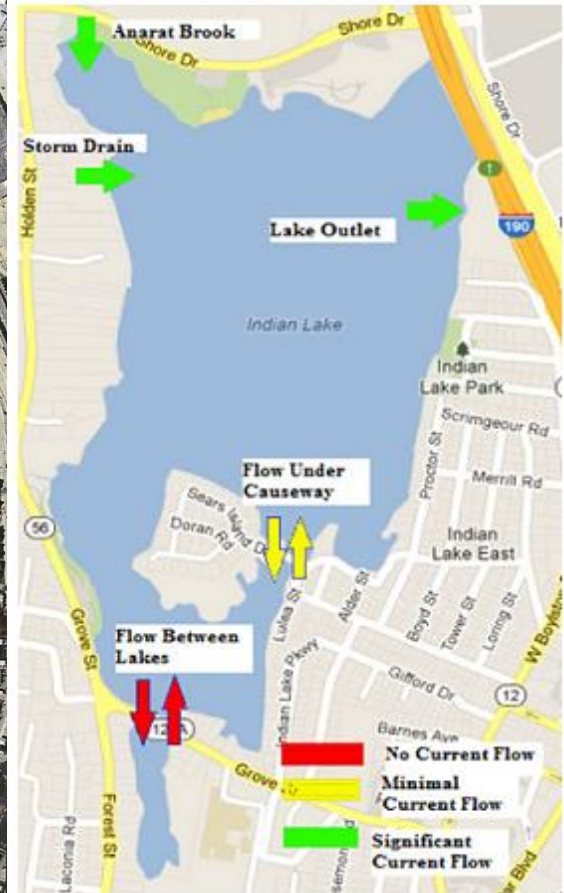
Figure 32 Map of Inflows at Indian Lake

Figure 32 shows the 4 main water inlets into Indian lake labelled from top to bottom in chronological order. We experienced the strongest current around stations 1 and 2 and little to no current at 3 and 4. There was a strong correlation between the presence of a strong current and depth of water. This correlation is affirmed by comparing topographical map created in

Revit LT™ and figure 32. We experienced heavily reduced flow in the area of the causeway.” We also noted that inhabitants of the area reported the pipe underneath the causeway as blocked or not functional thus preventing water circulation.

Furthermore, our observations of increased growth and reduced current we experienced during our survey time at the southern bank can be explained through these finding as the inlets at stations 2, 3 and, 4, (Figure 32) have speeds under the velocity boundary condition stipulated by Madsen. These effects also explain the overgrowth of thick vegetation beds in Little Indian Lake due to the Lake's extremely slow current velocity. This information

provides that a potential solution towards the growth of submerged macrophytes is to increase the current. One possible way this could be done is to increase the current velocity by improving the flow under the causeway mentioned in figure 32. It has been noted by the ILWA that this pipe is not well designed and fails to perform its function of increasing water circulation by being too elevated.
