Evaluating the Role of Stormwater Treatment Basins in Controlling Highway Runoff Quality

A Major Qualifying Project Report

Worcester Polytechnic Institute

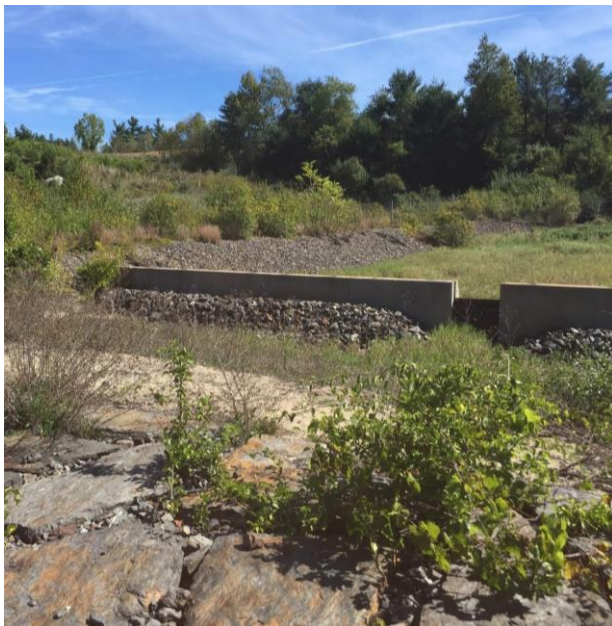
FIGURE 4: ACCESSIBLE BASIN

The first criterion was to have a basin with feasible entry to allow for the completion of sampling. Daniel Crocker and other members of the DCR visited all potential basin sites at the commencement of the project to determine their accessibility. Later, our team visited the basins that were not clearly ruled out as inaccessible along with members of the DCR to evaluate their conditions. Many basins had not been maintained in several years, therefore, the locks were stuck or the basins were too overgrown to drive or walk through. Figure 4 demonstrates a basin with adequate access, while Figure 5 demonstrates an inaccessible basin. Basins with inadequate access were eliminated from consideration and the remaining basins moved on to be evaluated according to the next characteristic.

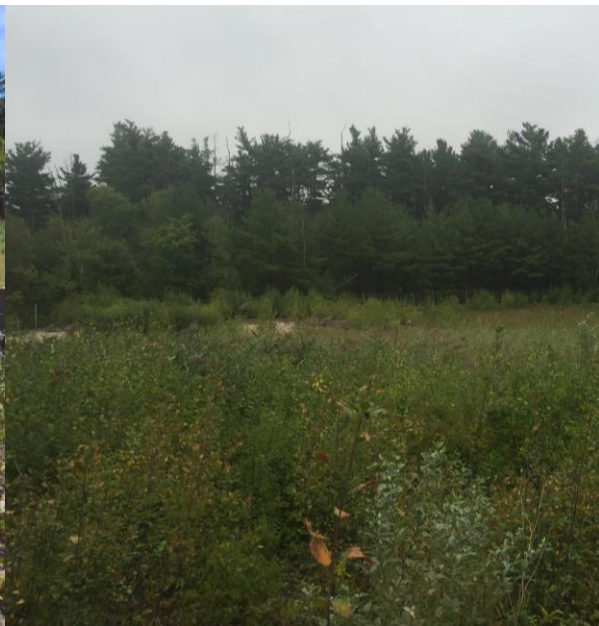
FIGURE 5: INACCESSIBLE BASIN

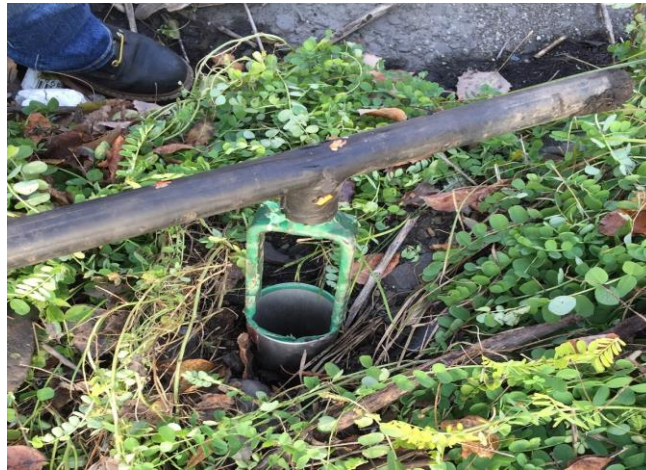
FIGURE 8: CORING DEVICE IN SOIL

Supplies	Procedure
<ul style="list-style-type: none">• Stainless steel shovel• Coring device• 250-mL Plastic sample bottles (one per sampling location)• Piece of notebook paper	<ol style="list-style-type: none">1. Remove topsoil with shovel2. Use coring device to dig deeper into the soil as seen in Figure 83. Pull coring device out of ground4. Pour soil in the bottom of the coring device onto the piece of paper5. Funnel the soil into the sample bottle6. Take measurements of the depth of the soil samples

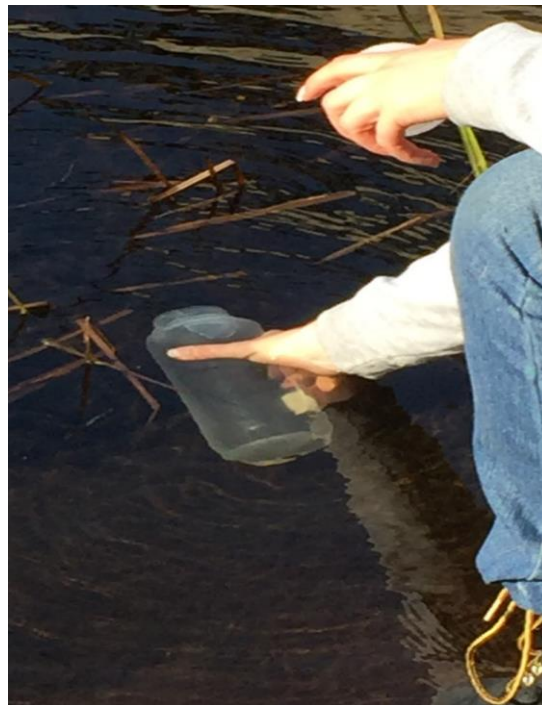
FIGURE 9: SUBMERGED SAMPLE BOTTLE

Supplies	Procedure
<ul style="list-style-type: none">• 1-L Plastic sample bottle (one per sampling location)• 250-mL Plastic sample bottle (2 per sampling location)• Thermometer• Cooler	<ol style="list-style-type: none">1. Rinse out sample bottle with river water three times2. Completely submerge sample bottle in the river until the bottle is completely full, as seen in Figure 93. Measure temperature of river with thermometer4. Bring sample bottles back to lab for analysis in a cooler

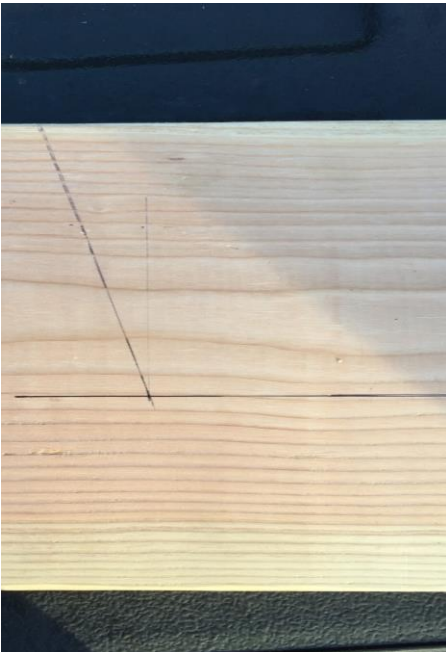
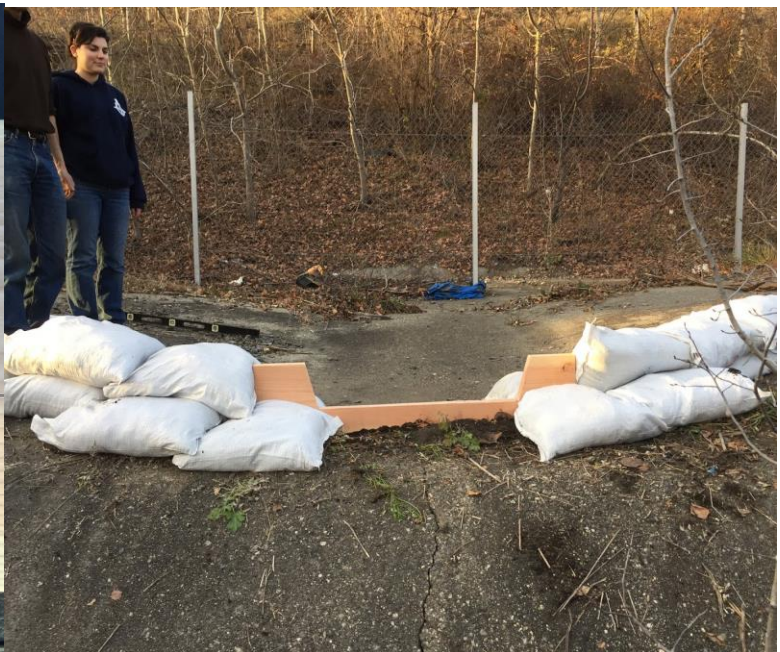
FIGURE 10: WEIR OUTLINE

Supplies	Procedure
<ul style="list-style-type: none">● Piece of wood● Measuring tape● Pencil or pen● Circular saw● Rafter square● Level● Sandbags	<ol style="list-style-type: none">1. Measure the length and height of the piece of wood2. With the use of the <i>Discharge of Standard Cipolletti Weirs in ft³/s</i> table found on the United States Bureau of Reclamation website, determine the amount of head needed to support the rate of discharge3. Use a measuring tape, rafting square, and pencil to draw the required dimensions on the board, as seen in Figure 104. Use a circular saw to cut out the drawn dimensions5. Place sandbags, filled with soil from the project basin, in a format that supports the weir and builds a wall to trap runoff as shown in Figure 11

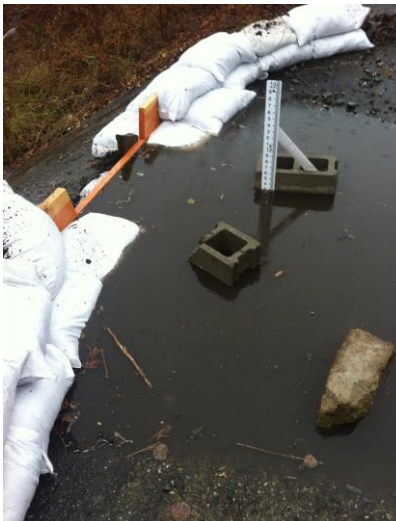
FIGURE 12: STORM RUNOFF POOL

Supplies	Procedure
<ul style="list-style-type: none">● 1-L Plastic sample bottles● 250-mL Plastic sample bottles● Water gauge● Staff gauge● Rain gage● Weir● Thermometer● Cooler	<ol style="list-style-type: none">1. During storm collect runoff that has pooled near the weir as shown in Figure 122. Rinse bottles 3 times with water3. Submerge bottle underwater to fill4. Take a 1L sample and two 250 mL samples5. Document the level of water in the rain gauge6. Measure height of the runoff with staff gauge7. Measure the temperature of the runoff with a thermometer8. Bring samples back to lab in cooler

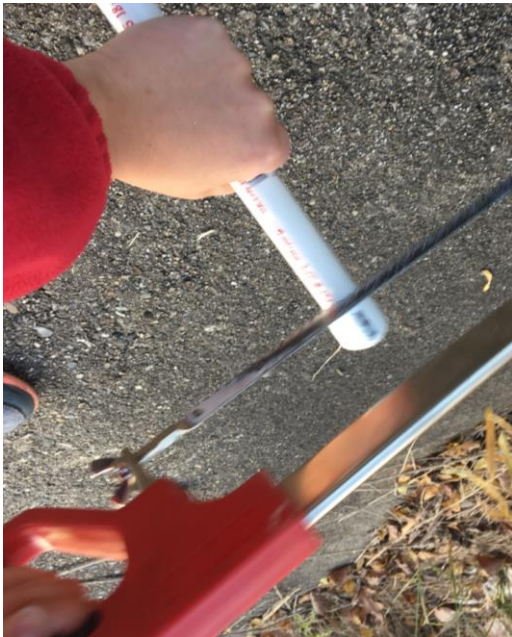
FIGURE 13: CUTTING PIEZOMETER SLITS

Supplies	Procedure
<ul style="list-style-type: none"> ● Stainless steel shovel ● Coring device ● Measuring tape ● PVC pipes ● PVC pipe caps ● Handsaw ● 1 Metal poll piezometer 	<ol style="list-style-type: none"> 1. Cut 3 ft. section of pipe 2. Saw 1 in slits in the bottom 6 in of the pipe as seen in Figure 13 3. Insert a cap into both ends 4. Remove topsoil with shovel 5. Use coring device to dig deeper 6. Measure depth of the hole and record location 7. Place piezometers in the hole 8. Collect small stones and place them around piezometer to prevent clogging 9. Fill in and back hole with removed soil as shown in Figure 14

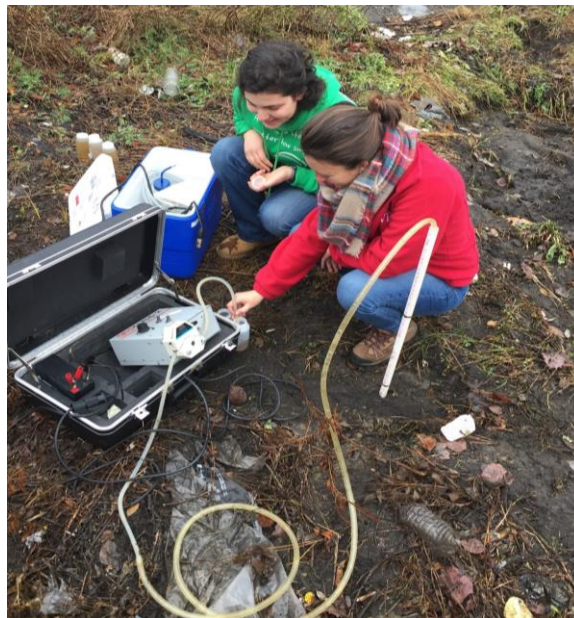
FIGURE 15: COLLECTION OF GROUNDWATER SAMPLES WITH GEOPUMP

Supplies	Procedure
<ul style="list-style-type: none">● GeoPump 2 made by Geotech Environmental Equipment Inc.● 4' Plastic tubing● 250-mL Plastic sample bottles (3 per location)● Cooler	<ol style="list-style-type: none">1. Insert or attach plastic tubing to piezometer2. Hook GeoPump 2 up to the tubing3. Connect the pump to a battery and turn on4. Take three flushes of groundwater and discard5. Take three samples using 250-mL sample bottles as seen in Figures 156. Unhook pump and leave piezometer7. Bring samples back to lab in cooler

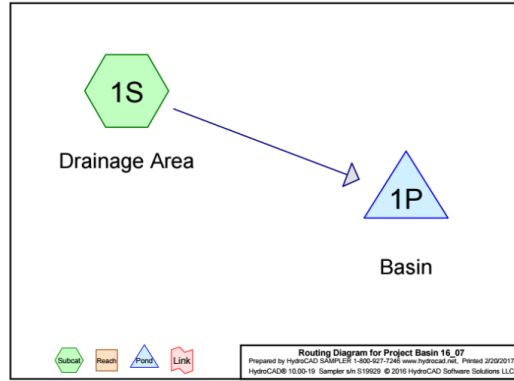
HydroCAD® was used to model the hydrology of the project drainage area and basin. Using HydroCAD® allowed our team to create hydrographs for the entirety of the storm events and theoretical storms, not just for the samples we had collected. To model the hydrology of the project drainage area and basin a series of 2 nodes was used. A subcatchment node (1S) was used for the drainage area and a pond node (1P) was used for the project basin as seen in the final diagram in Figure 16.

FIGURE 16: PROJECT BASIN ROUTING DIAGRAM

The parameters used in node 1S were the area, curve numbers (CN) and time of concentration (Tc). To determine the area, the drainage area was divided up by land use with soil type using ArcGIS and the acreage for each was recorded in the table as seen in Figure 17. The CN is a parameter representing the direct runoff and infiltration of an area. To find the CN value associated with each land section the "Lookup CN feature" on HydroCAD© was used as seen in Figure 17. The final weighted CN used was 88. To determine the Tc, the sheet flow, shallow concentrated flow, pipe channel, and parabolic channel methods were used. The sheet flow was used for the plane grass surface. The shallow concentrated method was used instead of sheet flow for the grassed waterway ditch because its flow length exceeded 300ft and it is assumed that at over 300ft sheet flow becomes shallow concentrated flow (United States Department of Agriculture, 1986). The pipe flow method was used for the concrete pipe and the parabolic channel method was used for the concrete ditch. ArcGIS elevations and distances were used in hand calculations to determine slopes. The final Tc used was 22.9 minutes. This Tc generally agreed with what we observed while in the field for when the storm started and when we began to see the runoff flow into the basin.

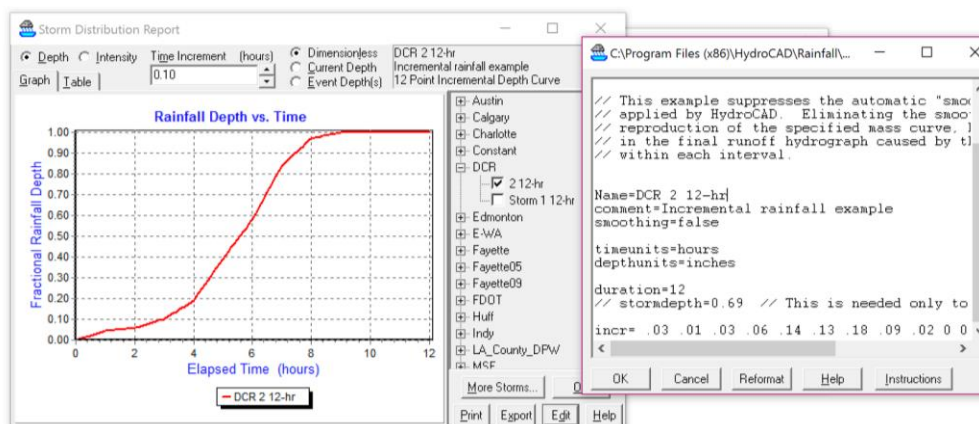
In order to create hydrographs for our specific storms we had to input the storm data into the HydroCAD® rainfall directory using the edit function as seen in Figure 18. The duration of storm was 12 hours and the total rainfall was used as the depth for both storms. The antecedent moisture condition (AMC) is the moisture level in the ground immediately prior to the storm according to the HydroCAD® Stormwater Modeling System Version 10 Owner's Manual. The AMC used was 2, which denotes normal soil as it is used in most design work (HydroCAD®, 2011).

FIGURE 18: INPUTTING STORMS

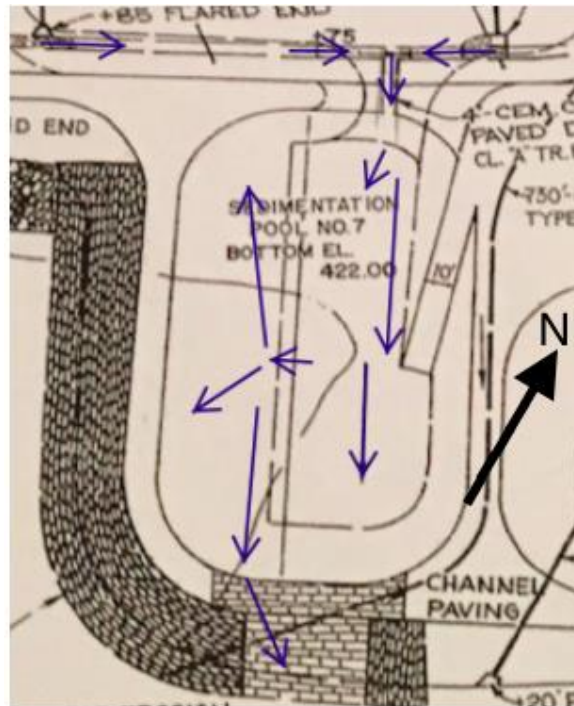
Sedimentation pools were built in the 1970s to collect sediment runoff during the construction of I-190. The basins were modified into stormwater treatment basins after construction was finished to protect the Wachusett Reservoir from pollutants and hazardous spills on the roadway. There are two ways by which water exits I-190. One option is through catch basins, which capture and transport the runoff via pipes to a concrete ditch. The other option is water running off of the road, down the embankment to a concrete ditch. Basin 16:07 utilizes both of these options. Once the water flows along the concrete ditch, it enters the concrete inlet of the basin. The inlet ditch funnels the water and deposits it into Chamber 1 of the basin, as seen in Figure 22.

FIGURE 22: OVERVIEW OF BASIN

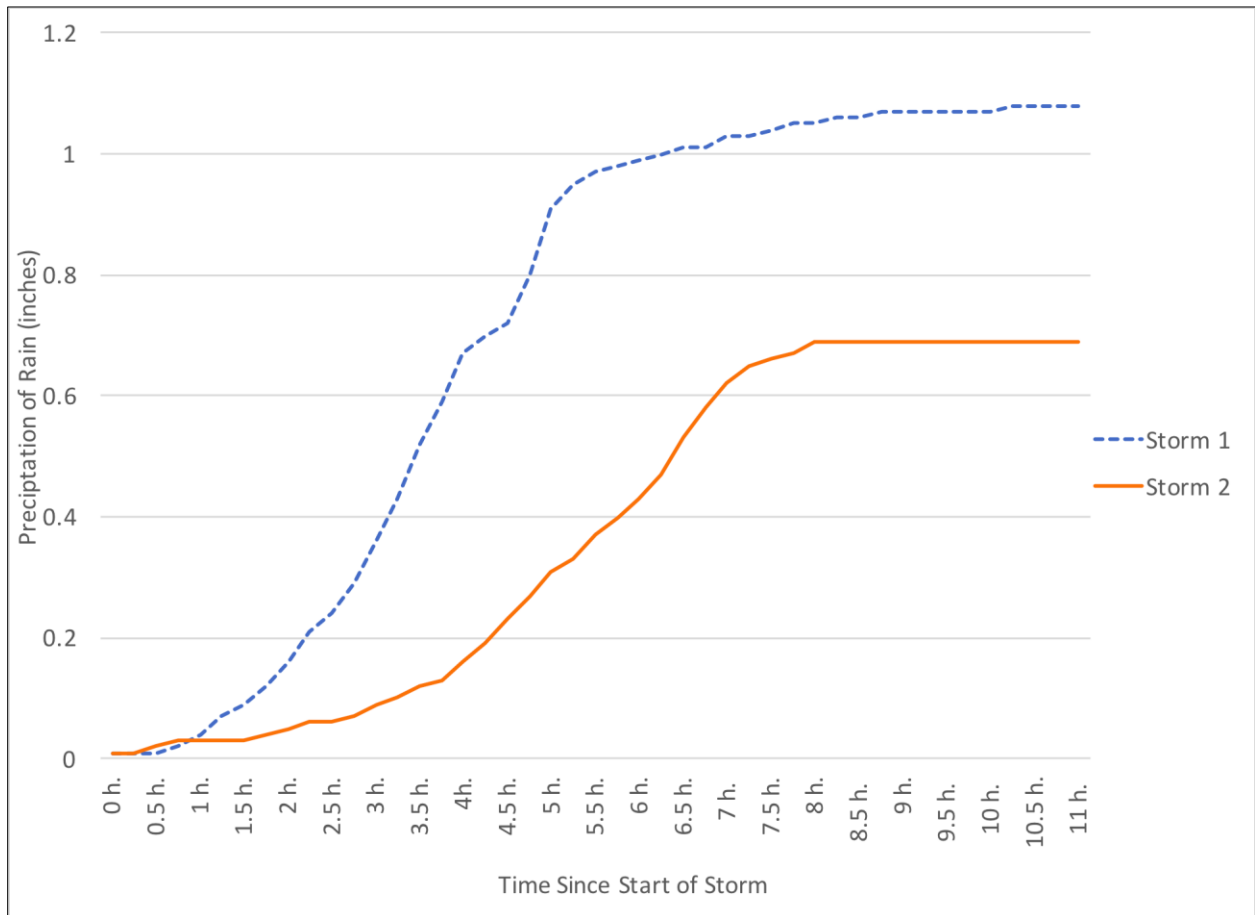
The hyetographs shown in Figure 26, shows a comparison of the rainfall between Storm 1 and Storm 2 over time.

FIGURE 26: CUMULATIVE PRECIPITATION OF STORM 1 AND STORM 2

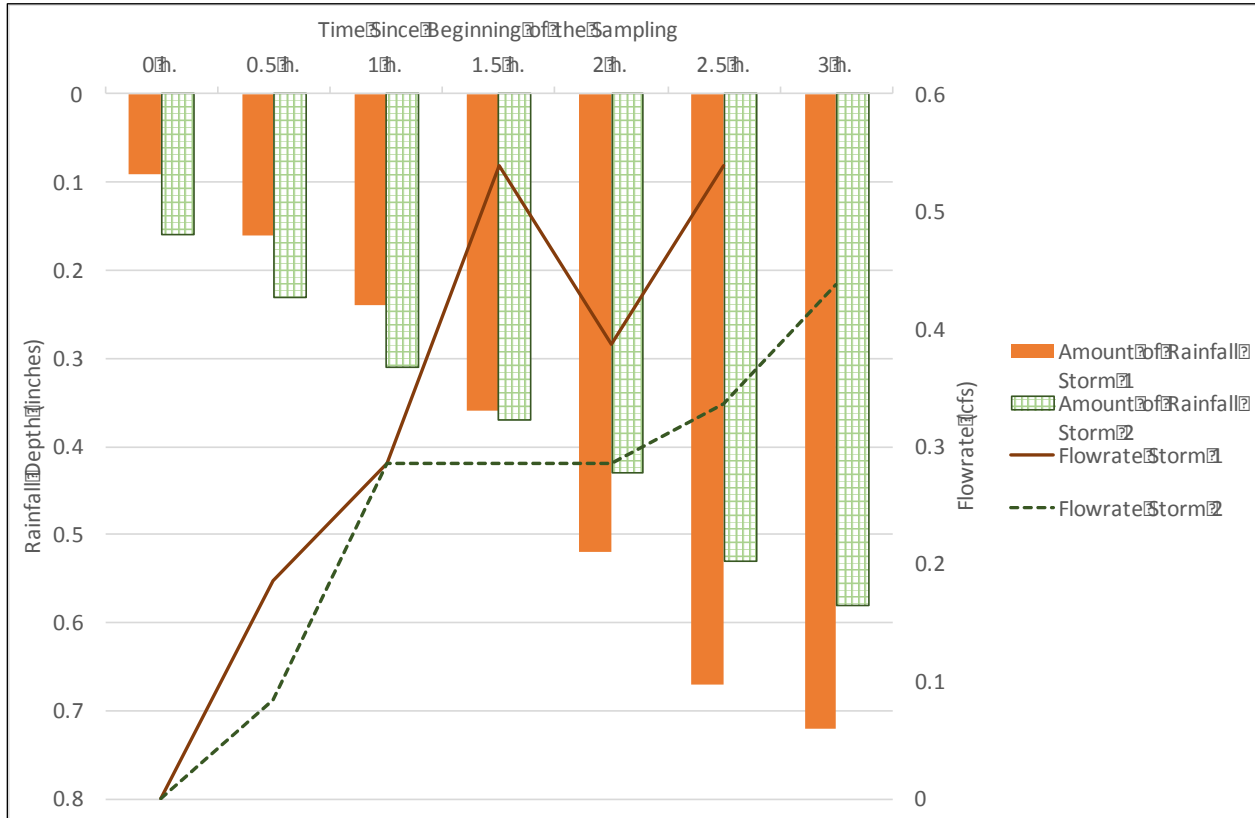
The flow rates mathematically calculated for Storm 1 and Storm 2 can be found in Figure 27 versus rainfall depth.

FIGURE 27: FLOWRATE AND RAINFALL FOR STORM 1 AND STORM 2 DURING SAMPLING PERIOD

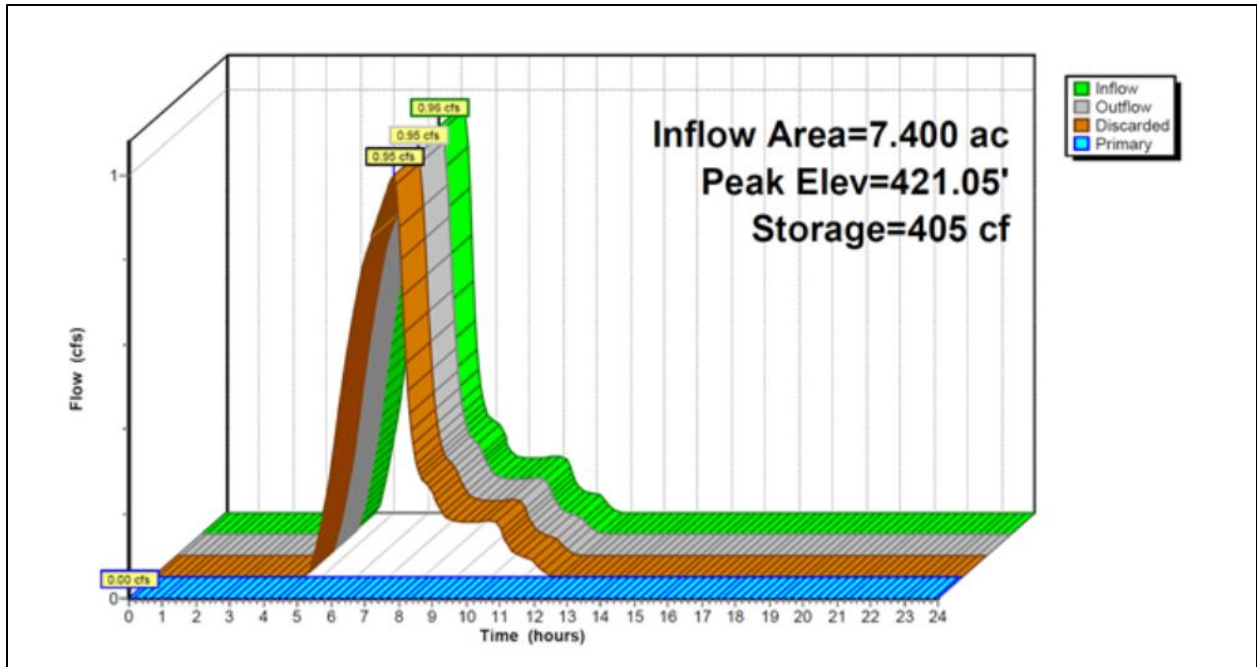
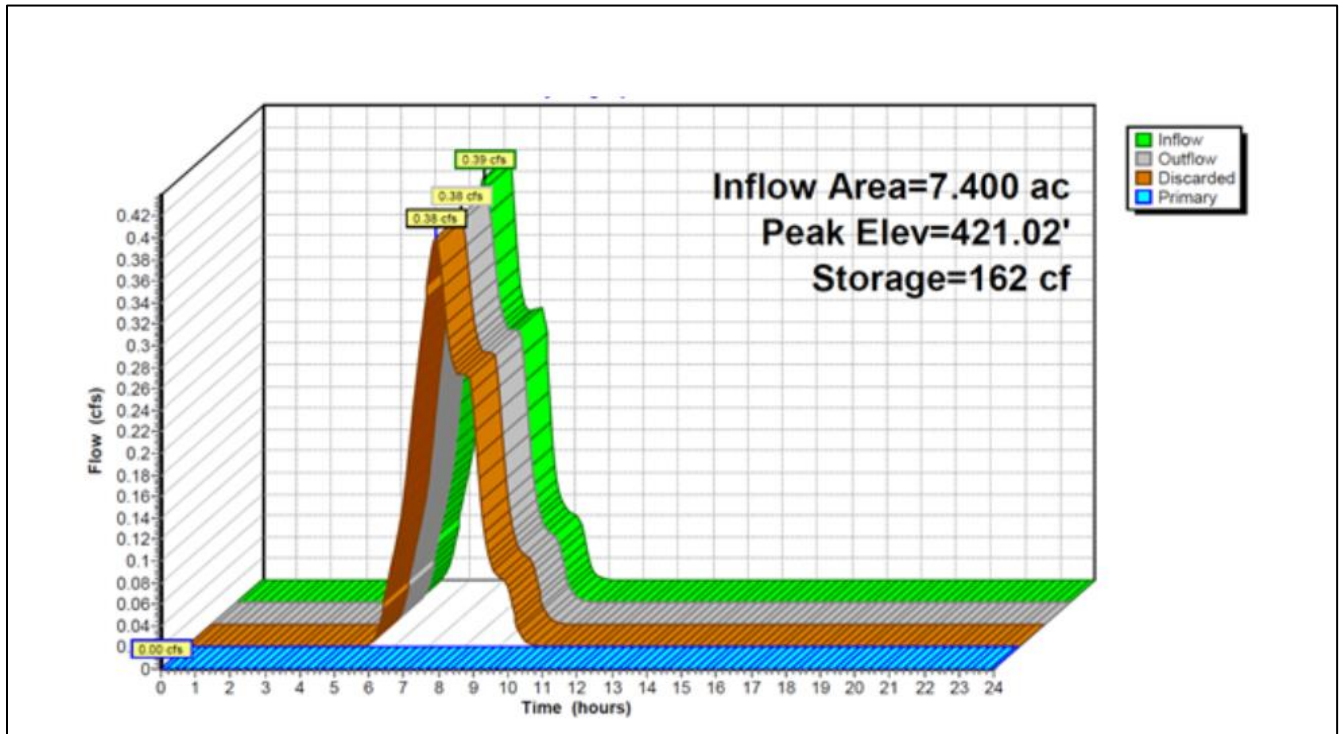
The hydraulic outputs for the HydroCAD® model based on Basin 16:07 can be seen for Storm 1 and Storm 2 in Appendix F:2 HydroCAD®. The only parameter different between the two models is the storm chosen. In the hydrology output, shown in Figures 28 and 29, the furthest line back represents the basin inflow. The second line from the back represents the total outflow or the sum of the “primary” and “discharge” lines. The third line from the back represents the discharge though infiltration. All of the water leaves through infiltration for the chosen storms in the project basin. The last line, closest to the front, represents the primary outflow which is at zero since no water leaves over the outfall.

FIGURE 28: STORM 1 HYDROCAD© HYDROLOGY

FIGURE 29: STORM 2 HYDROCAD© HYDROLOGY

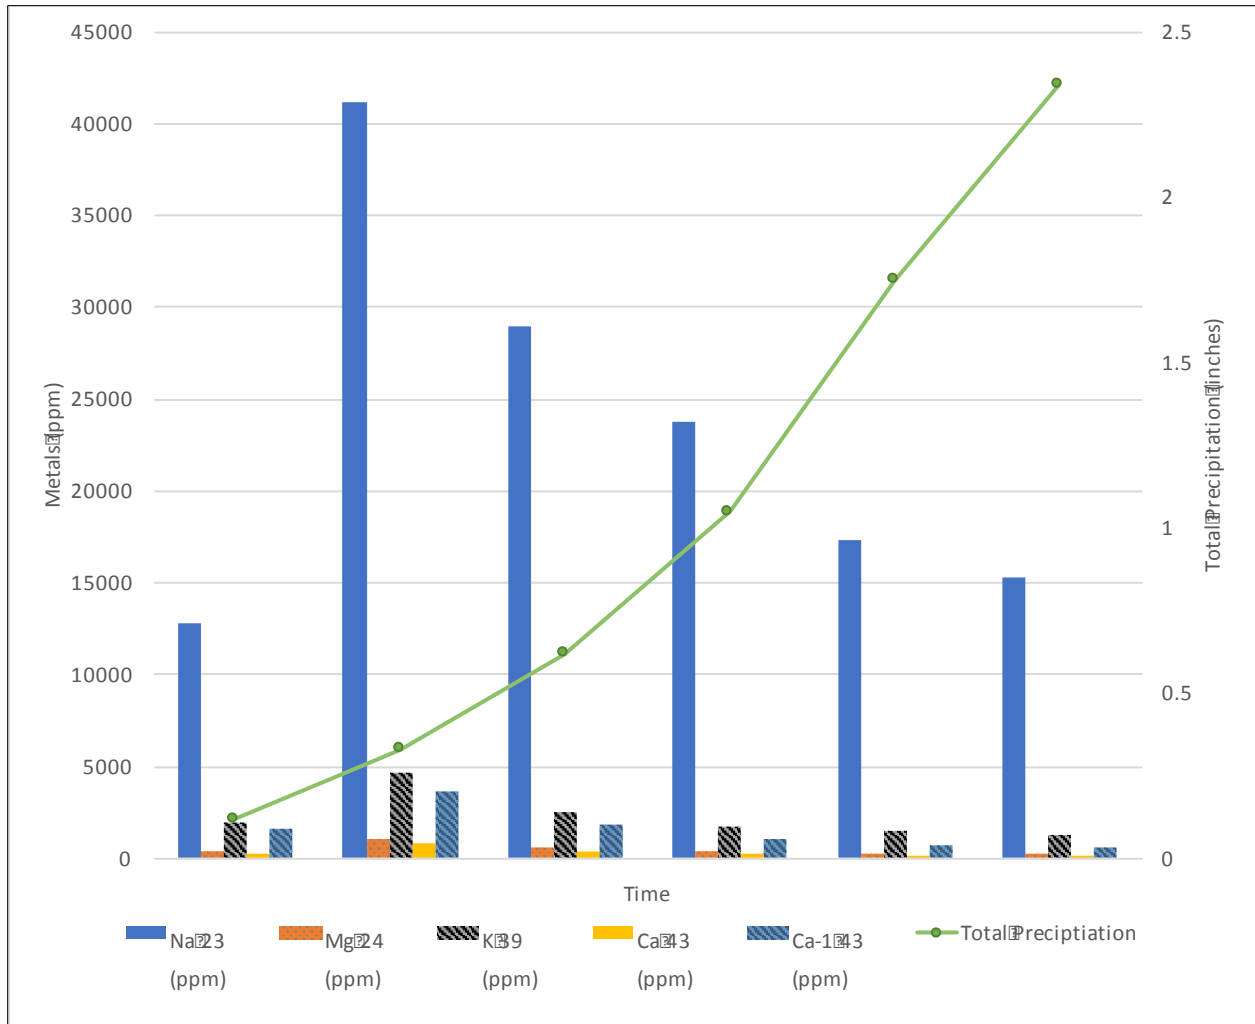
To better understand how the levels of Na increased we followed it as the storm progressed in the figures below.

FIGURE 30: RUNOFF DISSOLVED METALS WITH TOTAL PRECIPITATION FROM STORM 1

Figure 31 shows the levels of Na in runoff during Storm 2 along with Mg, K, and Ca. The data begins with the first flush. Figure 30 and Figure 31 have very similarly shaped figures but looking at the y-axis scale it can be seen that the amount of Na in parts per million (ppm) was much higher in Storm 2.

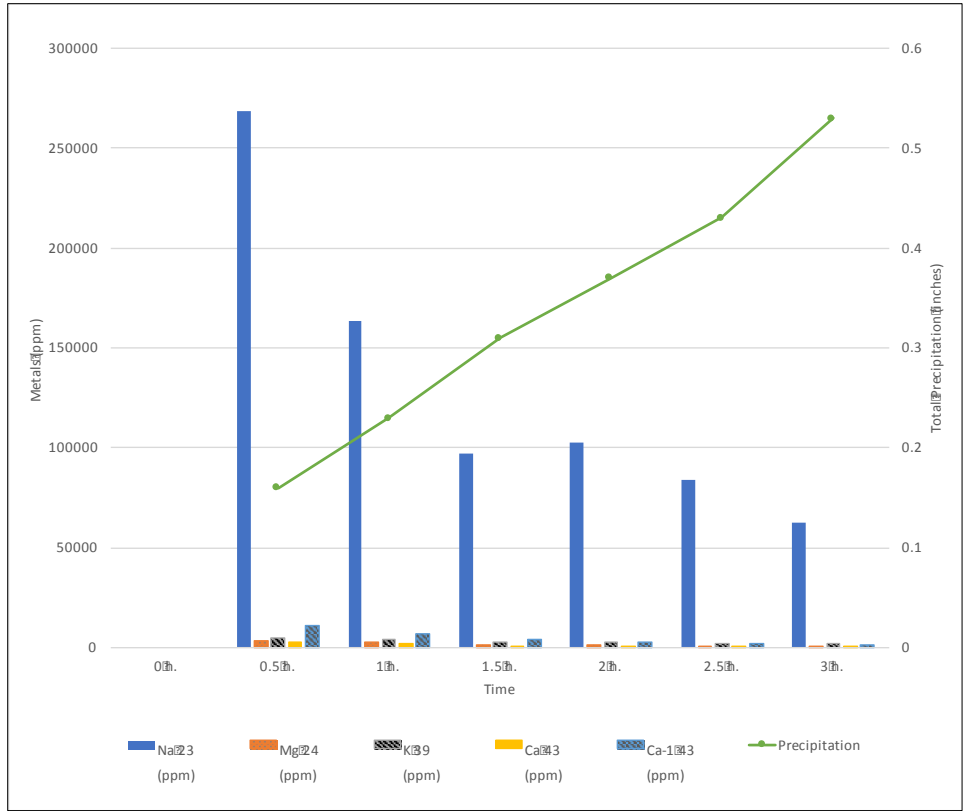
FIGURE 31: RUNOFF DISSOLVED METALS WITH TOTAL PRECIPITATION FROM STORM 2

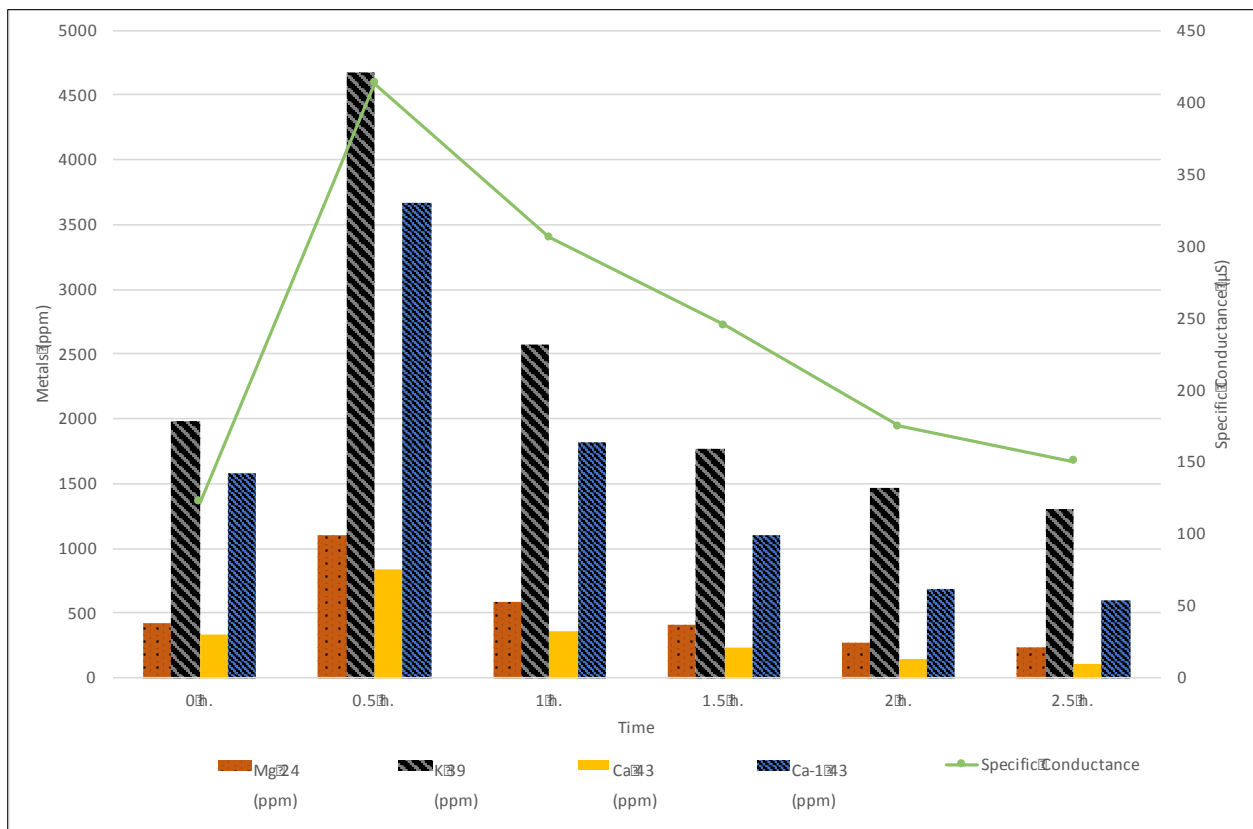
FIGURE 33: RUNOFF DISSOLVED METALS W/O NA WITH SPECIFIC CONDUCTANCE FROM STORM 1

Figure 33, shows the concentrations of Mg from Storm 1 present in the runoff. EPA regulation levels for human and organism health for consumption for Mg need to be below 50 $\mu g/L$. At the peak of Mg during the storm the runoff levels were above 1000ppm (1000mg/L). It is important to note that these samples were taken before the water entered the reservoir, before any water treatment processes.

The compound magnesium chloride is used as wet pre-treatment before road salt is used on the roads. For this reason Mg was also analyzed. Mg can also be found on the roads from cars; Mg alloy is used in multiple parts of cars, such as car frames due to its light weight and high strength.

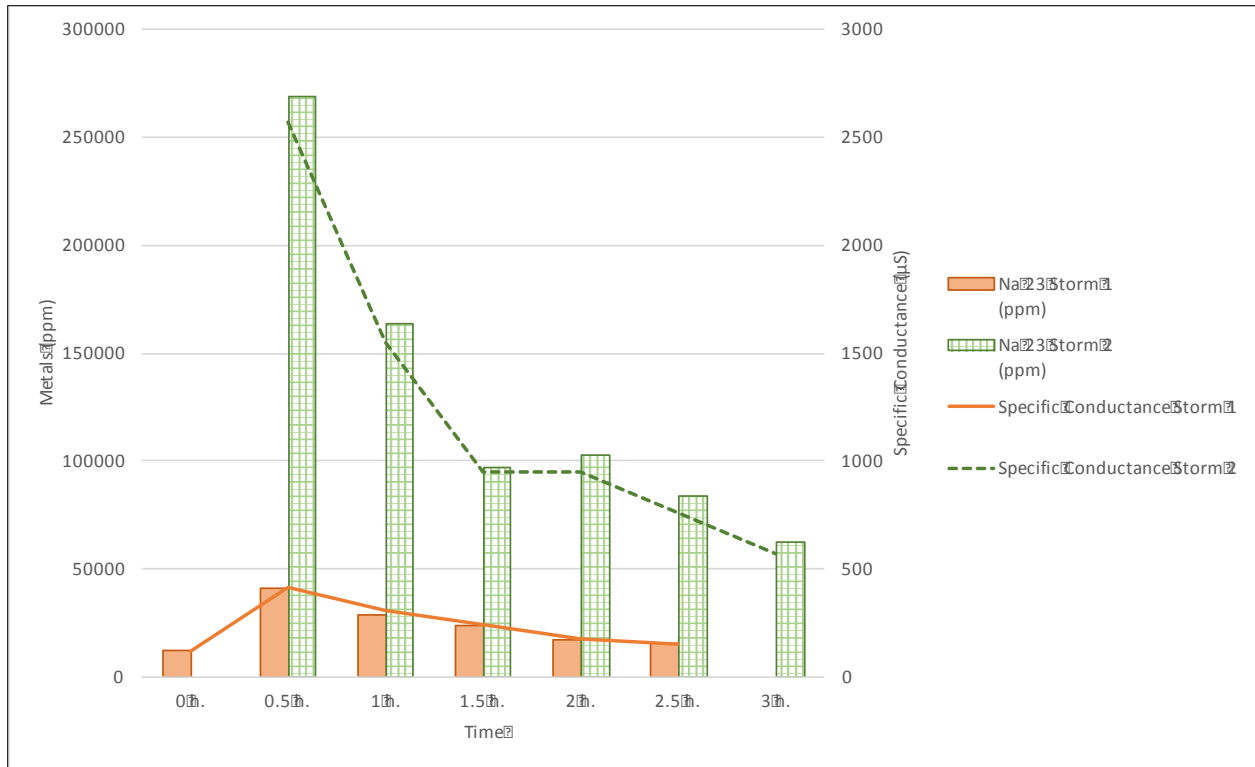
Figure 35 shows how specific conductance from Storm 1 to Storm 2 varied and how closely they matched the Na concentration levels. This revealed how the specific conductance levels decreased as the total metal concentration decreased.

FIGURE 35: COMPARISON OF NA AND SPECIFIC CONDUCTANCE OF STORM 1 AND STORM 2

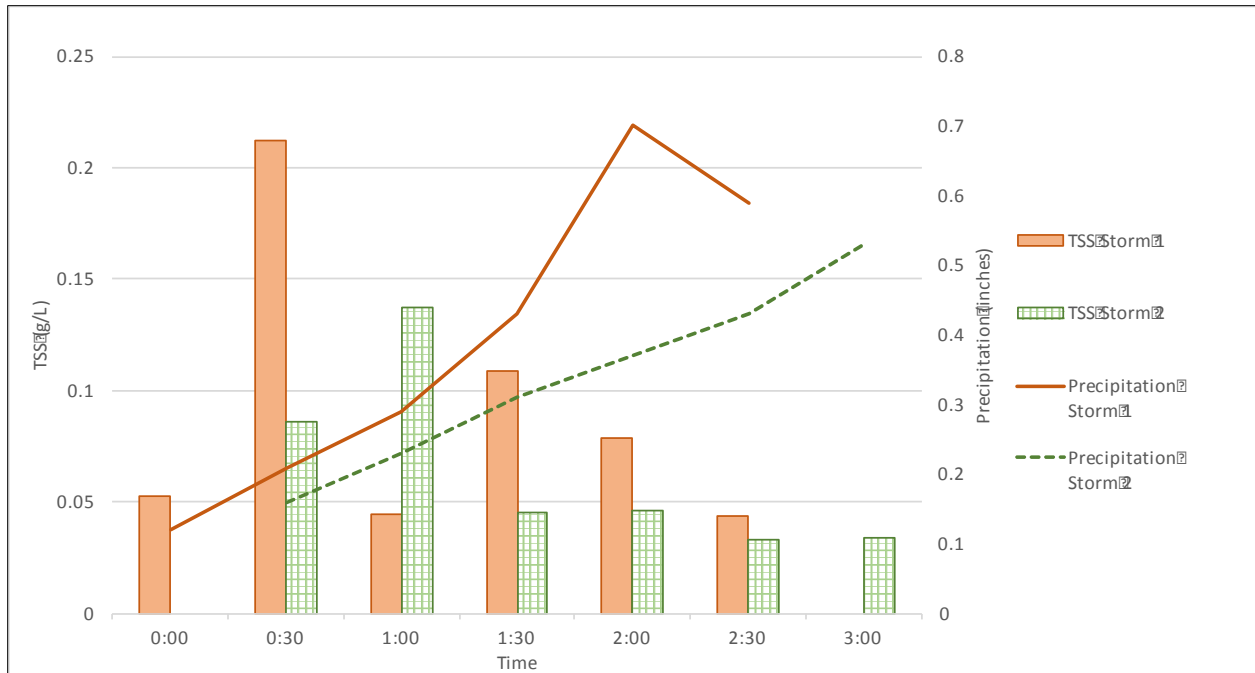
The TSS results for runoff as modeled in Figure 36 show a similar trend for both Storm 1 and Storm 2. The TSS data for Storm 2 were off placed by one in Figure 36 since Storm 1 caught the first flush at time 0. As the storm continues, the TSS per sample decreased.

FIGURE 36: RUNOFF TESTED FOR TSS WITH CUMULATIVE RAINFALL FOR STORM 1 AND STORM 2

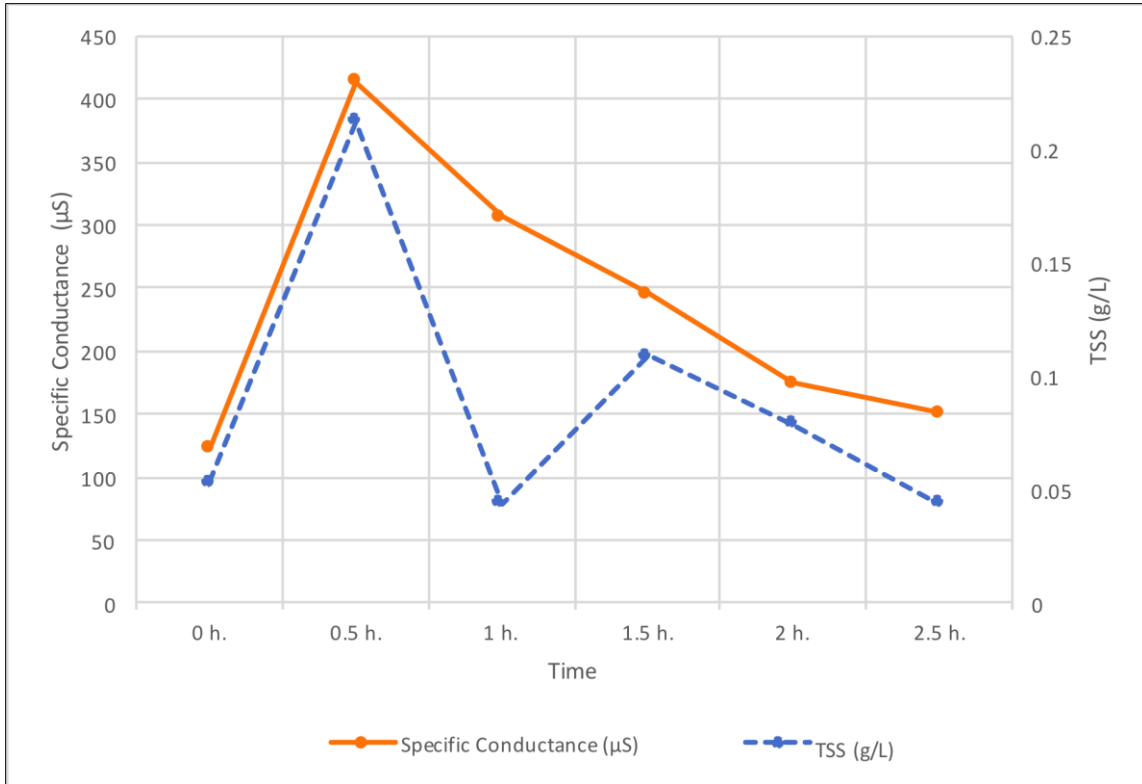
Figure 37 shows Storm 1 TSS data along with specific conductance. Even though these levels are read on two separate axes they closely mirror each other; when TSS levels rose, specific conductance levels increased as well. This can also be seen in Figure 38, which represents Storm 2. Except for the drop at hour 1 in Figure 37 and the increase at hour 1 in Figure 38, the similarities of specific conductance and TSS were very close.

FIGURE 37: RUNOFF TESTED FOR SPECIFIC CONDUCTANCE VS. TSS STORM 1

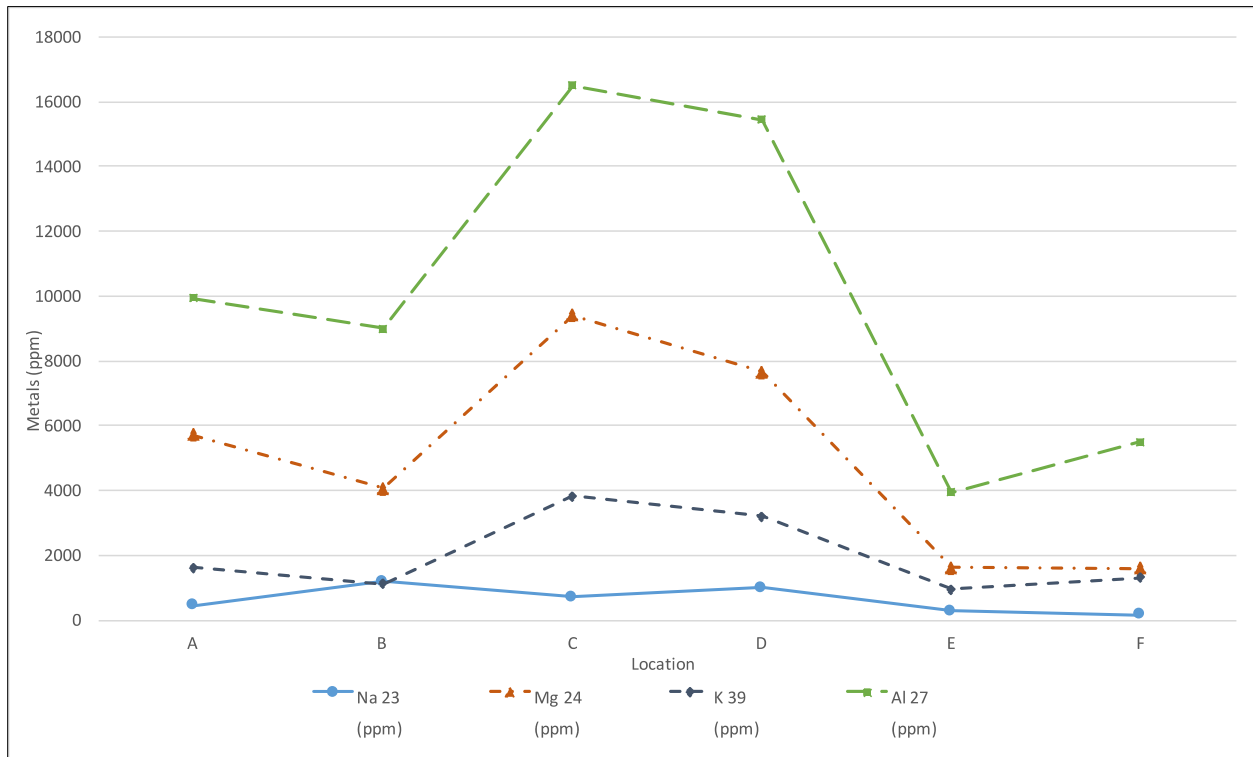
Figure 40 shows the location of sampling vs. the metals that were analyzed with the highest levels. Fe was not included since it was found naturally occurring in soil and its levels would have skewed the rest of the data.

FIGURE 40: SOILS TESTED FOR TOTAL METALS

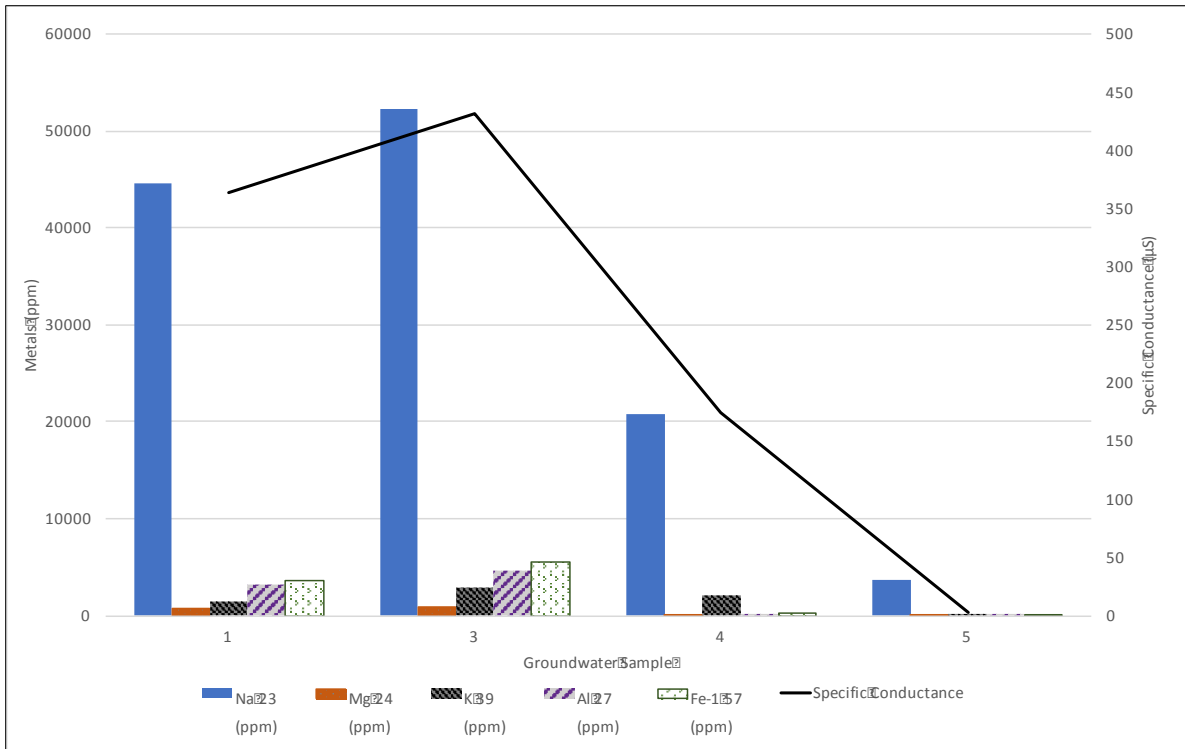
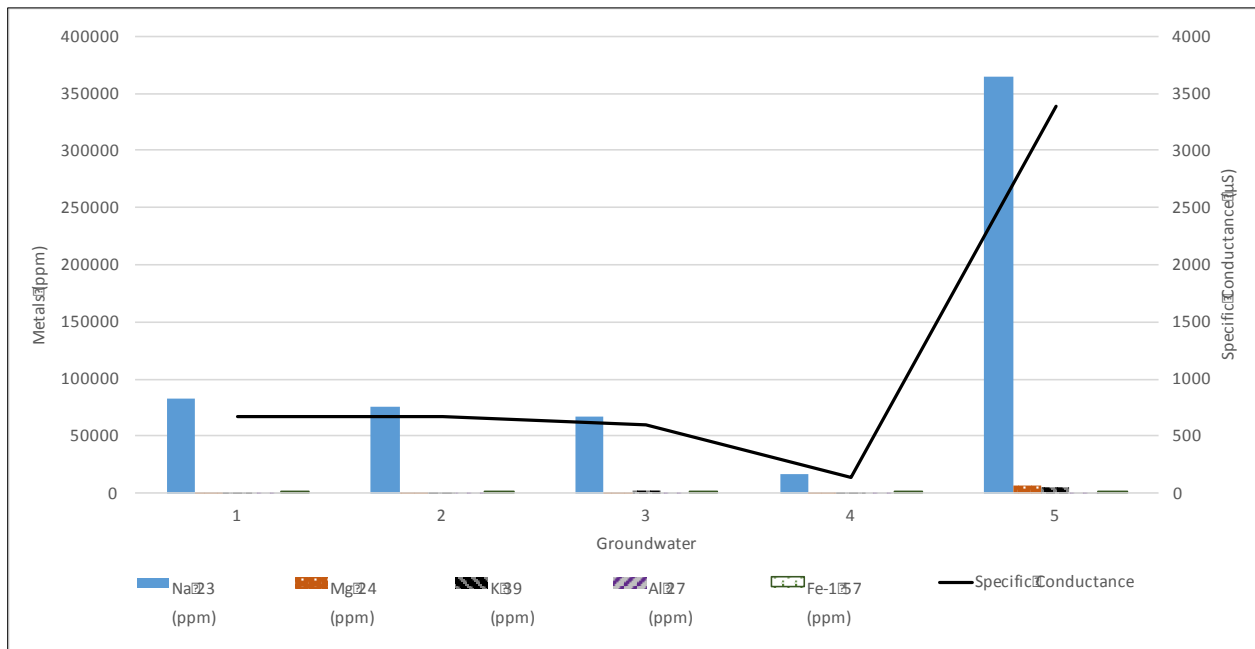
The groundwater samples from both storms were tested for dissolved metals and compared to specific conductance in Figures 42 and 43.

FIGURE 42: GROUNDWATER TESTED FOR DISSOLVED METALS STORM 1

FIGURE 43: GROUNDWATER TESTED FOR DISSOLVED METALS STORM 2

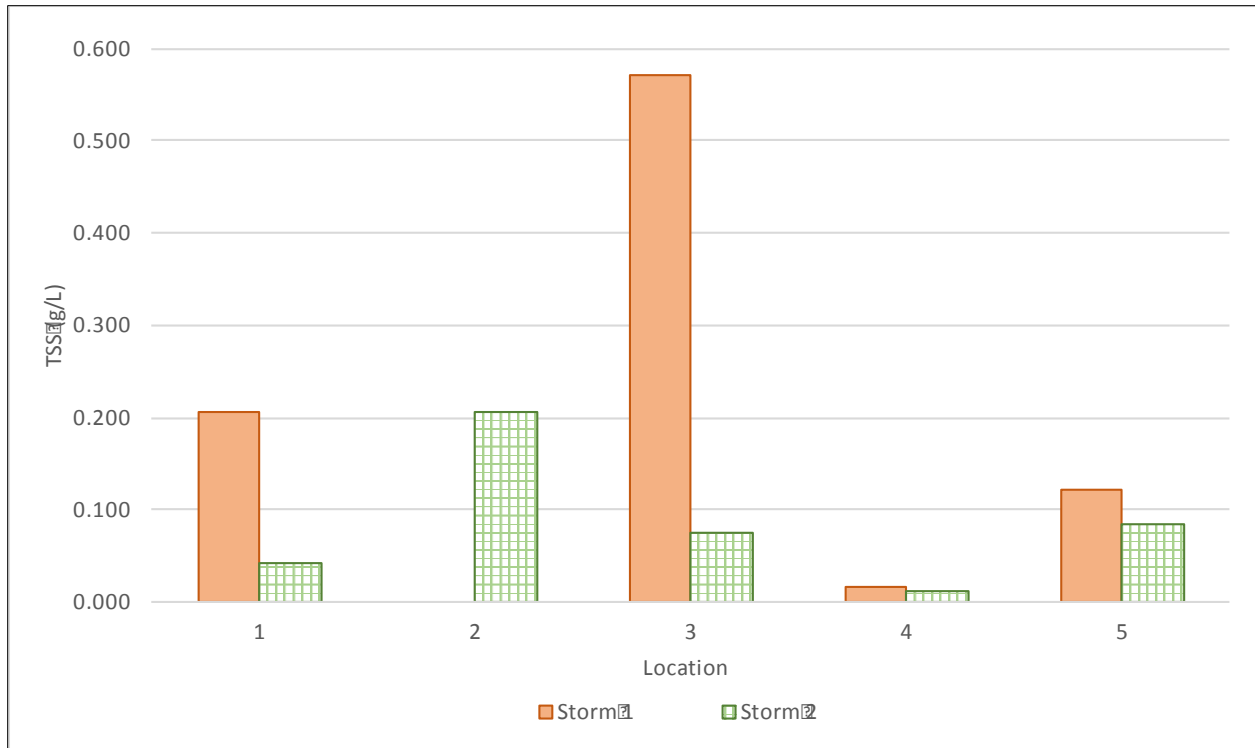
TSS was also tested for in groundwater as shown in Figure 46. Site 2 was not sampled during Storm 1, which is why there is no data shown. As seen in Figure 41, Locations 1, 2, and 3 were in Chamber 1 which explains their high levels of TSS due to direct runoff accumulation. Location 4, found in Chamber 2, was farther away from the inlet and did not have much runoff water infiltrating from standing water. Instead, we believe the groundwater samples were filtered water from Chamber 1 and by the time the groundwater reached this point the suspended solids had already been trapped. Location 5 had a higher level of TSS than location 4, which was interesting because in Figure 47 of the sample bottles the location 5 bottle was much clearer than location 4. That increase could be due to an error in the lab.

FIGURE 46: GROUNDWATER TESTED FOR TSS

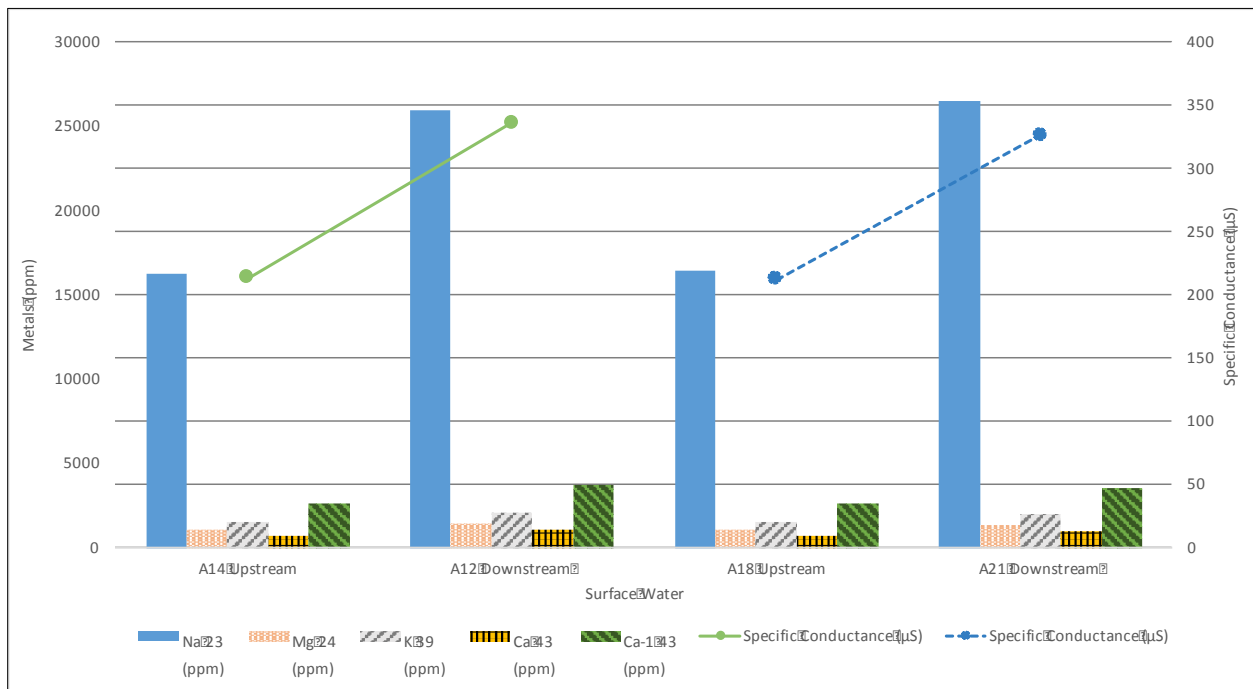
Specific conductance is an important factor to consider when looking at water quality. Figure 50 shows the increase of specific conductance from upstream to downstream in the Stillwater River. The upstream samples were lower than the downstream samples by a difference of 100 micrograms. Additionally, we referred to the data from the USGS sample station, Appendix J: USGS Data, and there was an increase in specific conductance between the beginning of the storm and end of the storm.

FIGURE 50: SURFACE WATER DOWNSTREAM VS. UPSTREAM TESTED FOR DISSOLVED METALS DURING STORM 2
