Evaluating the Role of Stormwater Treatment Basins in Controlling Highway Runoff Quality

A Major Qualifying Project Report

Worcester Polytechnic Institute

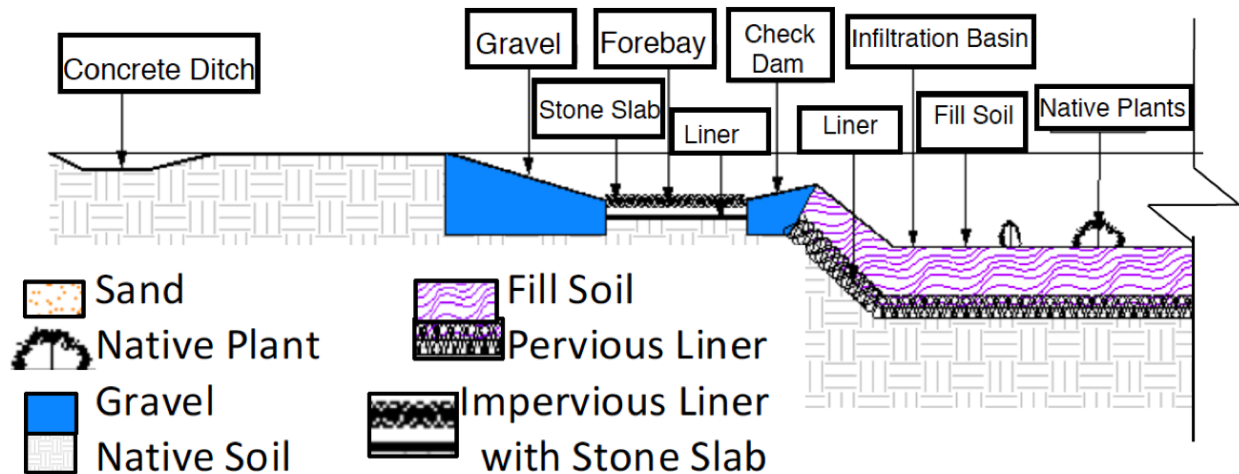
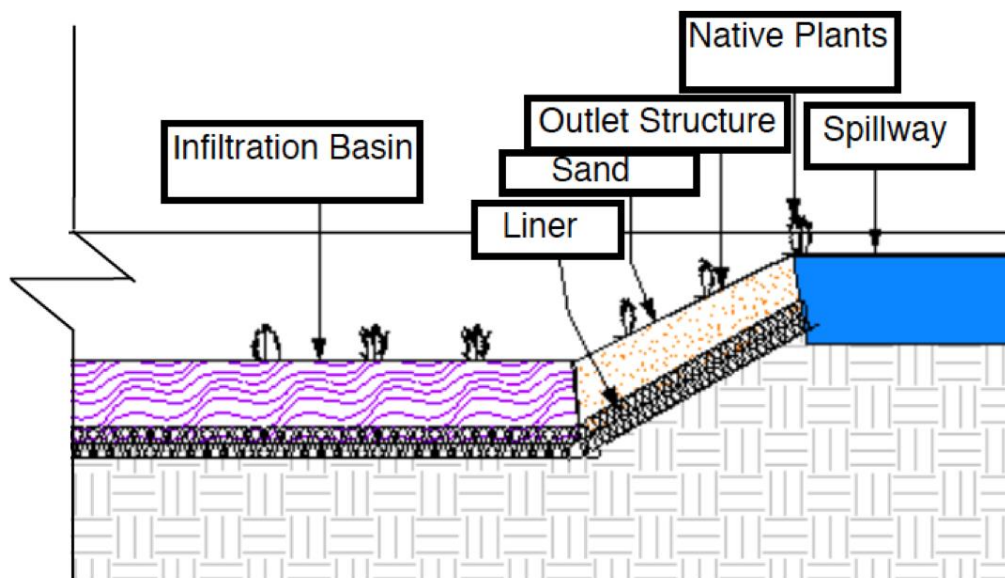
In addition to the increased size of the optimal basin, the materials in the basin are used to improve efficiency of the basin. Figure 52 displays a side view section which allows for the layers of the basin to be seen. The materials shown in the Figure 52 will be discussed in further detail to explain why these materials were chosen and how those materials would positively affect water quality.

FIGURE 52: OPTIMAL BASIN SECTION

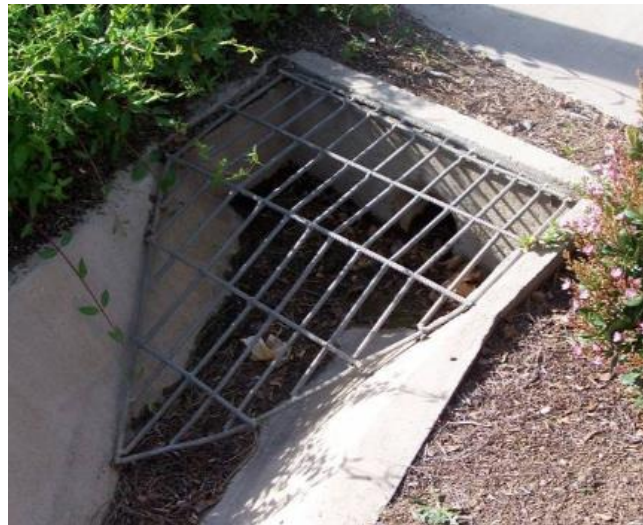
The accumulation of trash affects the flow of runoff through the basin and contributes to sediment buildup. One additional feature that could be added to the optimal basin to reduce this is a trash collection rack/cage. The rack would be attached to the concrete inlet on the slope and extend over part of the sediment forebay. This rack would allow for routine pickup of the trash that has collected on top and underneath the rack, preventing it from collecting in the basin like it currently does. Additionally, the rack would be made from steel, therefore able to sustain various weather conditions.

FIGURE 55: TRASH COLLECTION RACK DESIGN OPTION (MISC. METALS, 2012)

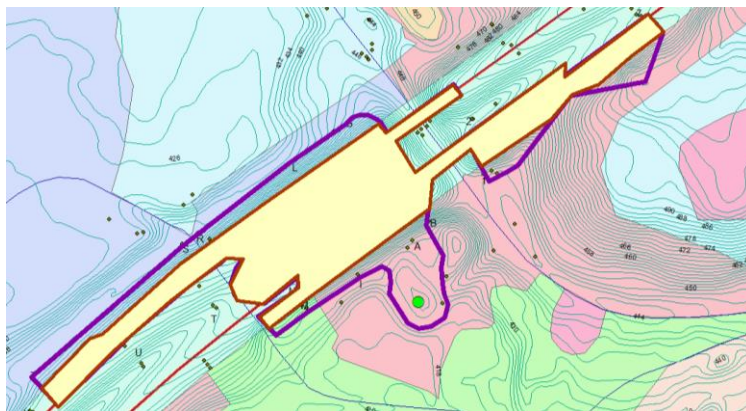
FIGURE 56: IMPERVIOUS AREA

recharge volume. The target depth factor was determined using Table 2.3.2 from the MassDEP Handbook also shown here in Table 15. From the table a weighted average was calculated using Soil Type A, B and C to get a target depth factor of 0.59 inches due to 96% of the soil being Type A. All land in the drainage area with a CN of 98 was considered to be the impervious area, equaling 6.2 acres as seen in Figure 56.

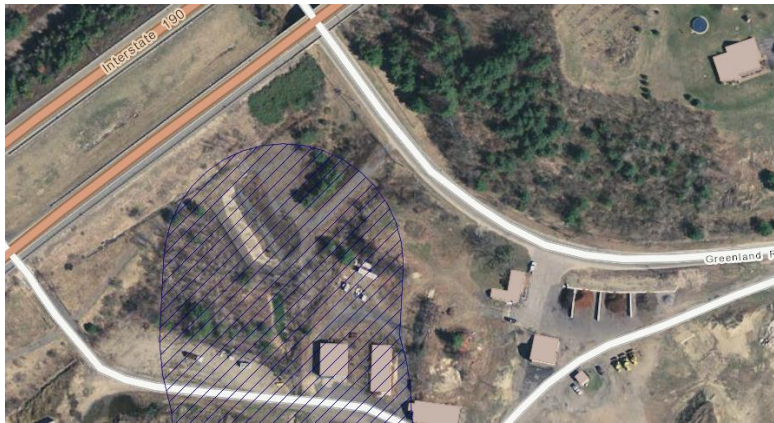
FIGURE 57: ZONE A AREA (OLIVER, 2016)

Standard 6 is for "stormwater discharges within the Zone II or Interim Wellhead Protection Area of a public water supply, and stormwater discharges near or to any other critical area, require the use of the specific source control and pollution prevention measures and the specific structural stormwater best management practices determined by the Department to be suitable for managing discharges to such areas." Discharges in these areas must comply with 314 CMR 3.00 and 314 CMR 4.00. 314 CMR 3.00 is a permit for surface water discharges (MassDEP, 2007). 314 CMR 4.00 is the Massachusetts surface water quality standards (MassDEP, 2013). Figure 57 shows that our project basin location is within a Zone A, Public Surface Water Supply Sources, area and therefore is considered a critical area and would have to comply with both 314 CMR 3.00 and 314 CMR 4.00. A Notice of Intent would have to be submitted to the MassDEP for the optimal basin design in order to gain a surface water discharge permit. If Stormwater Management Standards are met and the discharge permit is granted the surface water quality standards should be achieved.

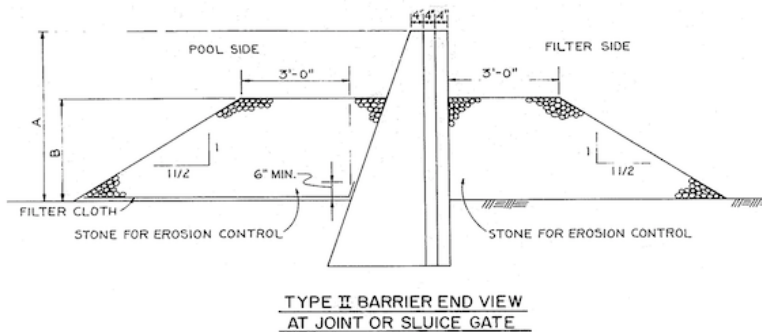
FIGURE 61: TYPE 2 OF BARRIER

Figure 60 and 61 shown above displays two types of barrier that can be found in basins between the chambers. Either type of barrier can be found in basins along I-190. The Chamber 1 is indicated on the left side and is called the “pool side” on the figures. The Chamber 2 is indicated on the right side and is called the “filter side” on the figures. Notice how both have stones built up on either side of the concrete weir wall for erosion control when the barrier is overtopped.

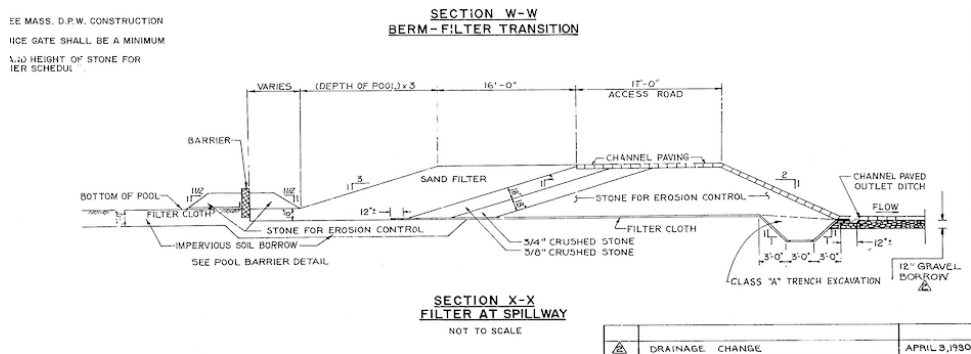
FIGURE 62: SIDE VIEW OF OUTLET WEIR

Figure 62 shows the outlet channel of the berm filter transition. There was crushed stone beneath the sand filter to increase infiltration into the soil and decrease future erosion. There was gravel outside of the basin which decreased erosion when water overflowed the basin.

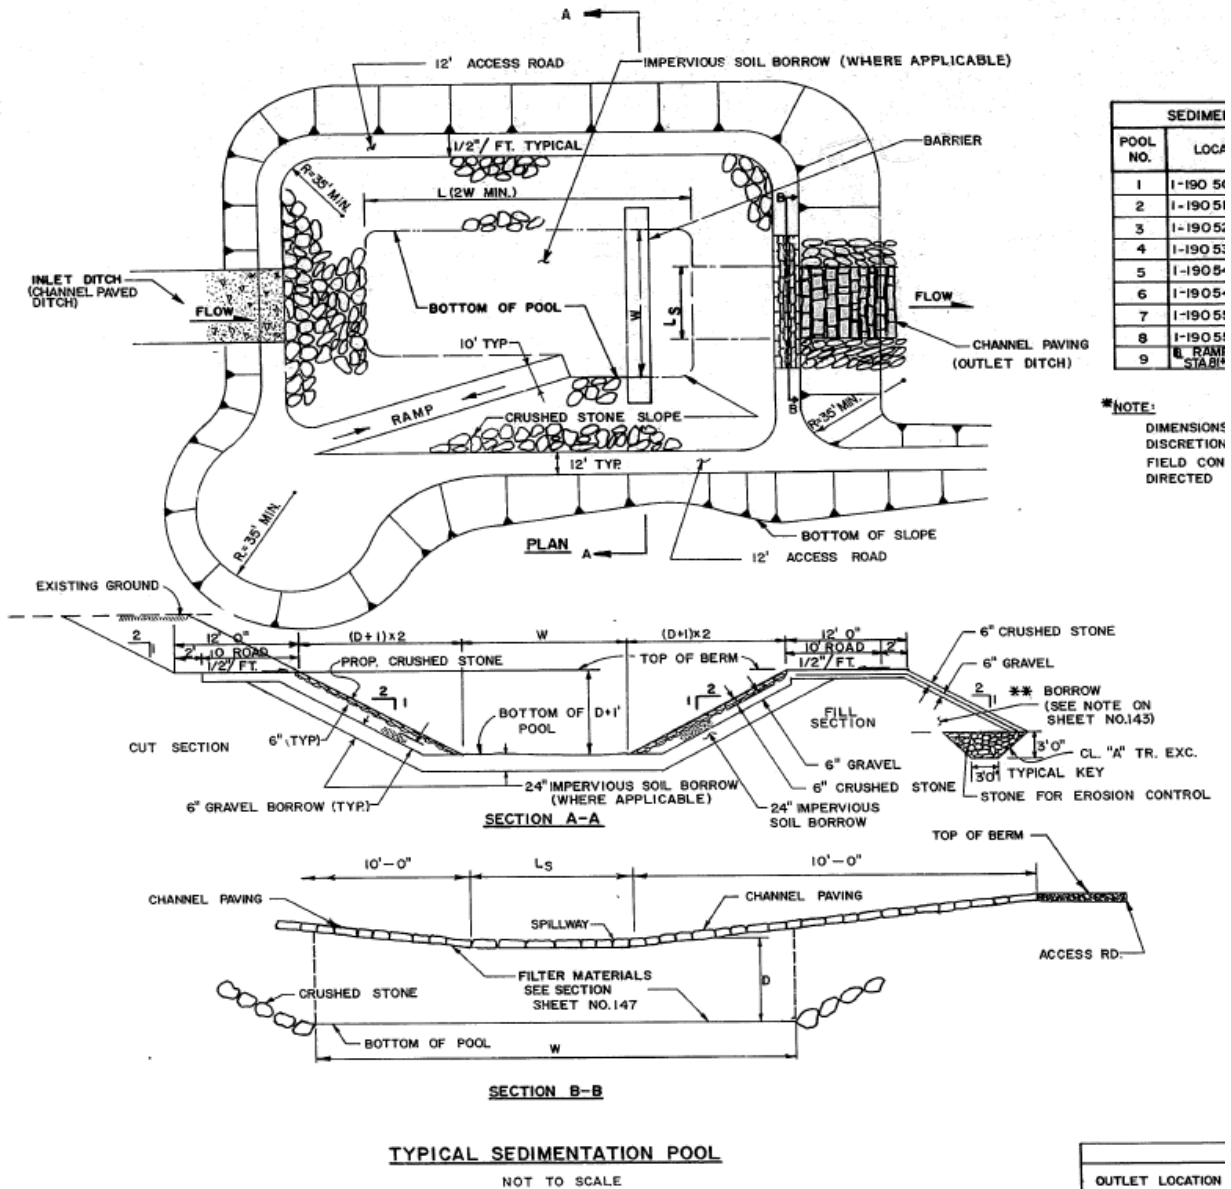
FIGURE 63: TOP VIEW AND SIDE VIEW OF THE BASIN

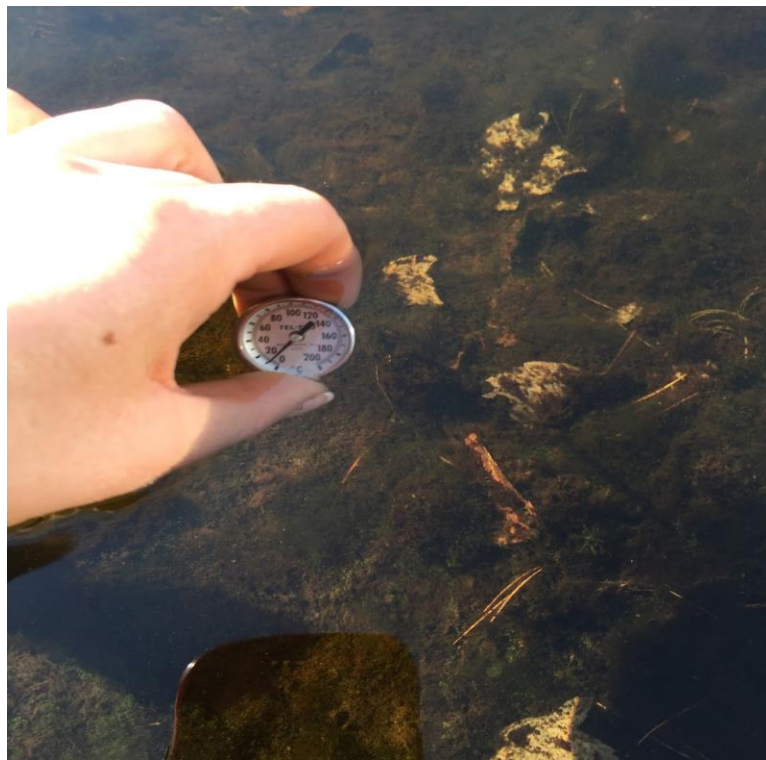
FIGURE 64: MEASUREMENT OF TEMPERATURE

Supplies	Procedure
<ul style="list-style-type: none">• Thermometer	<ol style="list-style-type: none">1. Place thermometer in water for 1 minute as shown in Figure 642. Read the temperature and record it in field notebook

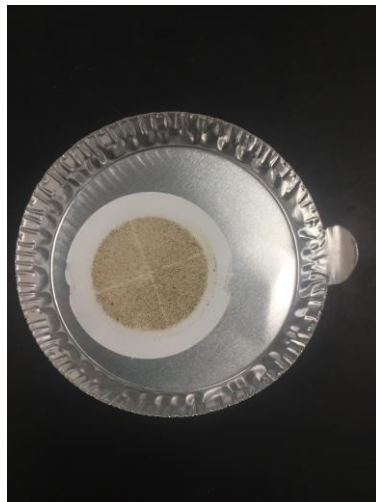
FIGURE 67: DRIED FILTER WITH SOLIDS PRESENT

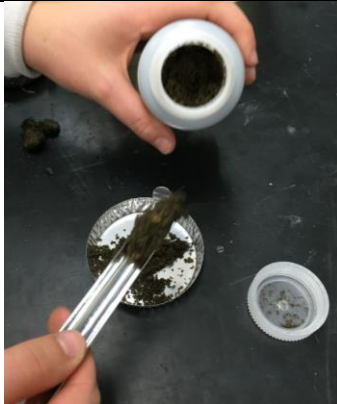
FIGURE 68: PLACEMENT OF SOIL SAMPLE ON PAN

Supplies	Procedure
<ul style="list-style-type: none">• Soil samples• Drying Oven• Pans• Ziploc bags• ICPMS Machine	<ol style="list-style-type: none">1. Label small aluminum pans2. Add small amount of soil as seen in Figure 68<ol style="list-style-type: none">a. Make sure sample does not contain rocks or plants3. Place in drying oven4. Remove from oven at least 24 hours later as seen in Figure 695. Place in labeled Ziploc bags and put in back lab room6. Don uses acids to digest soils7. Test soils in ICPMS

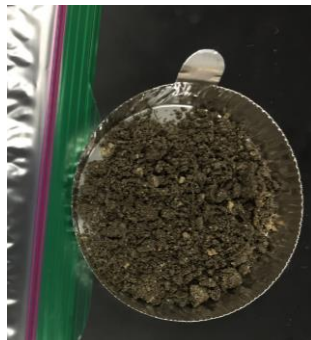
FIGURE 69: SOIL DRIED IN OVEN

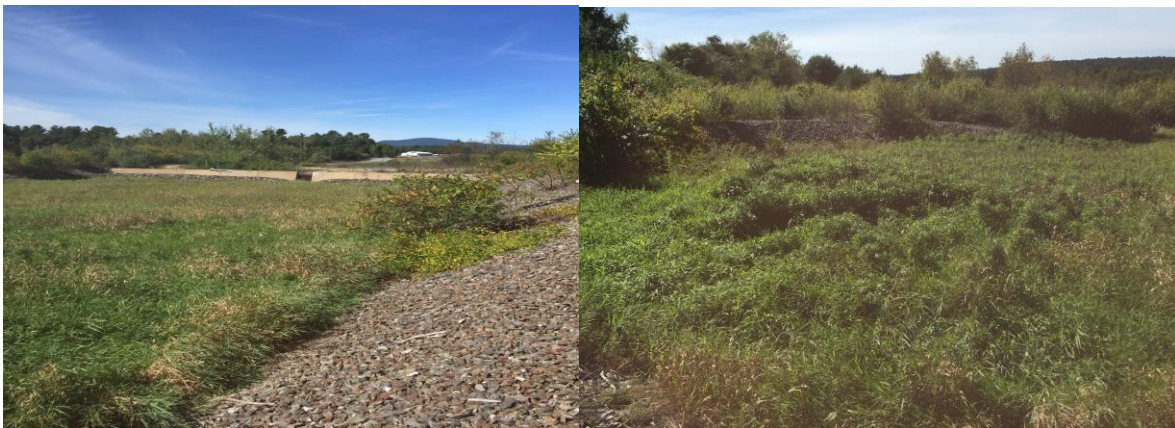
- Is the standard basin design we have been seeing with the two chambers, stone ditch and ramp
- The adjacent land is owned by DCR so there are no trespassing concerns
- There is a washout of sediment creating a plunge pool that has caused a high point with high plant growth, would be an ideal place to sample
- Dan believes that soil and bearing samples exist somewhere
- Would have to build a weir in the channel to be able to test flow rate
- Could potentially put a cloth fence in the basin to trap water in order to localize the infiltration to get groundwater samples
- In 2004/2005 they removed sediment returning back to an even grade

Figure 1: Basin 16-8

Figure 2: Sediment Plunge Pool

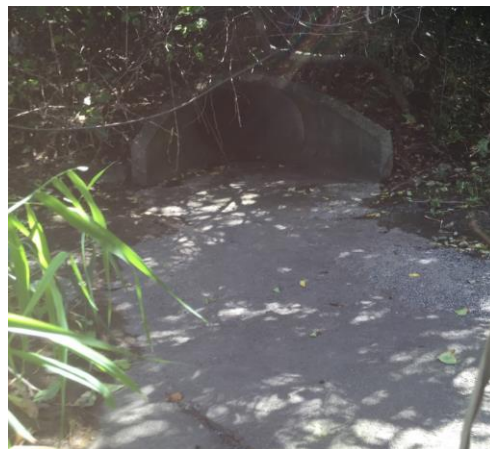
Figure 3: Discharge Pipe to Basin Weir

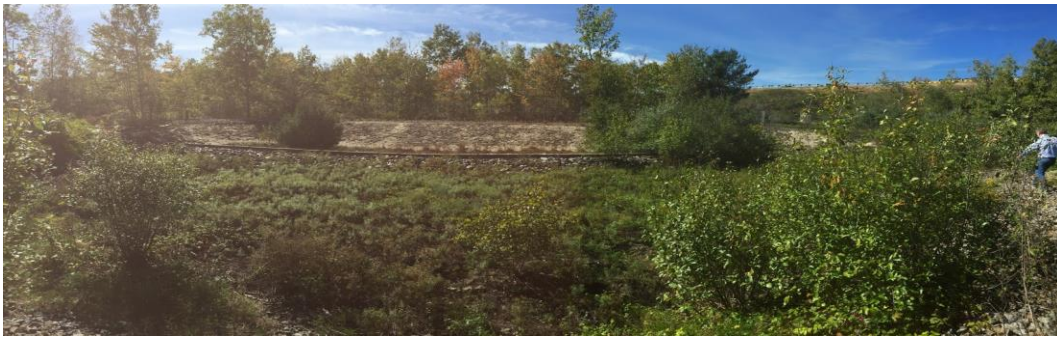
- Was changed after construction, made smaller after road work was completed
- Could potentially put sandbags along fence to be able to measure flow - would be a lot of work and may be able to get what is needed from a desktop analysis
- Important to figure out what we want to find out/test before we take steps that cost money/ time to sample
- Pipe -> Weir , estimate pipe is half full to determine what the weir size will need to be
- Will be dealing with flashy drainage areas (watershed is usually used for larger areas made up of many drainage areas, also called Catchments) since there is a lot of impervious area due to road

Figure 4: Basin 16-7

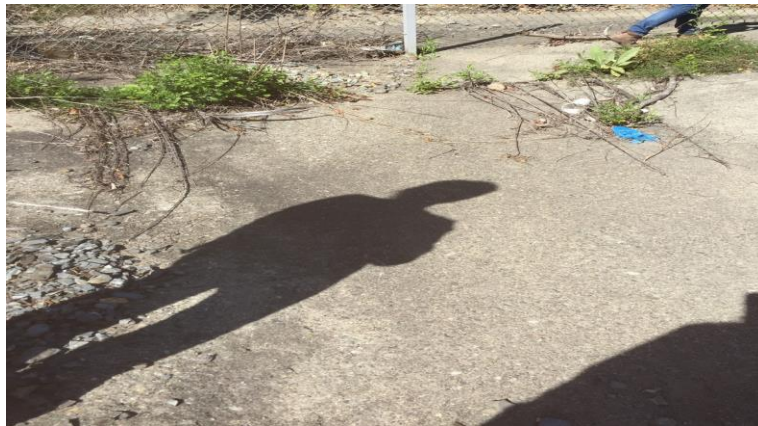
Figure 5: Inflow Weir

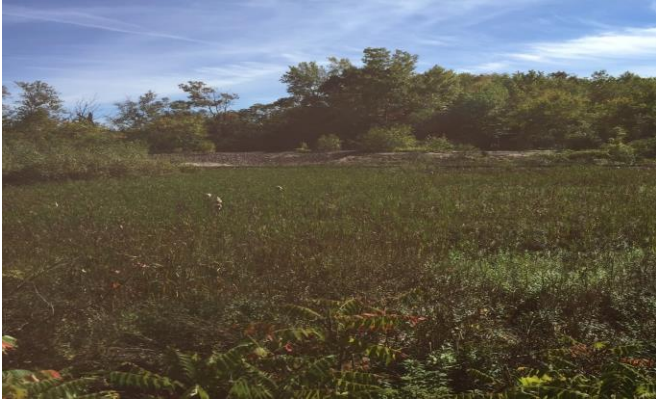
- Sediment was pulled out in 2004
- Lots of cattails
- Some water was present in the basin
- Was made smaller after construction of the road
- There is an old spring well nearby which means there is high groundwater which may be the reason why there was water present in the basin
- Path to get to basin and near inlet is overgrown with poison Ivy present

Figure 6: Overgrown

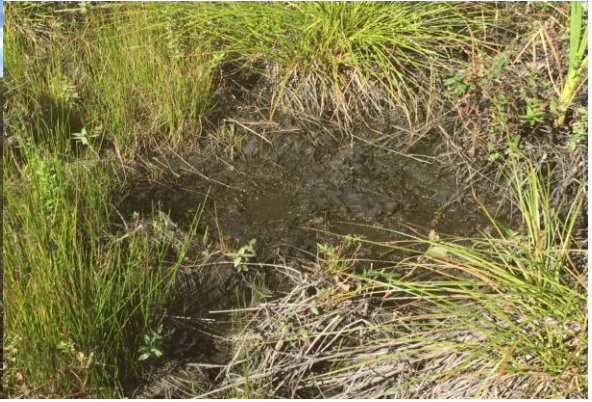
Figure 7: Water in the Basin

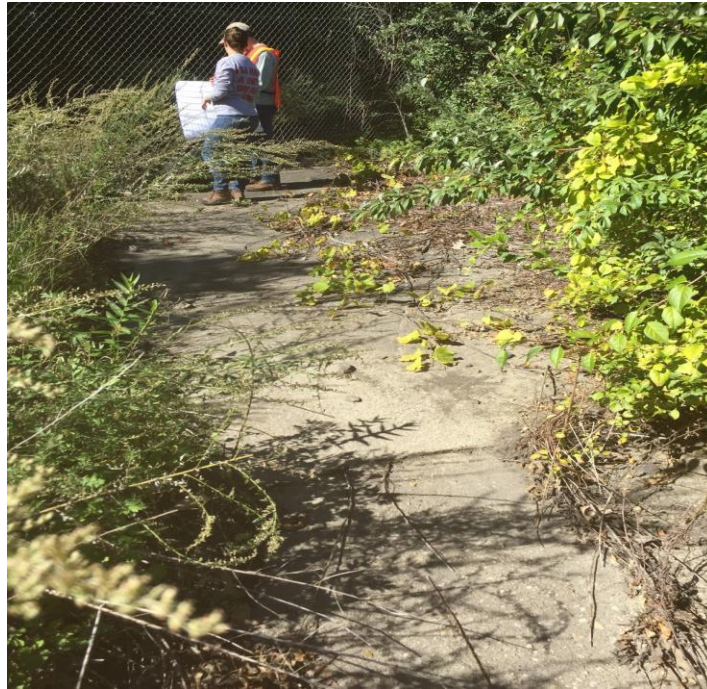
Figure 8: Inflow Weir

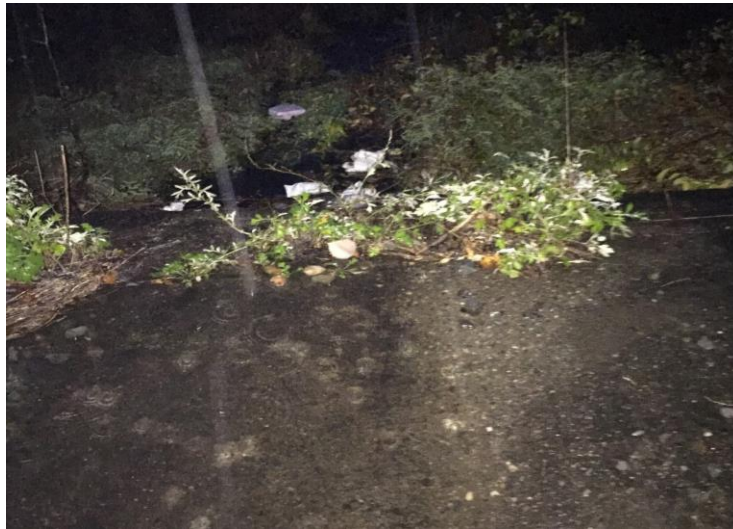
- It was noticed that MassDOT had cleared up the site for vehicle access
- Trash was scattered around the premise of the basin, likely from the flash floods the week prior
- There was flow entering the basin that will be able to be used for sampling

Figure 1: Flow into the basin

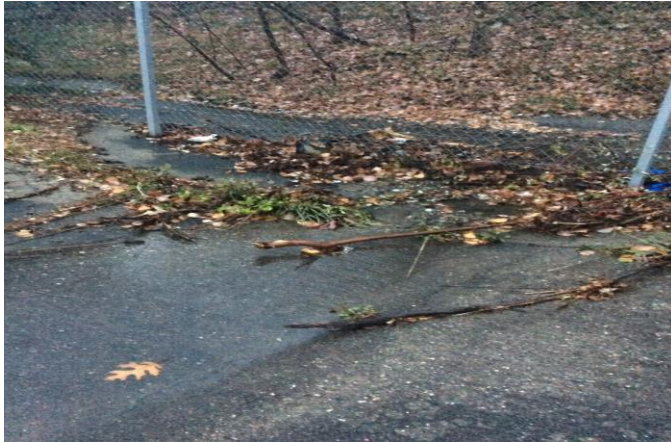
Figure 4: Precipitation data from October 27th

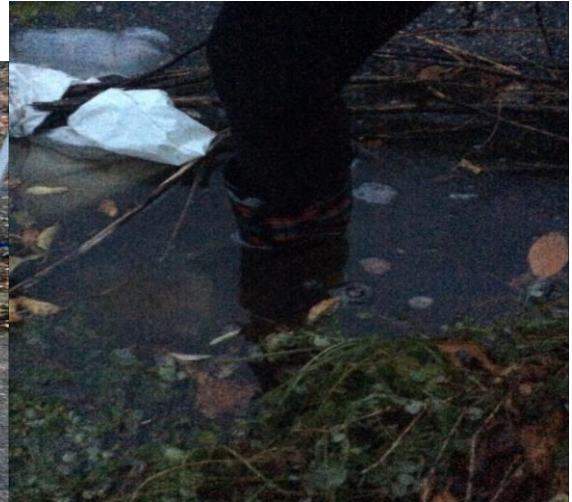
Figure 5: Precipitation data from October 27th

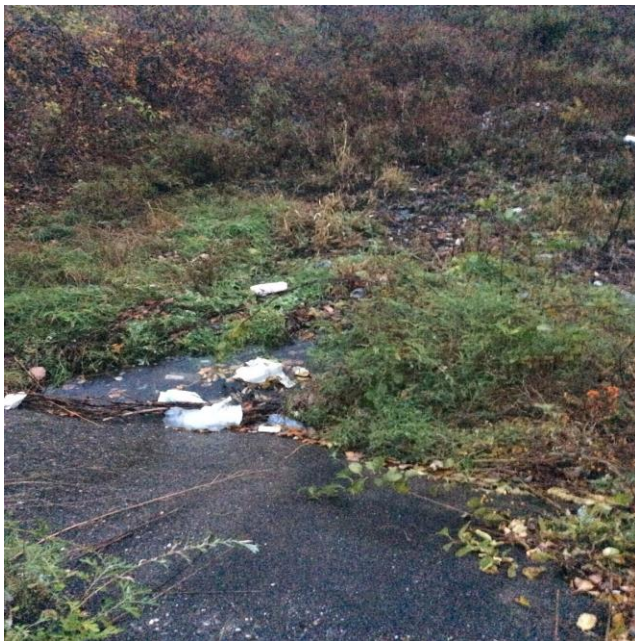
- There was a washout of sediment at the end of the concrete creating pooling
- At the beginning of the site visit water was only pooling in the area blocked by sediment but at the end of the site visit the water had started to flow further into the basin

Figure 6: Pooling at 5:30 pm

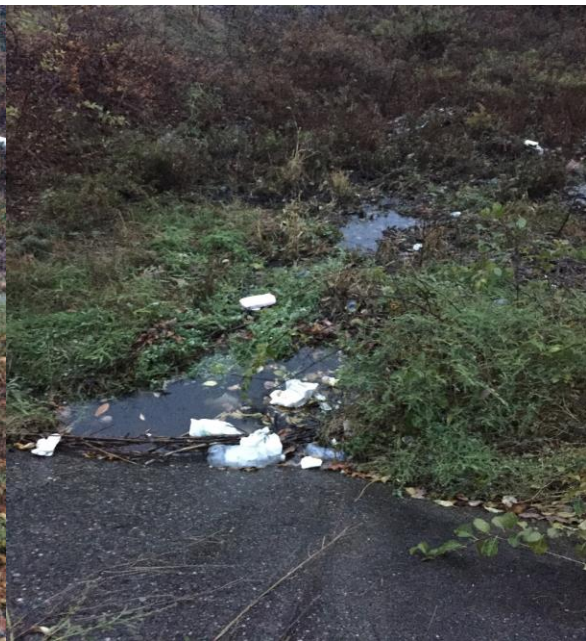
Figure 7: Pooling at 6:15 pm

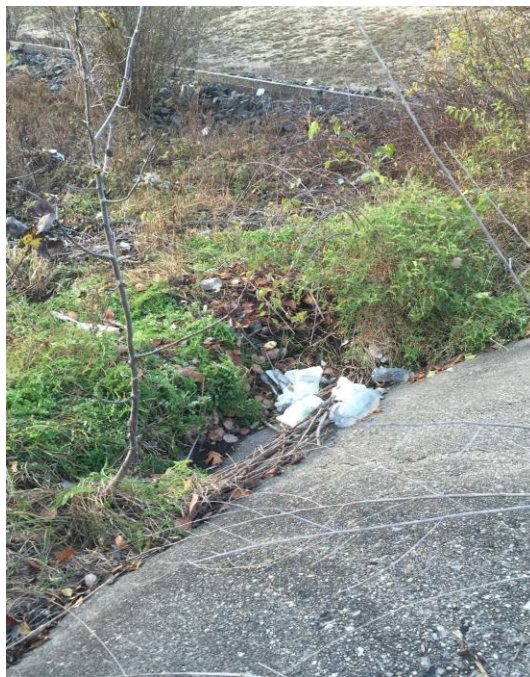
- Upon arriving at the site the team conducted a basic walk through of the site. It was observed that the site had no standing water and there was additional litter within the basin. Overall they did not observe any major changes.
- The sediment build up that was causing pooling during the last site visit (10/27/16) was observed for further detail and photographs were taken to reveal water was no longer present.

Figure 1: Sediment Build Up

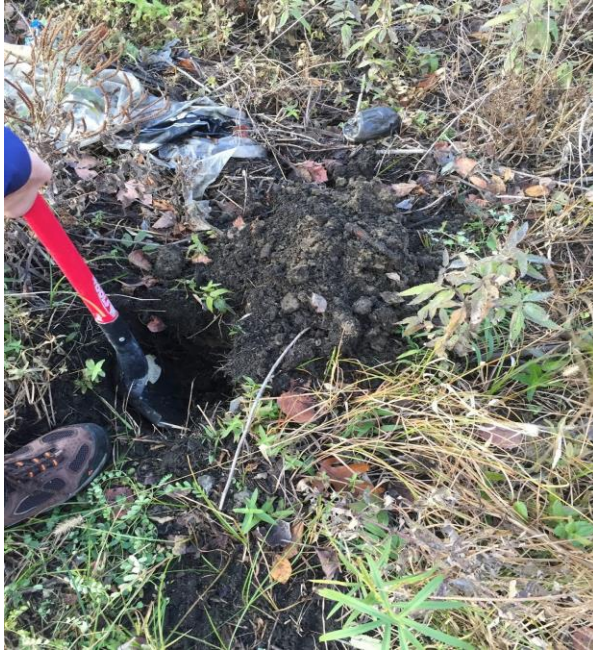
Figure 2: Removing Topsoil with Shovel

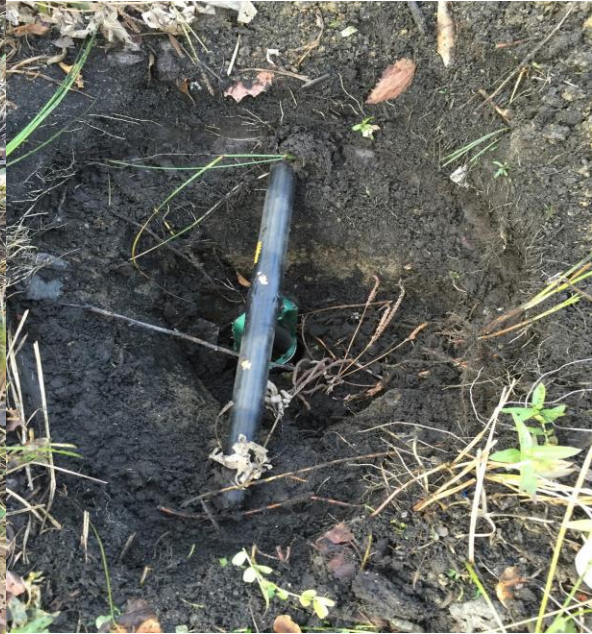
Figure 3: Removing Lower Soil with Coring Device

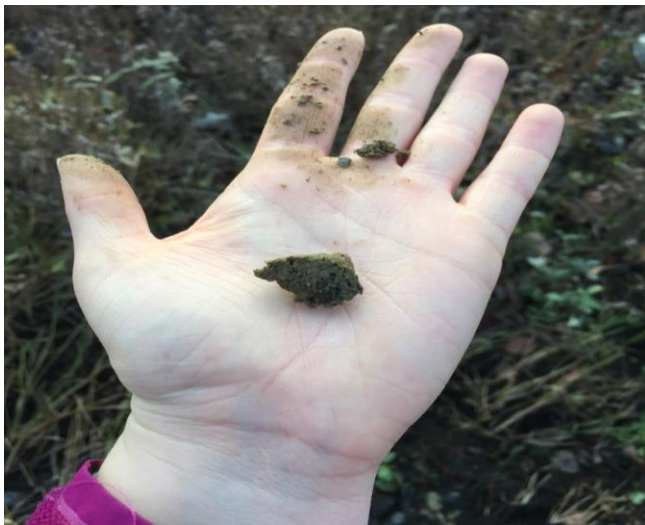
Figure 4: Lower Soil Used for Sample S1

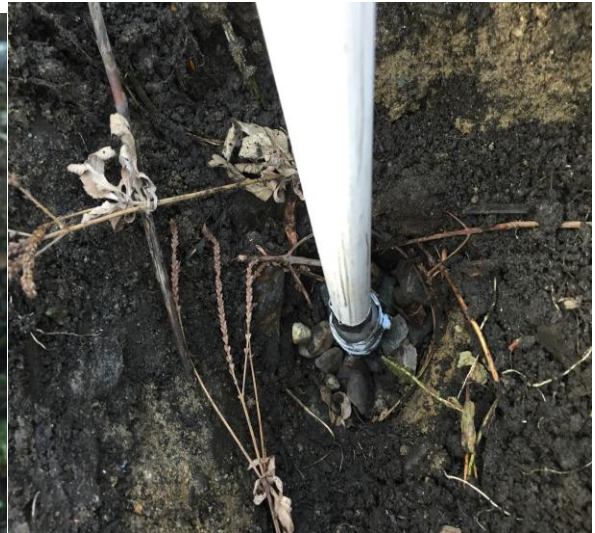
Figure 5: Groundwater Device Surrounded by Small Stones

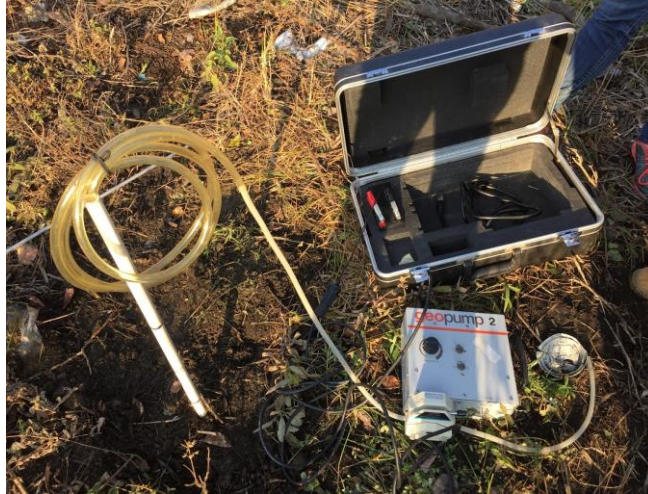
Figure 6: Groundwater Sampling Device with Pump

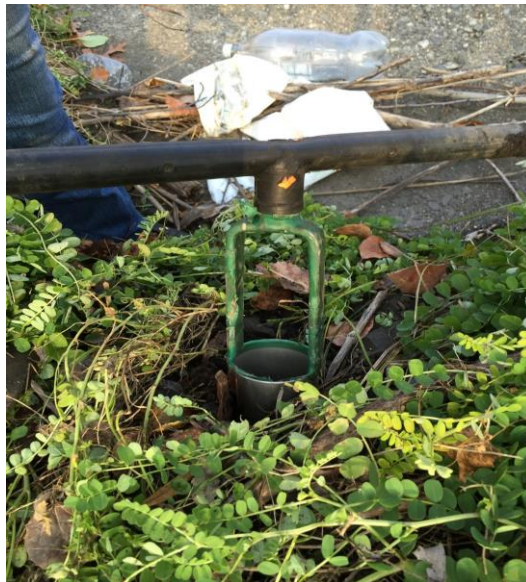
- After the two groundwater devices were set the team continued to take soil samples. A total of 6 soil samples (S1-S6) were taken to bring back to the lab to test. To visually see approximate locations of the sample locations please reference the map attached to these field notes.
- The second sample, S2, was taken only 9 feet from the inlet where the sediment had built up. The coring device was used to take the sample. The soil was all dark sediment and the hole was a depth of 6 inches.

Figure 7: Taking Core for sample S2

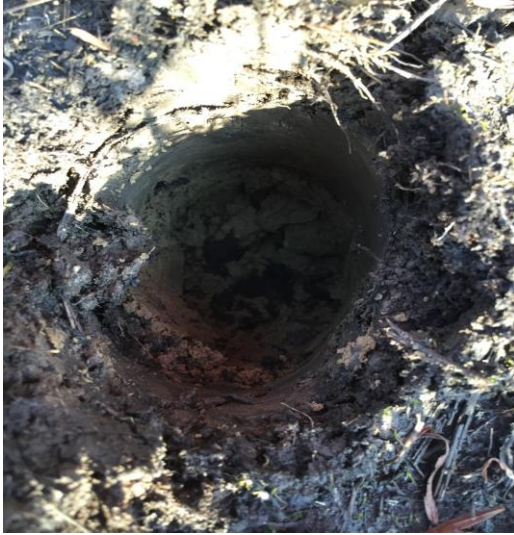
- The third sample, S3, was taken on the other side of the basin, 98 feet from the inlet using the same technique as sample S2.
- Sample S3 was a mixture of topsoil/sediment and lower soil. Most of this mixture was made up of lower soil. At this location there was only 1.5 inches of sediment.
- The lower soil was able to be formed into a ribbon.

Figure 8: Hole left after taking Sample S3

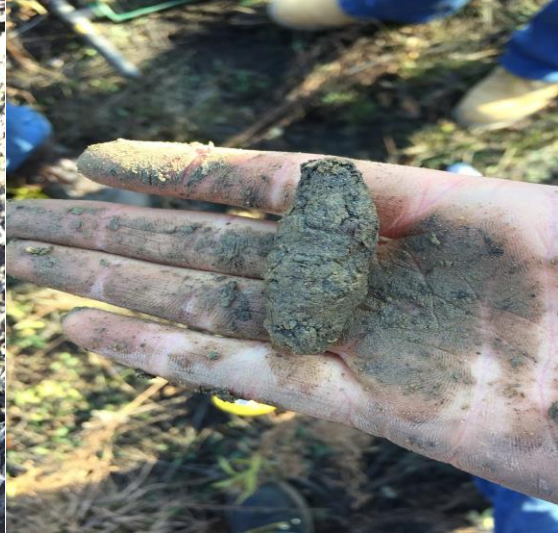
Figure 9: Sample S3

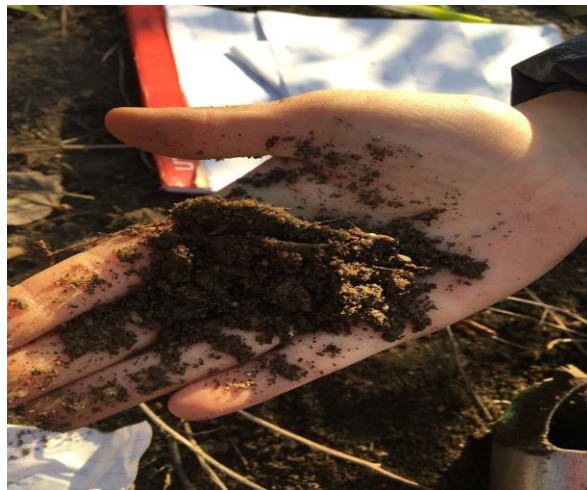
- The fourth sample, S4, was taken in the second chamber of the basin near the weir. It was taken 76 feet from the inlet using the same technique as sample S2. This soil was sandy and mostly dry and consistent. A hole 1.5 feet deep was dug and there was no noticeable change in the soil.

Figure 10: Sample S4

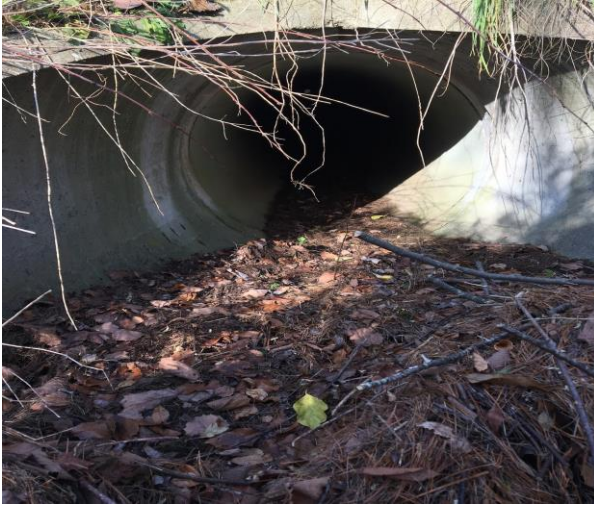
Figure 11: Dry Clean Water Bypass

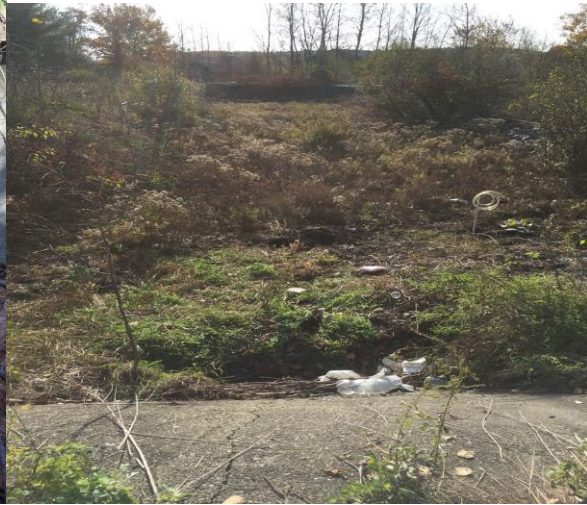
- The fifth sample, S5, was taken near sample S1 and S2. It was taken 17 feet from the inlet using the same technique as sample S2. This soil was all sediment. A 1.5 foot hole was then dug and it was observed that there was 11 inches of sediment before the lower soil.
- The sixth and final soil sample, S6, was taken outside the fence next to the concrete swale as a control. There was 9 inches of topsoil before sand was reached. Only the topsoil was used for the sample.
- Before the team left the site they located the clean water bypass pipe to see if there was water present that could potentially be tested. Unfortunately there was no water.
- The team looked at the inlet weir to assess the possibility of using sandbags to determine flow.

Figure 12: Inlet Weir

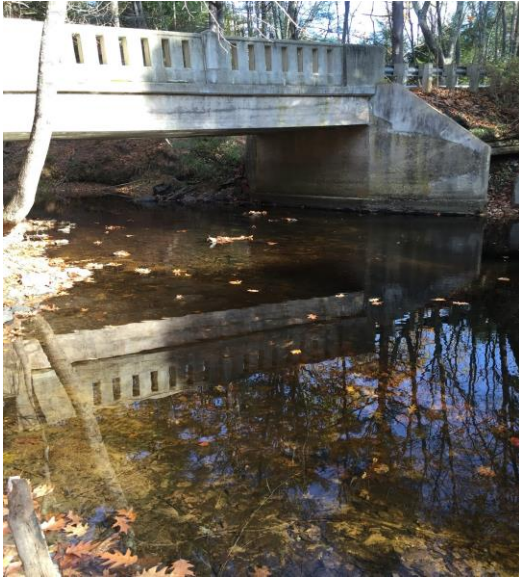
- On the way home from the basin the team stopped at three additional sites. Two sites were along the Stillwater Stream to take water samples and one was a spot along a stream that flows into the Stillwater stream to make observations.
- At the first location along the stream, upstream of the basin, samples A1-A2 were taken about 2 feet from the bank with sample bottle completely submerged in water. A liter bottle was used, A1, to test TSS and a 250 mL bottle, A2, was taken for the additional tests. The temperature was also recorded.

Figure 14: Stillwater Stream where A1-A3 was taken

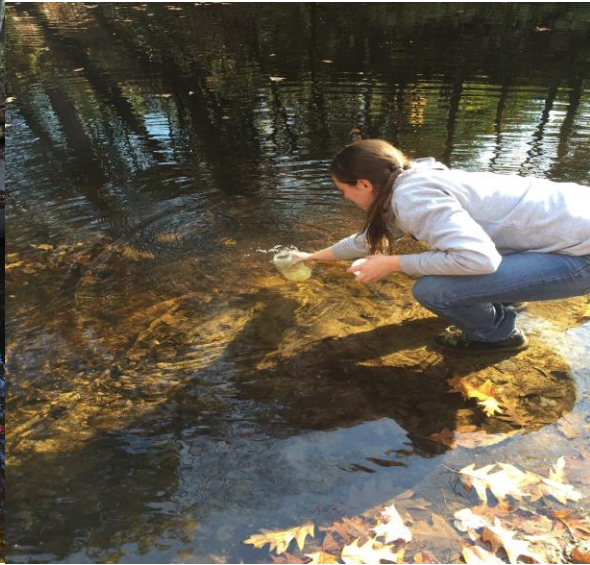
Figure 15: Sample A1

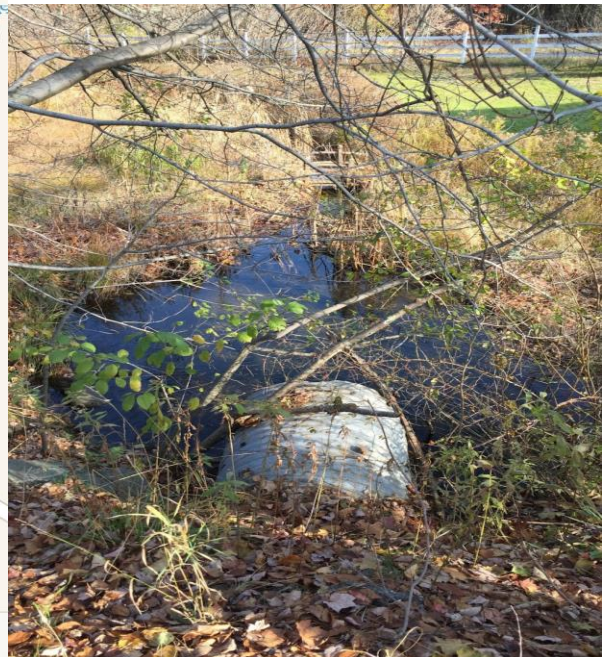
- The second location was along a stream that flows into the Stillwater stream to make observations. It was observed that the stream was flowing into the Stillwater at a fairly steady rate.

Figure 17: Stream

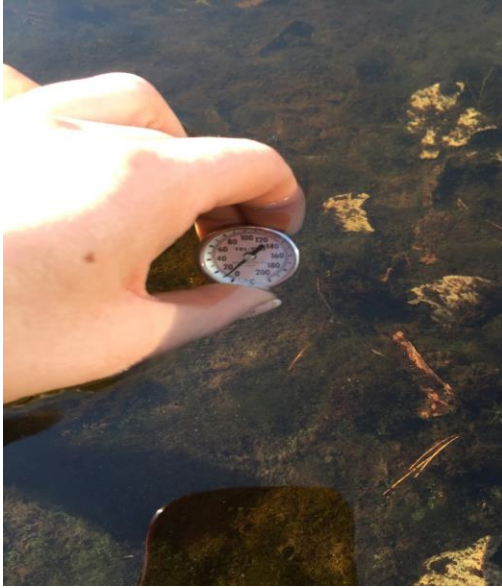
- The third location, downstream of the basin, at the USGS Stillwater sample location, samples A3-A4 were taken using the same method as the first location.

Figure 18: Temperature Reading

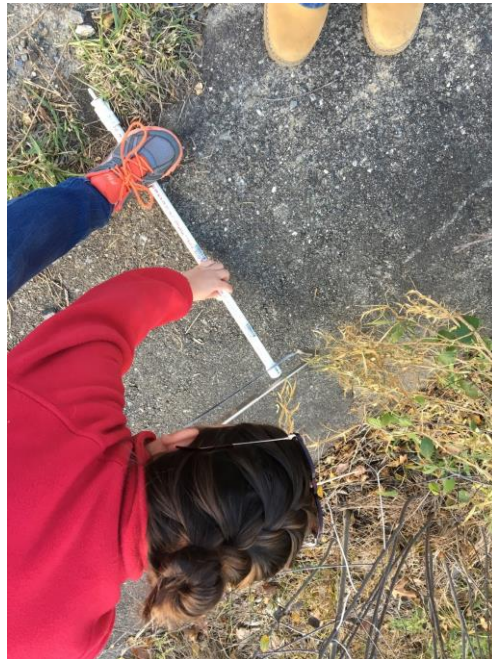
Figure 1: Cutting slits into groundwater devices

- Professor Mathisen prepared the materials for two more additional groundwater sampling devices prior to the field visit
- Mathisen brought two pvc pipes that have an interior diameter of .5" and a 1" nub on the bottom. The top was left open
- While at the site, Anna used a saw to make deeper slits in the bottom of the pvc pipe to allow for inflow

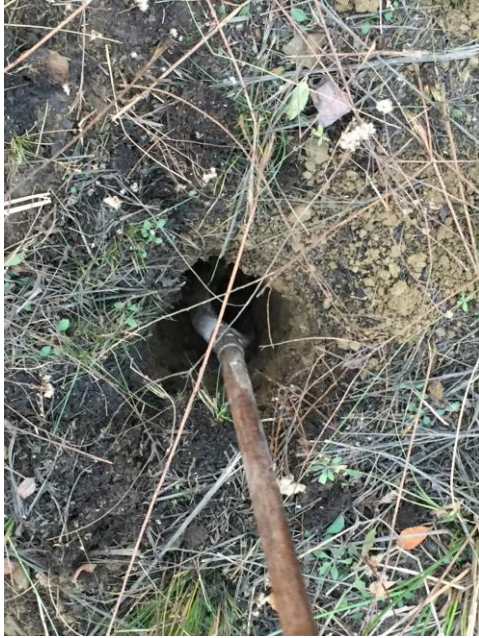
Figure 2: Coring device to dig hole

- At the groundwater sampling location a shovel was first used followed by a coring device to dig a hole to place the device in
- First device was placed in the first chamber in J8 at the depth of 15 inches
- Second device was placed in chamber two in H8 at the depth of 19 inches
- Once the groundwater device was placed in the hole, small pebbles were placed around the bottom to prevent clogging
- The hole was then filled back in with soil and the groundwater device was left until the first storm event

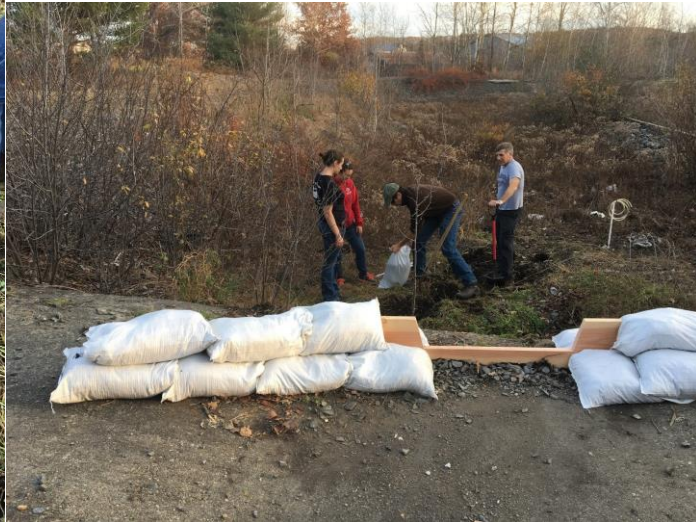
Figure 6: Setup of sandbags at weir

- Once the weir was built we placed it at the top of the cement inlet
- A level was used to ensure the weir was even
- Sandbags were filled with sediment from the basin and placed around the weir to hold it in place and build up the inlet so that all the runoff will be directed through the weir and we could calculate flow

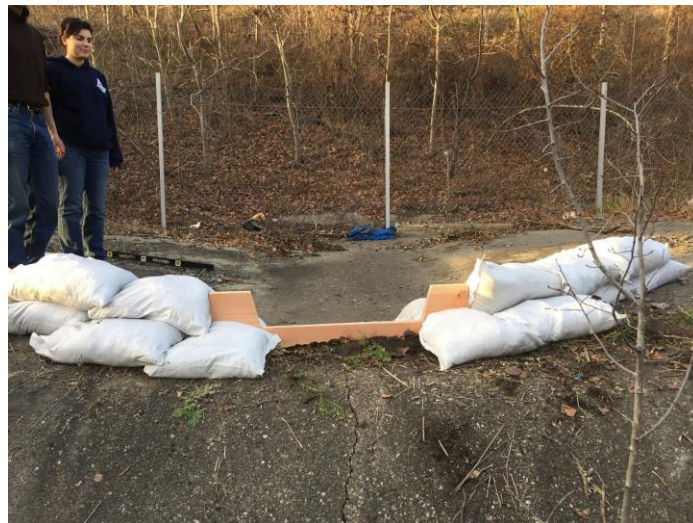
Figure 7: Completed setup of weir and sandbags

- The weir was left completely setup in preparation for storm event

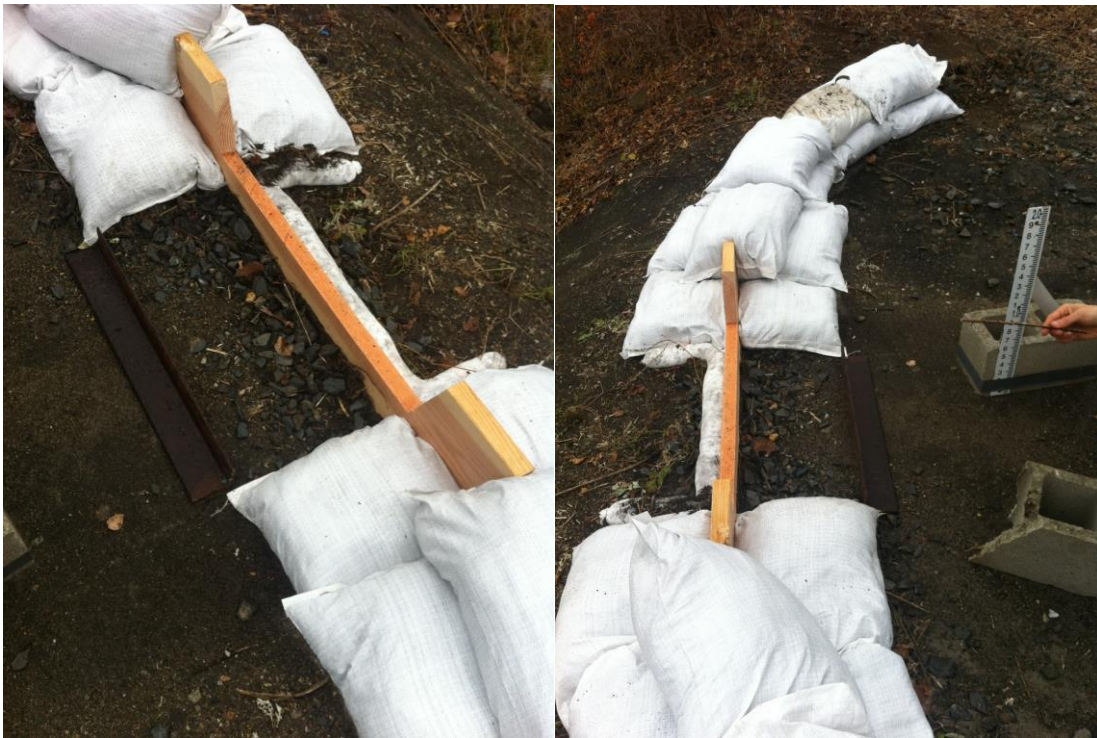
Figure 1: Top View of Weir Close up

- The wooden weir was surrounded by small rocks on both sides of the wood and sandbags on the side to make a pooling area. A metal “L” was placed in front to slow down the runoff. The “mesh bag” was placed on the down-gradient side of the weir to reduce erosive forces and prevent undercutting.
- Other metal pieces and concrete blocks were added to encourage pooling within the gauge pool.
- One concrete block had a staff gauge, which read in feet, attached to it with duct tape.
- A rain gage was also set up to measure precipitation.

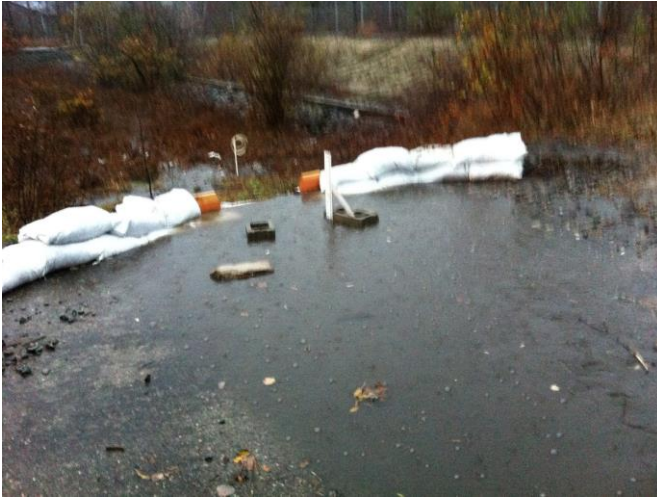
Figure 5: Basin during peak of the storm

- Samples were then taken every half hour
 - 3:15pm, 3:50pm, 4:15pm, 4:50pm
- The peak of the storm hit around 4:15pm
 - The water got its highest over the weir
 - Shown in Figure 5

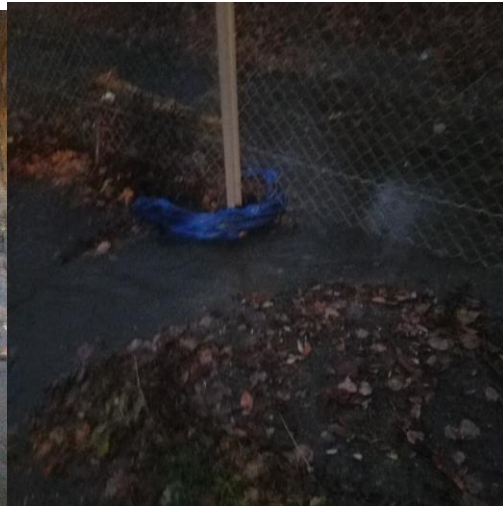
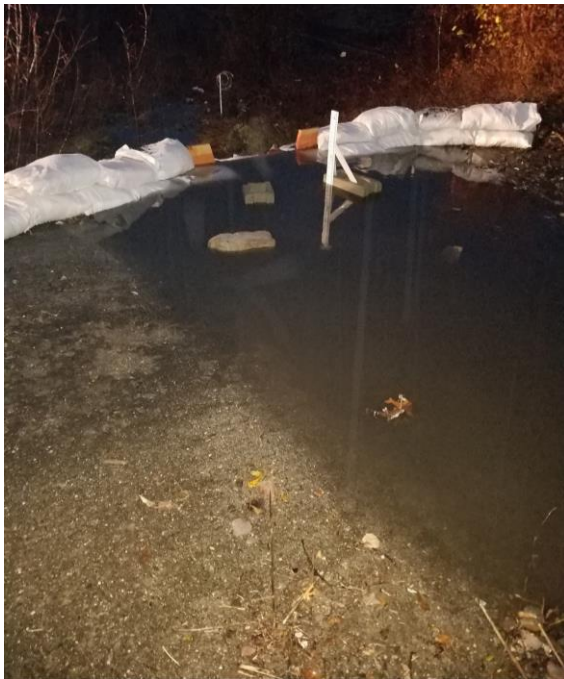
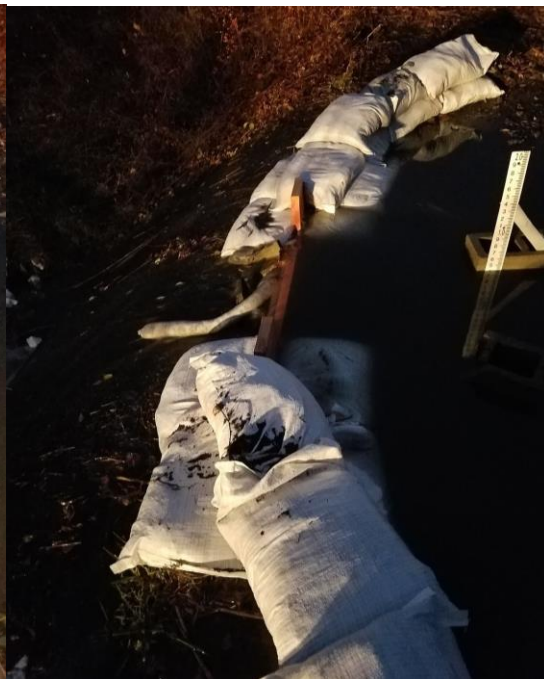
- Figure 6, 7, and 8 shows the site at the end of the sampling time
 - The sun had set so it was difficult to see
 - The back of the weir was a little damaged, most rocks were swept away with the rain
 - Sandbags worked but were saturated with water

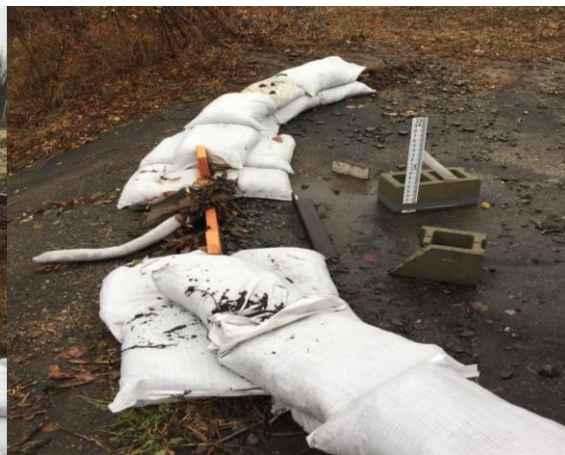
Figure 4: Damaged Weir

- Elizabeth, Julia, and Anna visited the site the morning after the first sampling storm to observe and take groundwater samples
- The first observation made at the site was that the second half of chamber 1 still had surface water present and there was a small pool of water in the second chamber near the weir
- The first half of chamber 1, by the inlet was moist but there was no surface water present
- The weir that was constructed by the team to determine flow, was observed to be slightly damaged and will need minor repairs and additional reinforcement prior to the next storm

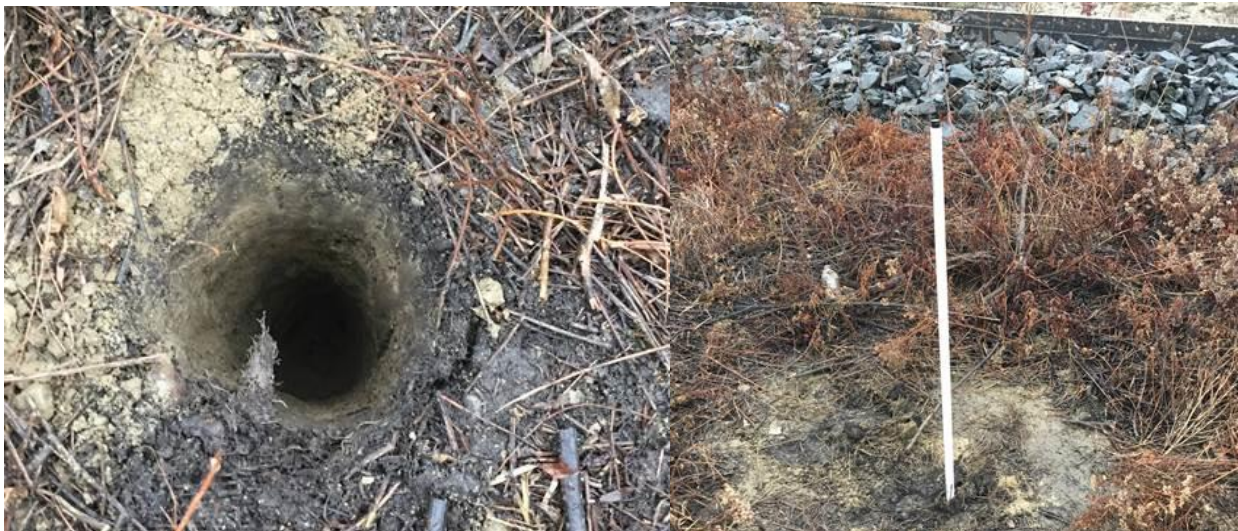
Photo 2: 2' Hole for Groundwater Well

- The rain gage was emptied before the start of the storm
- Vinny dug a 2 ft hole for a new PVC groundwater well in the first chamber
- The well was constructed using the same process as the wells currently in place
