Evaluating the Role of Stormwater Treatment Basins in Controlling Highway Runoff Quality

A Major Qualifying Project Report

Worcester Polytechnic Institute

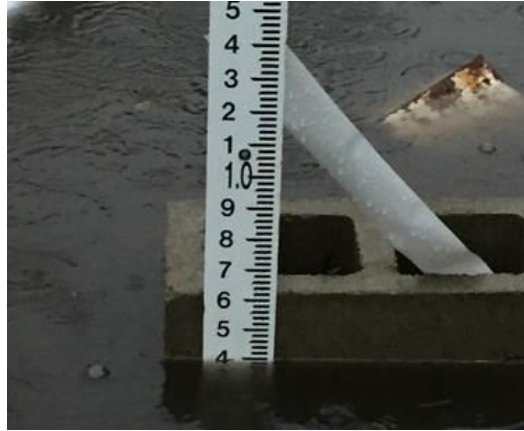
Photo 6: Example of Pool Height Measurement

- Steve arrived at site to see the layout of the weir, the groundwater wells and to observe our process for collecting samples
- Rain began at 10:45am but first sample was not taken until 3:07pm when a large enough pool had formed and the water started to flow over the weir
- The rain kept lessening and increasing from 10:45am-2pm and beginning at 2pm a steady rain storm had begun
- 3 samples were taken each time
 - 1 - 1 L bottle for TSS
 - 2 - 250 mL bottle for specific conductance and metals
- Other things noted
 - Height of pond
 - Temperature of water and air was noted
 - Amount of rainwater in gage was noted
- Samples were then taken every half hour
 - 3:38pm, 4:07pm, 4:40pm, 5:08pm and 5:38pm

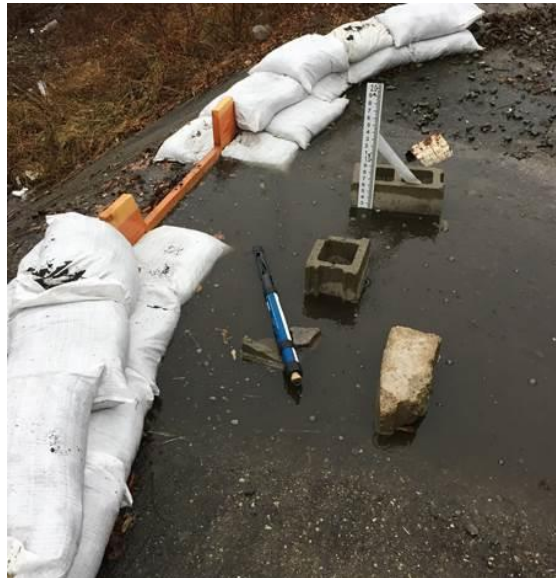
Photo 7: Hydrolab

Additionally at 3pm the hydrolab was placed in the pool area in front of the weir

- Around 10am the next morning, 11/30, Vinny picked up the hydrolab

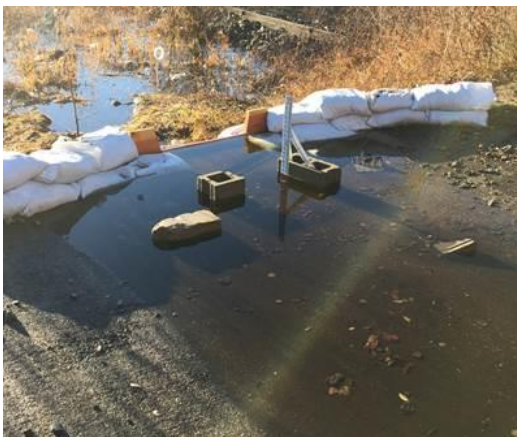
Figure 1: Pool Behind Constructed Weir

- Elizabeth, Julia, and Anna visited the site two mornings after the second sampling storm to observe and take groundwater samples
- The first observation made when arrived at the site was that there was still a small pool of water being restricted by the constructed weir
- The second observation was that all of chamber 1 still had surface water present and there was a small pool of water in the second chamber near the weir with flow entering the second chamber through a crack in the wooden weir separating the chambers
- There had been another storm the night before so the water observed in the basin was likely largely from that storm and not the storm samples

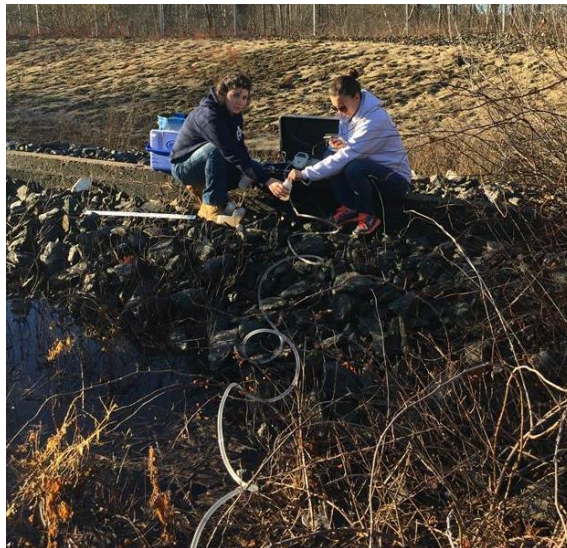
Figure 6: Sampling at Location 1

- After the team finished observing the site they began taking groundwater samples
- They took samples G13-G15 from the groundwater device in chamber 1 closest to the inlet. The groundwater device was surrounded by surface water
- The team hooked the pump up to the tubing that was already in the groundwater pump and took three flushes and then three samples. Only the three sample bottles were saved, the three flushed were poured out. The flushes were initially kept in case there was not enough water to fill three more bottles.

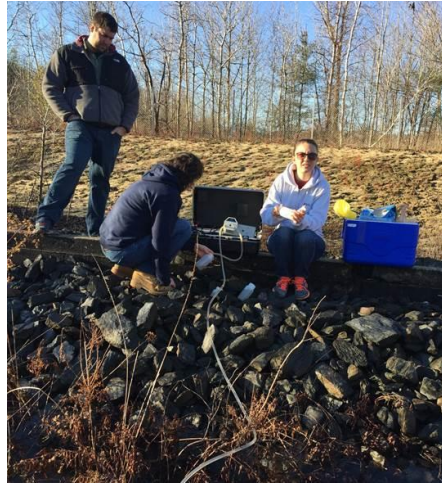
Figure 7: Sampling at Location 2

- While moving to sample at the second location Steve arrived to observe the groundwater sampling procedure
- At the second location in chamber 1, the newest groundwater device installed, samples G16

- G18 were taken. This groundwater device was also surrounded by surface water. At this location the team stuck a tube down the pvc pipe and hooked the pipe up to the pump. Again they took three flushes and three samples and only kept the samples.

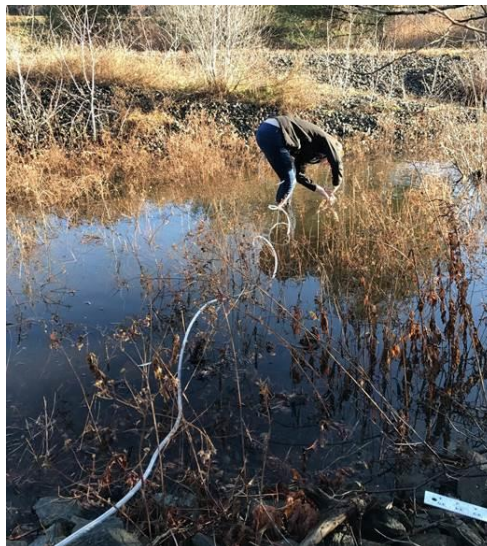
Figure 8: Sampling at Location 3

- The third location, Samples G19-G21, was in the middle of chamber 1, the furthest from the inlet in chamber 1. This location was surrounded by surface water that almost reached the top of the groundwater device. They then proceeded with the same process as location 2.

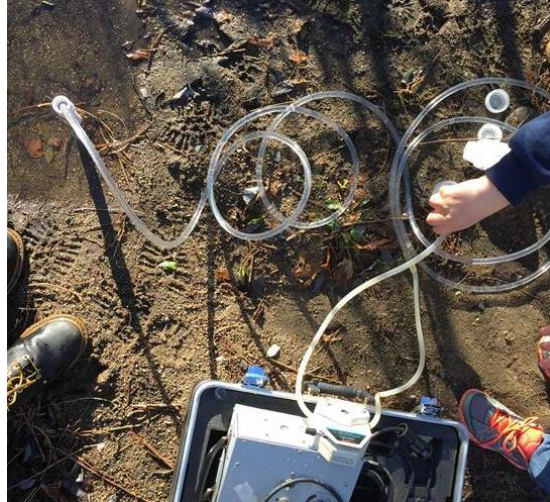
Figure 9: Sampling at Location 4

- The fourth location, chamber 2, Samples G22-G24 were taken. There was about an inch of surface water surrounding the groundwater device. The same method as in location 2 and 3 was used.

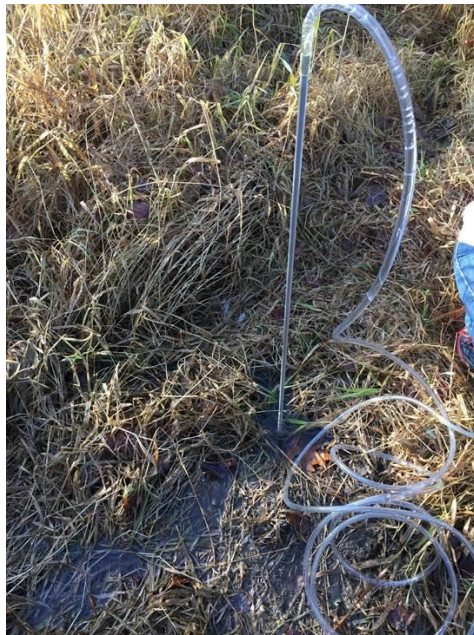
Figure 10: Sampling at Location 5

- For the fifth location the team had to walk on the outside of the fence to get to the groundwater device past the outlet of the basin where samples G25-G27 were taken. This groundwater device was different than the other three and the team had to attach the tubing to the metal rod. Only one flush was able to be taken at this site but the water was visibly clearer.
