High Energy Density Magnesium-Air Battery for Shipping, Rail and Aviation Electrification and Grid Storage

Worcester Polytechnic Institute

Major Qualifying Project

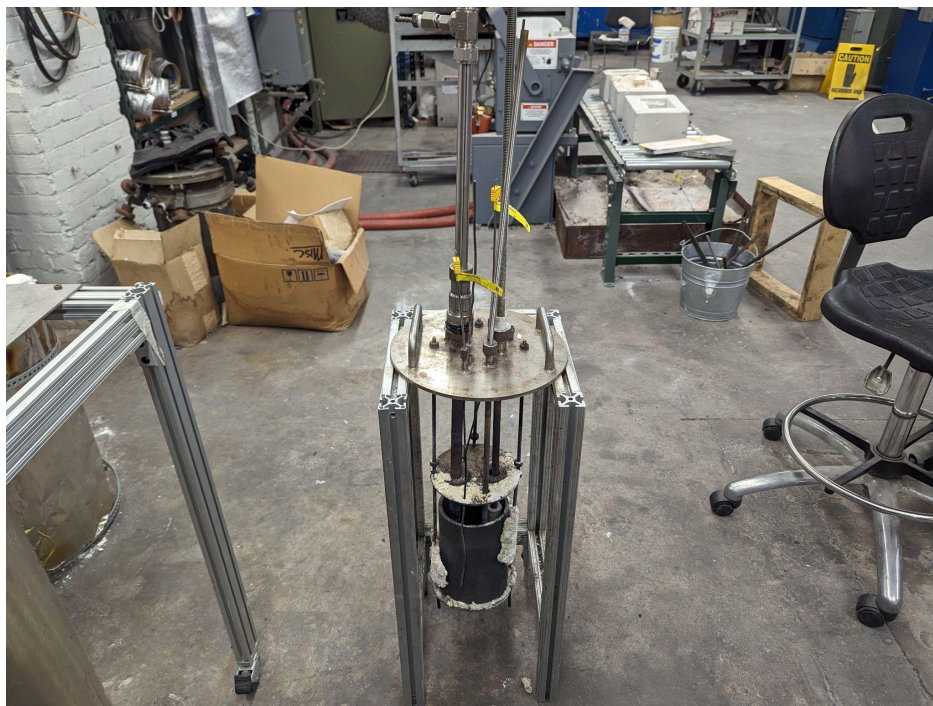
Image 1: Final setup of the Magnesium-Air Battery containment cage, including the cathode, anode, cold finger, and crucible.

of the cathode tube was cut off for subsequent mounting and optical examination. The cage after being removed from containment is shown in Image 1. Meanwhile, the mounted titanium and nickel mesh samples are seen in Images 12 and 13. These samples were then examined through surface metrology, which is discussed further in the results.

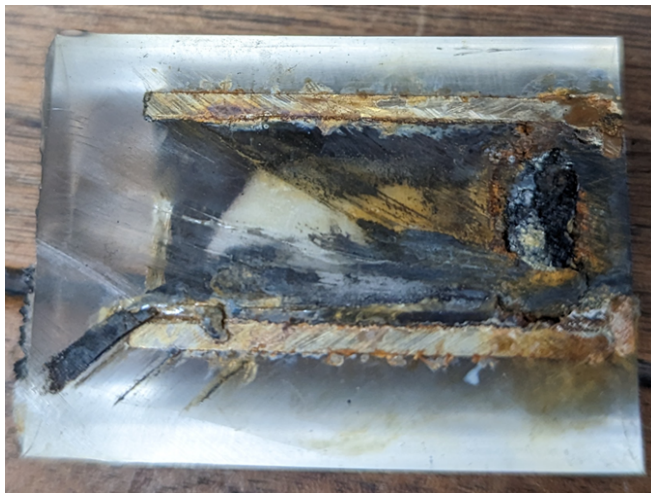
Image 13: Porous titanium cathode mesh sample from the second cathode test. The cathode was cut in half to reveal its cross section, as seen in the image.
