Reconstructing Sea Levels Prior to 1872 Through Venetian Art and Architecture

An Interactive Qualifying Project Report submitted to the Faculty of
WORCESTER POLYTECHNIC INSTITUTE
In partial fulfillment of the requirements for the Degree of Bachelor of Science

Project Center: Venice, Italy
Term: E04

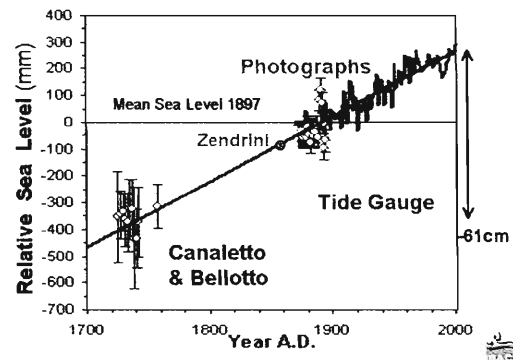
Figure 10- Camuffo's Data Coinciding with Tidal Data
Taking generalized error into account, Camuffo's study showed that it is possible to reconstruct sea levels using the artistic indicators of the 18th century.

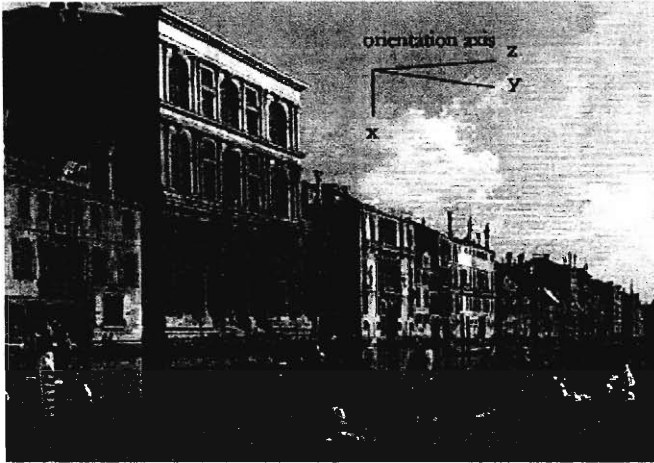
Figure 16 - Axial On-Site measurements

The next step is arguably the most important, since each indicator would be useless without the measurements that accompany them. Reference points predetermined from the initial visit to each site were made in two of the three dimensions of space. The first of which is along the z-axis, which extends from the viewpoint to the vanishing point. In the case of the view shown in *Figure 16*, the z-axis measurements are made along the foundations from each vertical line, as shown in red.

X-axis measurements are made as shown in red in the vertical directions. A smaller metric measuring device such as a meter stick, or short measuring tape is sufficient for the vertical measurements. These vertical measurements are crucial, and should be measured and documented to the nearest centimeter or millimeter to ensure accuracy. This x-axis measurement will be a crucial element when

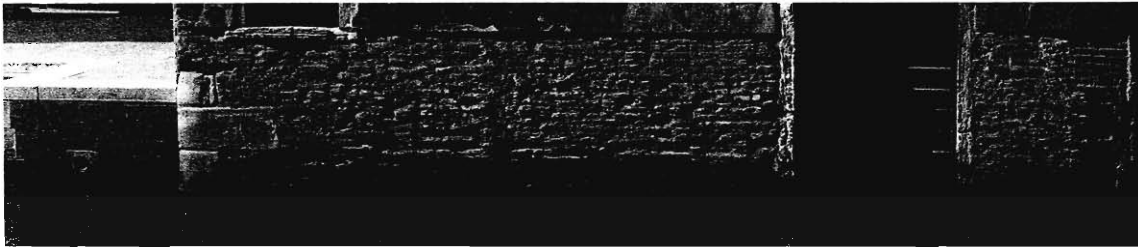
Figure 21 - Algae Line

All measurements in this study are referenced off of a naturally occurring, biological sea level indicator, the green algae line. This biological indicator is subject to a number of different variables which affect the way in which the organism proliferates, in turn affecting our measurements. The reliability of this study rests on the notion that all measurements in and around the green line are as accurate as possible. Hence, it is important to consider the possibility that the validity of measurements is threatened by many erroneous factors, which may culminate in one large margin of error for each statistical measurement.

There appear to be three main environmental factors which affect the naturally occurring algae line in Venice; sun light exposure, canal wall material composition, and waves created naturally or by boat wake. This “biological error” must be accounted for in all resulting measurements by performing a number of bio-statistic analyses of the organism’s reactions to different environmental variables.

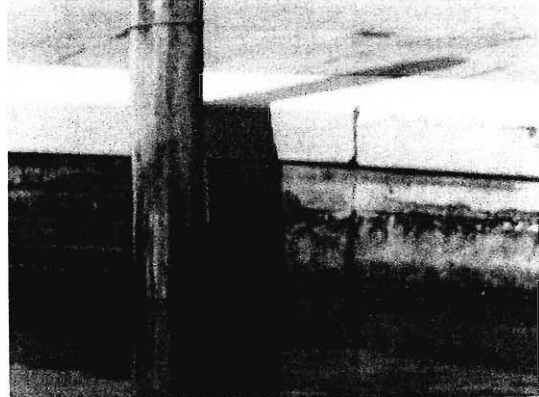
Figure 23 - Brick and Stone on a Canal Wall

The next variable to be examined is the canal wall material composition factor. Canal walls are commonly constructed with stone and brick. The algae grow on these materials, forming the green line used for all measurements in this study. Different materials in the green line however, may affect the rate at which algae grows. Because algae depend upon a moist environment in which to grow, one material may be more suitable to this than another, hence yielding a higher, or thicker green line. Brick, an inherently porous material, is hypothesized to be the more stimulating climate for algae.

The influence of building materials is tested in a manner that will isolate this variable from the other validity variables by using one side of a canal running east-west (to ensure that sun exposure is not a factor), or average wave height (to ensure wave height is not a factor) and measuring growth on two different types of materials. All measurements will be taken from areas of known elevation within the same canal. Thirty of the measurements will be on brick face and 30 on stone face, measuring from the current green line to the point of known elevation.

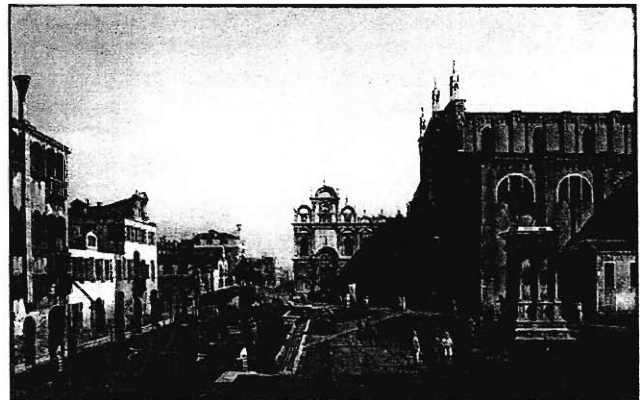
Figure 31 - P001b: Campo S. Giovanni e Paolo (Bellotto)

Bellotto also created the painting with index number P001b. Although it is of the same view as P001a, it was painted 6 years later in 1747. The same archway used in P001a was used for measurements in P001b (see Figure 31, red arrow). Using the scale formula in the same manner as in P001a, the waterline differential for P001b was found to be 72.97 cm. Applying the same absolute elevation formula, the absolute elevation was found to be -43.47 cm.

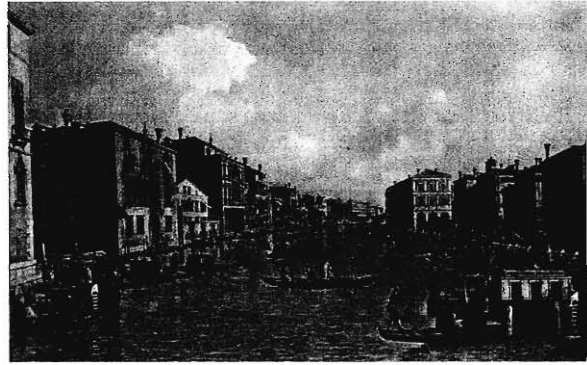
Figure 32 - P002: Grand Canal: From S. Sofia to Rialto (Canaletto)

Canaletto created this painting in 1758. The valuable green algae line is visible on the buildings on the left side in the painting. The building used for measurements was the second building in from the left, which today is the Foscari Palace hotel. Measurements used in the scale formula were off of the second window in from the left on the building (see Figure 32, red arrow). The

green line directly under this window is where the green algae line was measured from. Using the scale formula, the waterline differential at this site was found to be 58.6 cm (see appendix D, P002). The absolute height of the algae line in the painting was calculated to be -39.6 cm. Having been created in 1758, this painting is the youngest of the study. It was created nearly 20 years after S. Giovanni e Paolo; therefore its absolute was expected to be above that of S. Giovanni e Paolo. Site P001a was found to have an absolute elevation of -45.25, which is a 5.65 cm difference from this site.

Using the same .284 cm rise/year calculation that was found from S. Giovanni e Paolo, this site should be a 4.83 cm difference (.284 cm/yr x 17 yr) from S. Giovanni. Therefore the methodology still withstands within an error of less than one centimeter (5.65 - 4.82 = 0.83 cm).

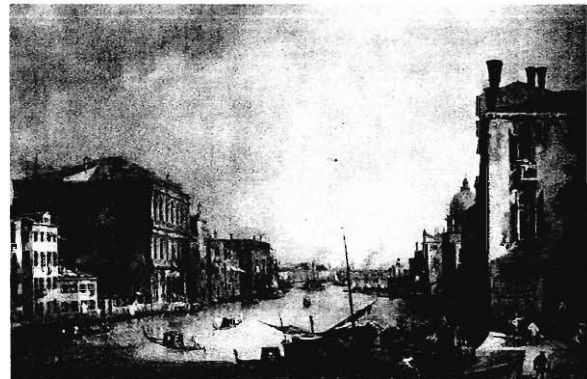
Figure 33 – Grand Canal: Looking East, from the Campo di S. Vio (Canaletto)

Canaletto created this painting from the Campo di S. Vio in 1725. The most visible green algae line is located on the buildings on the left side of the Grand Canal. The building used to take measurements from is the three-story building on the left (see Figure 33, red arrow). A vertical measurement was taken from the second window from the right. Then a measurement from the bottom of the window to the green line was taken. Using the scale

formula the waterline differential was found to be 73.0 cm for this site. Taking a measurement of 75 cm from the known elevation of the sidewalk in front of this building (105 cm) to the green line, an

absolute elevation of the green line was found to be -46 cm (*see appendix D, P003a*). This painting is the oldest used in this study and has the lowest absolute elevation, putting it as the first data point on the tidal progression graph.

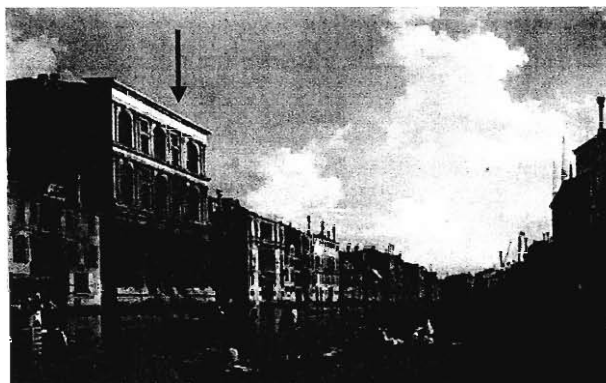
Figure 34 - Grand Canal: Looking South-West from the Palazzo Grimani to the Palazzo Foscari (Canaletto)

This painting site is located on the Grand Canal facing southwest from the Palazzo Grimani. The visible algae line can be seen on the buildings on the left side of the painting. The two first buildings from the left are those with the most visible algae line. The building with the orange tint color, first from the left, could not be measured from due to the construction of docks in front of the area where the algae line is visible. The next building from the left is the one that was used for measurement (*see Figure 34, red arrow*). The area measured was underneath the left-most window on the building. Using vertical measurements from the bottom of this window, a waterline differential of 58.6 cm was found from 1735 when Canaletto created this cityscape (*see appendix D, P005*).

To get an absolute elevation, the sidewalk in-between the two buildings on the left was used. The distance of the green algae line to the known elevation of the sidewalk was added to the waterline differential and then subtracted from the known elevation to get an absolute height of -45.6 cm from the zero line of 1897. This painting's absolute height should be lower than that of S. Giovanni e Paolo, which was created 5 years later. P001a's absolute elevation is -45.25 cm, which is a difference of less than one centimeter when compared to this site's absolute height. Therefore, the absolute heights are agreeable with the progression trend.

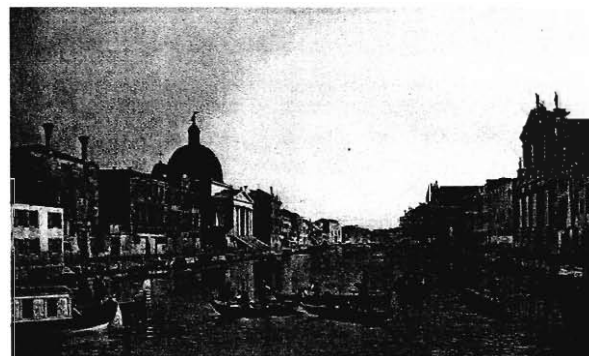
Figure 36 - Grand Canal: Looking South-West from the Chiesa degli Scalzi to the Fondamenta della Croce, with S. Simone Piccolo (Canaletto)

Canaletto created this painting of the Grand Canal near the Scalzi church in 1738. The area used for measurements is to the left of the painting. The horizontal of the low wall in between the two buildings on the left was used in the scale formula (*see Figure 36, red arrow*). The vertical from the sidewalk to the algae line was also used to get a waterline differential of 71.29 cm for this site. The

known elevation of the sidewalk (.92 m) was then applied to find the absolute elevation of the green line in the painting to be -41.29 cm. A waterline differential of 71.29 is a .268 cm/year rise in sea level, which is a difference of only .02 cm from that of S. Giovanni e Paolo's yearly sea level rise.

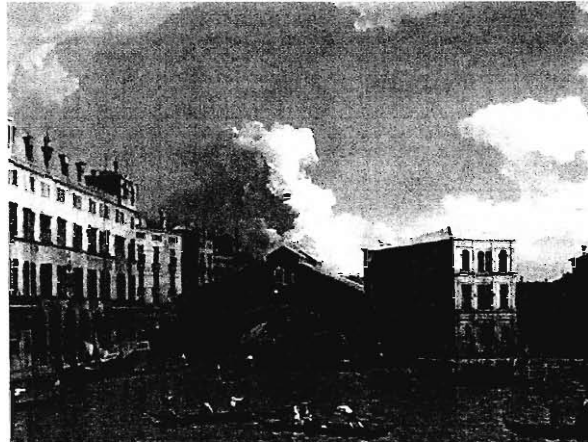
Figure 37 - Grand Canal: The Rialto Bridge from the North (Canaletto)

Canaletto created this cityscape in 1727. There are only two areas in this painting where the green algae line is visible. They are both located on the building to the left in the painting. The only accessible area where the algae is visible is under the railing on the right of the building (see Figure 37, red arrow). The window to the far right on this building was used for a vertical and horizontal measurement. When the scale formula was applied a waterline differential of 71.5 cm was found. In order to put this into absolute terms, the known elevation of sidewalk with the railing to the right was used. The resulting absolute height of the green line in this painting is -45.5 cm, which is agreeable with the year it was created.

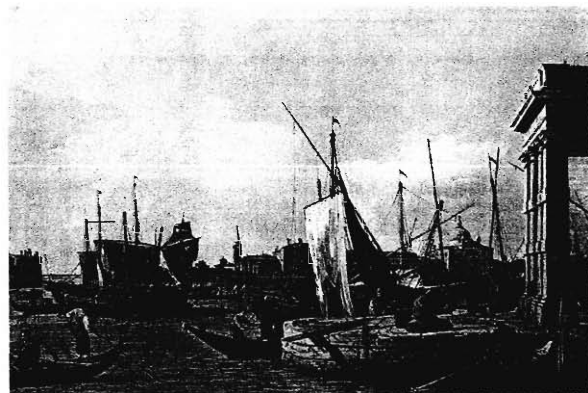
Figure 38 - Punta Della dogana (1727)

In addition to P009, Canaletto also created Punta Della Dogana in 1727. The punta still exists today, however there are some things that have changed. Most changes are not visible to the naked eye, but the level of the fondamenta on the punta has been raised by over 20 cm. However, measurements were still taken at this site. The height and width of a section of the near-most column was taken and scaled with a

measurement from the fondamenta to the green algae line. Since the fondamenta has been raised, the changes needed to be made to the measurements (see note in appendix D, P010). The resulting waterline differential was found to be 69.5 cm. Using the known elevation of the punta, the absolute elevation of the green line was found to be -37.5 cm. However, these results are very skewed.

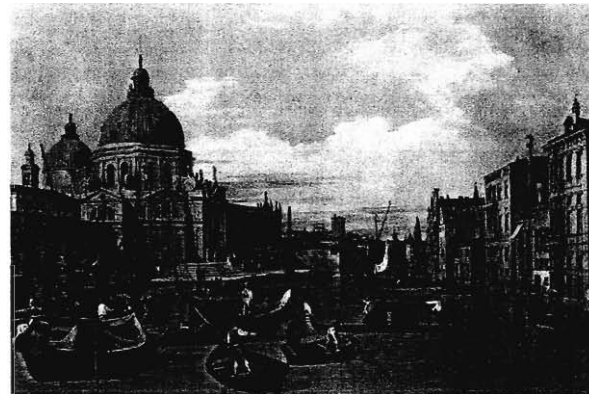
Figure 40 - The Grand Canal and the Church of the Salute (1730)

Canaletto created this painting in 1730. There is a visible algae line along the steps in front of the church of the Salute (see Figure 40, red arrow).

The measurements needed for the scale formula were taken off the church of the Salute under to windows to the left. The main vertical measurement that was put into the scale formula was taken from the top of the stairs to the bottom of the stairs. Then a measurement was taken from the bottom of the stairs, which is also the sidewalk in front, to the green algae line. A waterline differential of 72.57 was then determined from the scale formula. In order to find the absolute height of the algae line in this painting the known elevation of the sidewalk in front of the church was used. The resulting absolute height was found to be -48.57 cm (see appendix D, P011).

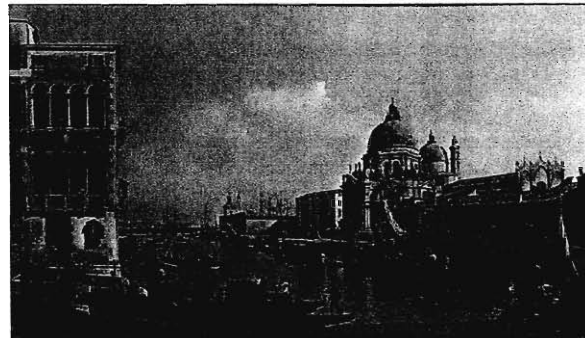
Figure 41 - Entrance to the Grand Canal (1741)

Bellotto created this painting in 1741 looking south towards the Entrance to the Grand Canal. One area that the green algae line is visible is located on the convent to the right of the painting. However, the convent no longer exists so that algae line could not be used. The usable algae line is located on the building to the left of the painting, just underneath the dock. The door on the first floor of this building still exists today as it was in the painting and it was used for measurements. Using a vertical on the door, and a vertical from the sidewalk at the bottom of the door to the algae line, the waterline differential for this site was found to be 70.25 cm (*see appendix D, P012*). Using the known elevation of the sidewalk, the absolute height of the algae line in this painting was found to be -44.75 cm.

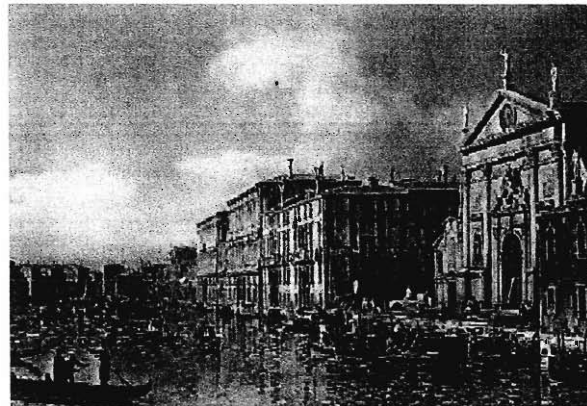
Figure 42 - P014: Grand Canal: Near S Stae Church

Site P014 is located near San Stae church on the Grand Canal. Bellotto painted this cityscape in 1740. The visible algae line in this painting is located on the red building on the right side of the painting. The building has not changed since the time of the painting so it can be used for measurement. The object measured was the window on the bottom-left of the building (*see Figure 42, red arrow*). A vertical and horizontal measurement was taken of the window and the distance from the bottom of the window to the green line. Using the scale formula, the waterline differential for this site was found to be 77.27 cm. In order to get the absolute elevation of the green line, the known elevation of the sidewalk next to the building was used. The absolute elevation was found to be -42.27 cm for this site (*see appendix D, P014*). This elevation is slightly lower than that of P001a (S. Giovanni e Paolo), which appears to make it accurate because it dates prior to that of P001a (1741).

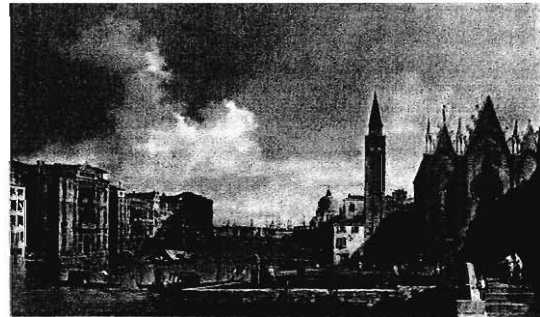
Figure 43 - P004: From Sta. Maria della Carita to the Bacino di San Marco

Canaletto created this painting in the early 1730's. There are a large number of changes in the present that occur from this painting. The spires on the church are gone and the bell tower is completely removed. The visible algae line in the painting is on the wall of the sidewalk foremost in the painting. This area has been completely covered up and extended out and the bridge is gone on the right. Measurements were taken at this site regardless, but there were not feasible results that could be formulated because too much has been altered in the painting.

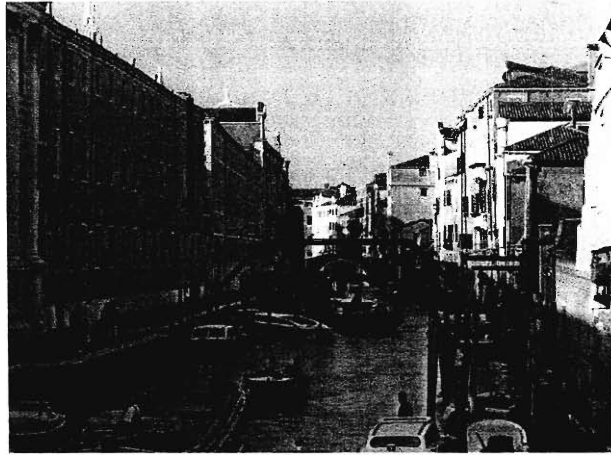
Figure 45 - Rio di Mendicanti Present-Day view

Also, to the right of the archway on the long building on the left there are four windows, however today there are only two windows and they have arches at the top. The only algae line in the painting is along the sidewalk, which today has been raised due to rising water levels. As a result, there is no place to take an accurate measurement from, and no accurate algae line to measure to.

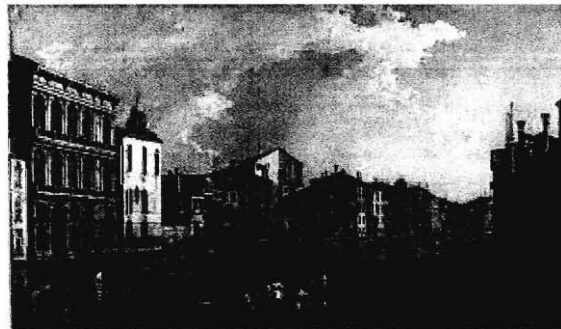
Figure 48 - Grand Canal: Looking East from the Palazzo Flangini to S. Marcuola (Unknown)

It would appear that this painting would be usable, but after further analysis it was deemed unusable for a few reasons. First of all, the date that Canaletto created this painting is unknown. Without the date of the painting, it would be impossible to put the

results on the tidal progression line. Even if the painting was dated, there still exist other factors to why it cannot be used. The first building on the left now has a wave blocker on the bottom of it (see Figure 48, red arrow). This blocker is simply a large piece of stone placed right above the water line. Not only does this prevent waves, but also algae growth. Therefore, there is no algae line on this building and it cannot be measured from. The only other building in the painting with an

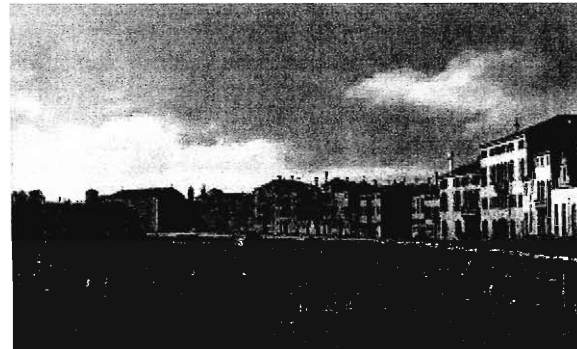
Figure 50 - Canale di Sta Chiara: Looking South-East along the Fondamenta della Croce (unknown)

Canaletto created this painting of the area near what are now Piazza le Roma and Ferrovia. The main problem with this painting is that the date of its creation is unknown. It would be impossible to put this painting on the tidal progression line without a known date. Also, all the buildings on the right side of the Grand Canal in the painting are gone and the train station is now in their place. This means the only algae line left to use would be that on the wall to the left. However, the line in the painting is very faint and there it is also possible that the wall has been reconstructed or raised since the creation of the painting. With all of these factors, especially that the painting is not dated, it is not possible to achieve accurate results.

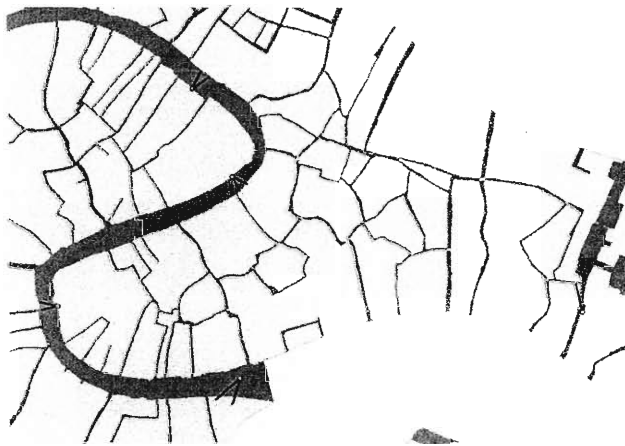
Figure 52 - Map of Usable Photograph Locations

changes in the waterline since the original date of the photograph, construction impeding accurate measurements, lack of access to the building or algae line for proper measurements, and extreme changes such as buildings that are no longer existent. Those photographs affected by these problems are shown in green in *Table 7*.

The remaining photographs were deemed reliable, and fit the necessary criteria for this study. Those not dismissed are shown on a map in *Figure 52*. All 5 of the remaining photographs are described in more detail in the following sections.

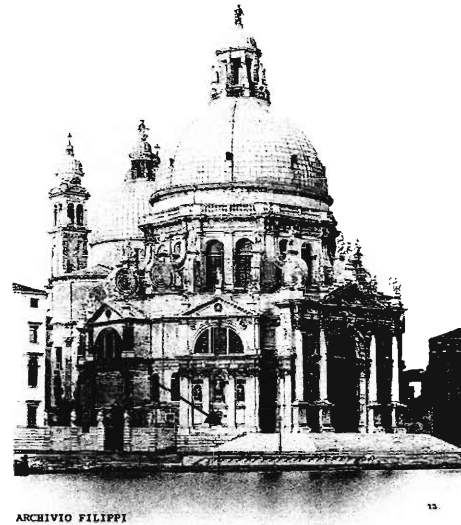
Figure 53 - F001 The Salute (1860)

The first photograph, given index number F001, is of the Salute, located in Sestier Dorsoduro. This photo was found in the Archivio Filippi²⁵, and represents the earliest photograph in this study, from 1860. The visible and usable algae line in the painting comes from the front of the Salute. On-site measurements were taken from the area under just to the left of the front façade, facing the direction of the camera. (see Figure 53, red arrow). The column on the far right of that face was used as a horizontal reference, while the distance from the column to the sidewalk with a known elevation was used for a vertical reference. The final vertical measurement was taken from the sidewalk of known elevation to the top of the green line (see appendix D, F001). Using these measurements and the scale formula, a waterline differential of 33.9 cm was derived. This translates to a 33.9 cm rise in sea level since 1860. Yearly, this averages a rate of approximately 0.252 cm per year. This numerical rate of increase is similar to the .23 cm per year generally accepted by researchers.

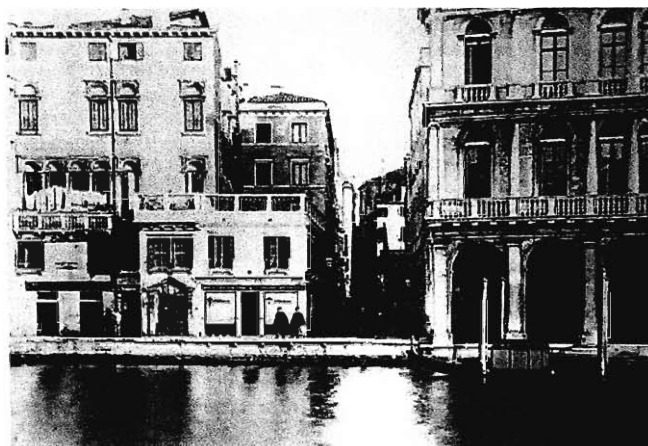
Figure 55 - Palazzo Manin (1867)

The third usable photograph, given index number F003, is of Palazzo Manin, located in Sestier San Marco. This photo was found in the Archivio Filippi, and is reported as being taken in 1867²⁷. The visible and usable algae line in the painting comes from the Grand Canal wall left to right.

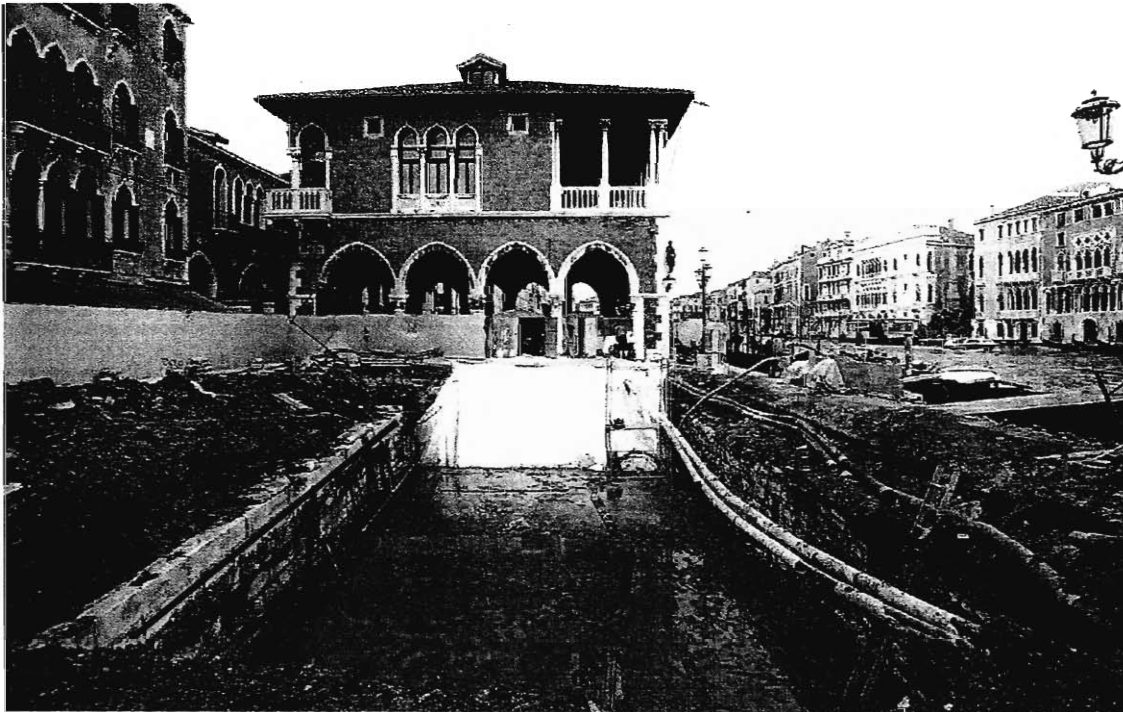
Figure 86 - Excavation at Rialto Pesceria

An excavation in 2000 in the area under the Rialto market turned up areas of interest with respect to barnacles. The original canal wall lining the Grand Canal was filled in with dirt and stone in 1398, freezing the wall in time exactly how it existed. On this wall there exists a line of barnacles that were cemented in place and “frozen in time” (see *Figure 86, red line*).

The barnacles at this excavation site were measured to be approximately 50 cm below the zero line of 1897. Theoretically, it is possible to measure how far from the green algae line barnacles

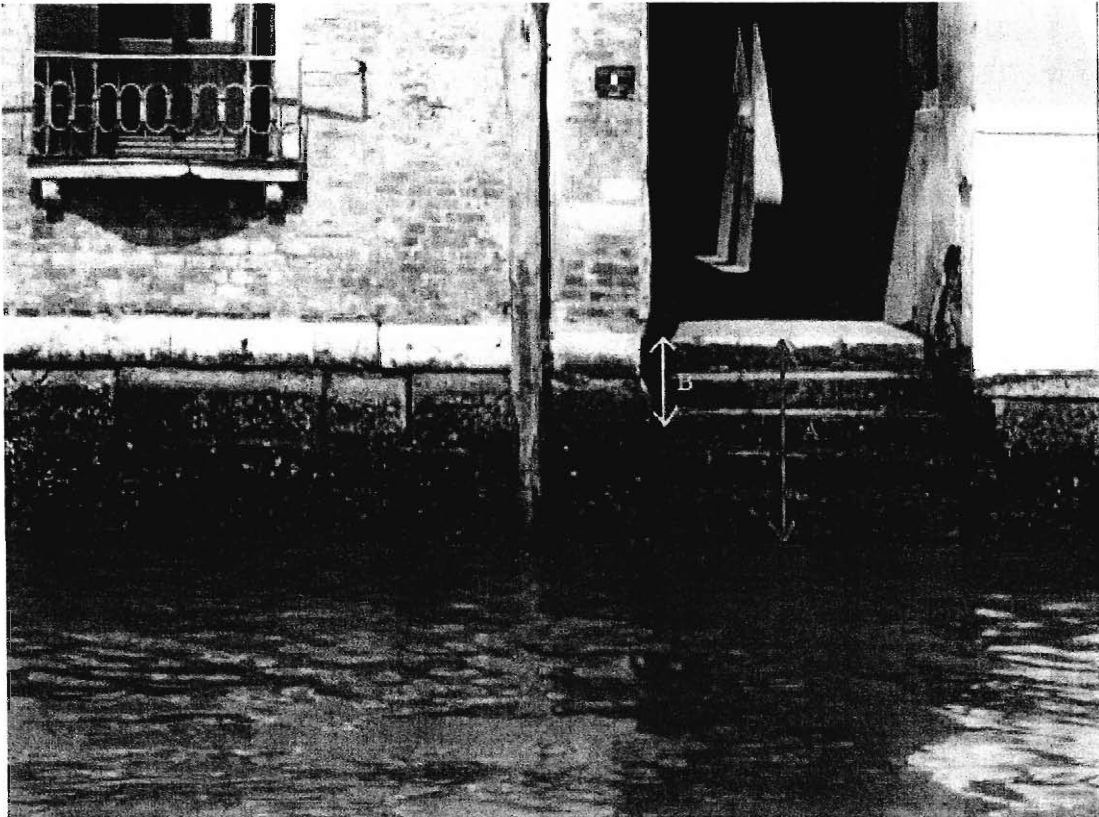
A is the know elevation of the sidewalk from the zero line established in 1897.
B is the distance measured from the sidewalk to the green line.

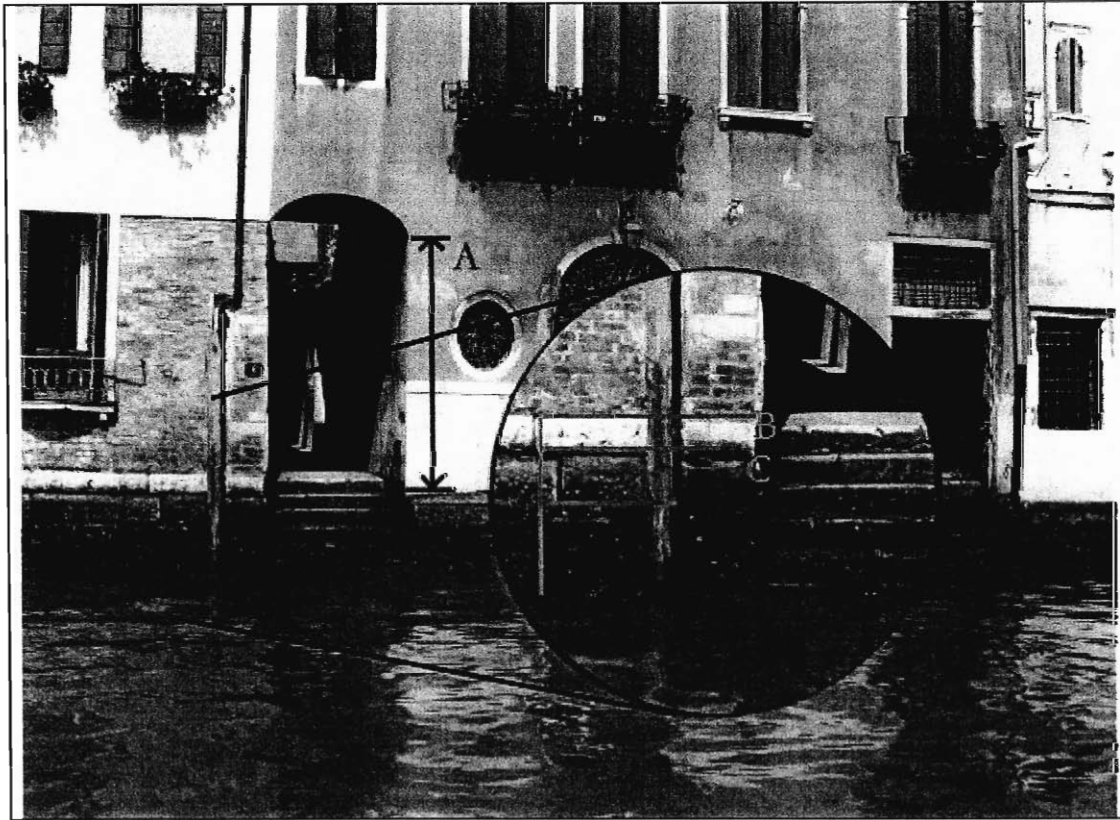
Figure 1
Drawing of measured objects

Section	Description	Value
A	Vertical Height of Archway	301.0 cm
B	Distance from top of black line to brickwork	12.0 cm
C	Distance from top of green line to brickwork	43.5 cm

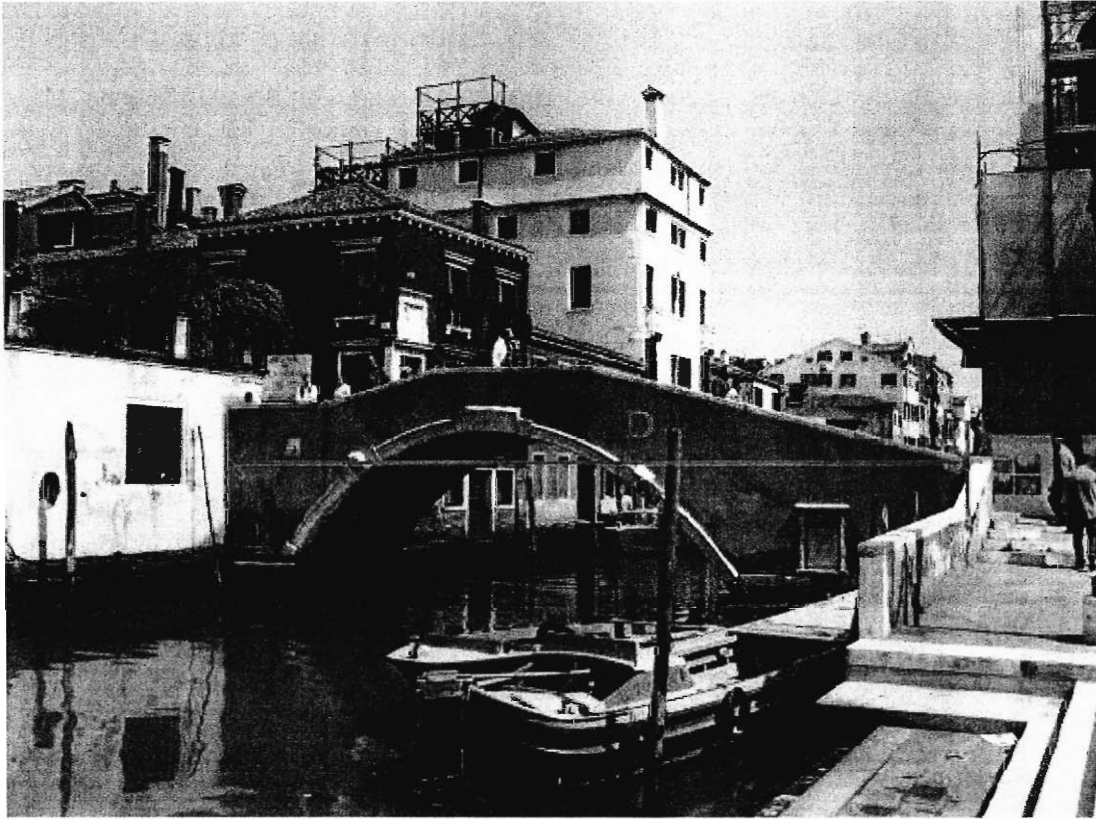
Section	Description	Value
D	Horizontal Length of Bridge

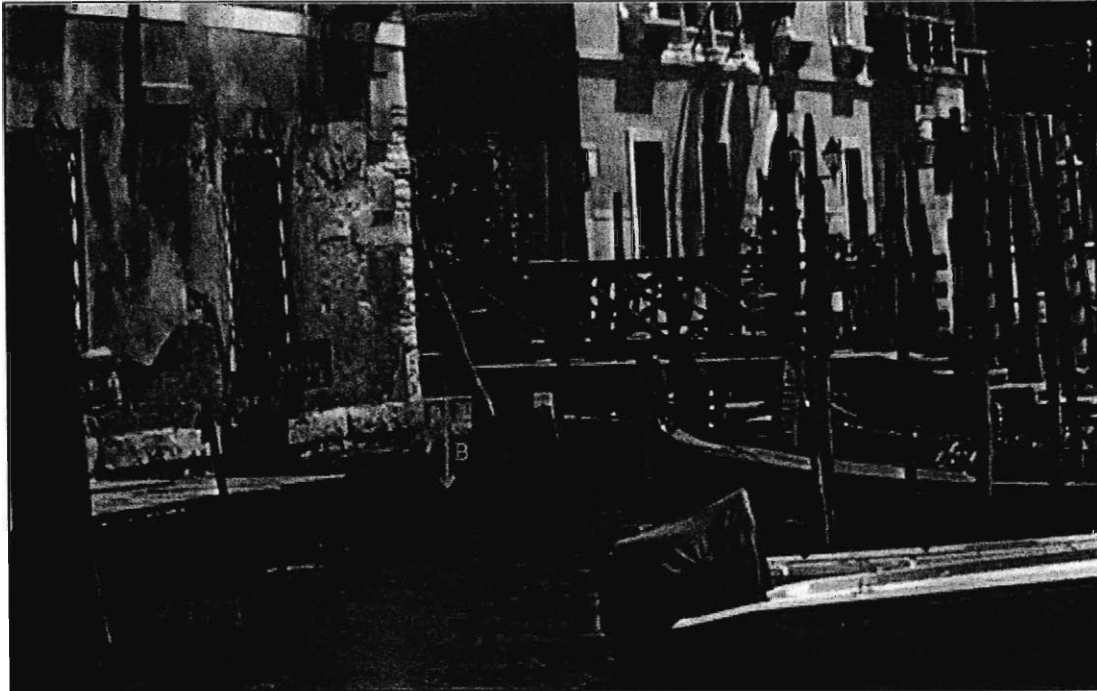
A is the known elevation of the sidewalk from the zero line established in 1897.
B is the distance measured from the sidewalk to the green line.

A= 99 cm

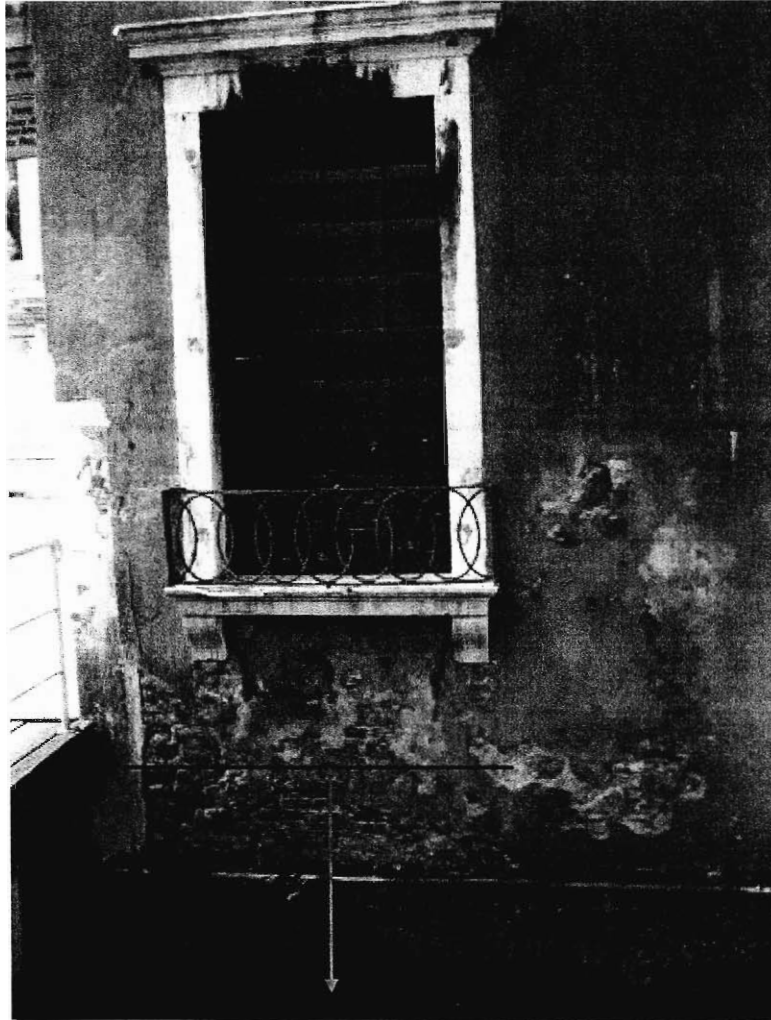
The red line represents the known elevation, which is 1.55 m.
