# Improving Visitor Experiences and Water Quality in Ugra National Park, Kaluga

Interactive Qualifying Project Report completed in partial fulfillment of  
the Bachelor of Science degree at  
Worcester Polytechnic Institute, Worcester, MA

Ugra National Park

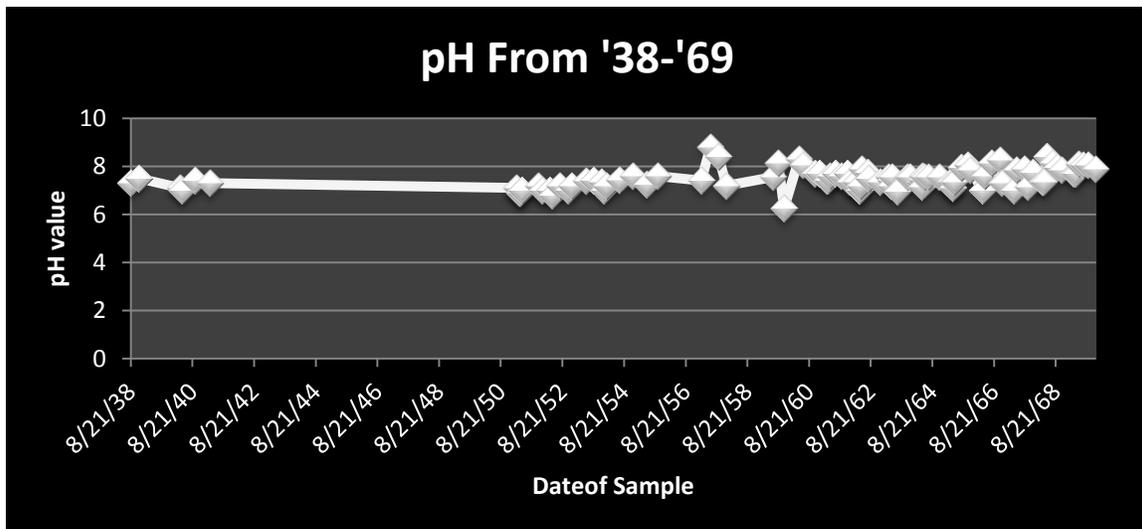
*Chart 1: A line graph displaying the linear quality of the pH levels in the Ugra River from 1938 to 1969 (Ugra National Park, 2013).*

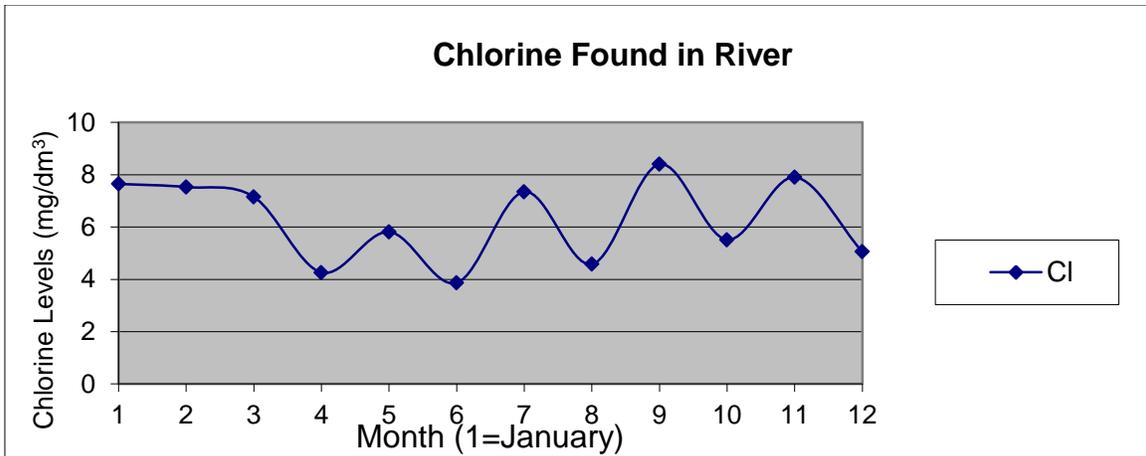
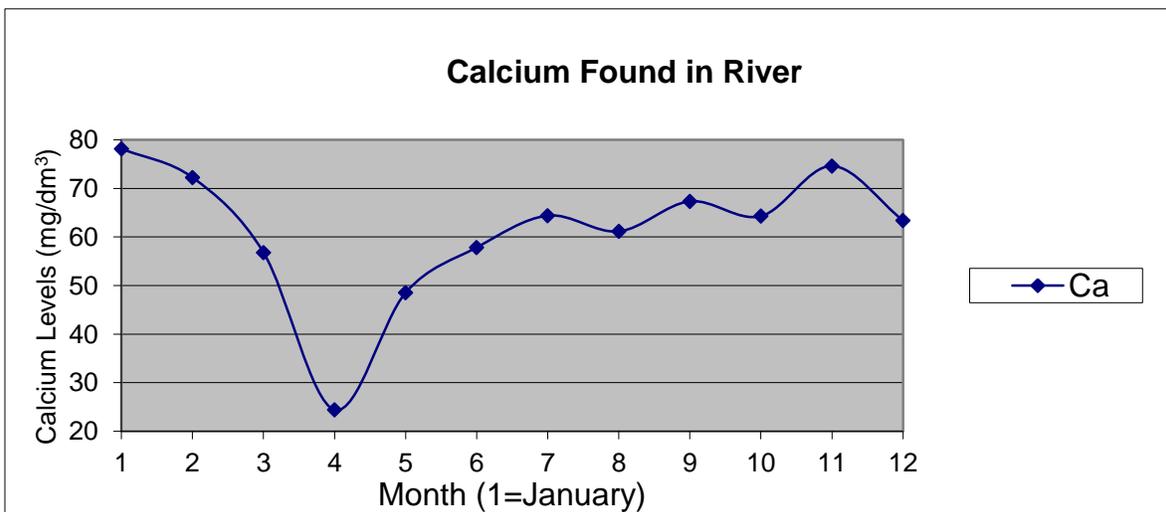
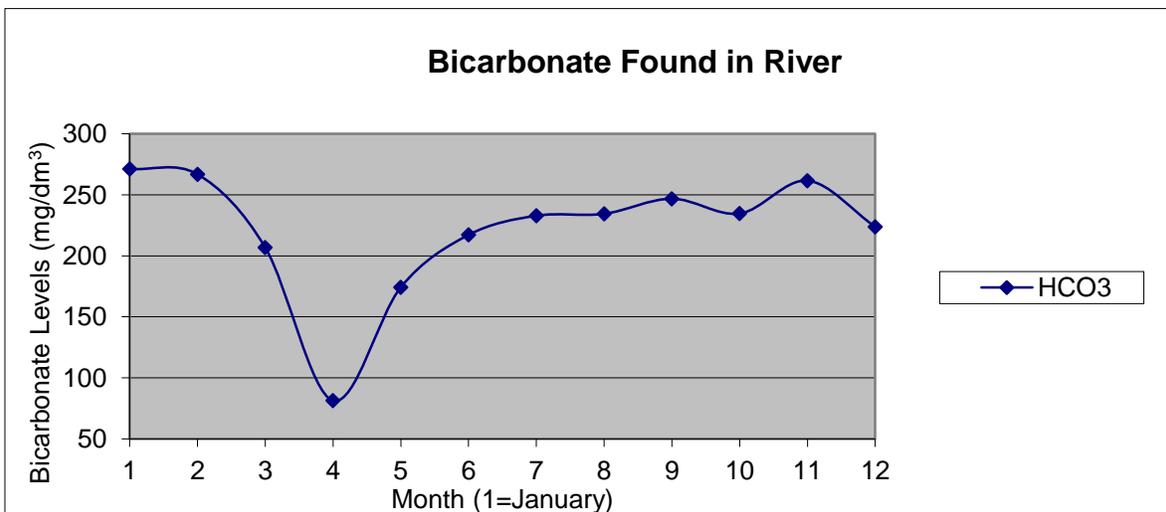
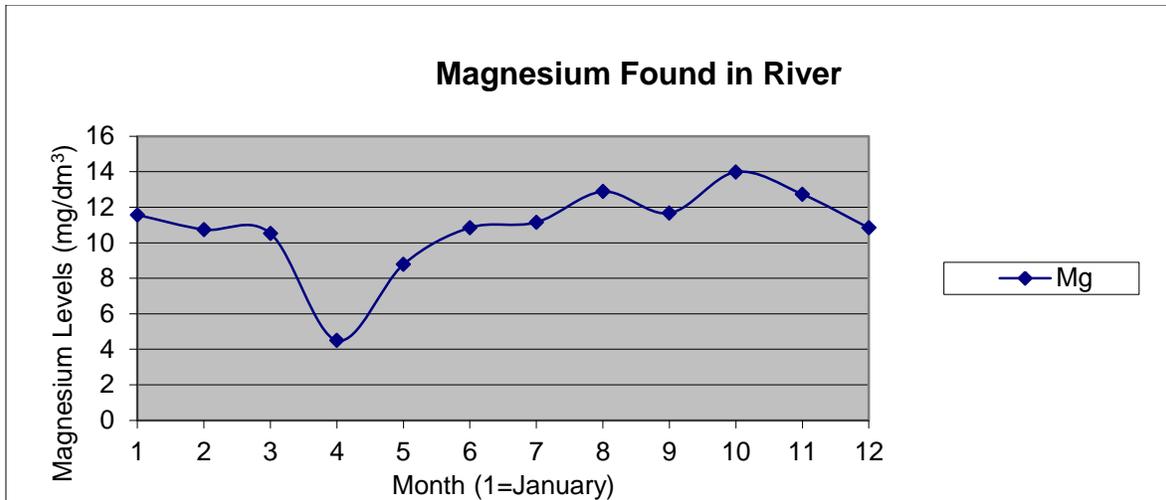
*Chart 3-6: These graphs display the average data per month of chlorine, calcium, bicarbonate and magnesium respectively (Ugra National Park, 2013).*

Most of the above graphs, while differing in terms of the elements they describe, show a downward trend in the month of April. This could very well be caused by an influx of melted ice from diluting the solutes. When the ice melts in the spring fresh water runs down into the rivers. If there is no comparable rise in the solutes to go along with the rising water, their relative amounts will decrease. In terms of the units calculated, (mg/dm<sup>3</sup>), the decimeter<sup>3</sup> volume of water would increase but the milligrams of chemicals would stay the same. With the bigger denominator, the total value of the solutes/water would decrease as shown in the graphs above. Even though this data shows the elements in the water, it does not specifically give us an idea of where the contamination is coming from. Since the samples were only collected at one point on the river, there is no comparison data. If the data showed information from a location before the contaminated tributary and then again after, it would be easy to see if there truly was contamination. Any significant changes could be attributed to the water flowing in from the tributary and contamination could be retraced to a specific source. At present, the park rangers

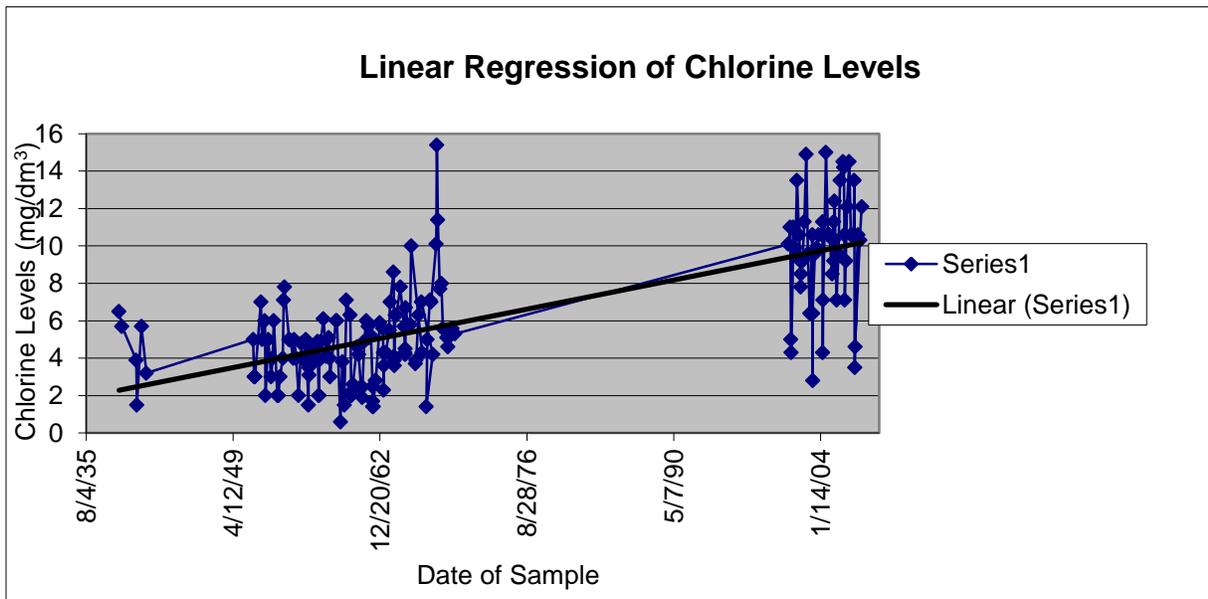
Chart 7: This graph displays the linear upward trend of Chlorine levels on top of the original datum points (Ugra National Park, 2013).

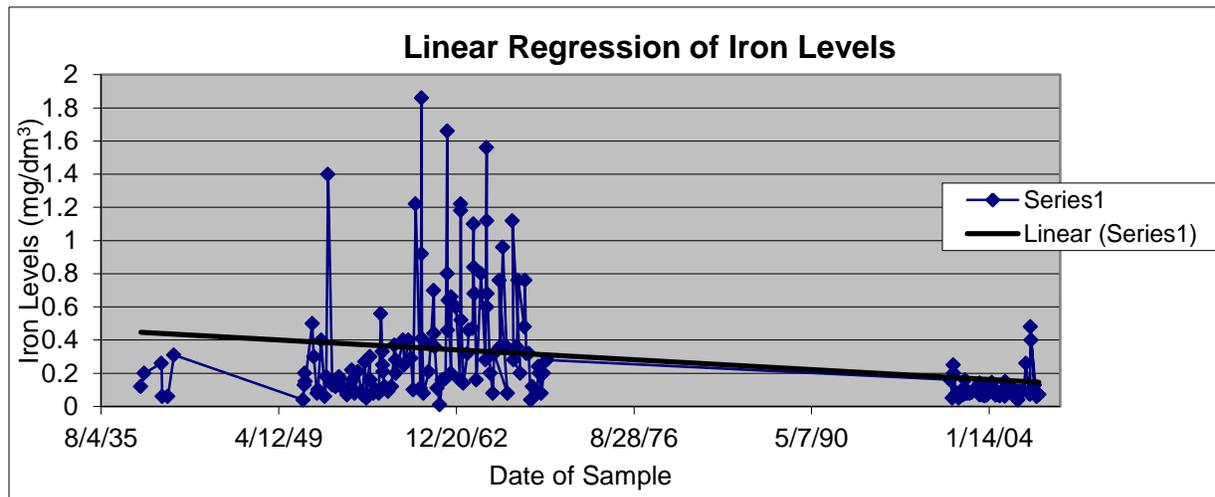
Chart 8: This graph displays the linear downward trend of Iron levels on top of the original datum points (Ugra National Park, 2013).

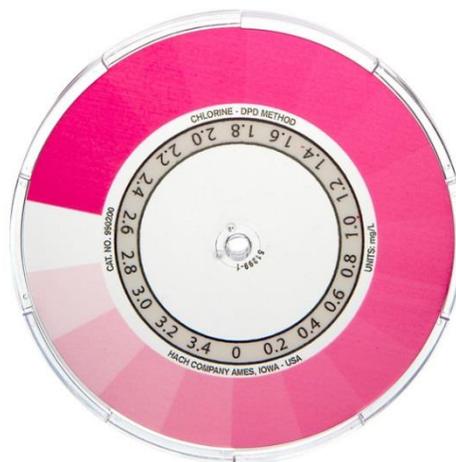
*Figure 4: This color wheel will indicate the amount of chlorine in a given sample (HACH, 2013b).*

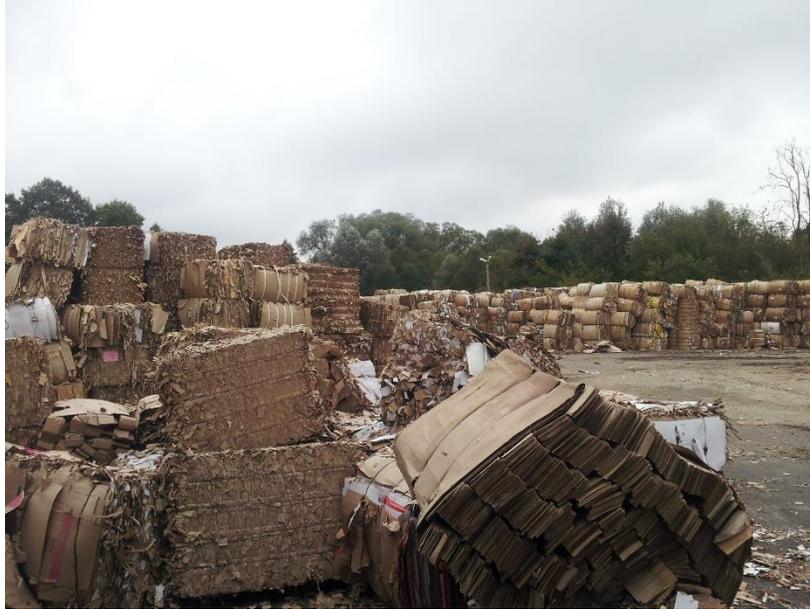
*Figure 5: Cardboard to be recycled by the factory (Photo taken by Matthew Crivello).*

No harsh chemicals are used in the paper making process at the plant in order to keep the costs down and to be more environmentally friendly. Going along with the same principles, the factory is very conscience of the importance of the Ugra River and the many ecosystems that are dependent upon its cleanliness so the factory runs extensive tests of the water upstream and downstream from the factory in order to be certain that the factory is not harming the environment in any way. It is important to mention that this company has the luxury of being more environmentally conscious because they are financially secure and that is not true for other companies (Blinova, 2013).

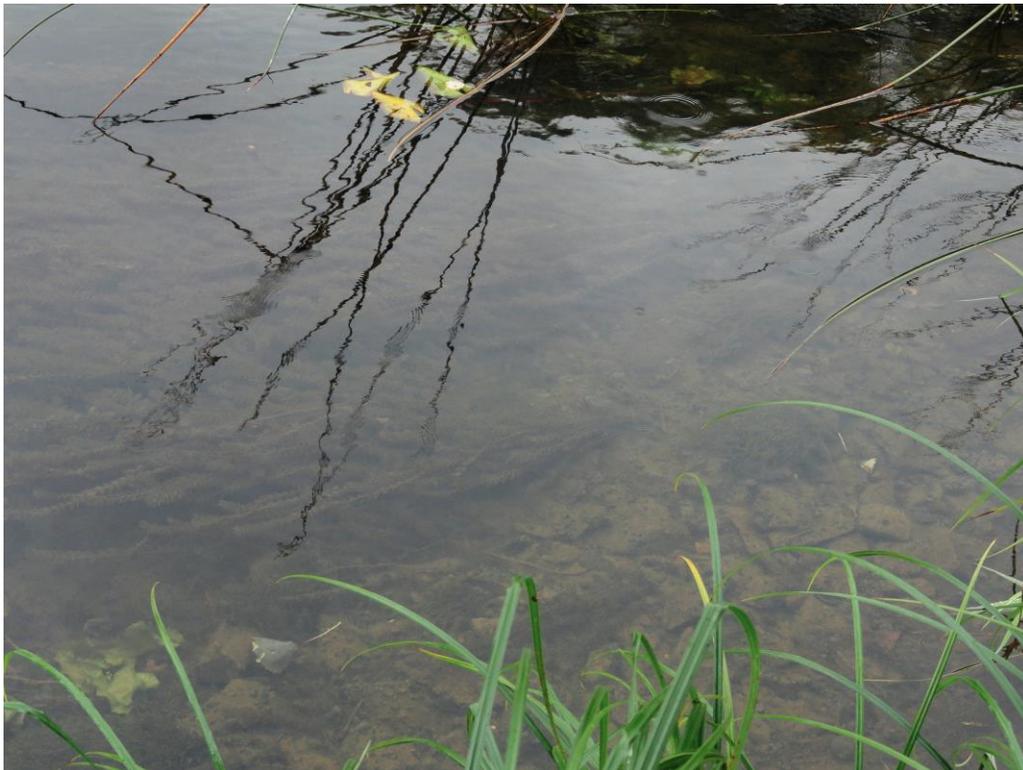
*Figure 7: A picture showing the bottom of the river through the clear waters (Picture by Madeleine Gomet).*

The water is unblemished, its transparency unparalleled. Floating upon the river, all that was seen was clean water and green scenery as far as the eye could see. This, however, is not true of the tributaries leading into the river.

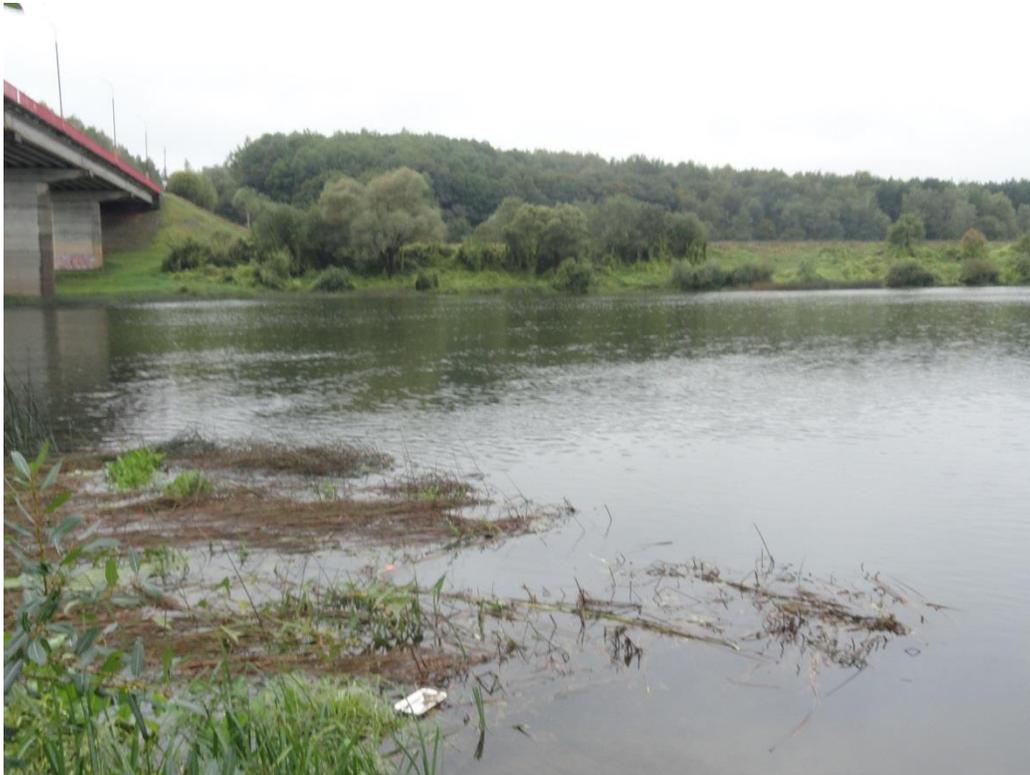
*Figure 8: A much different scene than the park, this picture depicts one of the tributaries under a bypass with dark, murky water (Picture by Madeleine Gomet).*

This section of the tributary does seem to display traits of contamination, but the type of toxin is unclear and would call for further testing. At a site further down the river there was trash thrown all around the mouth of the tributary. While this one did not have a blatant smell like the other the waters did show a type of cloudiness within them.

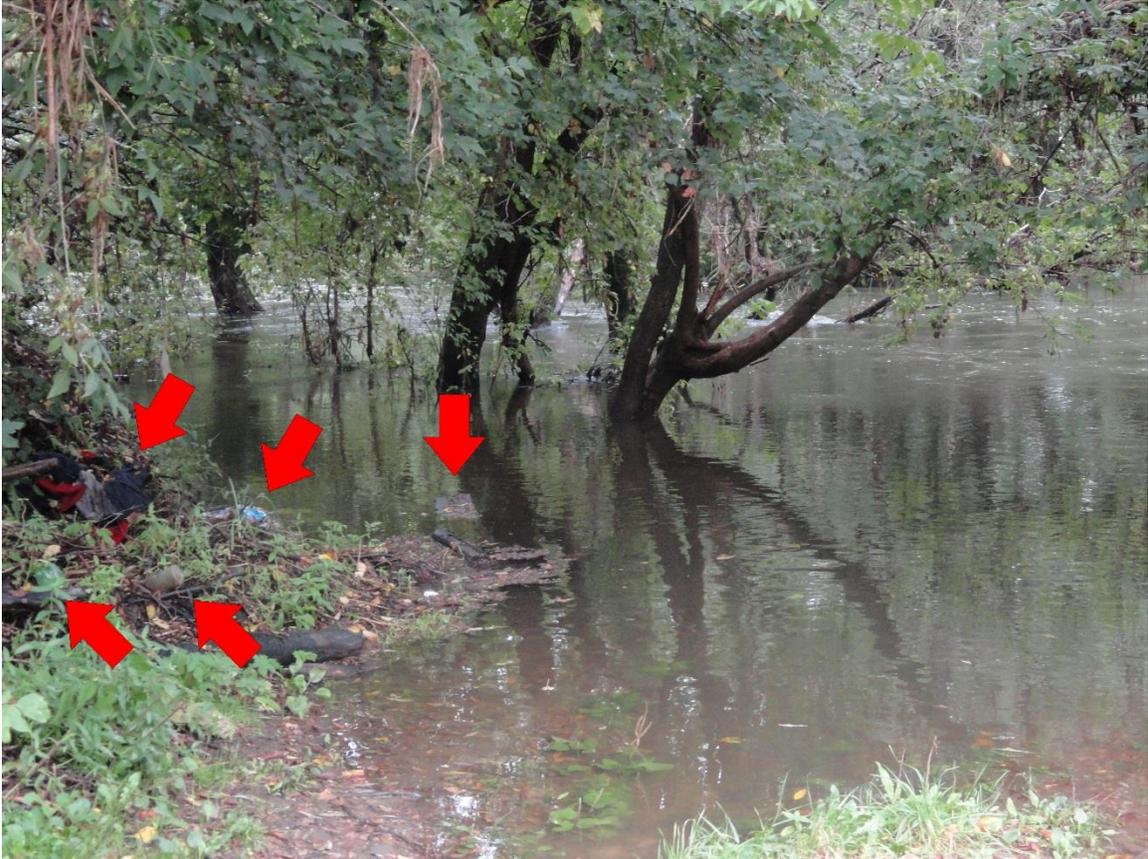
*Figure 9: These red arrows point to the trash on the bank of the tributary. These include: bottles, fabric and paper (Picture and editing by Madeleine Gomet).*

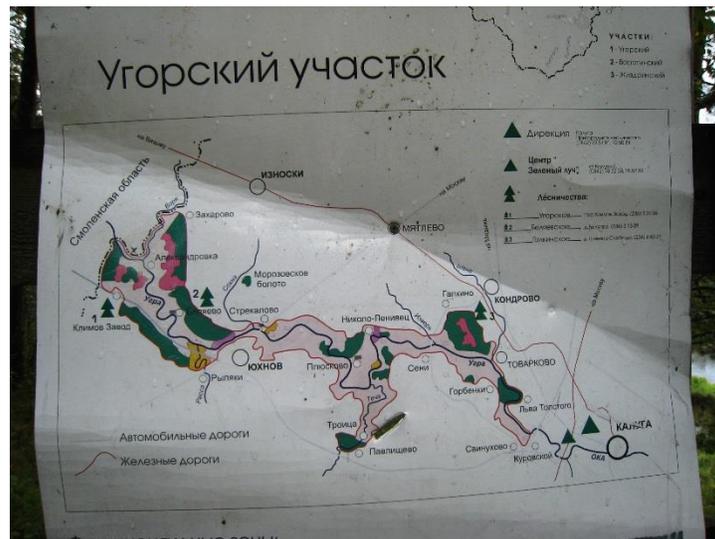
*Figure 10: A picture of the sign at one of the trailhead in Ugra National Park (Picture by Svetlana Nikitina).*

Signs like this are very helpful but cannot be the only representation of the trail in the park. For most of the touring of the park, it was unclear where we were. Places that seemed to be of no consequence suddenly turned into a trail. The guides knew exactly where they were but, to the

The trails of the park need to be marked at the trailheads and continuously throughout the trail. Signs at the trailheads are necessary for anyone touring without a guide to find the path. These signs can also list sites on the trail; historical markers, campgrounds, campfires, picnic tables and especially beautiful scenic overlooks can all be specified as well as the overall length of the trail.

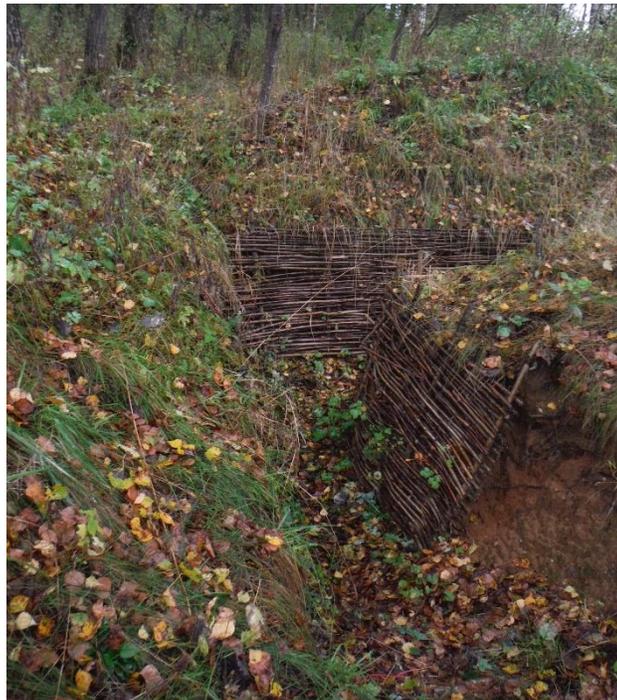
Along with the lack of posted signs about trailheads, there was also a dearth when it came to explaining the historically significant areas of the park. War memorials and old battlegrounds speckle the park all over but are insufficiently identified to the passersby. Old trenches and fortifications could be not ten feet away and yet lay unseen. These relics of the past should be seen and revered but, just as the trailheads and visitor center, they remain hidden in the wilderness.

*Figure 11: Restored World War II trenches hide in the brush unless specifically looked for (Picture by Matthew Crivello).*

The last type of sign that needs to be added to the park is that which mark the history of the surrounding area. Ugra National Park is fortunate to have such rich history on its estate, but without a guide most of the information on them is lost to the average passerby. As a place of battle during the Tartar yoke and as an important front during World War II, the area has numerous battlegrounds, trenches and burial sites but few of them are labeled. If they are labeled, the signs still do not give all the information that they should.

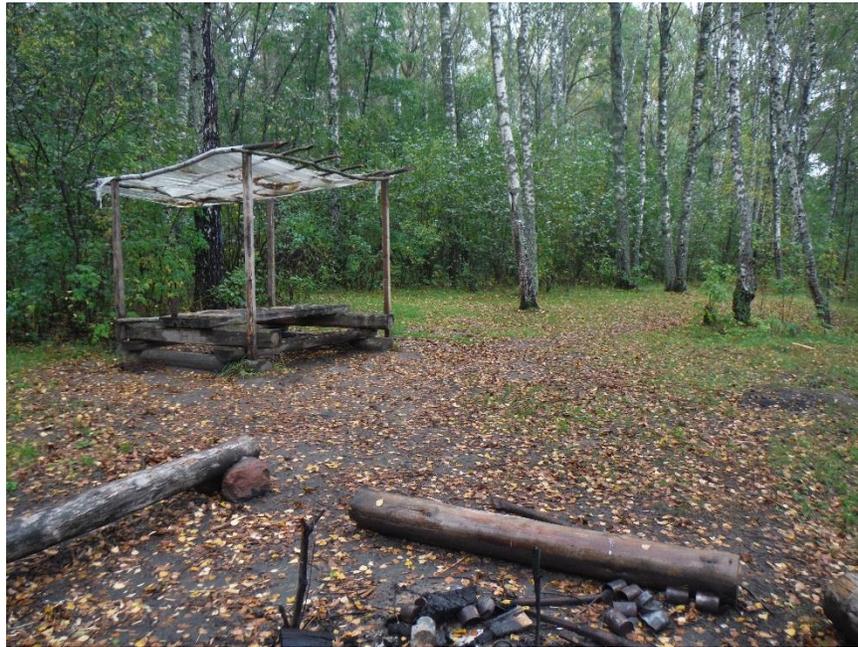
Another observation of the tourist areas revealed a startling lack of sufficient trash receptacles in most areas. In Russia, it is very usual for families to go picnicking when the weather is nice. Areas around the park are equipped for picnicking with tables and chairs however they have no trashcans. Without designated disposal sites tourists resorted to littering the area with their trash.

*Figure 12: Picnic tables and campfire area for tourists. Not pictured, large waste pile of trash off to the right near the riverbank (Picture by Matthew Crivello).*

To further improve upon the area, trashcans should be placed around the picnic areas for visitors to dispose their trash. These cannot be any trashcans; in national parks it is very important to have animal safe trashcans.

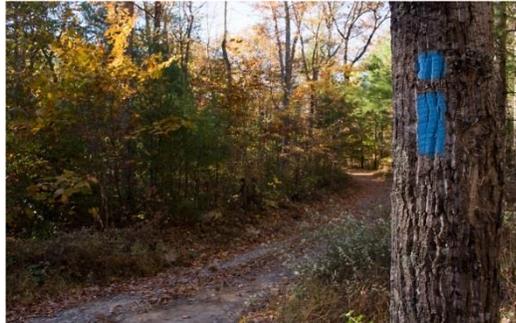
These additions will greatly improve the overall ease of access to the trails. To further enhance the park, paths need to be marked every so often throughout it as well. In dense forest, it is easy to get lost or wander off the path; these markers can mean the difference between a lost tourist and a happy one. Trails can be marked in many different ways some of which are very easy to set in place. The simplest of these styles is a paint stripe on trees every few meters down

*Figure 24: Option 1) The painted trail maker (Virginia Trails, 2013).*

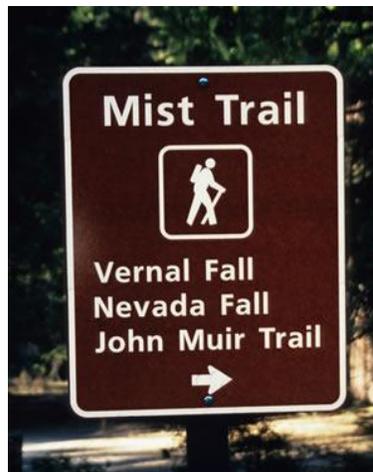
the path. Another option is to have a sign stuck into the ground with the name of the trail as a marker. This option is more expensive and can take away from the natural romanticism of the path.

*Figure 25: Option 2) The metal sign trail marker (John Muir Trail, 2013).*

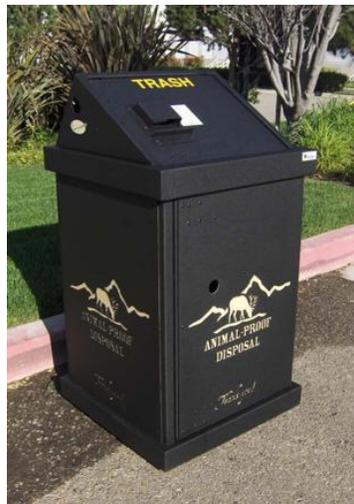
*Figure 27: An animal safe trashcan made from metal with an animal proof lid (Securr, 2013).*

Above is an example of one type of animal-safe trashcan. With a locked handle that paws cannot grasp, this trashcan makes sure nothing gets into the disposed of waste that should not. This method is safer for both humans and animals. Wildlife is attracted to the smell of the food left behind in trashcans and will dive right in and snag what they find. Inappropriate goods can lead to sickness in animals and the animals could also be caught in the trash. Things like six pack plastic rings and plastic bags can really harm animals if they are snared with them. Also, the animals that feast from the waste bins could stumble upon groups of humans and possibly hurt or

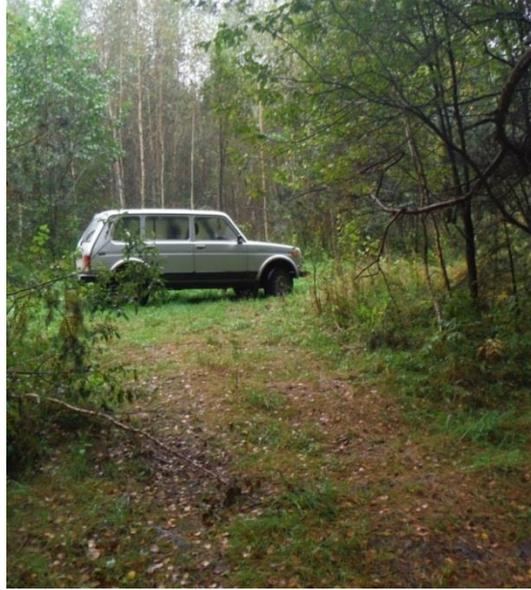
The park's many trails are clearly represented on maps found online and in the visitor center however, through field research within the park it is apparent that the trails need more distinguished markers on their actual grounds. While touring the trails it is hard to tell whether or not the path is a real trail or a road which makes it hard to stay on the route and easy for tourists to get lost. For example, there is a boulder left behind by the movement of glaciers many years ago in the park premises. The entrance to this trail is barely distinguishable from the surrounding forest and, without a guide present, would have been impossible to find. To solve this problem, the park should plan to blaze its trails professionally to make them more distinguishable.

*Figure 28: An example of a trail in which was only accessible by car (Picture by Matthew Crivello)*

To improve the trails they need to be widened and the underbrush should be cleared. There are different options when it comes to the extent to which this underbrush is removed; the trails can be cut to either short grass or be cleared completely. For Ugra National Park it would be better to go with the latter option. Since insects, frogs, snakes, and small animals roam the grass it would be safer for both them and humans to make the distinction between forest and path as well defined as possible.

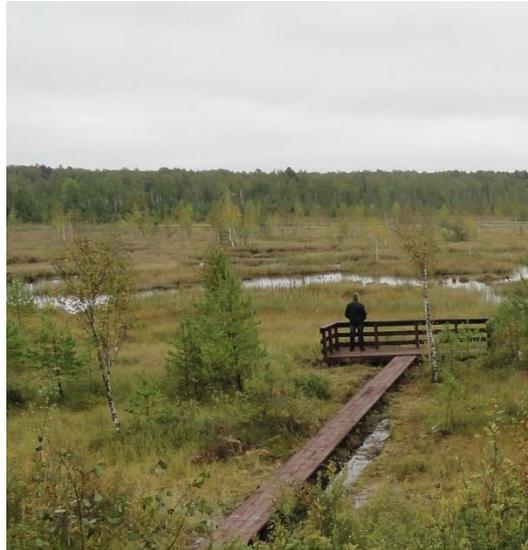
model for what the rest of the park should be. These areas had wooden paths that were easy to follow and were also very well maintained.

*Figure 30: Wooden paths in the swamps (Picture by Madeleine Gomet).*

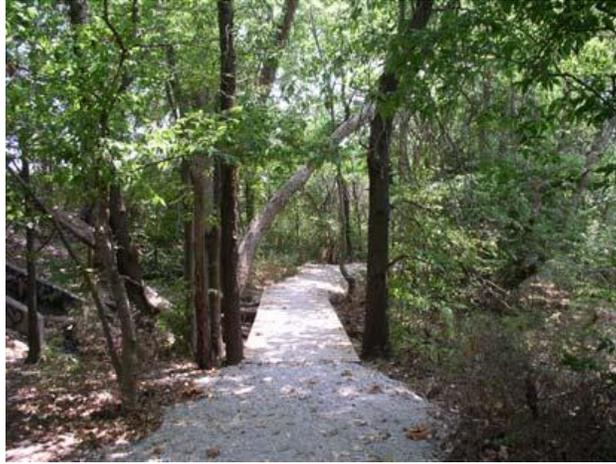
*Figure 31: Example of a gravel path inside of a park (The City of Columbia, 2013).*

This type of trail obviously marks the barriers of the trail without disrupting the harmony of the natural scene. Other benefits to using gravel are that it creates a stronger foundation for the path making it safer for walkers and also helps to fight off erosion. With these renovations the trails would vastly improve in terms of ease of use and tourists would feel more comfortable walking on them (Almond, 2013).

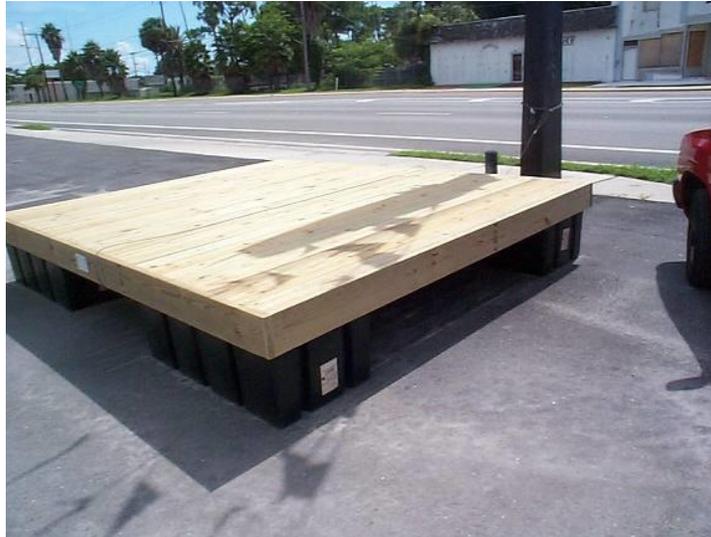
*Figure 32: Example of a floating dock that would be anchored to the riverbed by cables or rope (Dock Builders Supply™, 2013)*

This dock is a simple floating platform that anchors to the riverbed to keep it in place. We recommend modifying this design slightly with anchoring posts to make the dock more stable which is one of the secondary options of the kit. It does require more work to install, but it makes the dock look more polished and professional. Also, the posts would make the dock safer as the dock would be unable to tip over. A full guide on how to build a floating dock can be found in Appendix L.

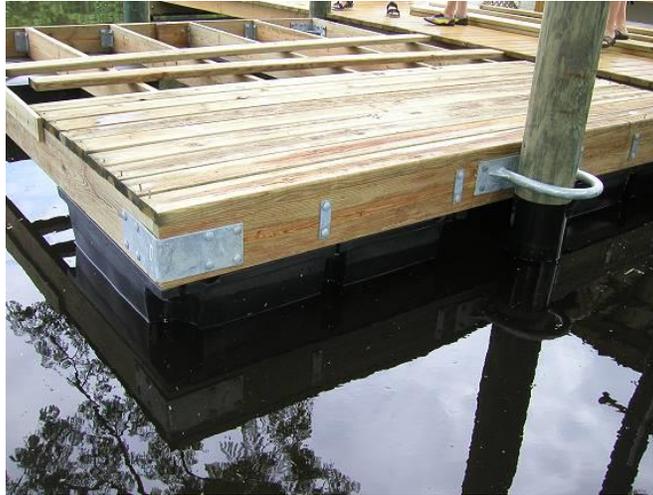
*Figure 33: Example of a floating dock that is held in place by stationary posts (Dock Builders Supply™, 2013)*

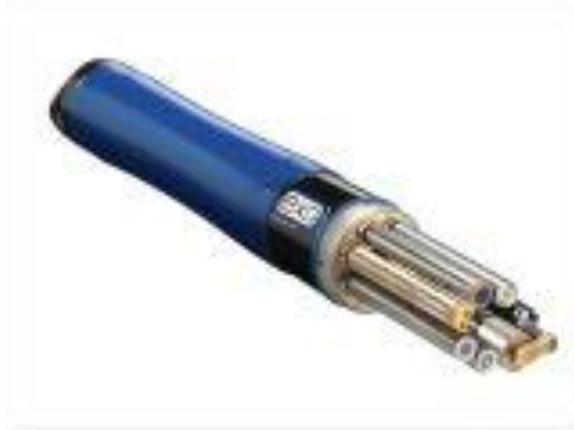
*Figure 34: Cut away of the internal components of the YSI EXO2 Sensor (YSI, 2013).*

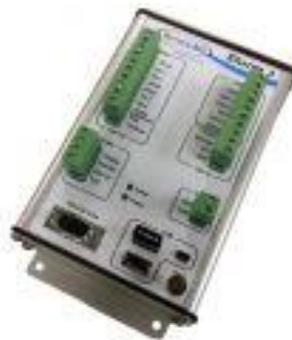
*Figure : WaterLOG Storm 3 data logger (LOG, 2013).*

Paired with EXO2, the “Storm 3 data logger” would provide the data logging that is required for this water monitoring system. WaterLOG is the creator of the Storm 3 and both WaterLOG and YSI are part of the Xylem brand. The Storm 3 comes with local data logging (storing data on internal memory storage), WiFi and USB connections for grabbing data from the device in the field, and the Storm 3 can be equipped with a cellular radio antenna, a point-to-point radio antenna, or a satellite radio antenna allowing the device to upload it’s data to a remote location where the data can be processed. WaterLOG also provides powerful software for the Storm 3 that sorts, logs, and graphs the data that it receives from the data logger and can be configured with alarms for uncharacteristic changes in the data (LOG, 2013).

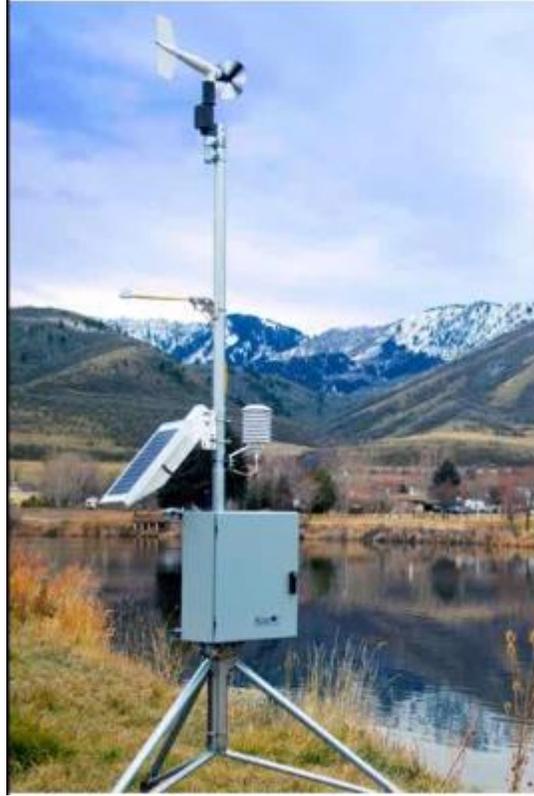
*Figure 35: Example of what an installed system would look like in the field (YSI, 2013).*

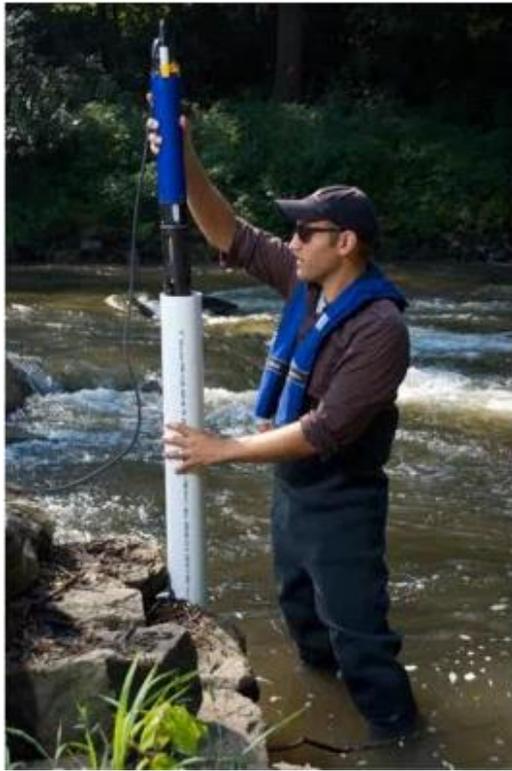
*Figure 36: Example of how an EXO2 would be installed in the Ugra River (YSI, 2013).*

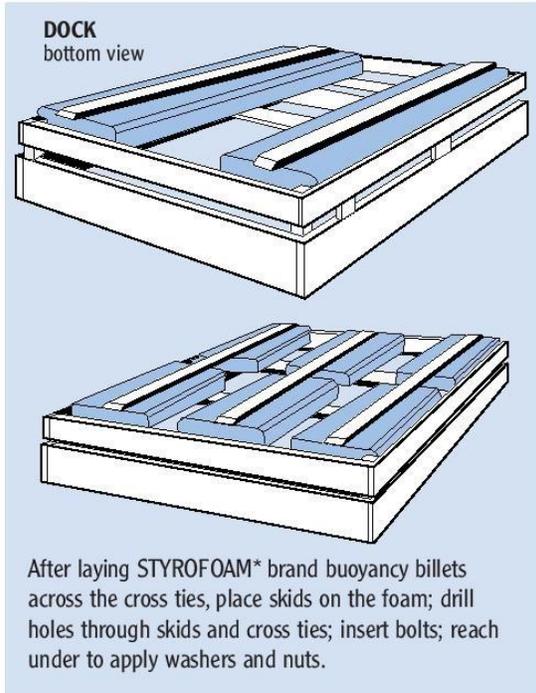
After inverting the structure, tighten nuts to a snug fit. Install lengthwise bracing first, then cross bracing. Nail on dock boards using a piece of 1/2" plywood to space boards 1/2" apart.
