**Assessing Factors Contributing to
Water Scarcity, Impurity, and Coastline
Erosion at the Mrigadayavan Palace in
Cha-am, Phetchaburi, Thailand**

An Interactive Qualifying Project submitted to the faculties of Worcester Polytechnic Institute and Chulalongkorn University in partial fulfillment of the requirements for the Degree of Bachelor of Science in cooperation with The Foundation of the Mrigadayavan Palace.

Submitted on: March 2, 2017

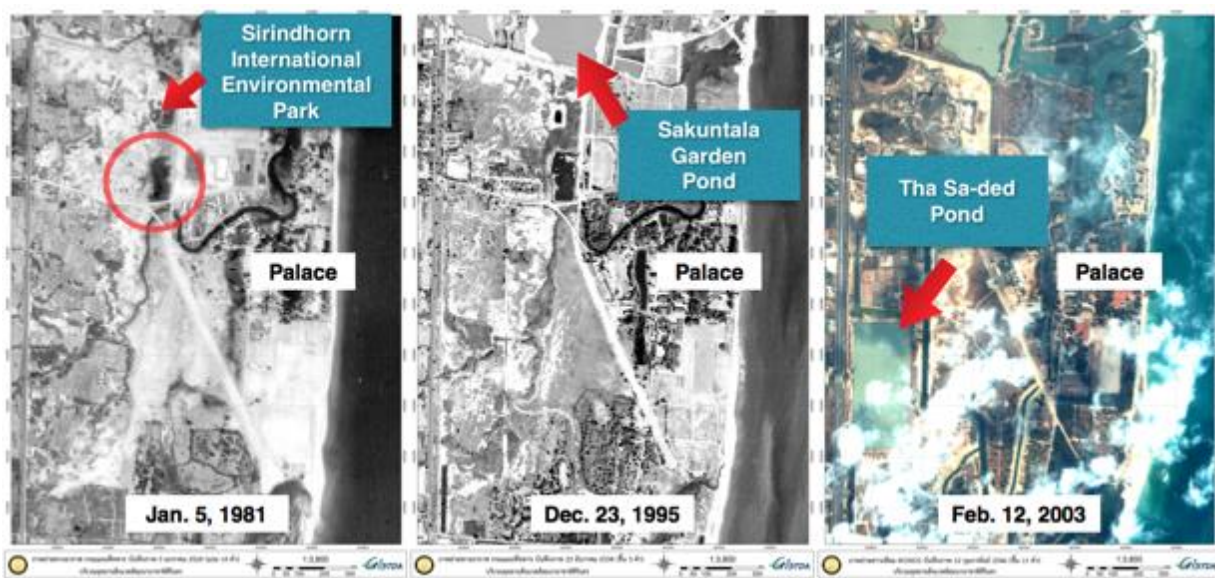
Figure 2: Aerial maps of Palace and the grounds with circles indicating reservoirs
Source: GISTDA

There are two canals in the Rama VI Military Camp where the Mrigadayavan Palace is located, Bang Tra Yai Canal and Bang Tra Noi Canal, both of which originally served as freshwater sources for the Camp. In addition, eight underground water wells supplied fresh water for the Palace, but some of them were shut down by bombings during the Pacific War (1941-1945) according to Mr. Somjai Noisaard, a 78-year-old Cha-am resident. Pol. Sub. Lt. Somjade Iamsopon, retired Division 1 Border Patrol Police, stated that the Patrol Police were not aware of existing wells, and accidentally covered them when they began to restore the Palace. A severe decrease in the availability of fresh water in the Camp occurred once the wells closed. As a result of this diminished availability, the Camp built reservoirs to retain water, as seen in Figure 2. Nowadays the Palace uses water from the Ta Sa-ded Reservoir, the biggest reservoir in the Camp built between 1995 and 2003, also shown in Figure 2. This reservoir is the main source of water for all organizations inside the Camp.

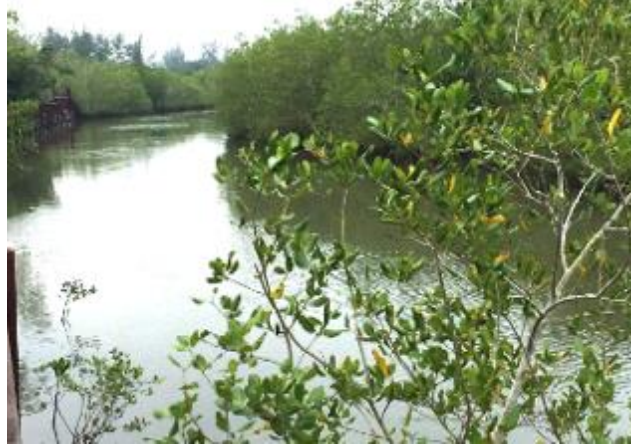
Figure 6: Man-made Mangrove forest at Sirindhorn International Environmental Park

After the introduction of the forest, the trees did not grow as well as hoped. Sand accumulation at the mouth of the canals led to an insufficient amount of seawater entering the canals to nourish mangroves. The park needed to give the trees the brackish water they craved, and a feature inside the jetties built in 2006, allowed seawater to flow into the canals and provide water to the forest (S. Iamsopon, personal communication, Jan. 20, 2017; D. Thaitakoo, personal communication, Feb 3, 2017). This feature, shown in Figure 7, is an inclined trough designed to bring water in with the waves, but to restrict it from moving out with the pull of the tide. Although the trough helped the mangroves grow, it also caused saltwater intrusion into the freshwater sources in the area. This can be damaging to gardens because most plants do not have a high salinity threshold and cannot filter out the salt (Parida & Das, 2005). Salt stress can slow growth because it creates a water deficit inside the plants, stunting their natural growth pattern (Parida & Das, 2005).

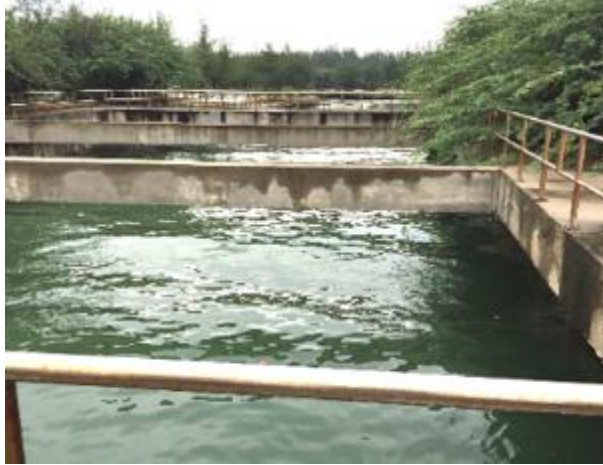
Figure 7: Inside feature that allows seawater to enter the forest through the jetty

The jetty structure allows for opening of the canal mouth all year round. Naturally, the direction of wind and the season greatly impacts the dynamic of the sand. During the winter season, the north wind blows sand to the beach in the south. Then when summer comes, the wind changes direction, sending sand back to its original place (The Climate of Thailand, 2015). The addition of jetties has disrupted this pattern by blocking the sand from moving with the seasons. Natural disasters such as typhoons and monsoons can also temporarily alter this erosion pattern. Moreover, this natural pattern used to create a seasonal sand dune that covered the mouths of the canals, which protected the water from leaking and ultimately prevented the fresh water from becoming brackish.

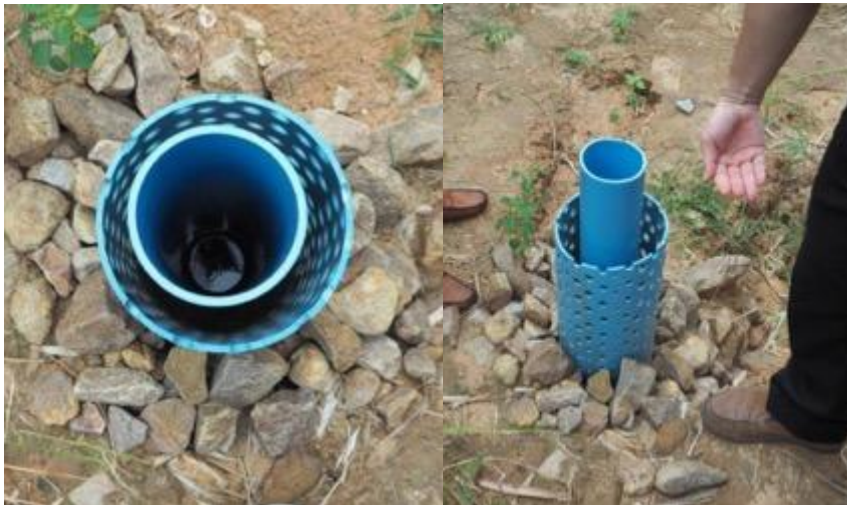
Appendix J: Water level marker

Top View

Front View
