Little Indian Lake: Diagnostic Study

Worcester Polytechnic Institute
Interactive Qualifying Project

By: Evan Costa, Victoria Mason, and Christian Waller

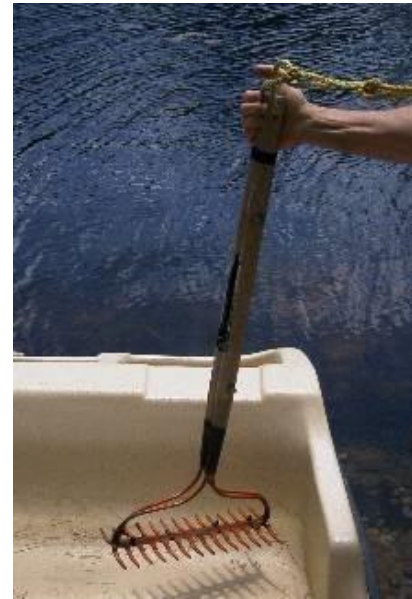
weasel at different angles around that point for 90°, 180°, 270°, and 360°. A weed weasel is a home-made contraption in which rope is attached to the end of a rake, and was utilized to collect samples from the bottom of the lake floor (Fig. 3.2). When collecting, the weed weasel was allowed to settle to the lake bottom and the line was then pulled up so that the teeth of the rake dragged along the bottom of the lake. The weed weasel was then raised out of the water with plant samples and brought into the boat. All the vegetation trapped on the teeth was put into separate piles, so that

*Figure 3.2: Weed Weasel
(Massachusetts Water Watch
Partnership, 2006)*

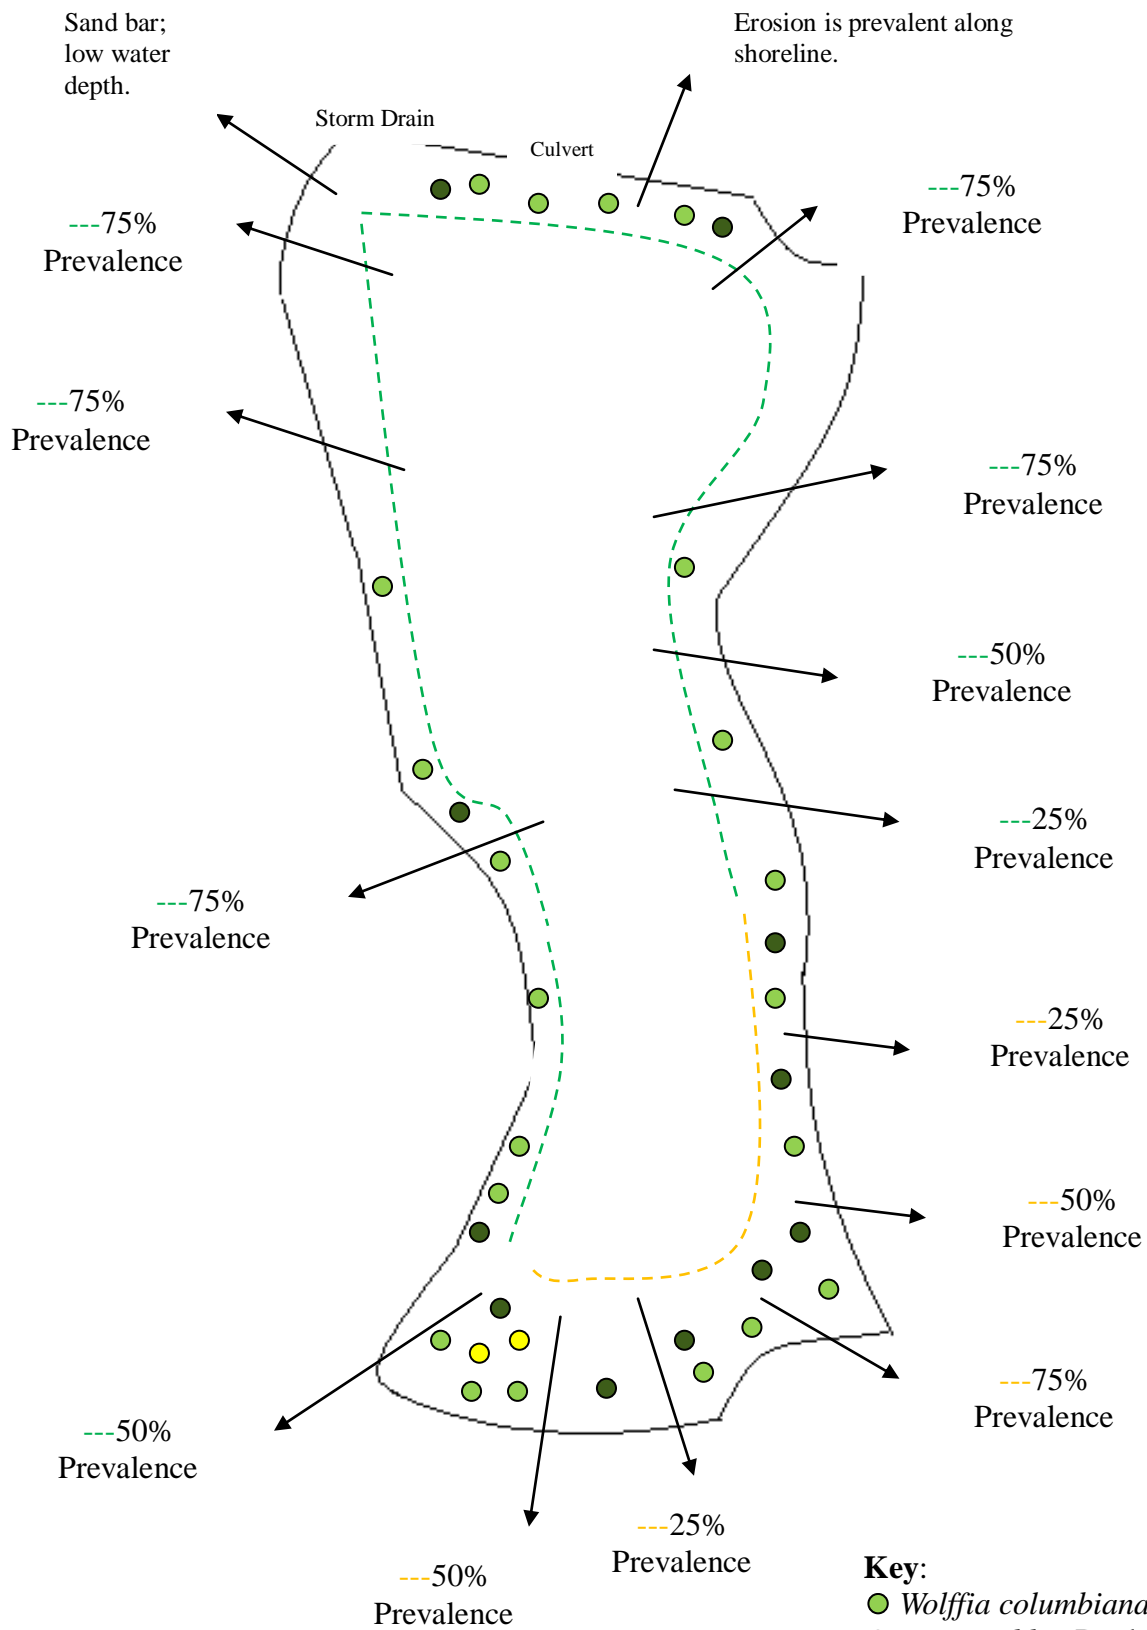
On November 9, 2009, a shoreline sketch was performed on the first boat outing. An outline was drawn of the shore and notes were collected on plant life and their prevalence while on the tour. *Nitella spp.* was the first algae species found which is indicated by the green dashed line. This algae predominated greatly along a majority of the coast of the lake and more so towards the north end of the lake that is near MA 112A. Filamentous algae was also collected and observed, which was mainly localized towards the south end of the lake and the lower end of Forest Street. Two floating plants, duckweed and watermeal, indicated by the dark and light green circles, were also seen and their presence was fairly consistent around the entire shore. Also, two pond yellow pond lilies, indicated by the yellow circles, were found towards the south end of the lake and the lower end of Forest Street.

Figure 4.1: Shoreline Sketch

Shoreline Sketch Conducted on
November 09, 2009

Duckweed, watermeal, and yellow pond lilies were the only aquatic plants found while performing the shore line sketch. Unfortunately, when the aquatic plant survey was conducted a week later, the yellow pond lilies were not seen again. Duckweed (*Lemna spp.*) can range from 1-5 millimeter in size and watermeal (*Wolffia spp.*) is less than 1 millimeter and during the aquatic plant survey, since we were mainly observing larger algae/plant species that could be collected by the rake, we did not closely examine if these two plants were present in the samples ("Common duckweed (*Limna gibba*)," 2009; Texas AgriLife Extension Service, 2010c).

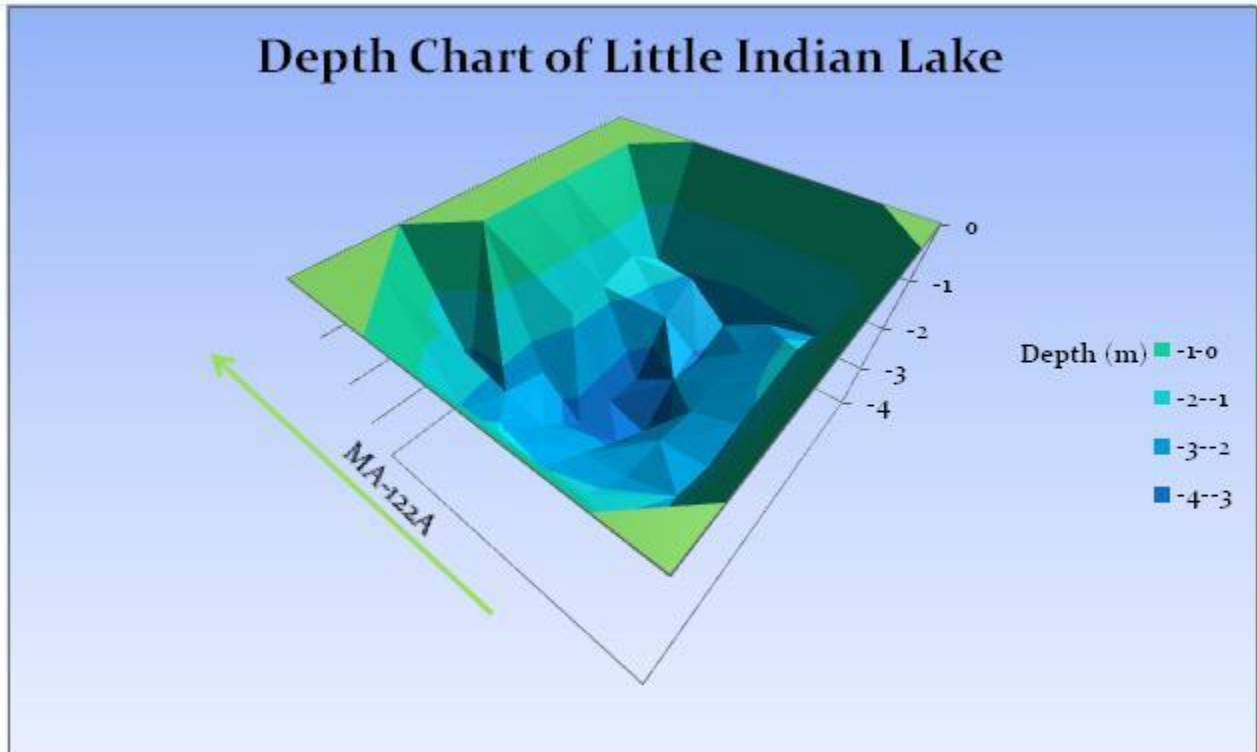
This data is presented in graphical form below in Figure 4.1.

Figure 4.2: Depth Graph of Little Indian Lake

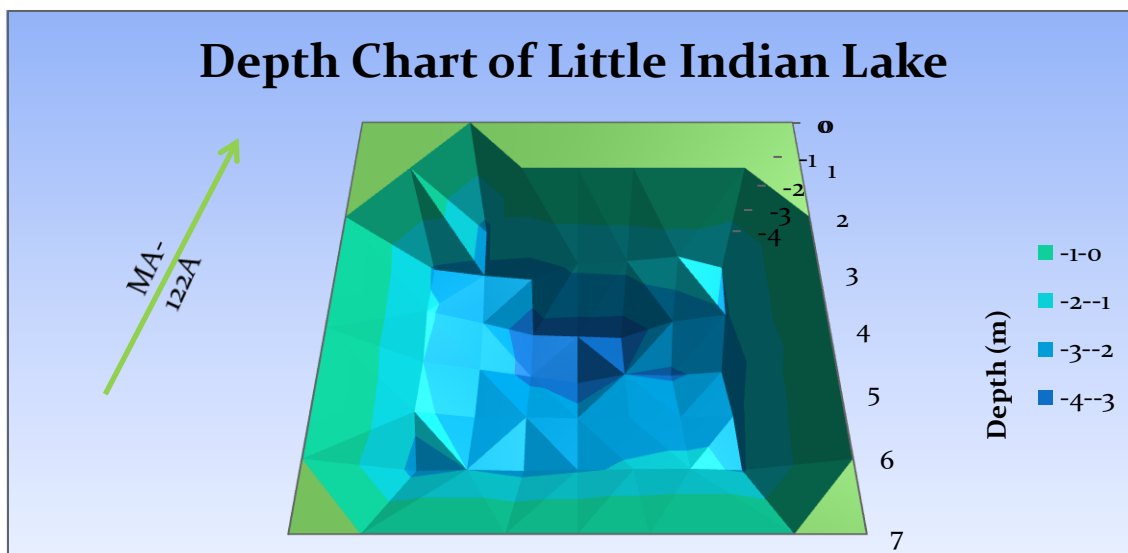
Figure 5.2: Depth Diagram (2010)

This comparison demonstrates that the average depth of Little Indian Lake has decreased during the past four years. Although evaporation may account for a small fraction of water loss, accumulation of sediment is primarily responsible for the decreasing depth of Little Indian Lake. The accumulation of sediment on the lake floor presents a significant long-term problem for the ILWA which, if ignored, may result in the disappearance of Little Indian Lake. One of the most effective methods of remedying the problem of accumulation on lake floors is dredging.

Dredging should be carefully considered by the ILWA. In order to maintain the health of a lake it must contain enough water that water loss by evaporation and seepage into the ground do not remove all of the water in the lake. According to the U.S. Department of Agriculture a depth of 1.5 to 4.5 meters is necessary to ensure the survival of the lake (Cooke, Welch, Peterson, & Newroth, 1986, p. 139). Since Little Indian Lake's depth reaches a maximum of 3.8 meters (Table 4.2), this should cause some concern to the association.

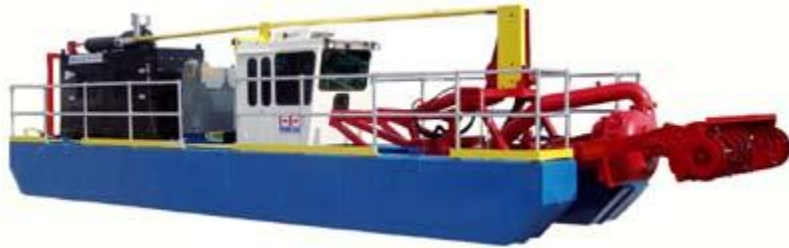
Because of size constraints, traditional cutterhead dredges are not particularly reasonable options. Instead, the Mud Cat dredge is essentially a miniature version of large cutterhead dredges. The Mud Cat boasts a horizontal auger which dislodges and transports sediment through its pipeline (151). The primary advantage of the Mud Cat is its extreme mobility, critical for the cramped shores of Little Indian Lake. Furthermore it has been shown that the Mud Cat can produce slurry with nearly double the solids content of conventional cutterhead dredges: "... the Mud Cat dredge should be capable of producing slurry containing 30-percent to 40-percent solids. This represents nearly a doubling of the solids content commonly

Figure 5.7: Mud Cat Dredge (Mud Cat Dredges, 2010)

Mud Cat dredges have been used with great success on small lakes. Its guidance system makes it ideal for work on small lake restoration projects. The dredge relies on a cable, anchored at both shorelines, and its guidance system to make passes on the lake floor: "The guidance system permits uniform dredging of the bottom, with few missed strips" (152). Finally, the increased water turbidity due to dredging with a Mud Cat has been shown to be within acceptable limits: "... turbidity plumes due to dredging with a Mud Cat machine were confined to an area no more than 6 m from the dredge" (151). All of these factors combine to make the Mud Cat dredge a strongly competitive choice when deciding how to dredge Little Indian Lake.
