WPI IQP: Congestion and Passenger Flow in the Tube

Edward Chiang, Robert Crockett, Ian
Johnson, and Aidan O'Keefe

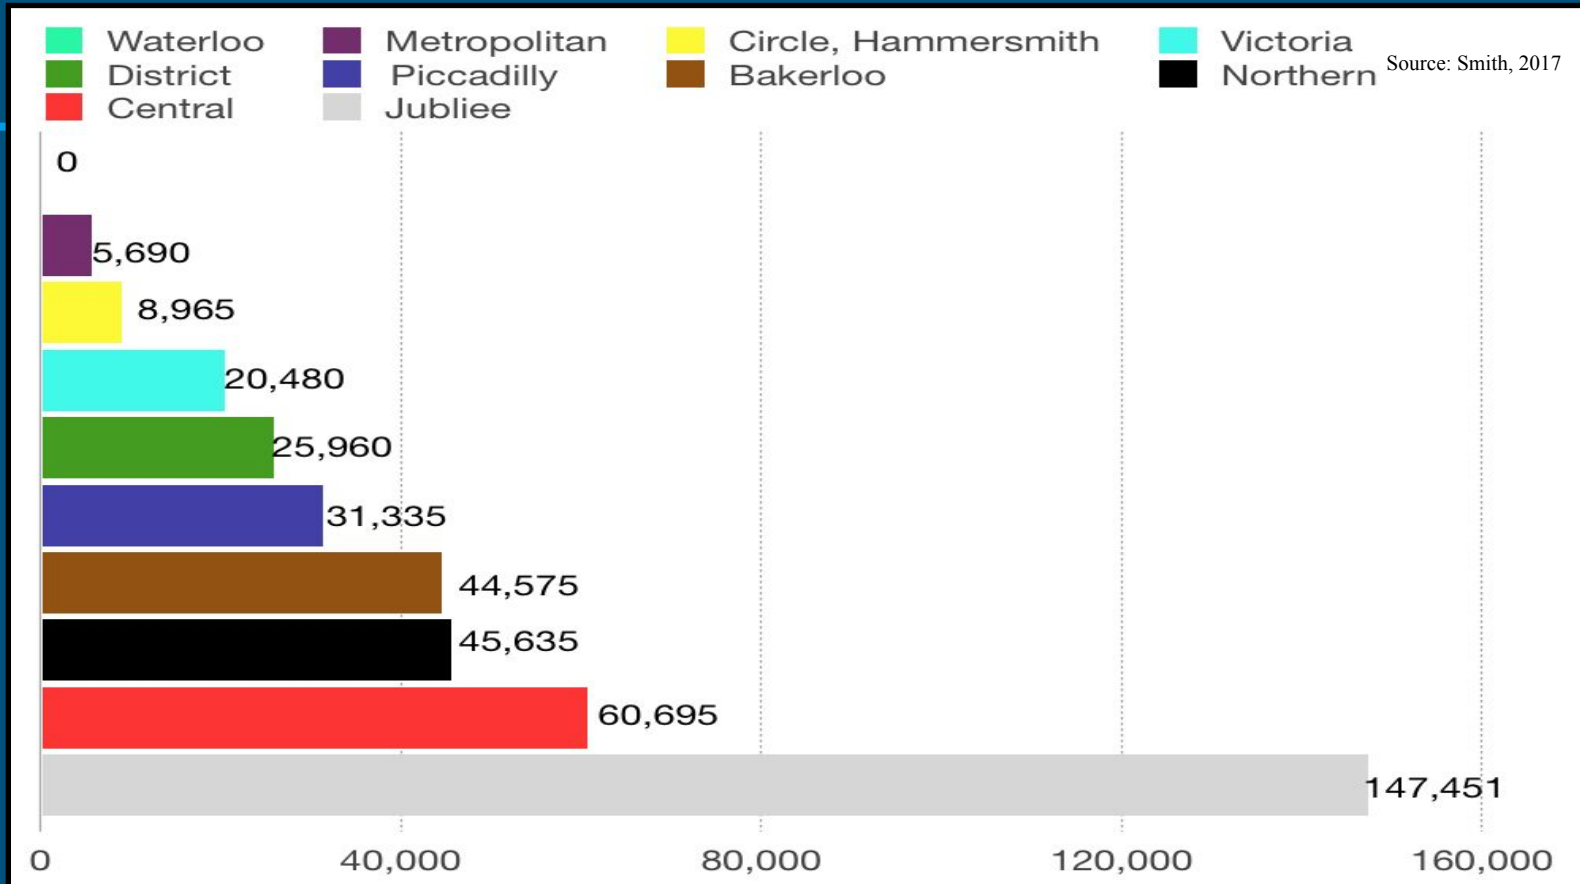
Tube Delays due to Overcrowding, Hours/Year

- The first Tube lines were built in 1863 (Metropolitan, Circle)
- Since 1863, the population of London has increased almost three-fold
- Renovation and maintenance on the tube is common
 - Four Lines Modernization, Victoria Line Improvements
 - Revamp of Victoria Station, Bank/Monument Maintenance
- Delays cause hundreds of thousands of hours in lost productivity for passengers

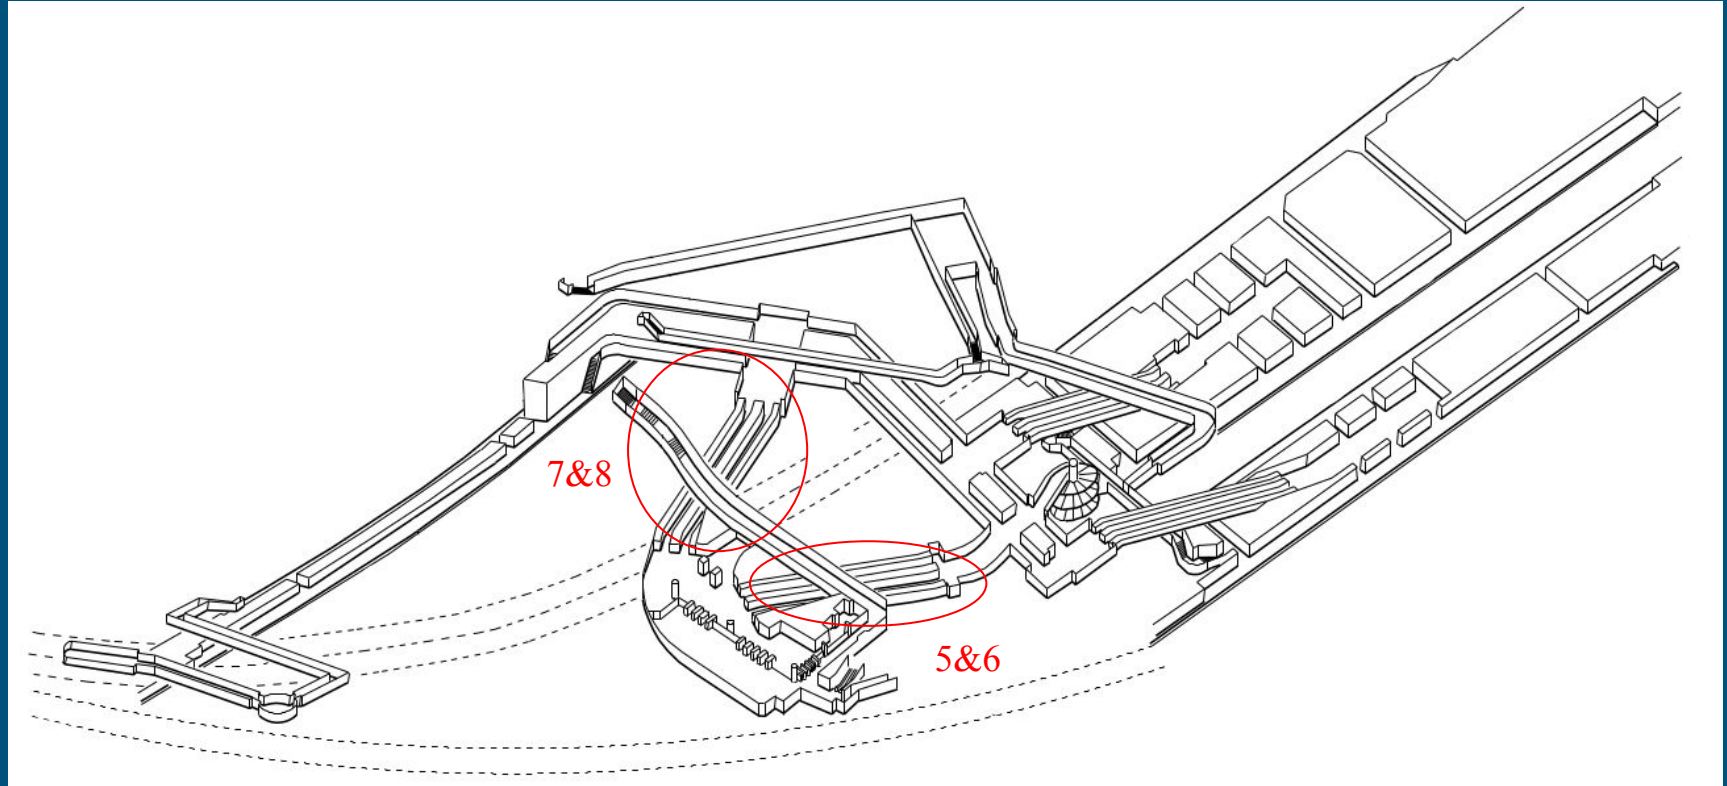
Packed Escalators (6,7,8)

- Euston
 - 6 employees
 - Peaks: Fri. (0700-0900, 1730-1900) and weekend (0930-1200, 1730-1900)
 - Customers had problems with wayfinding
 - Identified problem areas

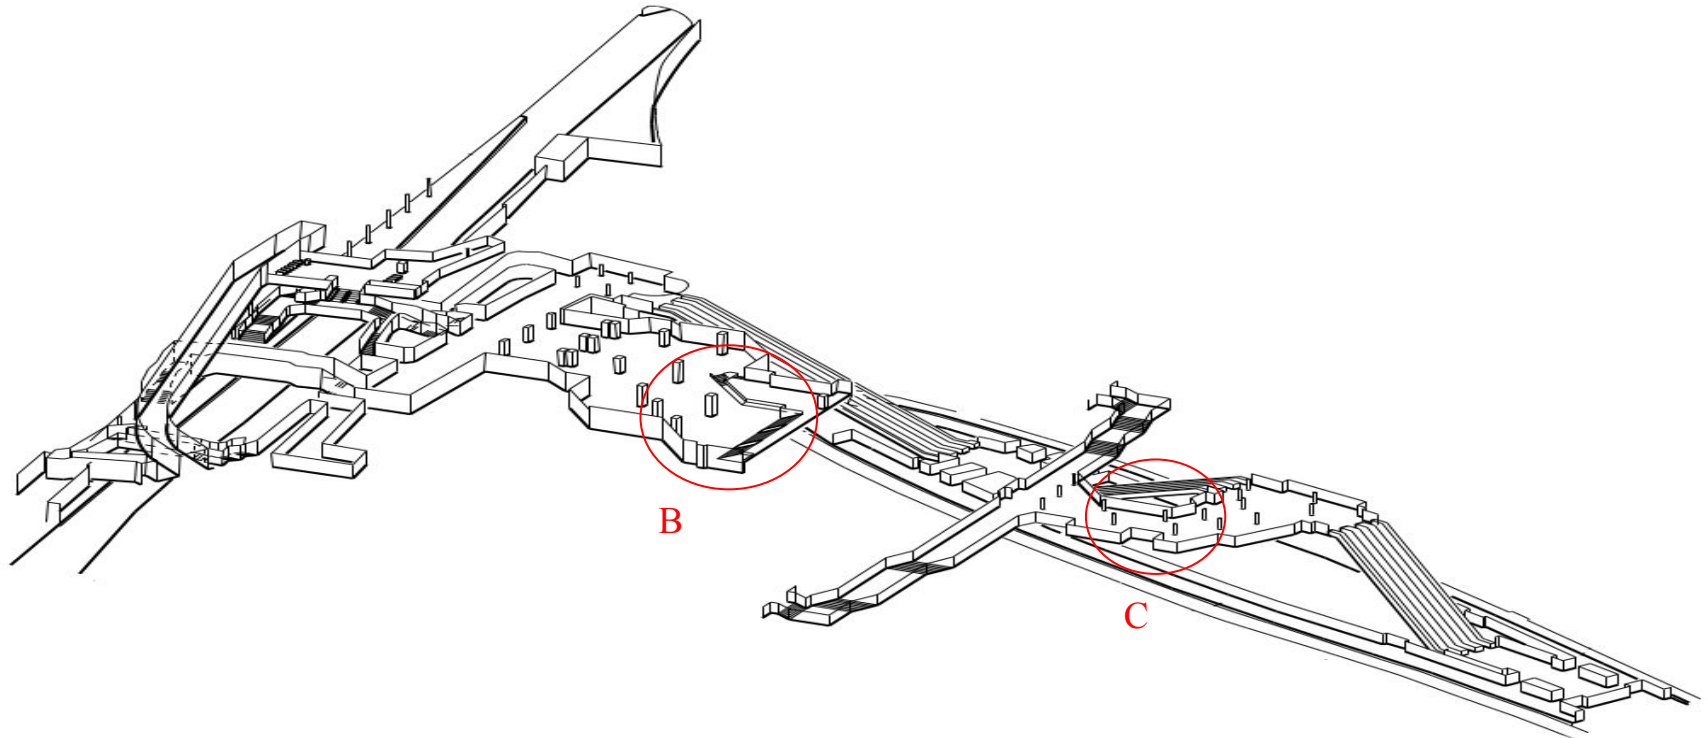
Ticket Hall B & C

- Liverpool Street
 - 10 employees
 - Peaks: Tue. and Wed. (0630-0930, 1630-1930), weekend (0930-1230)
 - Customers had problems with wayfinding
 - Identified problem areas

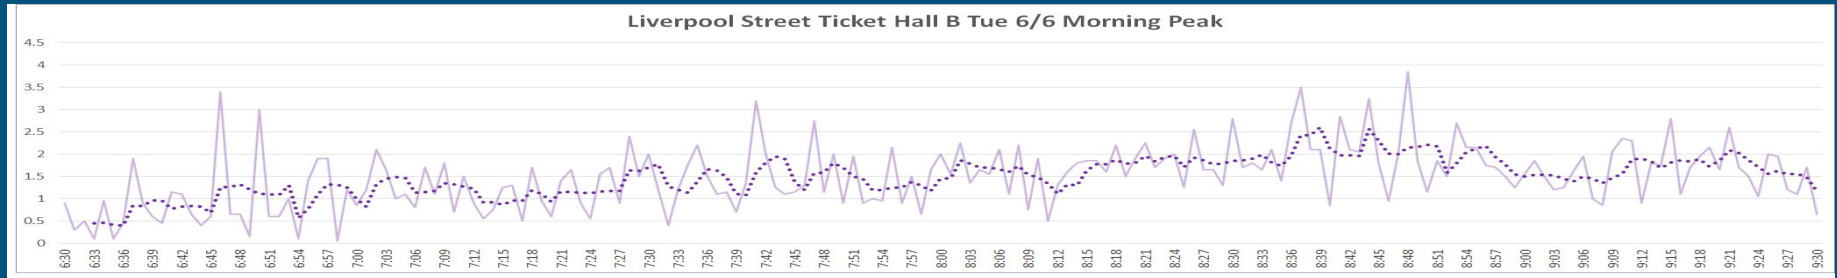
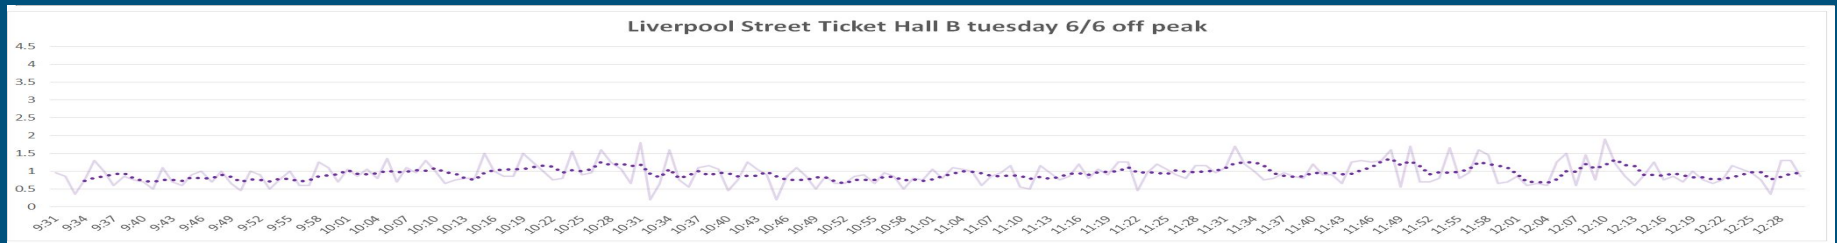
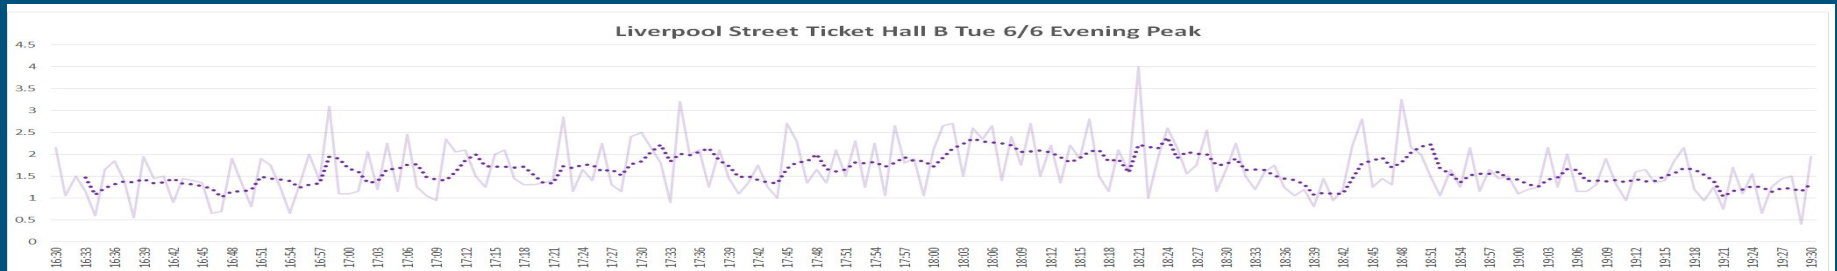
On-Peak vs. Off-Peak Example: Liverpool Street Ticket Hall B, Tuesday 6/6

- British Transport Police laptop
- Capture image every minute, on the minute
- 180 captures taken for each 3-hour set
- Count passengers in frame
- Repeat for different views

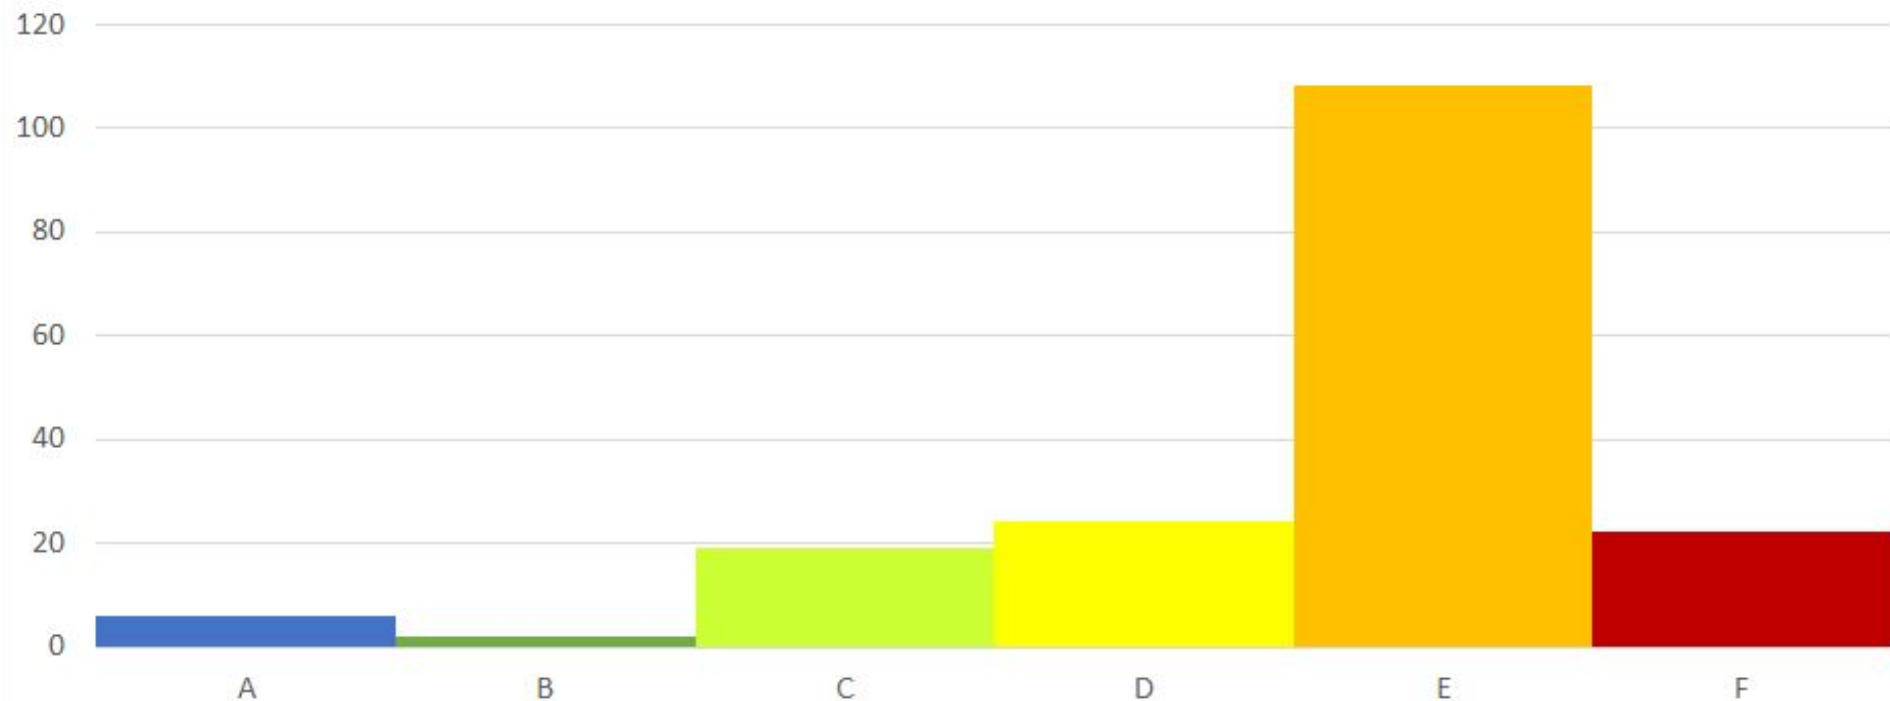
Liverpool Street Ticket Hall B Tue 6/6 Morning Peak LOS

LOS Rating	A	B	C	D	E	F
density (p/m ²)	0.3	0.3<d<0.43	0.43<d<0.718	0.718<d<1.08	1.08<d<2.15	2.15<d

- Level of Service
 - Measurement devised in the 1970s
 - Determines how well a system flows based on density

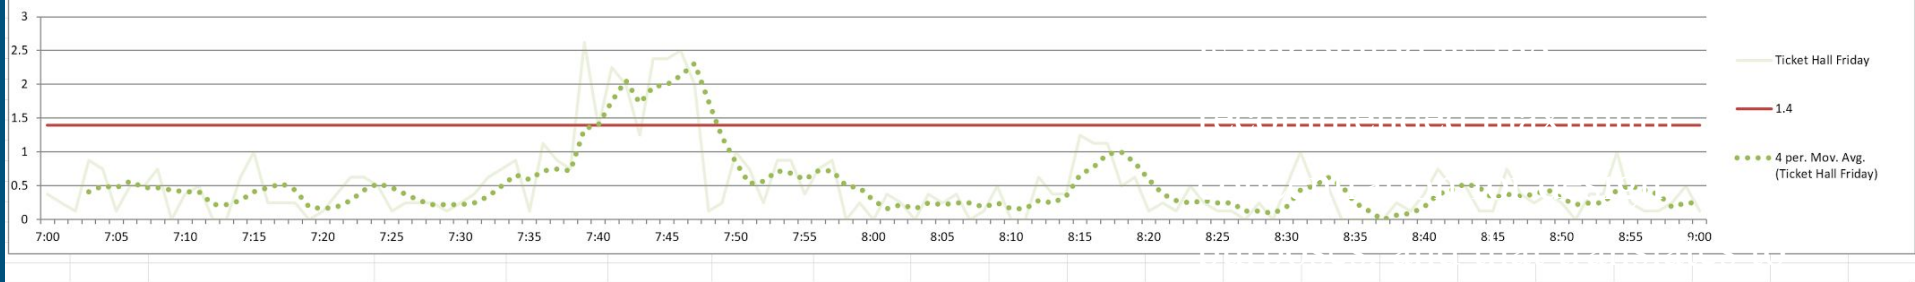
Euston Ticket Hall Friday 19/5 Morning Peak

Euston Ticket Hall On Peak vs. Off Peak

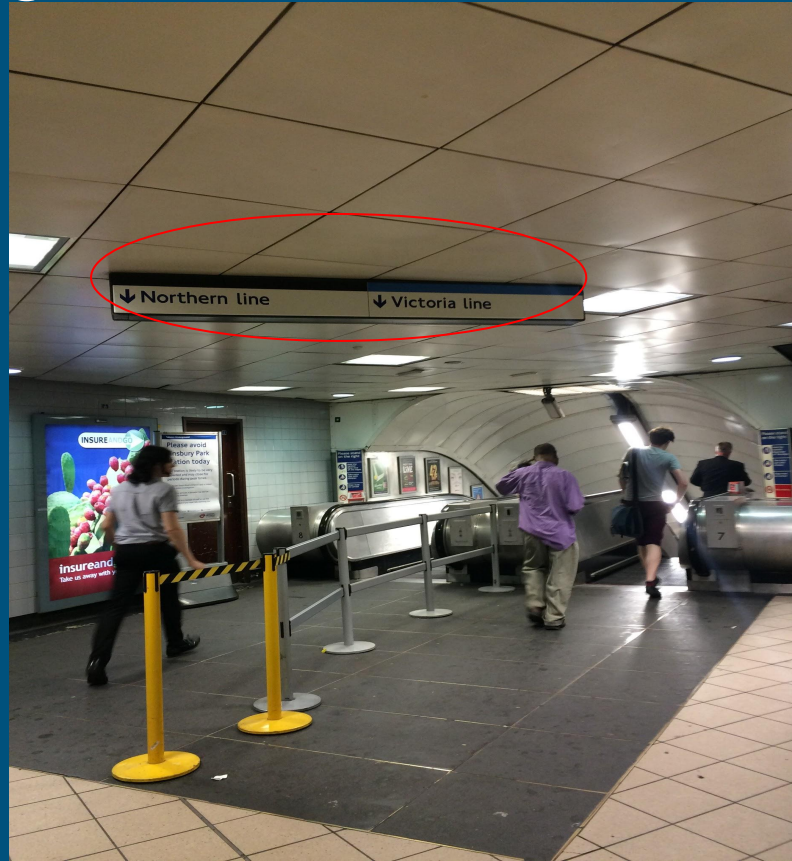
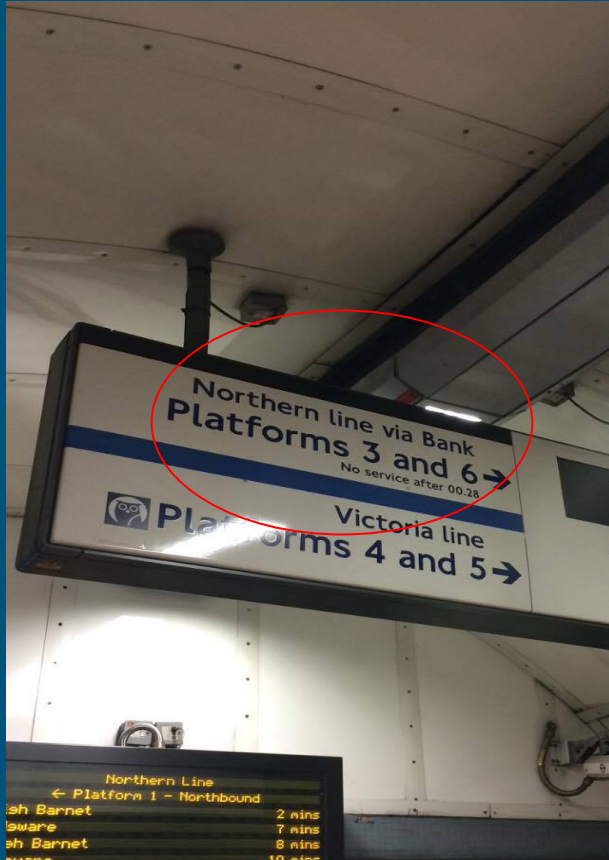
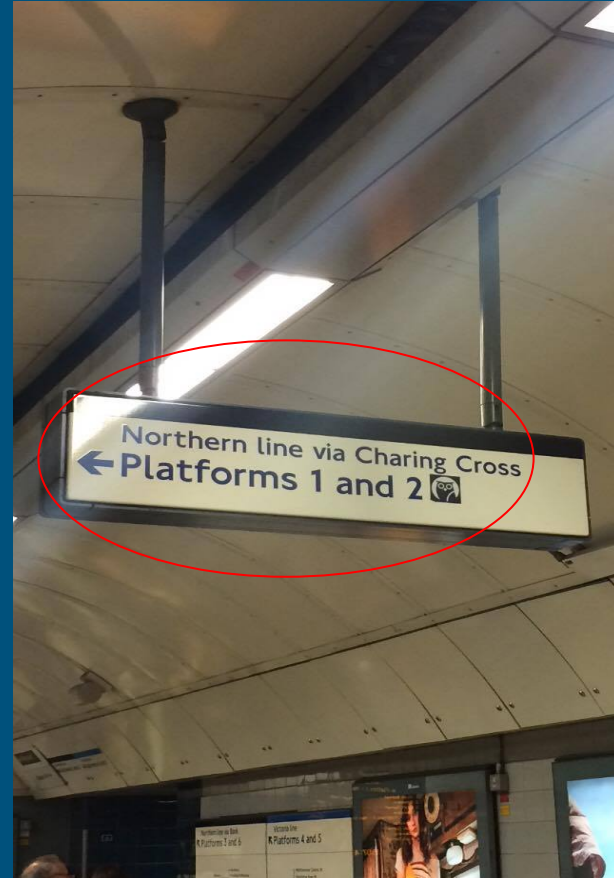
Unclear Signage

- Increase width of all major passageways
- Remove or replace confusing signage
- Move maps away from choke points
- Split the Northern line to reduce confusion
- Consider a station revamp/rebuild to account for Crossrail 2/High-Speed 2 traffic

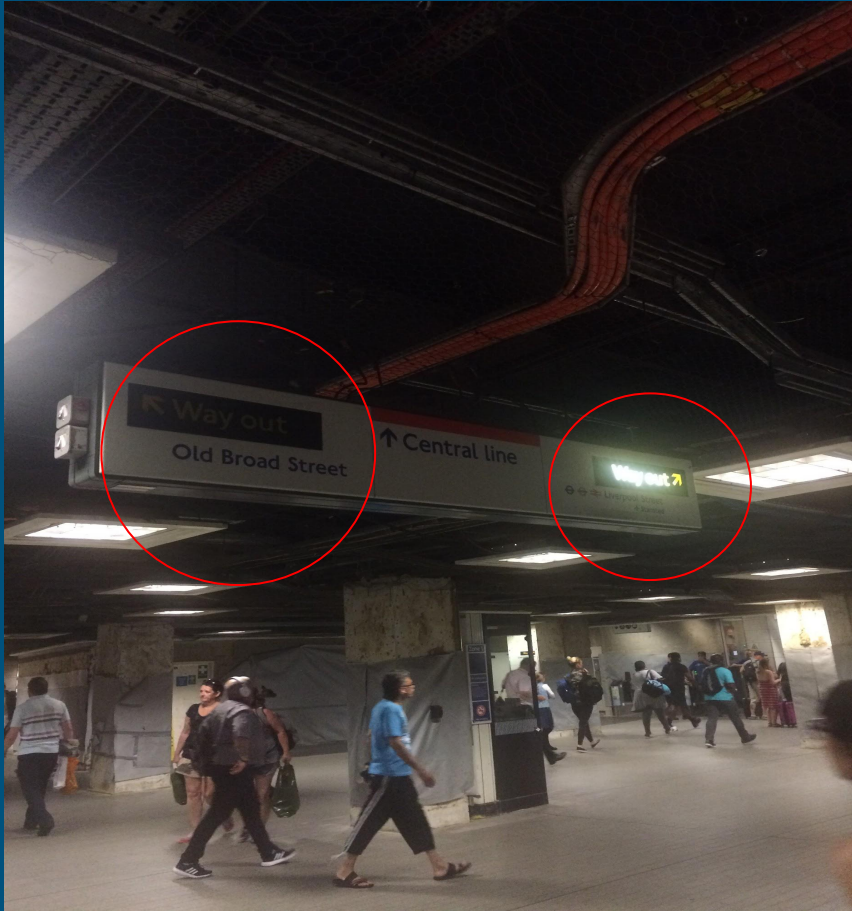
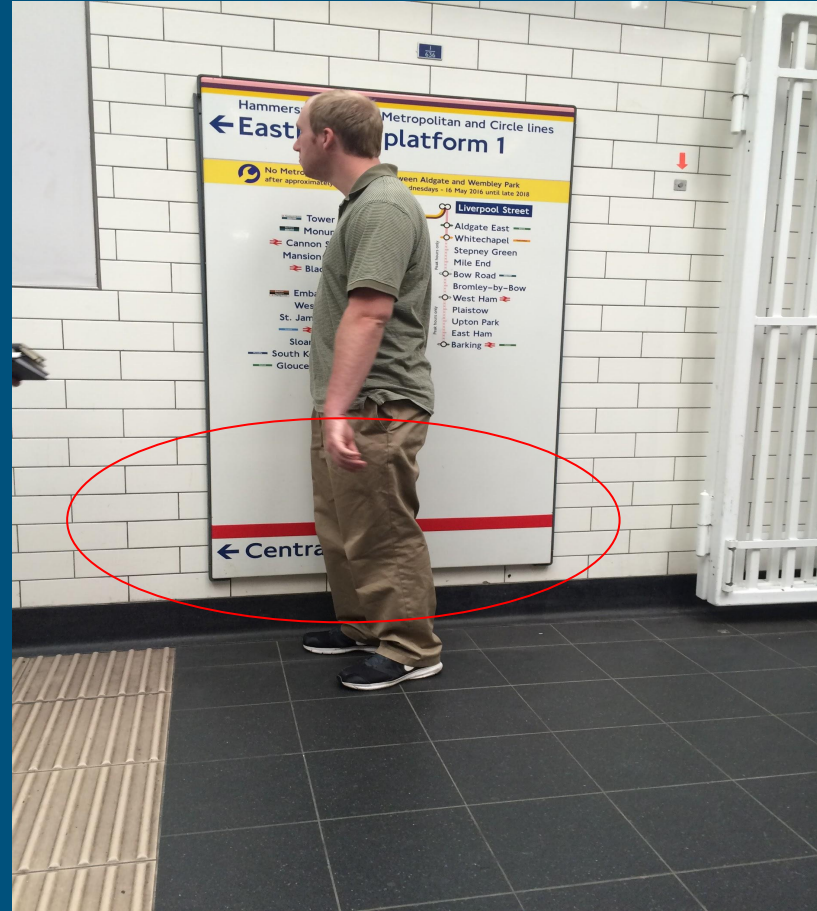
Unclear Signage

- Add more Ticket booths to Ticket Hall C
- Add another bridge across the tracks near Ticket Hall A
- Expand the platforms, or
- Implement platform doors to improve safety on congested platforms
- Add lifts from street to platform for more handicapped accessibility
- Brighter signage and platforms
