Rehabilitating Hazardous Structures in Rabat's Medina

Project Center: Rabat Morocco

Prefecture of Rabat

Date: October 16, 2015

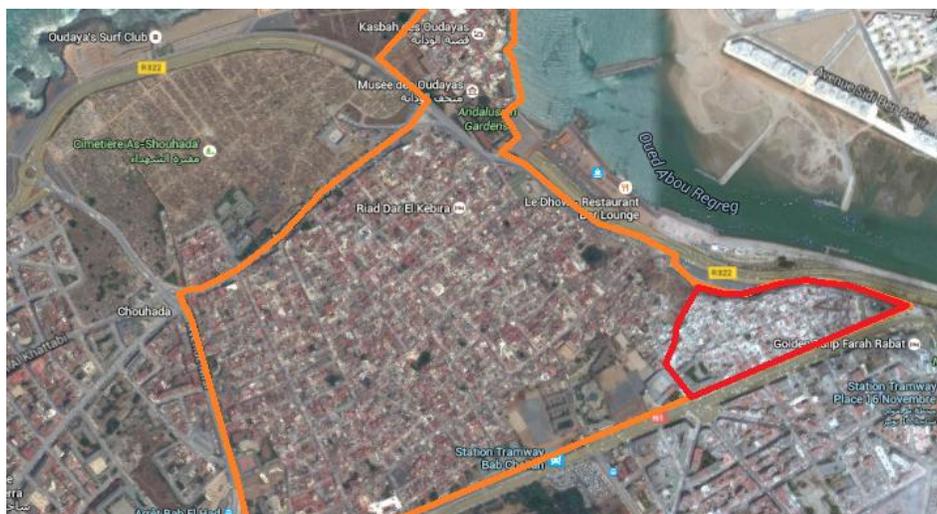
Figure 1: Satellite view of Rabat (Rabat Google Map) with the medina borders highlighted with the mellah highlighted in red

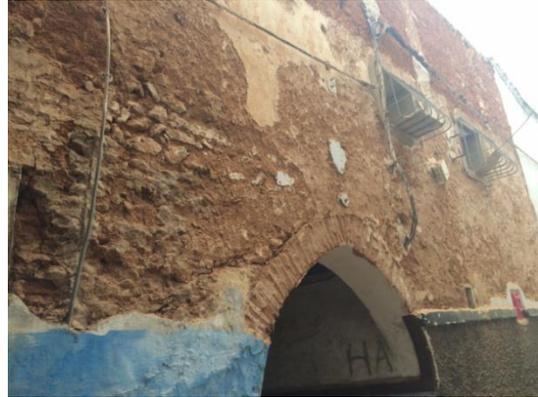
Figure 2 : Exposed Brick wall with plaster being replaced

Rabat's medina consists of two or three story buildings comprised of stone or brick with a lime mortar (figure 2), which is then covered in plaster. Wooden columns and beams are used for support and roofs are made of wood, layered reeds, and clay mortar (Omira, 2010).

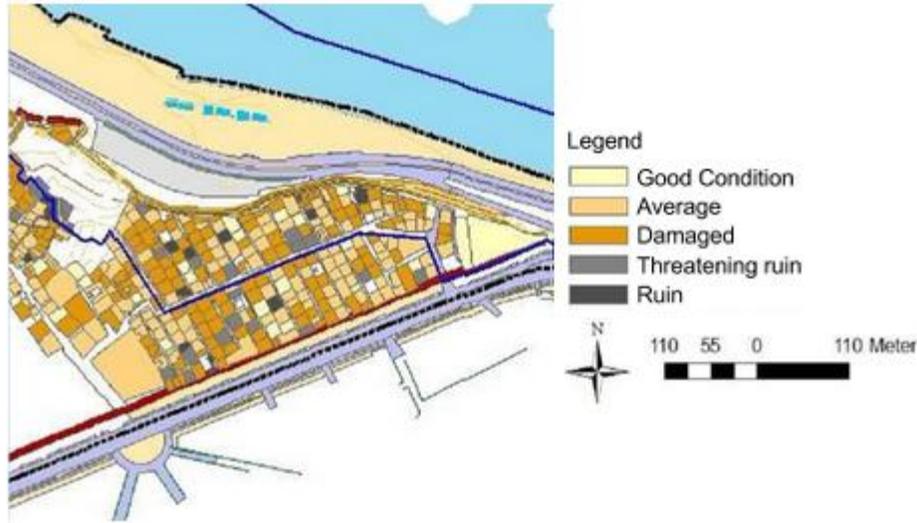
Recently, a series of consultants reviewed cases of hazardous structures in the mellah and surrounding areas. These consultants provided the prefecture with data involving the damage to individual residences as well as information on the medina as a whole. Accompanying this data, the prefecture has a variety of maps charting ruined and damaged buildings throughout the medina. Figure 3 shows a section of a prefecture map of the medina. This specific section of the map shows the mellah, which has a high density of ruined or in danger buildings.

Figure 3: Map of building conditions in Rabat's Mellah

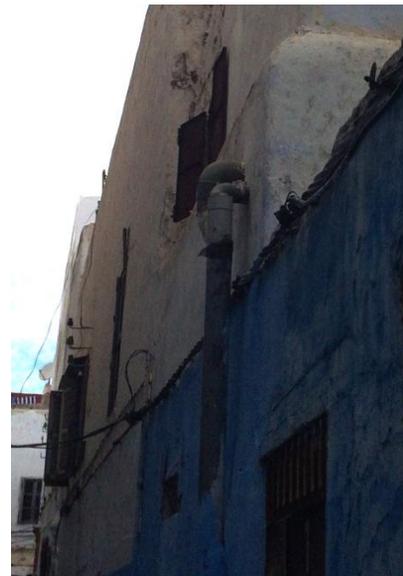
Figure 4: Exposed drainage pipe in mellah

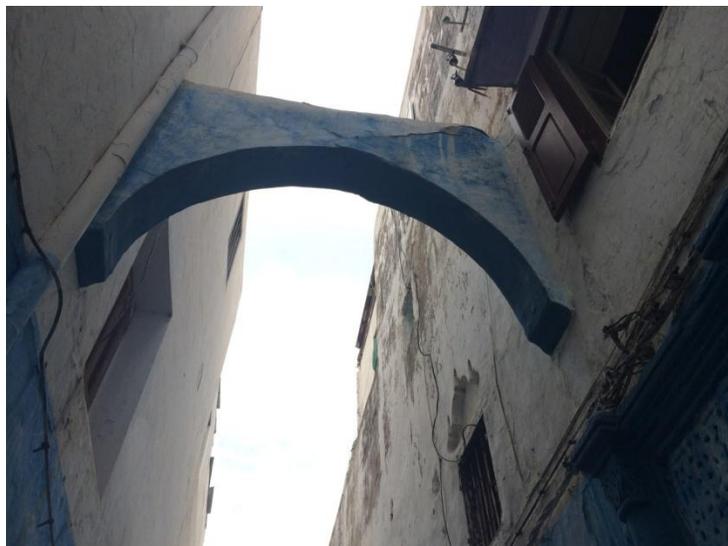
Figure 5 Damage arch between two homes in mellah

Some methods have been employed to help prevent walls from buckling outwards. Figure 5 shows a case where an arch has been placed between homes to transfer forces between two buildings and reduce risk of collapse, however, many of these arches have begun to display signs of wear in the form of cracks and bending. Combined with excess weight from additions, water leakage plays a large role in decreasing the structural integrity of buildings in Rabat's mellah. During winter there is increased precipitation which renders many rooms unusable as water leaks through the ceiling. This leakage furthers structural damage and exacerbates the risk of full or partial collapse. In Figure 7, a crossbeam has fractured in the center due to a

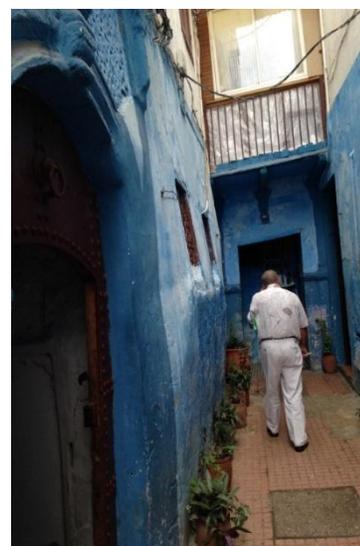
sources. One example of this is new structural additions built above old structures. These additions add excessive amounts of stress to the walls of these homes, causing them to buckle outwards into the roads as shown in Figure 6. These bulges are typically not addressed on a structural level; instead cracks that form are plastered over allowing the degradation to continue.

Figure 6 Bowed wall in the mellah

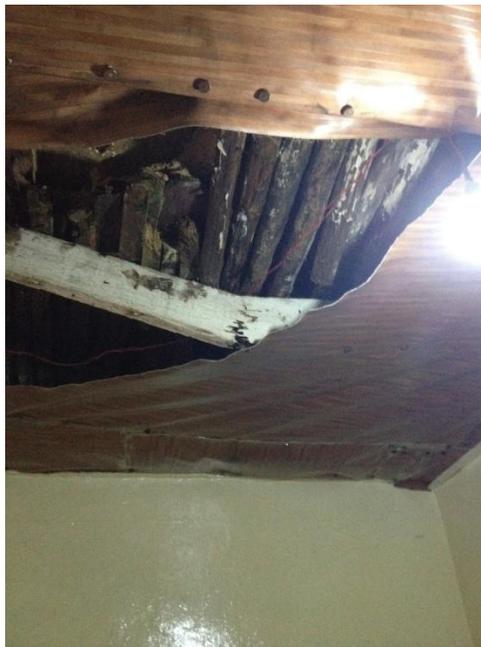
combination of water and insect damage. The majority of the ceiling in this case is made of untreated cedar timber and has undergone the same degradation as the crossbeam. Despite this broken crossbeam, the family continued to use the space as a bedroom until dirt and small bits of material began falling. For safety the family no longer uses the room except for a small space which they reserve for storage. Situations like this not only pose a risk of eventual collapse, but are also immediately detrimental to the quality of life of the residents. Without this bedroom the children now sleep in other rooms, thus making the home feel significantly more crowded.

Figure 7: Broken waterdamaged cross beam

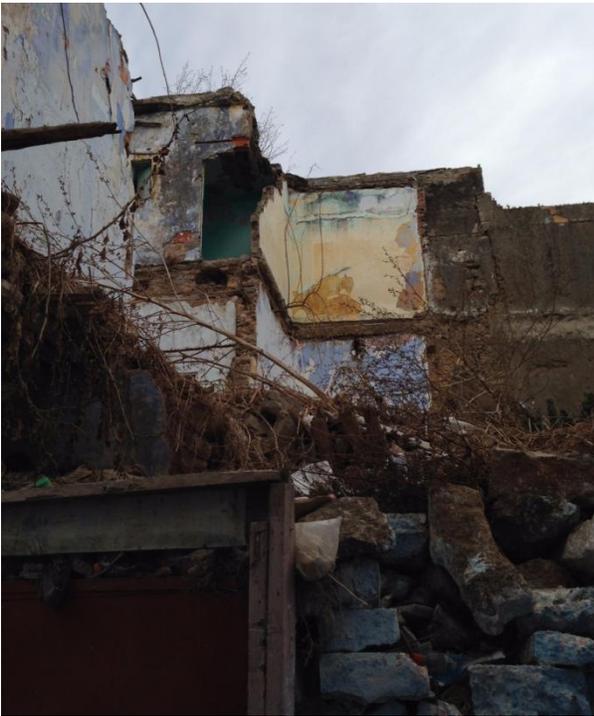
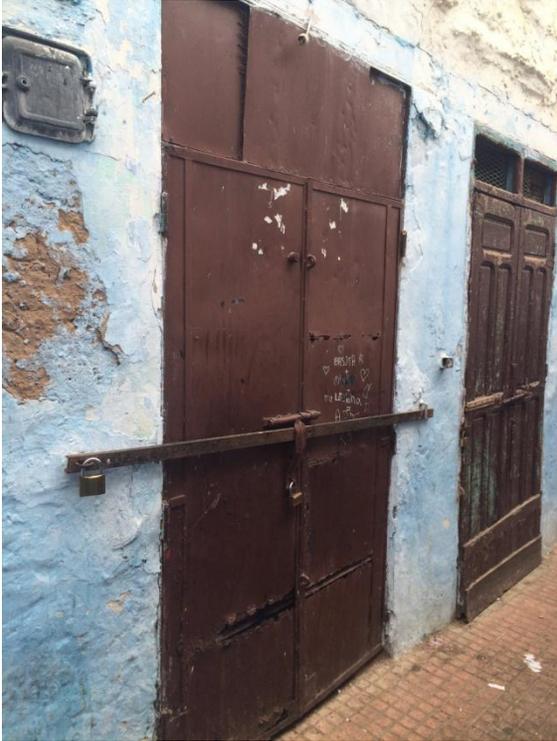
In addition to residences, we were shown a number of abandoned lots where structures had either fully collapsed or reached an unstable state, rendering them uninhabitable. At the collapsed houses we visited, no significant effort has been made to remove the debris and thus the houses remain abandoned and condemned. In some particular cases, the ruins of partially collapsed buildings posed a hazard to nearby

buildings via their potential to fully collapse and fall into other structures. Many standing abandoned structures in the mellah are closed off and have signs warning against entry (Figure 8). These buildings pose a serious risk to the safety of residents and block potential foot traffic and transportation.

Figure 8: Left: a collapsed home. Right: a barred entryway to a collapsed building

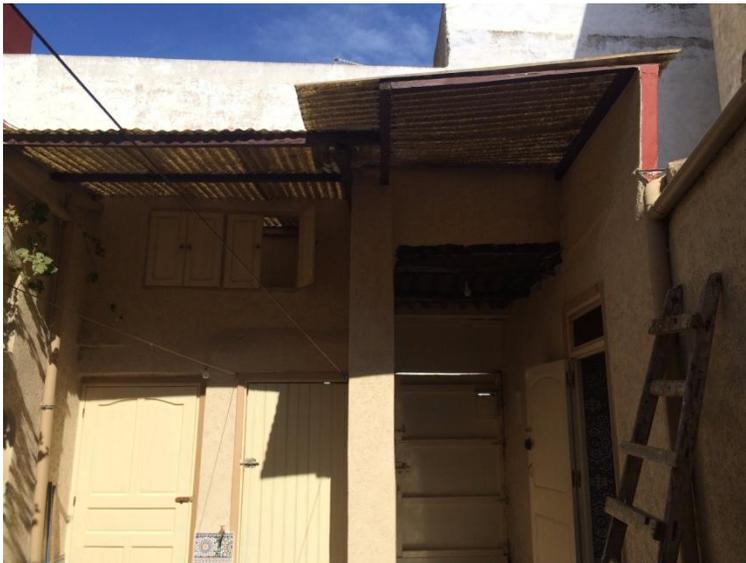
The guided mellah walkthrough helped focus our research questions for the specific site visits conducted afterwards. The first site we visited was a one-story home located less than a block away from the outer wall on the Bouregreg river side. The owner had invested considerably in renovations of his home having expected them to be a long-lasting solution, but since the renovations were made, rain had begun to leak through the new roof and cause water damage in every room in the home. Water had deteriorated the ceiling in many locations, thus causing structural instability. The resulting structural hazard rendered three of the seven available rooms completely unusable during rainy winter months. One solution was to use corrugated fiberglass sheeting to help rain drainage, as seen in Figure 9. This method is cheap but needs to be replaced every two to three years due to sun damage and is not an effective long term roofing strategy.

Figure 9: Corrugated sheet in case study home 1

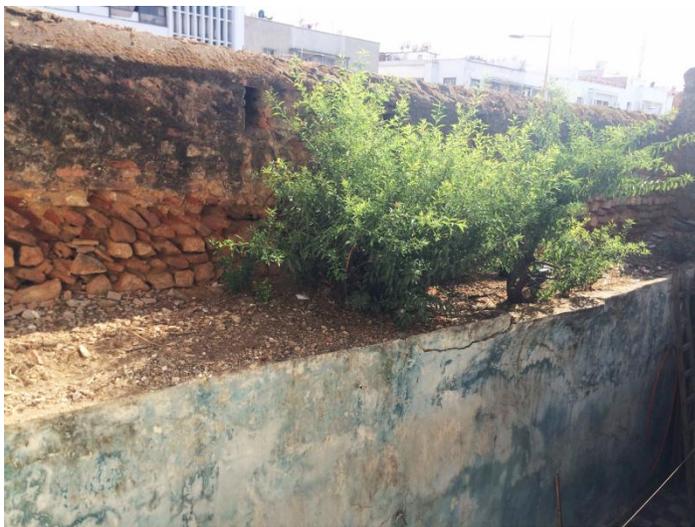
Figure 10: A tree cracks through a restraining wall into the courtyard of case study home #2

On the first floor courtyard, there is a retaining wall roughly one meter offset from the medina wall that is filled completely with dirt, as seen in Figure 10. A tree is currently growing in this dirt and has caused cracks to form along the wall. A sapling offshoot and the roots from the main tree have also damaged the

floor tiling in the courtyard and the base of the retaining wall.

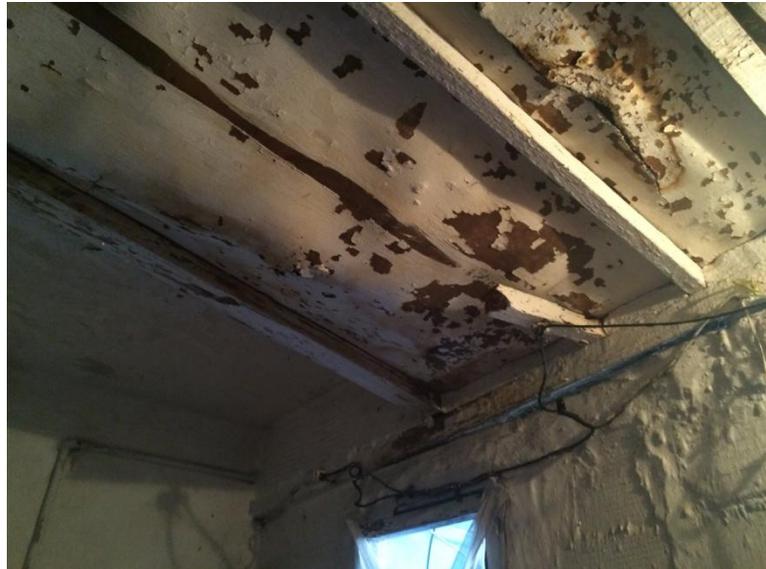
A shed-like structure was built as an addition to the first floor courtyard. This shed shares part of the ceiling of the main structure, with the remainder of the roof being a newer section. The new roofing on the shed consisted of wooden crossbeams supporting a layer of particle board and insulation surfaced with corrugated metal sheets. One of the crossbeams was visibly broken, and the particle board was badly warped from water damage (Figure 11).

Figure 11: Damaged roofing in added shed

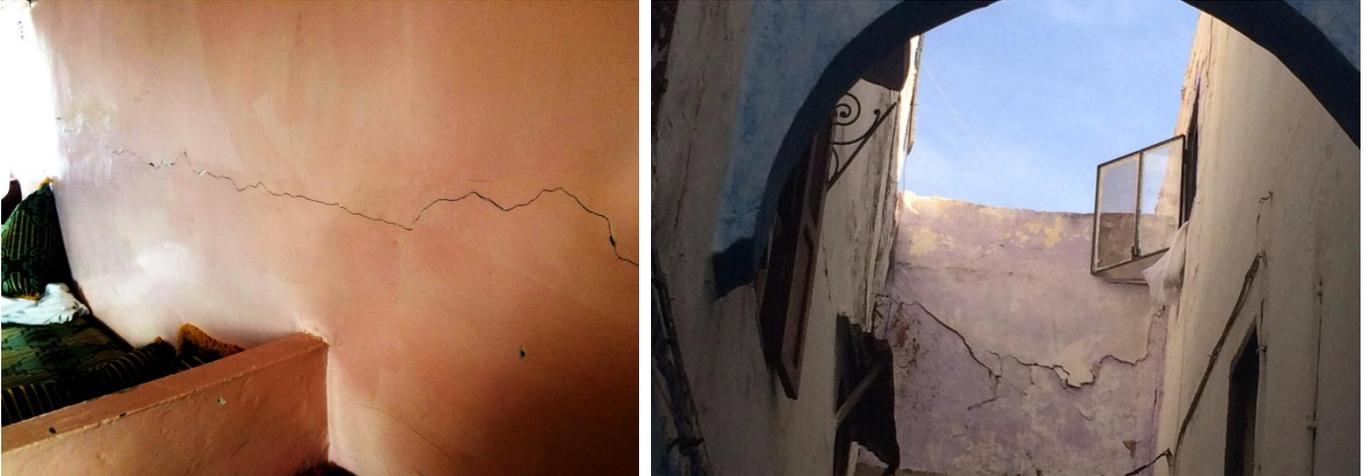
Figure 12: Cracked third floor wall and a perpendicular supporting wall

Upon inspection, the stairs and walls on the second floor were uneven due to the superstructure shifting and sinking under the weight of the added third floor. The walls also showed signs of water damage and hollow spots on the walls were discovered when knocked on. The owners explained that horizontal wall cracks are not localized issues and penetrate through to the other side of the wall due to the shifting of the connected building (Figure 12).

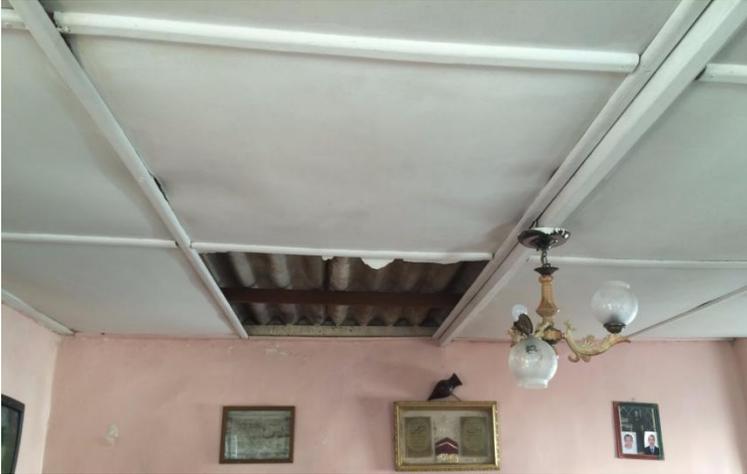
During our visit, the added third floor had already begun to degrade despite the use of modern construction materials. The ceiling consisted of painted fiberglass fastened to wooden cross beams over a particleboard drop ceiling (Figure 13). The initially watertight fiberglass ceiling had begun to crack from heat and UV degradation leading to water damage in the walls and drop ceiling. The walls were constructed mostly of brick and plaster with concrete used for some walls and the second to third floor staircase. These concrete walls showed significant signs of instability with a number of cracks running horizontally, particularly in areas close to the ceiling.

Figure 13: Removed drop ceiling

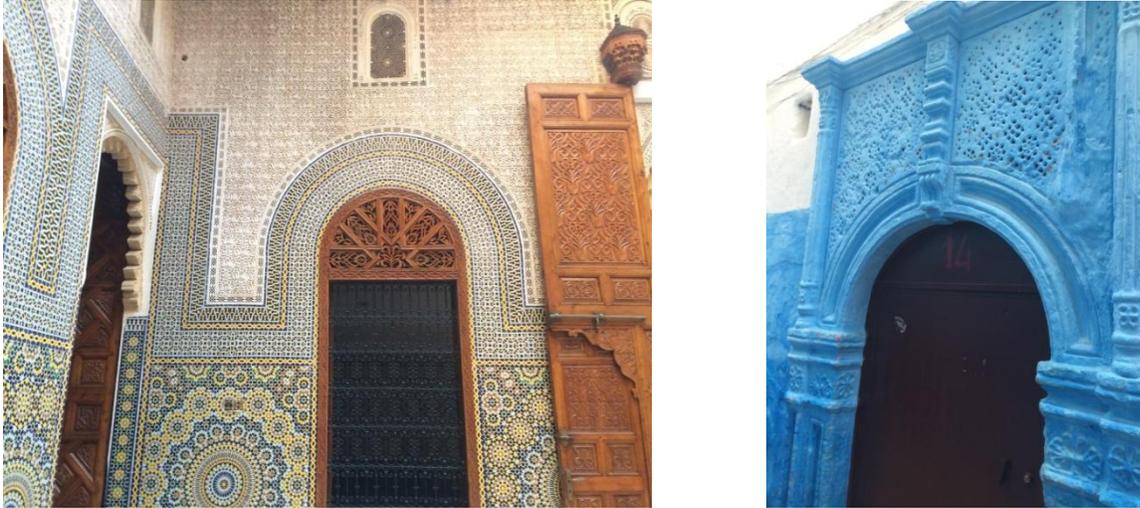
Figure 14: Left: A typical mellah entryway. Right: Dar Merini, a rehabilitated medina house

The entryways to homes in Rabat's mellah commonly have a decorative archway. The most prevalent style seen in the mellah follows the design seen in Figure 14. This archway is part of a facade that mimics columns surrounding the door and contains many decorations including flower and star patterns. These archways are typically painted with a bright color like blue or an earthen color like tan. Many houses in the mellah do not have entryway architecture like this and adding these to houses can raise that value of residents' homes and add character and variation between buildings.

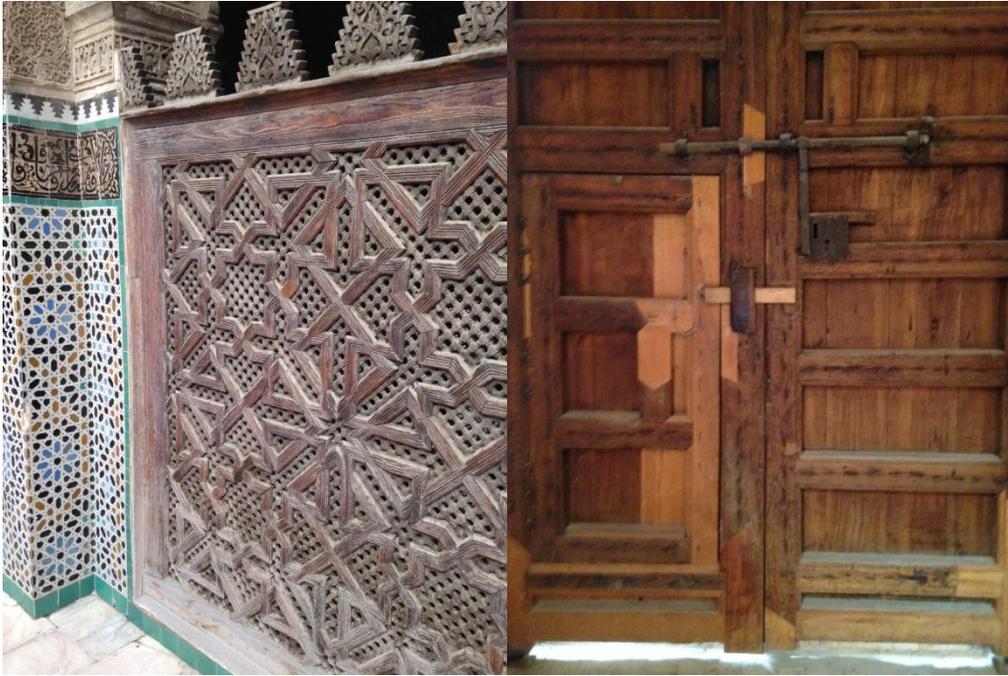
Figure 15: Left: Fine woodworking on privacy wall. Right: Door in a fonduq in Fes

Wooden finishings are most commonly carvings, doors, or window frames. Wood carving is an artisanal craft that can be seen in virtually any wood material used in a house. Fine wood carvings can be seen on the doors and windows in Figure 15. Original wooden fixtures can be damaged over time but can often be repaired or salvaged instead of scrapped completely. In one rehabilitated fonduq in Fes, an original wooden door was used but new pieces of wood were used to replace damaged areas as seen on the door in Figure 15. In another fonduq, original wood was recycled by sanding off damaged sections, re-carving them and then re-staining them. The same fonduq had many wooden beams that had become too damaged to be used structurally, so they were repurposed to cover I beams that were providing structural support in the walls. Repairing or repurposing wooden materials in houses is practical and preserves traditional styles and materials but wood carving can be incredibly time intensive and

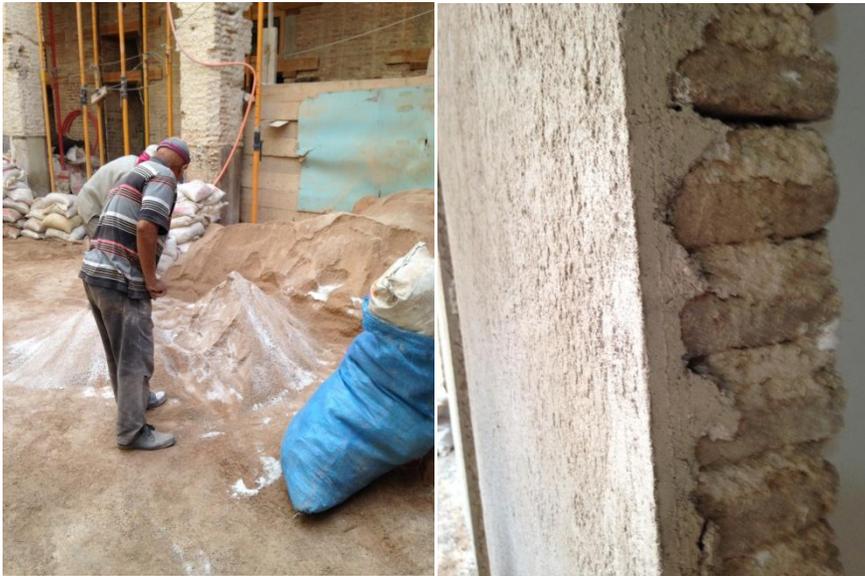
Figure 16: Left: Workers mixing mortar. Right: Fresh mortar on old bricks.

Walls and columns are commonly finished with a mortar made of sand, lime, water, and other additives. Figure 16 shows the creation of this mixture by contractors working with ADER-Fes. An original brick wall and stone columns can be seen being finished with this plaster in figures 16 and 17 respectively. A lighter plaster is often applied on the surface of walls which can be carved into intricate designs. This plaster carving is a traditional art form which can be seen in Figure 17 Plaster carving, much like wood carving, requires large time investments of skilled labor that may be too expensive for projects that are not large scale public buildings.

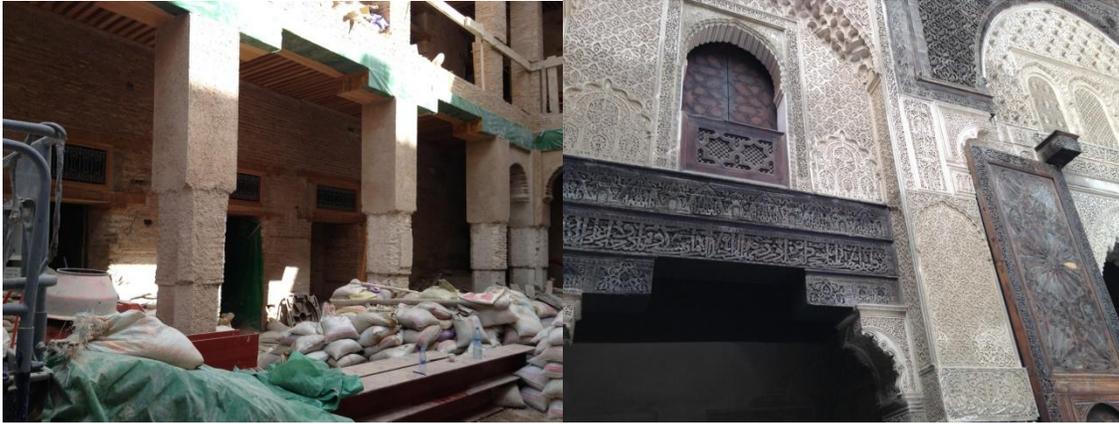
Figure 17: Left: Plaster on old stone columns. Right: Intricate plaster carvings in Fes

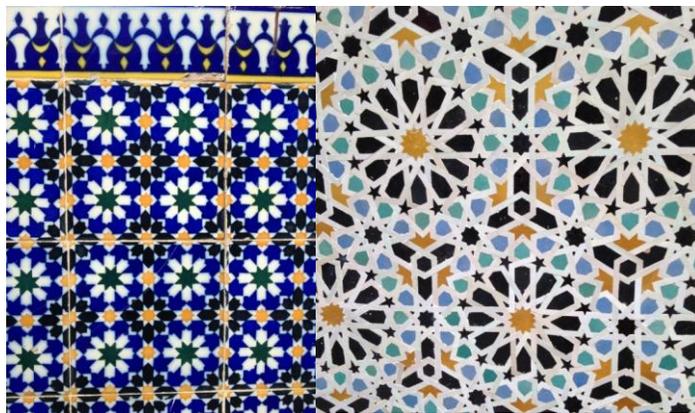
Zellij is an historic Moroccan tile mosaic crafted with meticulously hand cut pieces placed in complex geometric patterns. This beautiful craft is widely considered an art form of its own and is known only by master craftsman. Zellij can be seen on walls in figure 18. Zellij tiling is a unique and classic Moroccan art which is in limited supply in the modern world due to the expertise and vast quantities of time required for production. Unfortunately these limitations of skill and time consumption make zellij rare and expensive and will be difficult to include in rehabilitated homes. Alternatively, renovated homes in Morocco display faux zellij, of tiles that have been painted in similar geometric patterns to traditional zellij. Imitation zellij can provide a similar aesthetic experience for much less monetary cost, but loses the benefit of supporting local craftsmen.

Figure 18: Left: Faux zellij. Right: Zellij in Dar Merini
