The Implementation of a Crosswalk Improvement Plan for the Town of Brookline, MA

An Interdisciplinary Qualifying Project
Submitted to the faculty of
Worcester Polytechnic Institute
in partial fulfillment of the requirements for the
Degree of Bachelor of Science

The Town of Brookline Department of Public Works

Date: May 29, 2005

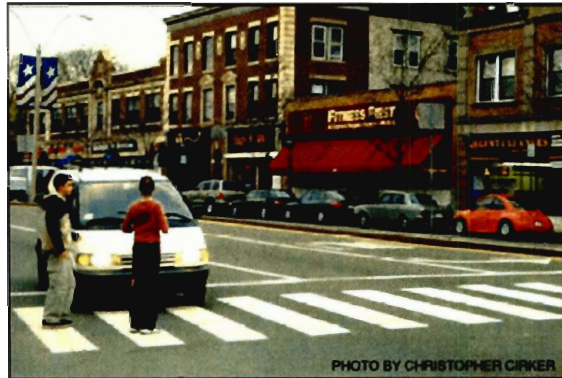
Figure 4: Double Threat Crosswalk Example

Roadway and crosswalk design often present problems in some communities. Among these problems is the “Double Threat” crosswalk that is created when two or more lanes of traffic are going in one direction. In this situation if the nearest lane driver stops for the pedestrian, then both the pedestrian and the driver in the far lane are blind to each other. Figure 4 clearly demonstrates how the white van obstructs the view of the pedestrian and makes it difficult for them to see a car approaching in the far lane. It is also clear that the white van in the near lane hides the pedestrians from the view of the oncoming motorist. There could easily be an accident if the driver and the pedestrian do not make eye contact. The design of this crosswalk system is often very dangerous, and extreme measures must be taken to prevent these types of accidents from occurring. For instance, if having a “Double Threat” crosswalk is unavoidable due the roadway situation, then better signage and prevention systems must be put in place, further increasing the costs of the crosswalk.

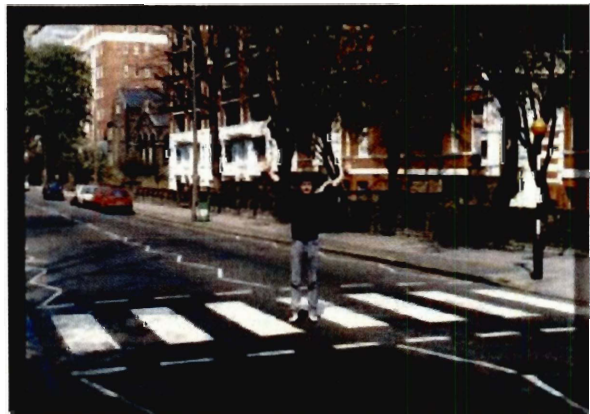
Figure 5: Mid-Block Crossing Example.

Another type of problem is the “Mid-Block Crossing”, where crosswalks are installed in areas far from intersections. This presents a major problem because drivers usually won’t slow down at these crossings and often do not pay attention to pedestrians crossing the streets at random locations along the road. Often these crosswalks are equipped with extra paint or signage on the approach to alert motorists of the crosswalk, as is the case in Figure 5. This type of crosswalk is usually reserved for schools or other high traffic areas such as shopping districts due to the added costs.

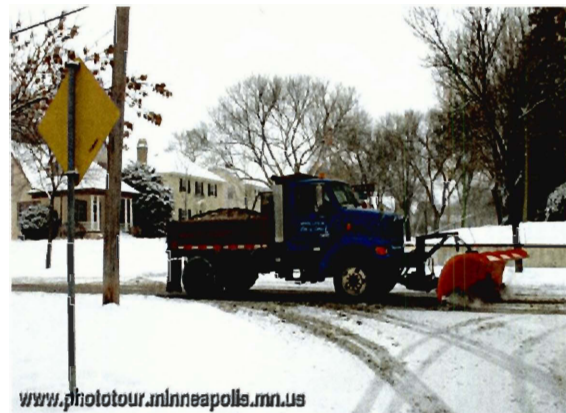
Weather conditions, construction disputes, and poor planning also lead to deteriorations in crosswalk maintenance and infrastructure (Figure 6). Communities with low budgets or budgets that are not geared towards road maintenance often suffer the most. If there is low support for projects within these communities then it is more likely that a road or crosswalk accident involving a pedestrian will occur. For example, Seattle, Washington is a major

Figure 6: Snowfall, salting, and plowing accelerate crosswalk deterioration.

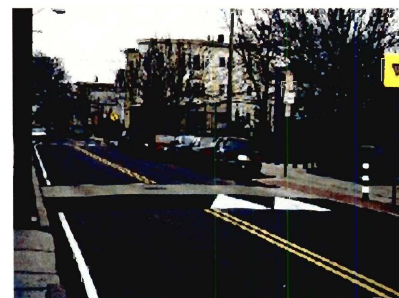
Figure 11: A Raised Crosswalk

Raised crosswalks (Figure 11) slow on-coming traffic by acting as a speed bump. These devices are more desirable than ordinary speed bumps, as they are not as steeply inclined and allow vehicles to travel over them at higher speeds and reduce the likelihood of vehicle damage. They also put the crosswalk itself higher up in the view of motorists, which makes them more visible.

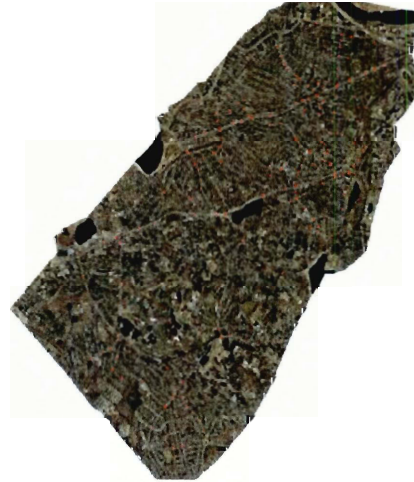
The GIS inventory located 585 crosswalks throughout the town (Figure 22). The field inventory was concentrated in the northern area of the town, where crosswalk density is highest. Examples of the five crosswalk types found in Brookline are shown in Figure 23. Brick was chosen to describe the solid marking pattern because all of the solid pattern crosswalks inventoried used an inlayed brick material to produce the solid pattern.

Figure 22: Locations of all crosswalks found during the GIS inventory.

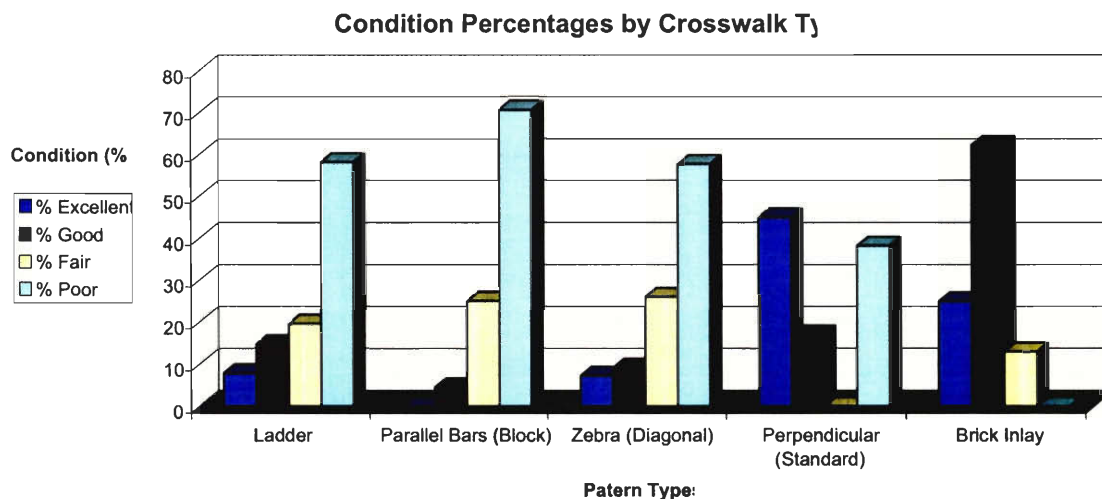
Figure 24: Percentage of each marking pattern in each condition.

Figure 24 shows the extent to which poor condition prevails across almost all pattern types. It should be noted that the ladder, block, and zebra marking patterns share a similar trend, and that the brick and standard patterns deviate from this trend. The

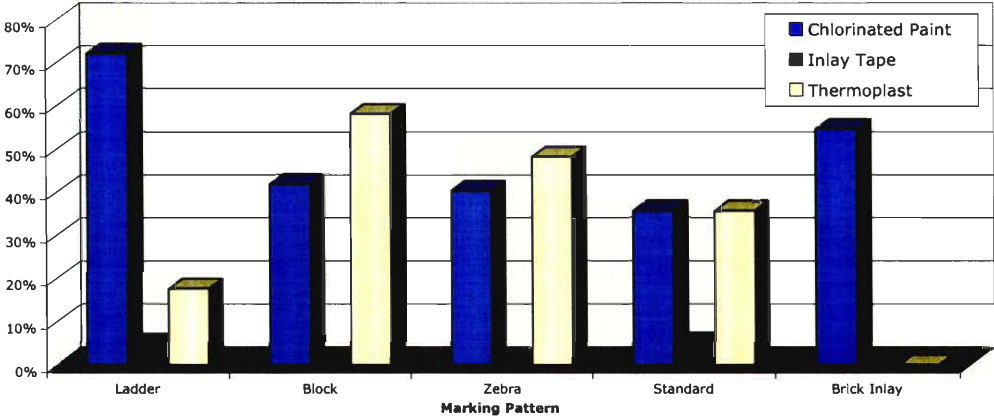
material used to mark a given pattern was divided by the total amount of all materials used to mark that same pattern. This resulted in the percentage of each material used to mark each pattern (Figure 25). Paint is the material usually employed to mark ladder patterns as well as to mark the perpendicular bars of brick crosswalks. Thermoplastic and paint are used in almost equal frequency to mark block, zebra, and the standard marking patterns. Inlay tape has only been used in ladder and standard patterns by the town. This is likely the result of the installation requirements previously discussed, and an effort by town officials to standardized the marking patterns used.

Figure 25: Crosswalk types and common marking materials.

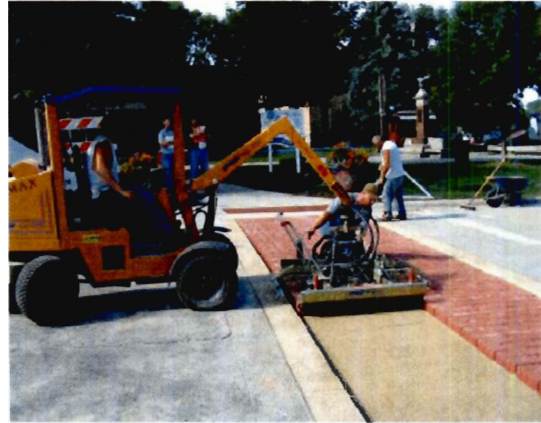
Other than their visual appeal, brick inlay crosswalks are not very effective. They have very low retro-reflectivity and, therefore, are difficult for operators of vehicles to see during the day time and nearly impossible to detect at night. In wet conditions brick inlays become wet and slippery which could be hazardous to both pedestrians and motorists. On top of the already mentioned drawbacks, brick inlay is an expensive crosswalk treatment. This treatment should be avoided if possible.

Figure 37: Example of an inlaid brick crosswalk.

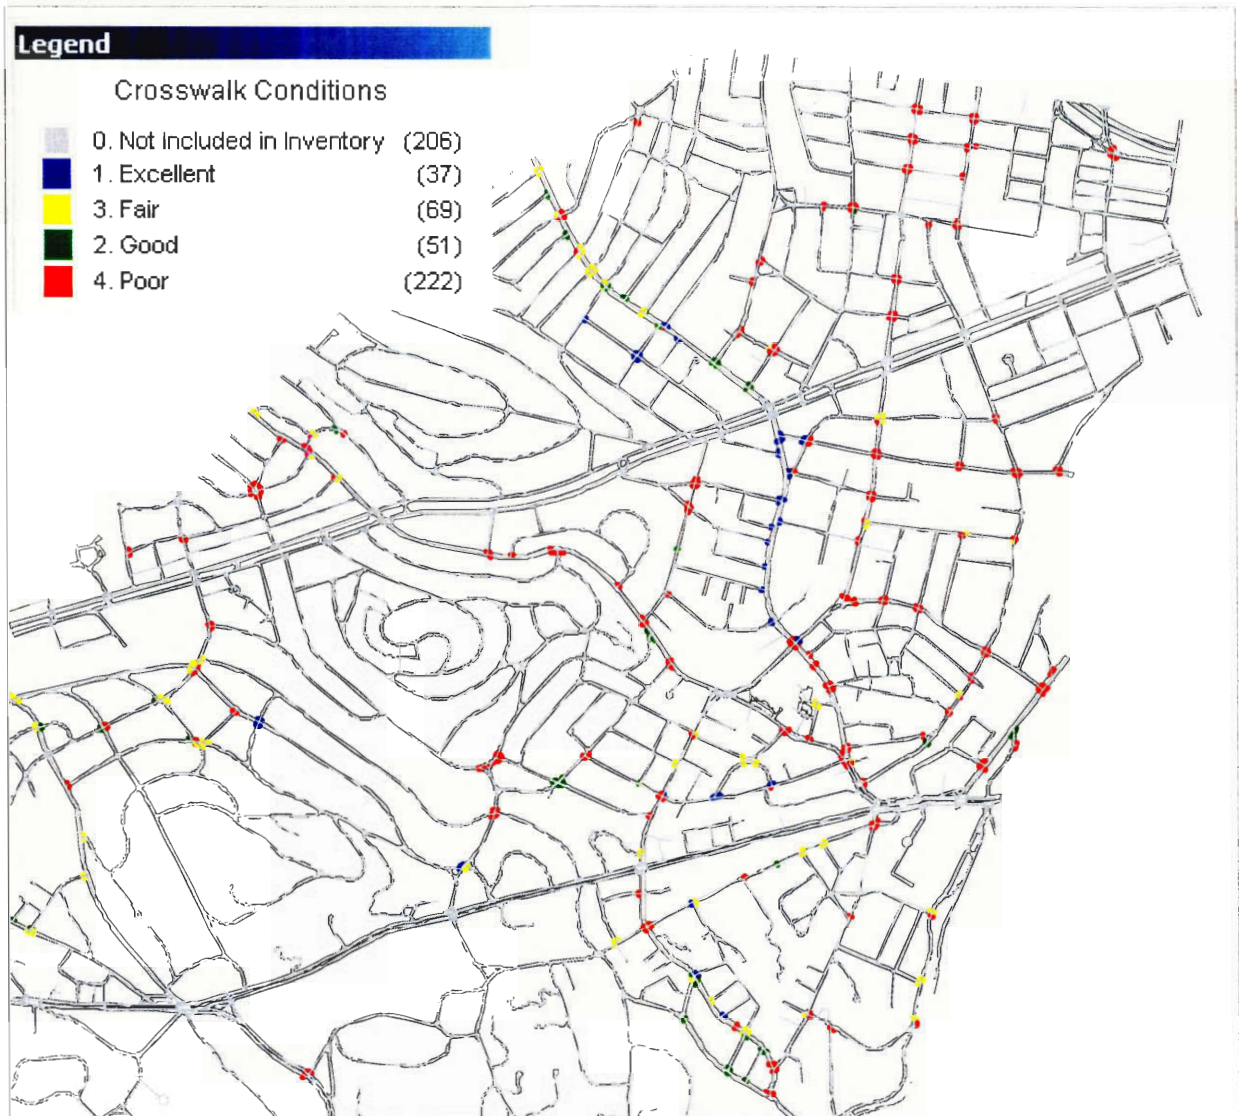
Appendix G: Condition Map

The map below shows the northern half of Brookline and the locations of all crosswalks. Inventoried crosswalks are color-coded by marking condition and these values are shown in the legend.
