A Conceptual Framework for Assessing Post-Earthquake Fire Performance of Buildings

Degree of Master of Science
in
Fire Protection Engineering

Abstract

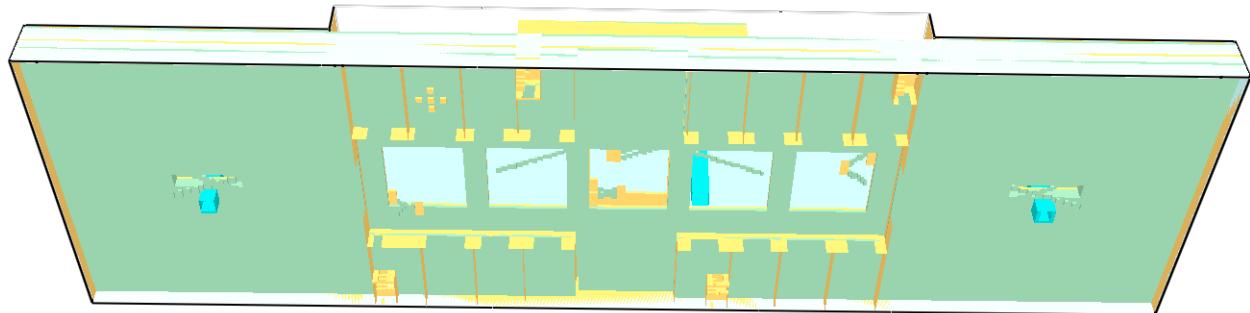
Figure 50. WPI Mall looking from below in Smokeview

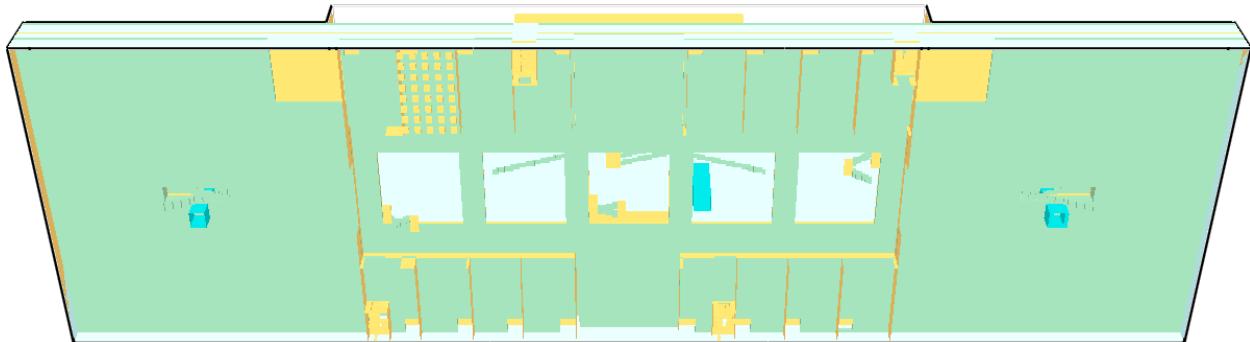
Figure 70. WPI Mall looking from below in Smokeview

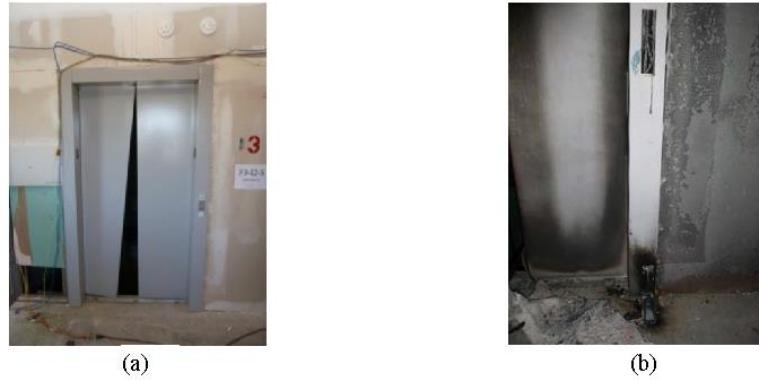
Fig. 4. Damaged elevator door after motion tests (a) and melted elevator button after EL-1 (b)

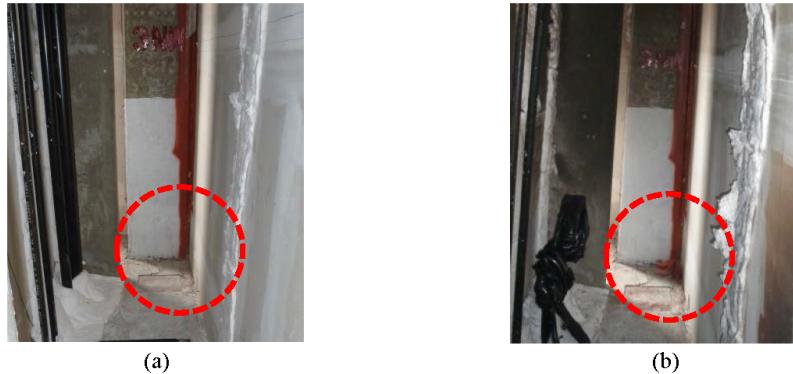
Fig. 6. Fire stop sealant before ES (a) and its fall-down after ES (b)

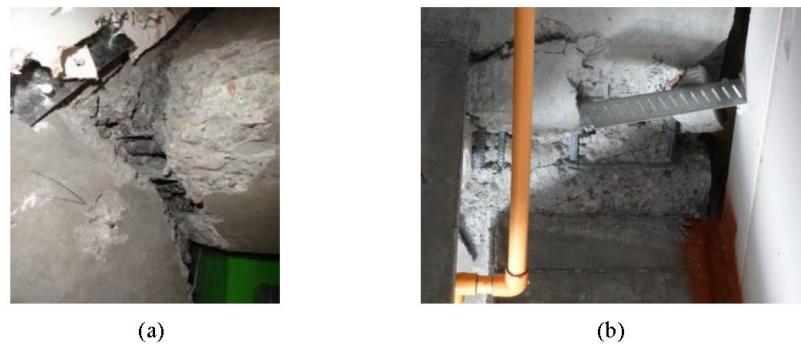
Fig. 8. Structural damage after the motion tests in the second floor: north center column and east beam connection (a) and northwest column and the 3rd floor slab connection (b)

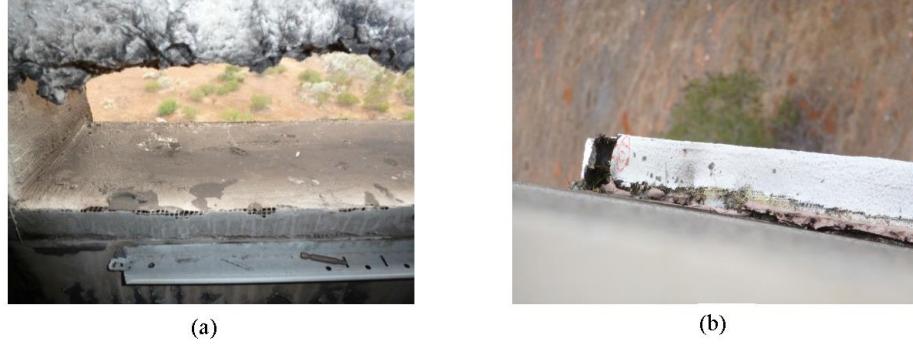
Fig. 9. Burnout of EIFS on window 4 opening (a) and smoke residue on damaged balloon framing (b)
