Restoration of the Walker Street Culverts in Norton, Massachusetts

A Major Qualifying Project

Submitted to the Faculty of Worcester Polytechnic Institute

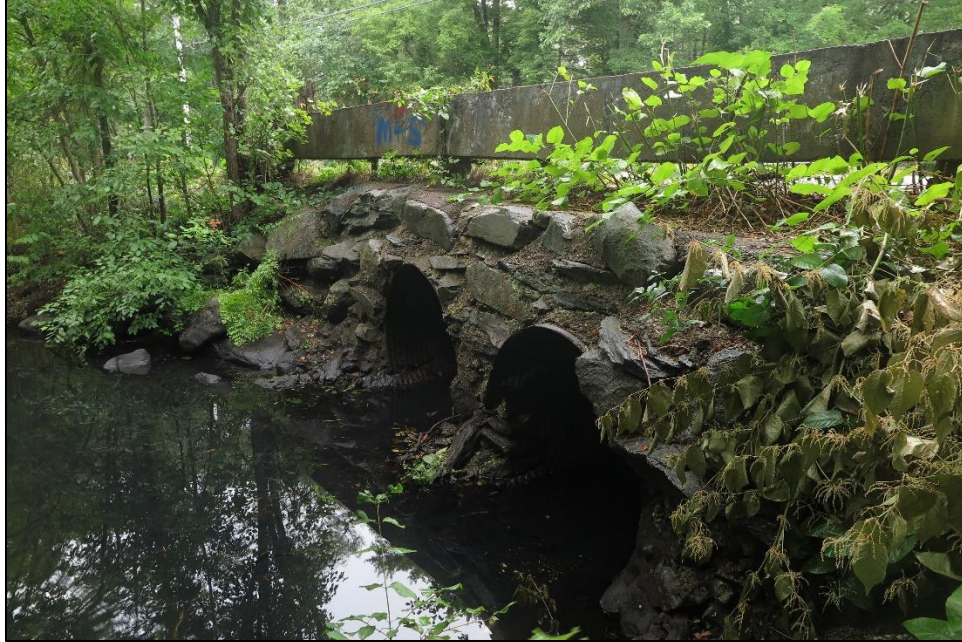
Figure 2.1: The inlet of the Walker Street stream crossing

The Walker Street stream crossing consists of two 72” corrugated metal pipes. The structure itself is made of cement and medium-sized (1-2’ diameter) reinforcing boulders with cement fill surrounding them (see Figure 2.1). The culverts are in moderate to poor condition with corrosion around the sections of the pipe which contact water around the inlet and outlet. The rust is extensive enough to create holes all the way through the pipes in some areas. The roadway itself is in decent condition with recent patching used to cover any holes present.

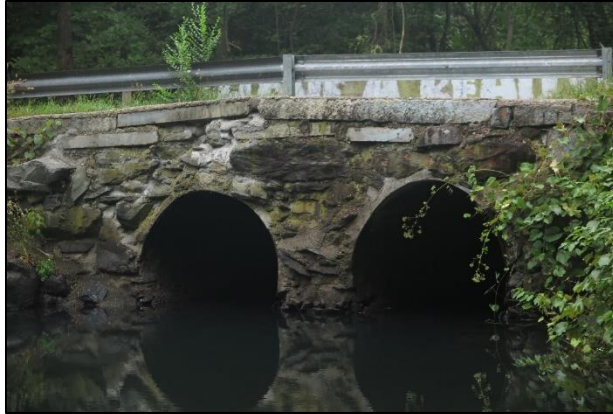
Figure 4.1: A downstream view of the existing culverts

We made several visits to the site of the Walker Street stream crossing (Figure 4.1). These visits gave us insight into the current status of the structure itself and helped to validate flood claims made by our project sponsors, abutting property owners, and our own literature review. Overall, the culverts were in a suitable structural condition, but the outdated structure did not meet the requirements set forth by the Massachusetts Stream Crossing Standards.

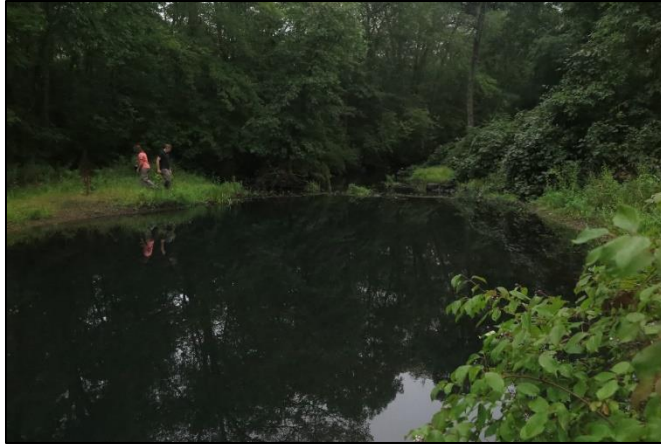
Figure 4.2: The downstream scour pool

We observed very low flow at the time of our visits. This was due to a prolonged drought during the 2016 summer season, and was inconsistent with the United States Geological Survey (USGS) flow data. The stream appeared to have a very low velocity, and was not more than a foot deep through the culverts. We observed and measured the upstream and downstream scour pools, which were much deeper than the rest of the surrounding stream. The majority of the smaller upstream pool was approximately 2 feet deep and the larger downstream pool (Figures 4.2, 4.3) was up to 8 feet deep in some places. The results of our downstream scour pool depth calculations may be seen in Table 4.1.

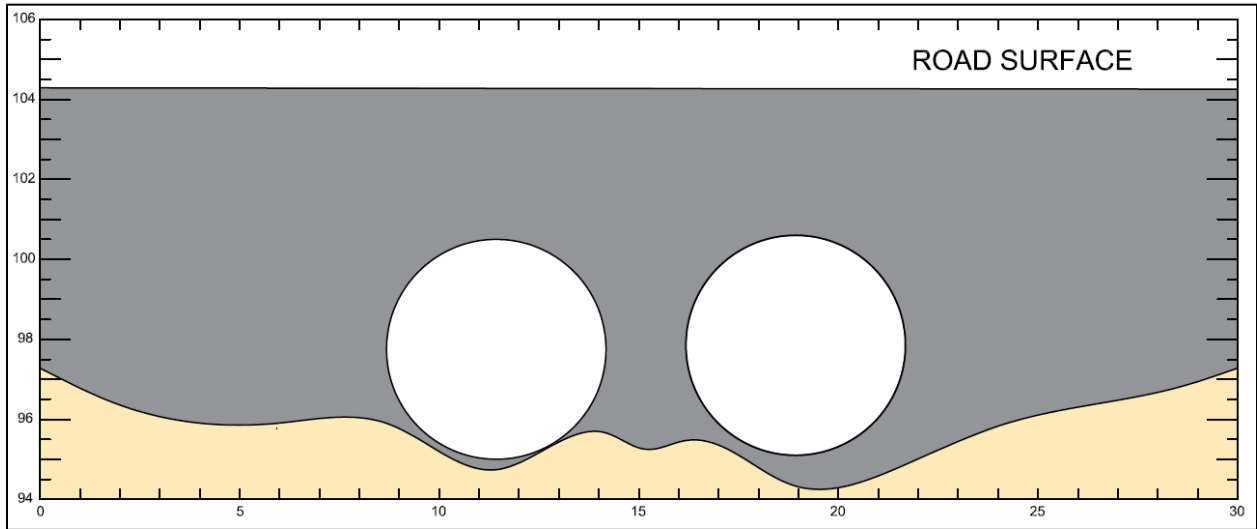
Figure 4.5: AutoCAD model of the existing outlet profile. Measurements are in feet.

We measured the dimensions and elevations of the existing structure in order to accurately determine flow depths for given flow rates. Simply put, if a flow depth exceeded the height of culvert openings, we would know the stream would back up. If a flow depth exceeded the height of the structure, we would conclude that the stream would flood over the roadway. Our inlet (Figure 4.4) and outlet (Figure 4.5) profile drawings helped our team to visualize what was happening with the current structure.

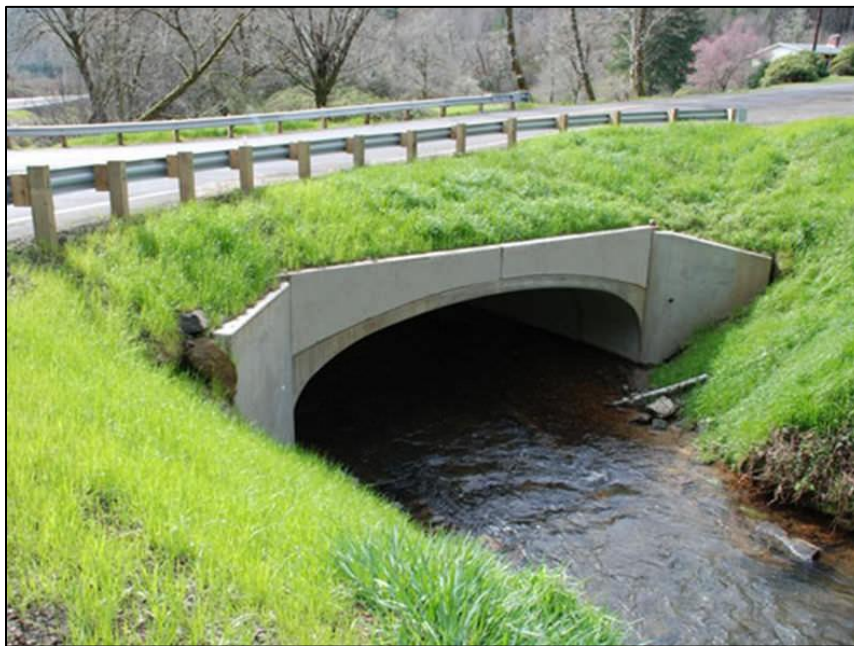
Figure 5.2: Example of a finished B-Series® buried bridge, a similar Contech® structure with different span and rise options (ArchiExpo, 2017)

Our team recommends a prefabricated concrete open-bottom arch culvert for Walker Street. Contech® Engineering Solutions manufactures and provides technical specifications for these structures, so we used their product (Figure 5.2) as an example for our calculations. Our team based the flow capacity calculations on an O-Series® structure. These precast concrete hydraulic structures come in a standard range of spans and rises, which are discussed in Section 5.1.2. The buried bridge structures are comprised of 8-foot wide concrete arch segments connected together onsite. The Walker Street stream crossing would require at least four of these segments. The O-Series® product brochure may be found in Appendix 7.8 and the details specification sheet may be found in Appendix 7.9.

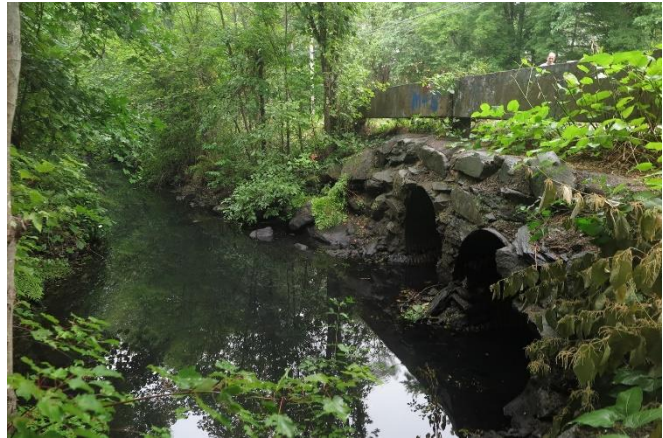
In its current state, the Wading River runs parallel to Walker Street and crosses from the north at a near to 90 degree angle. It runs under the road and into a large scour pool. The pool's maximum dimensions are approximately 70 feet long by 40 feet wide and 6 feet deep. Downstream of the scour pool the turbidity increases and the stream constricts back to regular size.

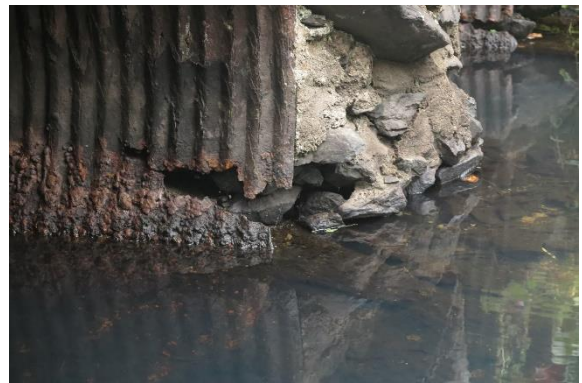
The Walker Street structure that crosses the Wading River is made up of two 72" CMP culverts. The structure itself is made of cement and medium-sized (12"-24" diameter) reinforcing boulders with cement fill surrounding them (see Figure 2). The pipes are in moderate to poor condition with corrosion around the sections of the pipe which contact water around the inlet and outlet. The rust is extensive enough to create holes all the way through the pipes rendering them substandard. The roadway itself is in decent condition with recent patching used to cover any holes present. Overall the road conditions do not have an effect on the usability of the road.
