# Restoration in El Yunque National Forest: Riparian Corridor Assessment and Prioritization

**Restoration in El Yunque National Forest:  
Riparian Corridor Assessment and Prioritization**

An Interactive Qualifying Project  
submitted to the Faculty of  
WORCESTER POLYTECHNIC INSTITUTE  
in partial fulfillment of the requirements for the  
degree of Bachelor of Science

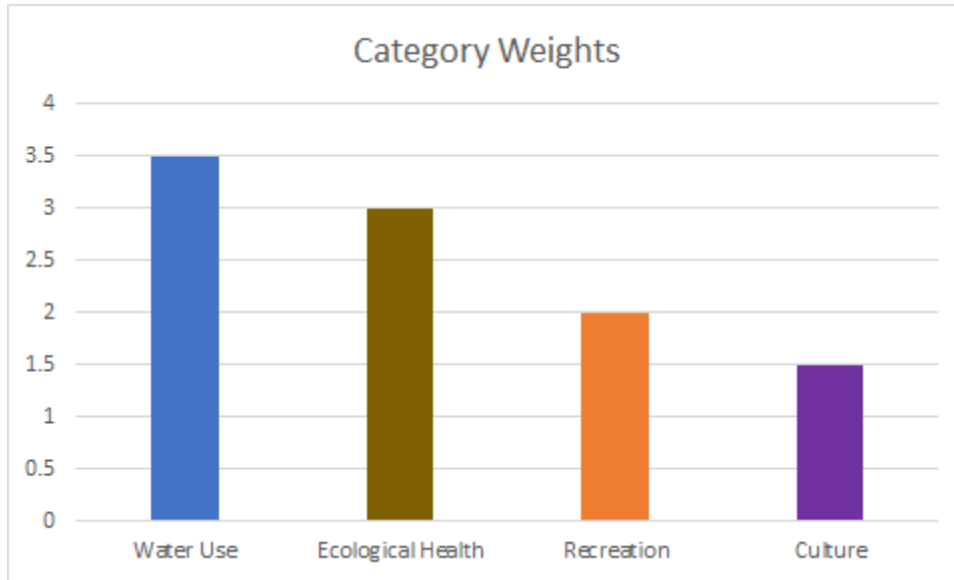
Figure 11: Average Category Weights Graph

During the participatory mapping exercise, the interviewees each ranked the four categories from 1-4, with 4 being the most important. We averaged the weights for each category and generated the graph in Figure 11. Water Use had the highest weight of 3.5, and Ecological Health was a close second with a weight of 3. Four out of the five interviewees said that water use was most important, as they felt sufficient clean water takes precedence over the other three categories until they have access to it.

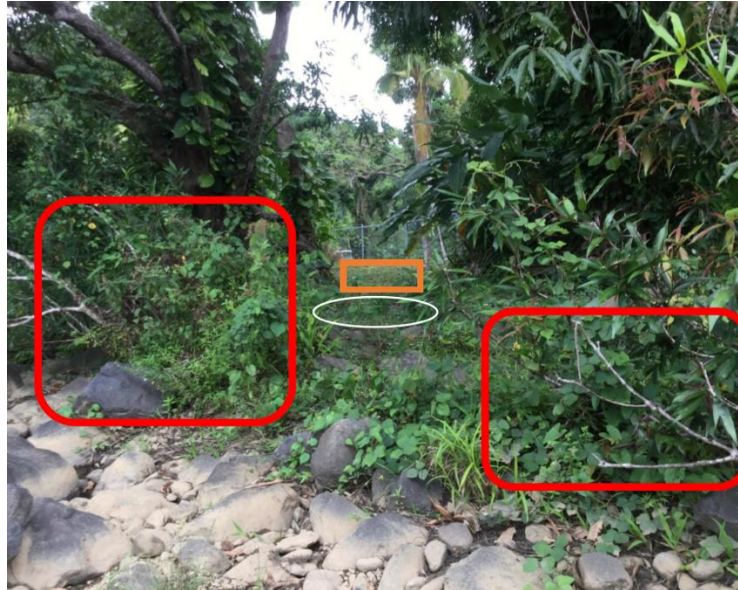
Ms. Nieves-Rivera generated a restoration plan for the selected riparian area near the Eliza Colberg Girl Scout Camp using the results of the assessment protocol. The plan, which

contains several specific methods to restore the riverbank, can be found in its entirety in the Appendix C.

Figure 15: Restoration Plan

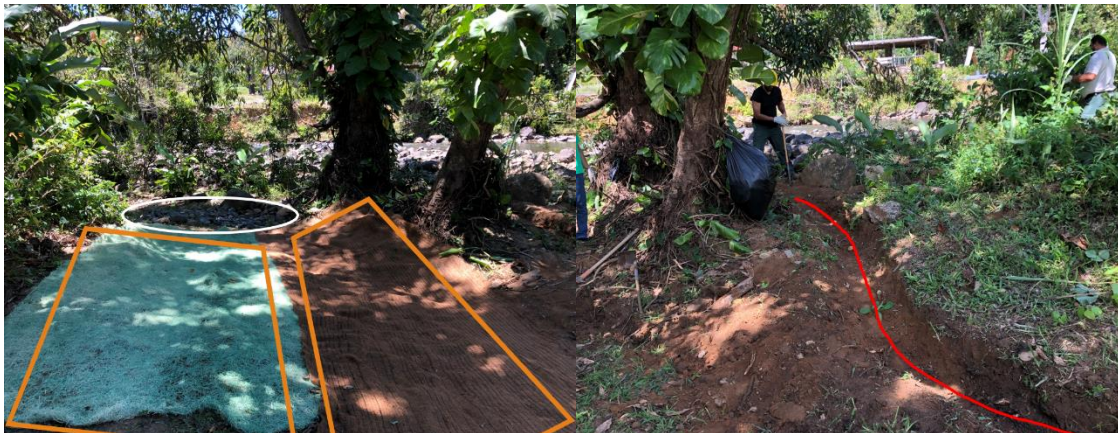
Figure 16: Restoration result

The selected riparian proved to be feasible for restoration. The first step in the restoration process was to set aside any woody debris on the way to the river channel. Next, invasive species of plants, specifically the vine kudzu, were removed by hand, as they interfere with the proper growth of native species. The next step was sheet flow reduction activity, in which the team covered the surface of the buffer with the aspen fiber erosion blankets shown in orange in Figure 15. Next, a check dam was created with rocks to provide erosion control in area shown in the white circle in Figures 14 and 15. Next, a side ditch, shown by the red line in Figure 15, was dug to facilitate drainage into the river. Finally, eight tree saplings were planted along the bank of the river to provide stability and reduce encroachment. Our team spent a half day performing this restoration alongside Forest Service personnel and several volunteers. More pictures of the results of these restoration activities can be found in Appendices E, F, and G.

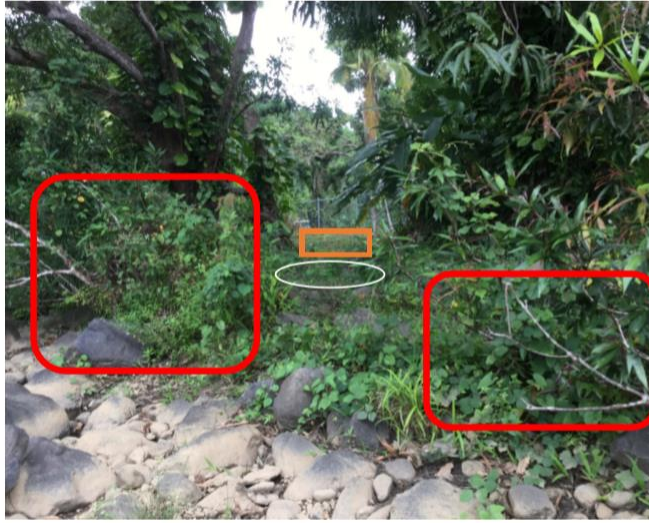
# Appendix J: Restoration Plan

## First Restoration Steps:

1. Pick up any woody debris material such as limbs branches all the way to the river channel and set aside in a pile.
2. Hand remove any invasive species in all the project area. Follow El Yunque National Forest Ecologist input for areas. Try removal if necessary at least 2 feet inside the rocky bed channel.
3. Follow the page design on page 3. Each color square represent a restoration activity.
  - a) Orange – sheet flow (erosion) reduction task
  - b) White - Small check dams and water flow
  - c) Red sections – area of water deposition/saturation and riparian planting reforestation.
