Sustainable Water Management in the San Miguel Community

Interactive Qualifying Project Completed in Partial Fulfillment of the Bachelor
Science Degree at
Worcester Polytechnic Institute

Submitted:
October 11th, 2018

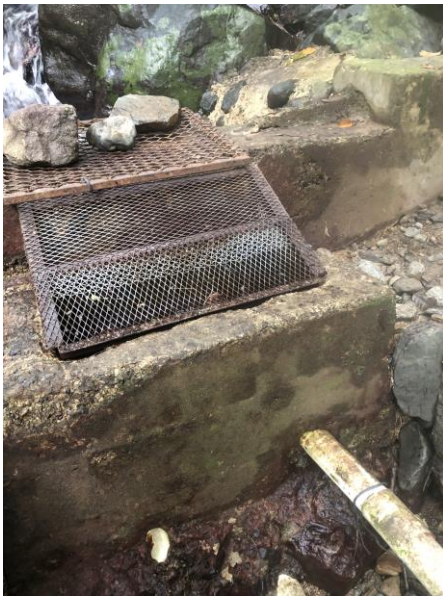
San Miguel relies on a gravity fed water system. The water system originates at the top of the mountain at a grate filter as seen in figure 2.3.1 using the Rio Pacora as the main water source. The location of the source was chosen due to the fact that it lacks any farms or houses

Figure 2.3.1: Grate Filter at beginning of water source

From an engineering standpoint, we found many flaws with the water system. The source is located a good distance up one of the nearest mountains, and there is no direct path that leads to it which means that the hike itself is physically taxing. The path that leads to the source and the reservoir tanks cuts through cow pastures, woods, and local farmland. As noted before, there is a metal grate that acts as a rough filter for the water as it enters the pipes. This presents an issue because after every heavy rainstorm, the maintenance workers have to hike into the mountains and clean the metal grate by scraping the leaves off of the metal and removing any excess sand or debris that reduces the flow of water. This takes a great deal of time and energy especially during the rainy season since it rains almost every day. The metal filter is rusting,

which is undesirable because the rust can seep into the water system and contaminate the water. The piping system is made up of PVC. The tubing itself is cheaper than metal but can break easier and often does. This is a major problem especially if the pipe is not installed properly. While tracing the pipe we saw an excess of piping above ground, which is a prime example of not installing the piping system properly. This can cause a lot of future problems because if the pipe is above ground, there is a higher chance of it getting damaged. Another problem we saw was that when the pipes crossed the road they were attached to trees and hanging above the ground without a proper suspension system. This is a shockingly poor design because that pipe can easily fall if struck by something.

The primary concern for the JAAR is to properly repair the current damages to the pipes. These include replacing the metal grate and fixing any cracked pipes. The community should improve the current conditions of the sand filter and use the four unconnected pressurized slow sand filters as this would improve the quality of water before entering the pipes. Additionally, the pipe diameter should be increased to improve the distribution of water. Our final recommendation is for the JAAR to improve the organization of payments and have more communication with the community members. These may be difficult changes without proper funding, so it is important that the JAAR reach out to the local government to acquire fiscal assistance.

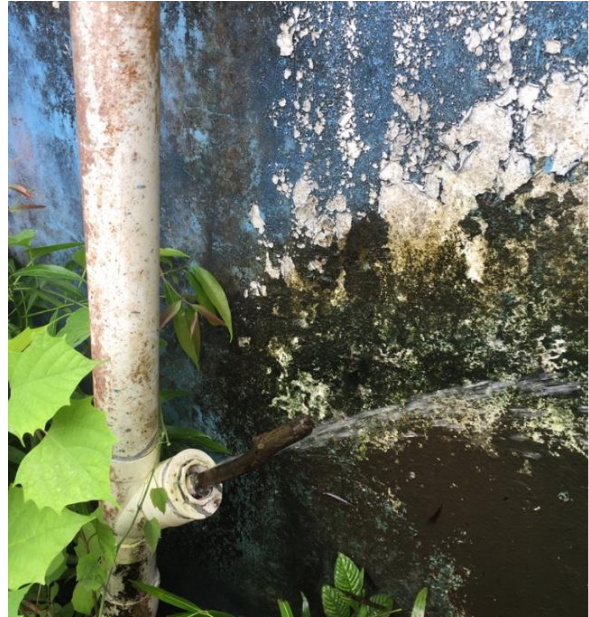
This is a particular problem with the Rio Pacora because when it rains the rain runs through the farms bringing cow waste into the water and contaminating it. After the source, the water then travels into the pipes and moves to a sand filter. From there the water travels to a holding tank where an unknown amount of chlorine is added to the water. The holding tank is where water is kept so if the pipes were to become damaged the community would still have a small supply of water. Proceeding from the holding tank, the water travels through pipes directly to the houses and is not filtered again unless the houses possess a private filter for the faucets. The water system is flawed as it has frequent leaks that can cause

further dirt and bacteria to enter the pipes. The current method to fix the leaks is not ideal as there have been instances of pushing a stick in a crack of the pipe as an ineffective attempt to stop the leak as seen in figure 2.3.2. Not only are leaks common, but there is a high probability that the inside of the pipes could be growing bacteria. There is also the question of whether the pipes can support a flow rate fast enough to supply the entire community

Figure 2.3.2: Leak at sand filter

There are numerous cracks and leaks in the plastic pipe. These flaws should immediately be addressed because the cracks cause a drop in the water pressure inside the pipe which decreases the rate of flow. Additionally, the cracks expose the water to outside contaminants, which puts the residents who drink it at risk. All it takes is dirt or waste to land near the crack and then seep into the piping system before the whole system becomes contaminated.

The ideal solution would be to replace the pipes in the entire community since they are fifteen years old. However, this is not a feasible option as it would be expensive to fund and San Miguel most likely does not have the savings to accomplish this in a reasonable time frame. Instead, the damaged pipes should be replaced with new sections of piping.

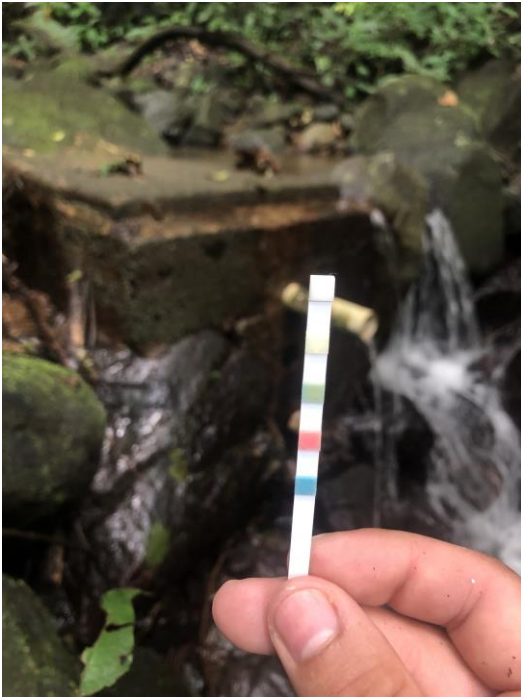
We tested the water at several different test sites along the main pipe and in the community. The material we used to test the water were pool strips found at a local hardware

Figure 3.4.1: Water Test Strip

store as seen in figure 3.4.1. The first test location was at the first filter where the source is located. At this filter, we tested the source, where the raw water is located. Then we walked down to the next filter and tested the water before it was filtered again. Walking down a little further, we reached our third test site which is the holding tank where chlorine is added to the water, and we tested both before and after the chlorine was added. This is the final filter before the water enters the pipes and travels to the community. We wanted to assess the degree to which the filters improved the quality of water, so we also chose significant locations in the community. We tested house we

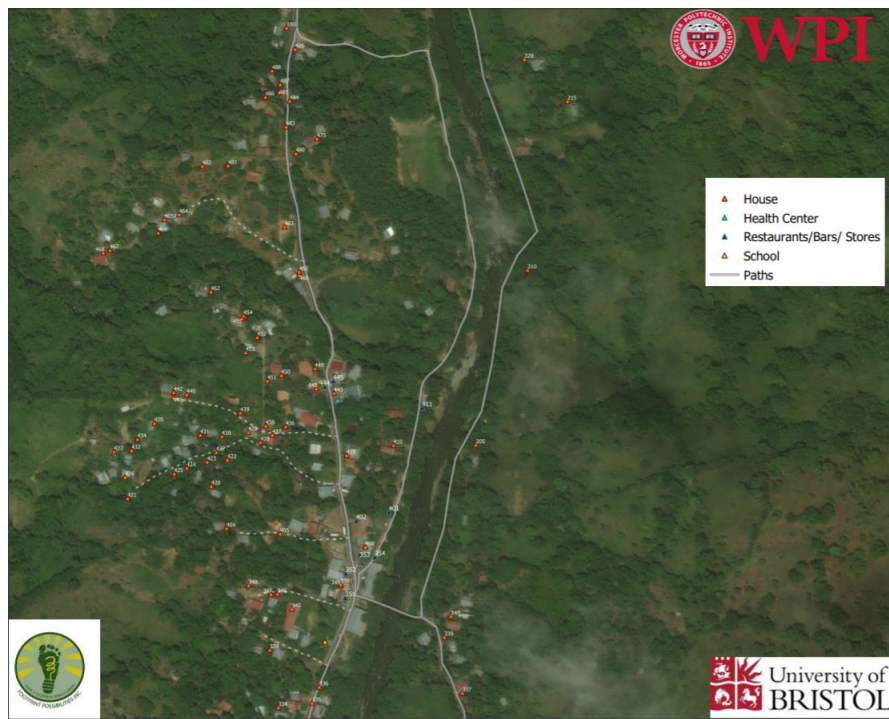
Figure 4.2.1: Social Infrastructure Map: Center of Town

Provided in Figure 4.2.1 is a portion of the full map of the social infrastructure of the community. This map focuses on the center of town and highlights some of the key aspects talked about above. First, when one looks at the map we see groups of red triangles with

corresponding numbers which are the houses within San Miguel. These closely follow the grey lines which unsurprisingly correspond to the roads. Most of the houses are located on the west side of the river along with all of the bars, stores, and the school and the health center. Finally, the dashed lines indicate smaller side roads that only lead to a small number of houses and are dead ends.
