# Feasible Restoration of El Yunque National Forest Structures

Rendered designs and cost analyses  
for Baño Grande,  
Baño de Oro, and  
Army Barracks

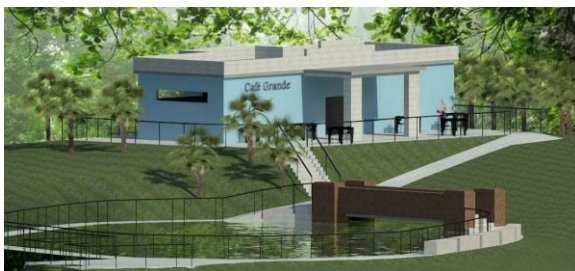
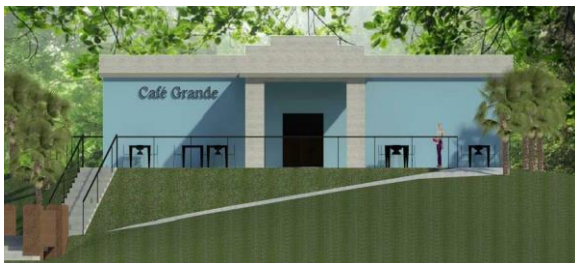
## Baño Grande

Baño Grande has an eighteen foot deep circular swimming pool that is reinforced by concrete and fed by La Mina River. Baño Grande was first opened in 1936 as a recreational swimming pool along with a bathhouse for the public. These structures were closed in 1968 and have been out of use since. It is proposed that the Baño Grande pool be kept as a photo spot for safety and ease, but the bathhouse to be restored into a Café to create some revenue for this site.

Photo Spot	Recreational Swimming Pool
Restoration Cost	\$6,257 - \$15,520	\$14,762 - \$24,661
Yearly Expenses	\$0	\$30,000
Yearly Revenue	\$0	\$54,750 (50 customers/day) (average purchase: \$3)
Return on Investment after 5 Years	0%	56.7%
Return on Investment after 10 years	0%	68.6%

Cafe	Changing Rooms
Restoration Cost	\$11,577 - \$29,260	\$10,139 - \$21,562
Yearly Expenses	\$30,000	\$10,000
Yearly Revenue	\$54,750 (50 customers/day) (average purchase: \$3)	\$18,250 (25 customers/day) (average purchase: \$2)
Return on Investment after 5 Years	52.7%	27.5%
Return on Investment after 10 years	66.3%	50.1%

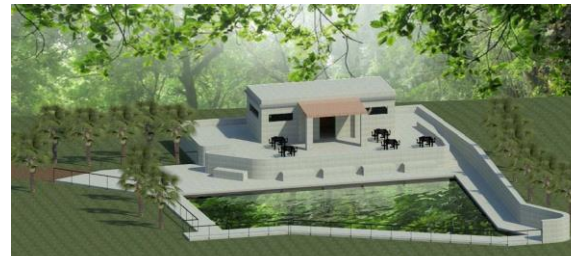
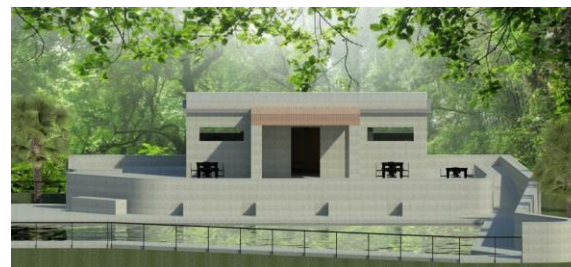
## Baño de Oro

Baño de Oro has a rectangular pool that is reinforced by concrete and is fed by an unnamed stream. The pool varies from 18 inches to 8 feet at its deepest point. Baño de Oro is also accompanied by a bathhouse and both were used for a short period of time after the 1930s. The site is currently overcome with vegetation and is in disrepair. It is proposed that the pool is cleaned and reopened as a recreational and handicap accessible wading pool and the bathhouse to be turned into a concession stand.

Wading Pool	Flower Garden
Restoration Cost	\$16,888 - \$22,463	\$50,927 - \$53,127
Yearly Expenses	\$30,000	\$0
Yearly Revenue	\$54,750 (50 customers/day) (average price to swim: \$3)	\$0
Return on Investment after 5 Years	58.7%	0%
Return on Investment after 10 years	69.8%	0%

Concession Stand	Flower Exhibit
Restoration Cost	\$16,369 - \$36,739	\$14,670 - \$29,357
Yearly Expenses	\$30,000	\$30,000
Yearly Revenue	\$54,750 (50 customers/day) (average purchase: \$3)	\$18,250 (25 customers/day) (average purchase: \$2)
Return on Investment after 5 Years	46.6%	-49.1%
Return on Investment after 10 years	62.6%	-44.6%

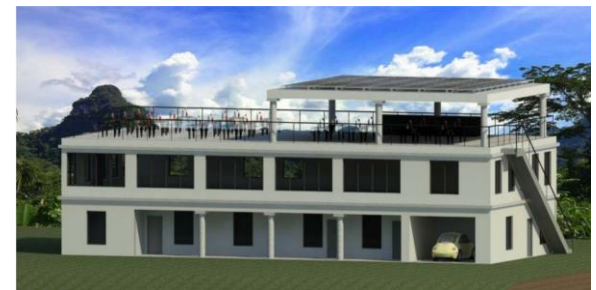
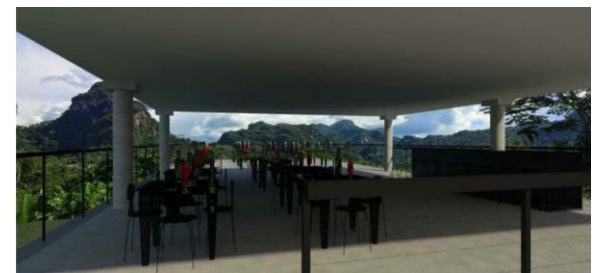
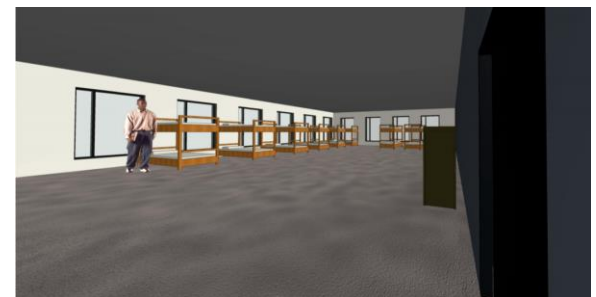
## Army Barracks

The Army Barracks was used as army housing during World War II, and was then used as an aviary for the Puerto Rican Parrot in the 1980s for about ten years. The aviary has been relocated and the army barracks has been out of use since. The building is around 6,000 square feet and approximately 19 rooms. It is proposed to be restored into a hostel.

Hostel	Hotel
Restoration Cost	\$165,267 - \$394,360	\$178,778 - \$418,160
Yearly Expenses	\$60,000	\$150,000
Yearly Revenue	\$164,250 (15 customers/day) (average purchase: \$30)	\$438,000 (10 customers/day) (average purchase: \$120)
Return on Investment after 5 Years	18.3%	87.5%
Return on Investment after 10 years	65.2%	128%
