## Accessibility Assessment of the Worcester Art Museum

December 10, 2014

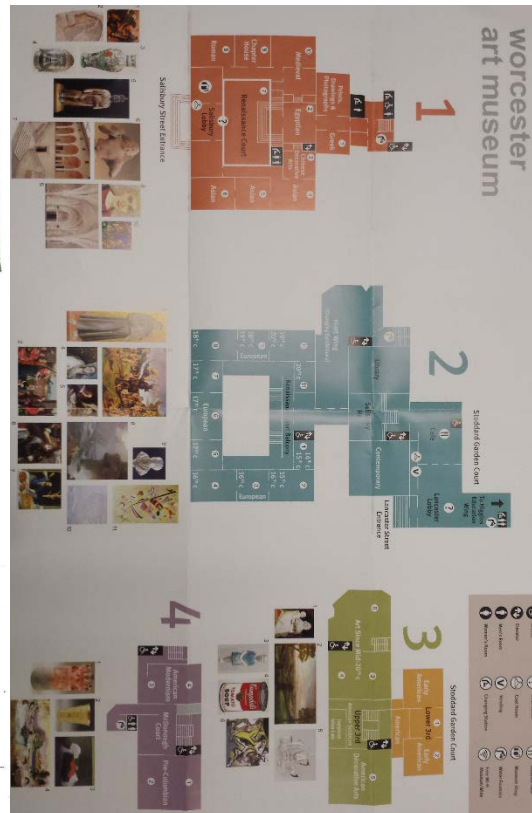
Figure 11: Revised Visitor Guide

It is Ms. Riach's responsibility to develop strategies to improve the visitor experience. For example, when it was brought to her attention that visitors had trouble navigating the museum, she developed a new visitor map to help alleviate confusion. She became aware of the issue through visitor complaints. Many of the complaints dealt with the lack of clarity of the previous map the museum provided. For example, even after reading the previous map, some visitors were unaware that the museum had four floors. To improve the quality of the map, she incorporated descriptive signs within the map and increased the font size of the wording. She also color-coded the map for improved clarity and visual appeal. To further appeal to visitors, she added example pictures of art pieces that corresponded to the four floors. Her rationale for incorporating the example pictures was to allow visitors using the map a preview of what was on each floor. From here, visitors could have a better idea of what part of the museum they wanted to see first. Figure 10 below shows the previous map. Figure 11 below shows the revised map Ms. Riach worked on.

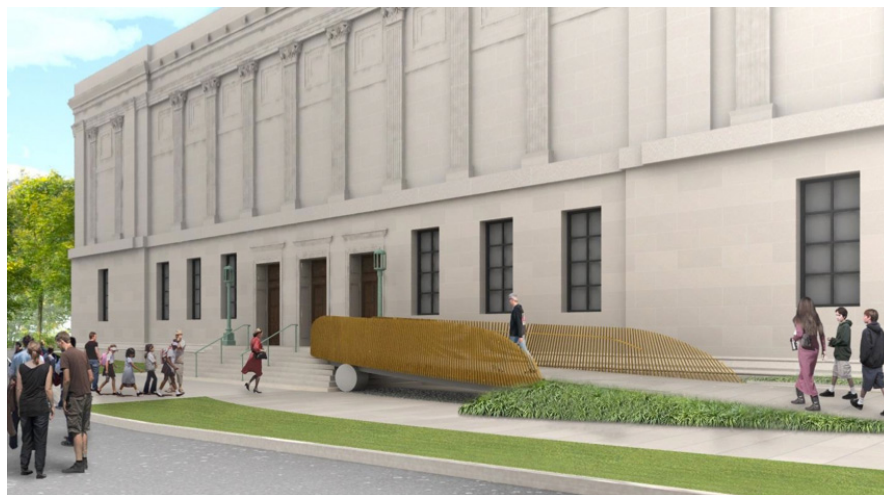
**Figure 12: Access Bridge Model**

One of the larger projects WAM has taken on to increase their level of accessibility is the installation of the Access Bridge. Shown below in Figure 12 is the intended design of the Access Bridge. The construction began September 15, 2014. The goal of the Access Bridge is to make the Salisbury entrance of the WAM more accessible. The addition of the Access Bridge will give the museum a new handicap accessible entrance, providing greater convenience for visitors.

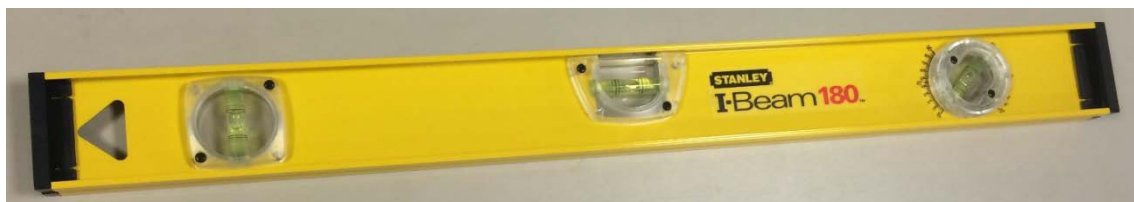
**Figure 17: Level**

The first tool we used was a standard two foot long level. This level was used to assess ramps, handrails, and thresholds. For ramps and handrails the tool was used to find the slope and pitch. For thresholds, we looked at both hallways and doorways. The level was used to check that the thresholds were symmetrical and uniform. The threshold was symmetrical if the height on either side was the same, and uniform if the threshold was the same measurement along its entirety. Figure 17 is an image of the level we used.

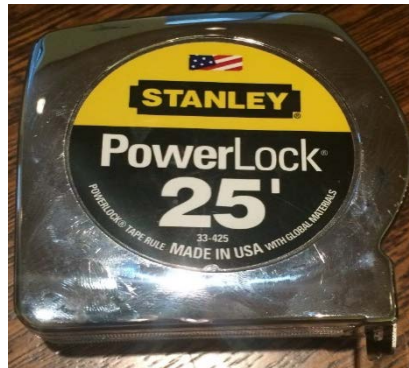
**Figure 18: Measuring Tape**

The next tool we used was a 25 foot measuring tape. The measuring tape was used in nearly every test for ADA compliance. The multiple uses of the measuring tape included: measuring the widths of doorways, heights and depths of stairs and lengths of grab bars within bathrooms. Below in Figure 18, is an image of the measuring tape we used.

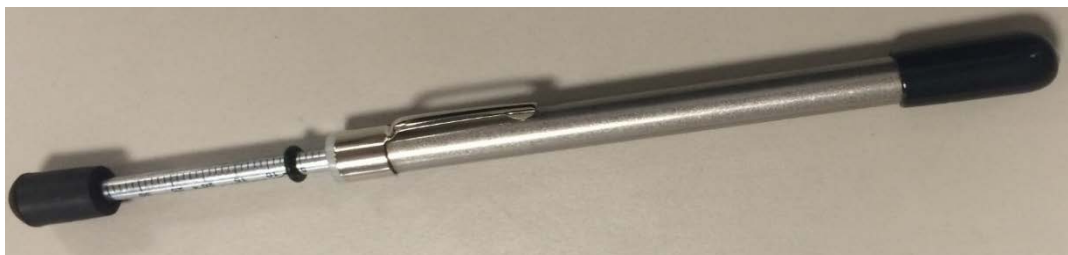
**Figure 19: Pressure Gauge**

The last tool we used was a pressure gauge. The pressure gauge was vital to assessing the force it takes to open the doors within the WAM. The pressure gauge can measure up to 35 pounds (lbs) of force. All of the doors within the WAM can either be pushed or pulled open therefore we were able to use this tool to assess each door within the museum. The pressure gauge is shown below in Figure 19.

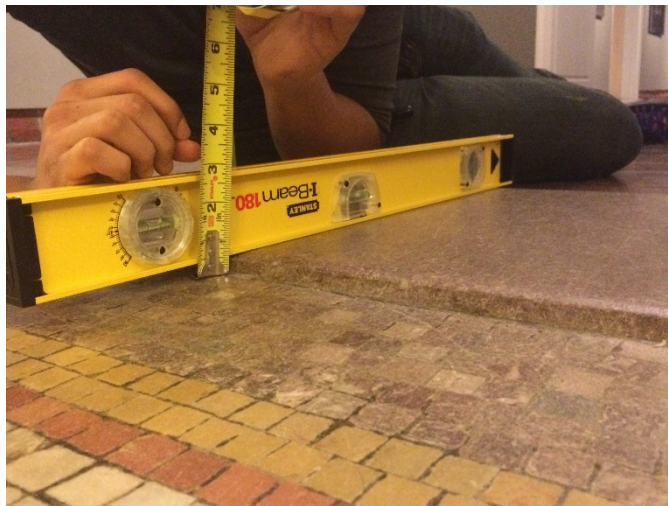
**Figure 20: Threshold Measurement**

From the 24 thresholds that we assessed, 22 of these were in doors and two were in hallways. Of the 22 thresholds in doorways, 18 were compliant. Of the two thresholds that we assessed in hallways, one was compliant. The requirements that we looked at included measuring the height, symmetry, and uniformity of the thresholds.

We learned through interviews with our sponsor Laura Riach that in the past visitors have tripped on the thresholds in the hallways. The threshold between rooms 120 and 117 in particular has caused many complaints.

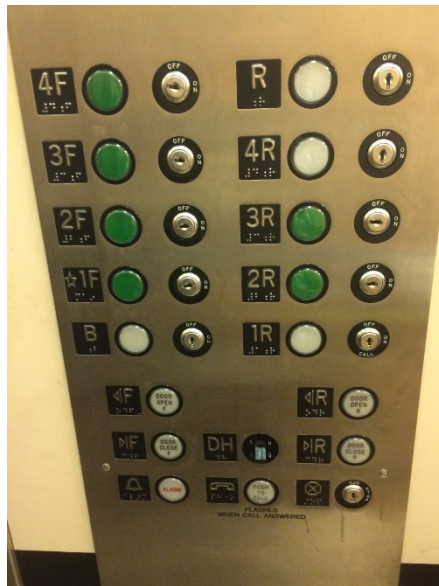
**Figure 21: Call Buttons within a WAM elevator**

the elevator listed the floors that that particular elevator was capable of going to. Based on the data we collected concerning elevators we provided the following list of recommendations.

- i. *Remove call buttons that do not work.*  
Removing all call buttons that do not work for that particular elevator will help alleviate visitor confusion.
- ii. *Improve elevator Directories.*  
Improving elevator directories to contain information on why each elevator does not go to every floor will help alleviate visitor confusion and frustration.
- iii. *Provide elevator training for employees.*  
Providing elevator training for employees will help them explain to visitors how to navigate the elevators more effectively.

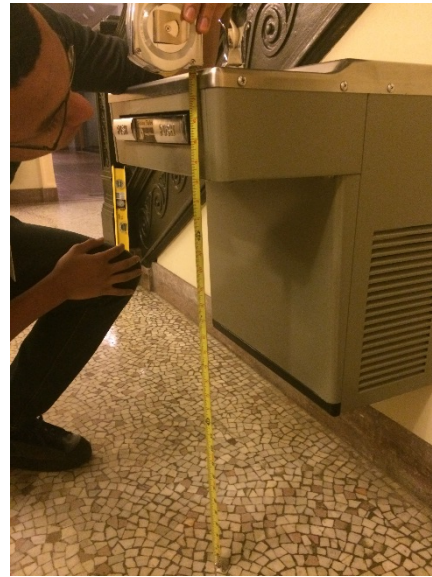
**Figure 23: Height of Drinking Fountain**

Seven out of 31 responses from the visitor survey found that the drinking fountains were either somewhat inaccessible or mostly inaccessible. There was also one visitor complaint out of 108 accessibility related visitor complaints that focused on drinking fountains. The complaint focused on the drinking fountain on the fourth floor not working.

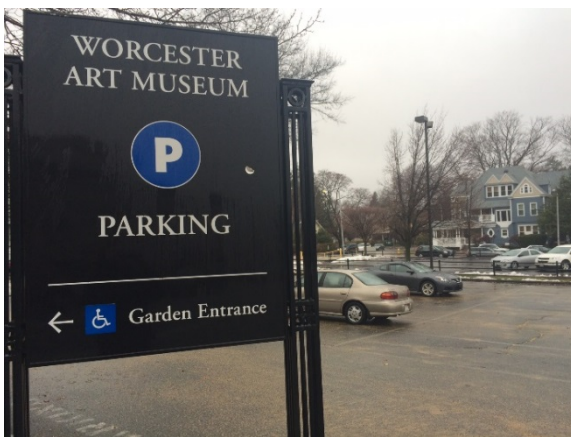
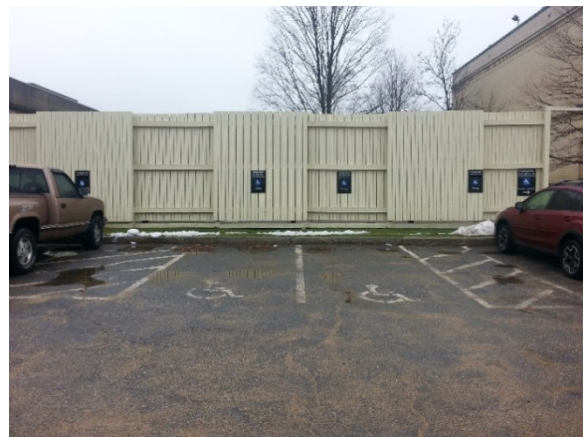
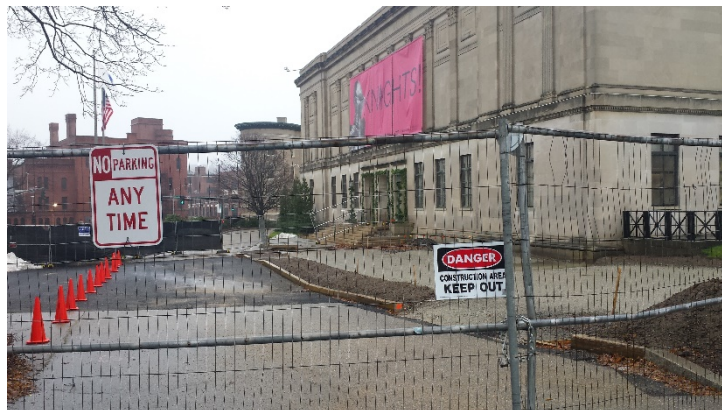
**Figure 25: Parking Lots**

compliant. Our group assessed the available lot and found that the WAM currently has 57 spaces available to its visitors. Within the Tuckerman Street Lot and the Lancaster Street Lot, we found the number of spaces, widths of spaces and widths of access aisles are ADA compliant. In Figure 25, Lancaster Street Lot is shown in (a), Tuckerman Street Lot is shown in (b) and in Salisbury Street Lot is shown in (c).

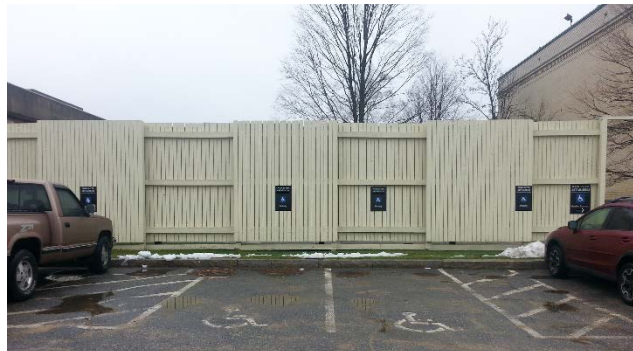
**Figure 28: Tuckerman Street Lot**

The requirement of the ADA is that if there is an access aisle present within a parking lot adjacent to an accessible space, the width of the aisle must be at least 60 inches. Within both the Lancaster and Tuckerman Street Lots we found that all of the access aisles meet ADA compliance. Below, in Figure 28, is an image of the Tuckerman Street Lot. The access aisles can be seen bordering the accessible car spaces with diagonal lines through them.

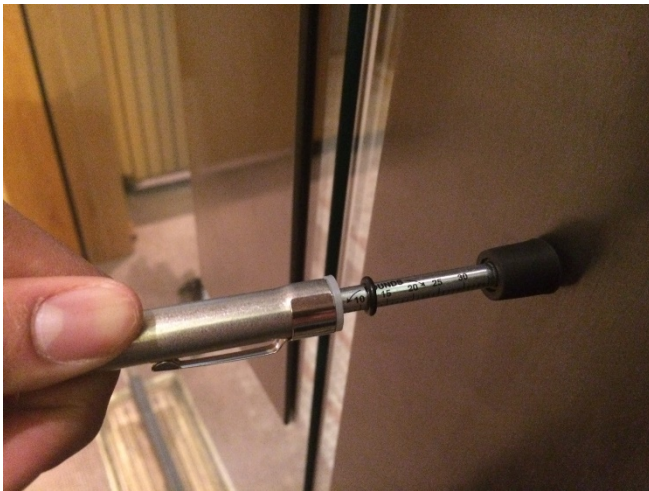
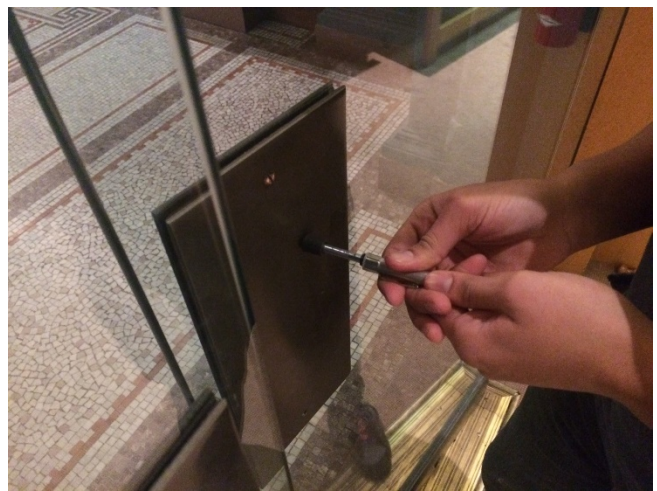
**Figure 29: Application of Pressure Gauge**

Visitors also found the weight of the glass doors problematic. Question five of our visitor survey focuses on the level of accessibility of these doors and how visitors viewed them. Of the

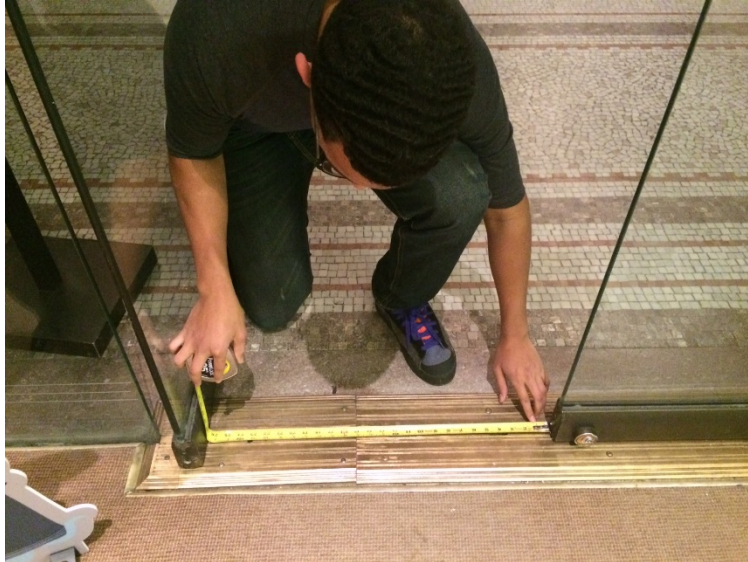
**Figure 30: Width of Door Assessment**

When conducting employee interviews, we found that three out of 12 employees mentioned that they have witnessed visitors have difficulty with the narrow doors. They elaborated on how three employees have helped visitors by opening the doors. One employee explained that they needed to help a visitor pass through the gallery doors due to the fact that the visitor's wheelchair could not fit. Due to the gallery door being too narrow, the employee as well as another visitor had to hold open both gallery doors so that the visitor in the wheelchair could pass through.

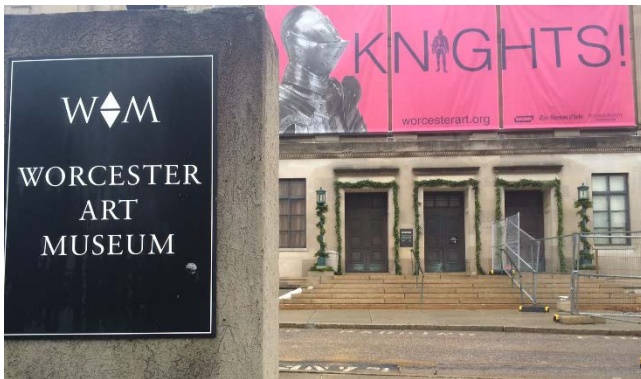
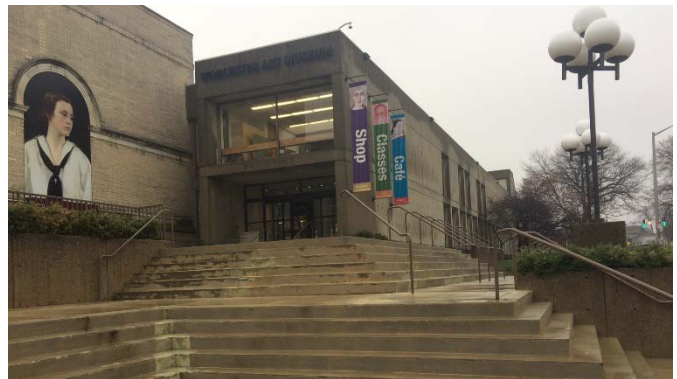
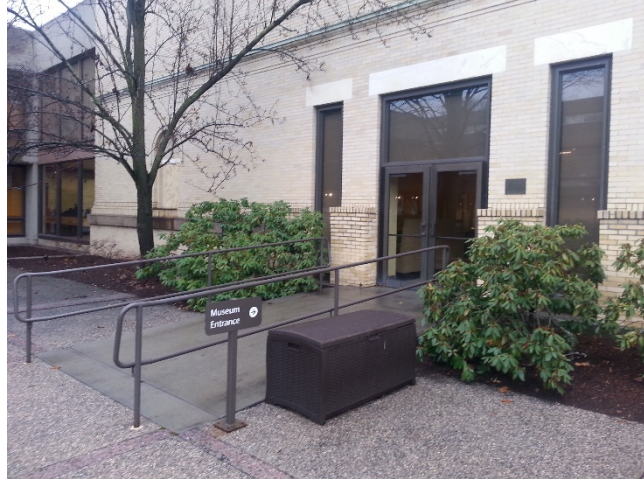
We found that each entrance was compliant with the appropriate door width. The requirement of the ADA is that no doorway is smaller than 32 inches. Between the three different entrances, the smallest door width is 38 inches and the widest is 61 inches. From these measurements, we were able to verify that each door was compliant in door width.

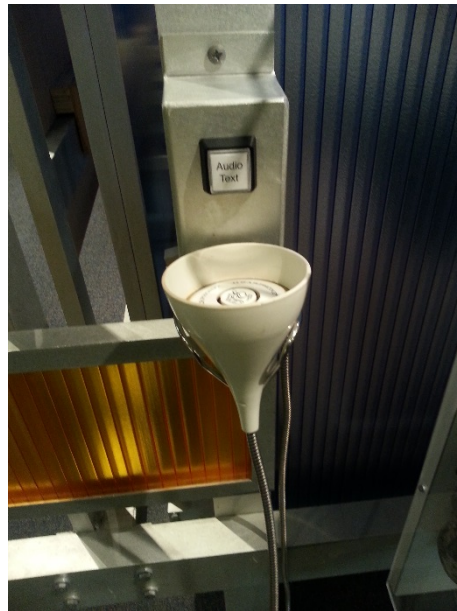
**Figure 33: MoS Audio Tour Station**

Hannah Goodwin was influential in the creation of an application for a mobile device that offers audio tours for visitors. The tour is offered in a multitude of different languages, including a video portrayal of the audio tour in the American Sign Language. Unlike most audio tours this application allows visitors to explore the museum without following a set path The Peabody Essex Museum has audio tours available in many different languages for a majority of their exhibits. For the convenience of the visitor, these audio tours can be found in the galleries that they focus on. The Museum of Science in Boston had a different approach to providing audio tours. Almost every exhibit had a listening device attached nearby, that you could hold up to you ear to hear information about the specific object. A picture of the listening device can be seen

below in Figure 33. We recommend that the WAM improve their audio tours and offer them in additional languages.
