Sustainable Campus Buildings: A Case Study of Climate Control in Kaven Hall

May 2, 2016

This project analyzed the energy usage of Worcester Polytechnic Institute's Kaven Hall, and examined various improvements that would efficiently provide a comfortable climate for learning. These improvements were ranked based on various factors, such as energy efficiency, comfort, and cost. The methods used to determine improvements were described in detail, so that a similar process could be applied to other buildings in need of indoor climate improvements.

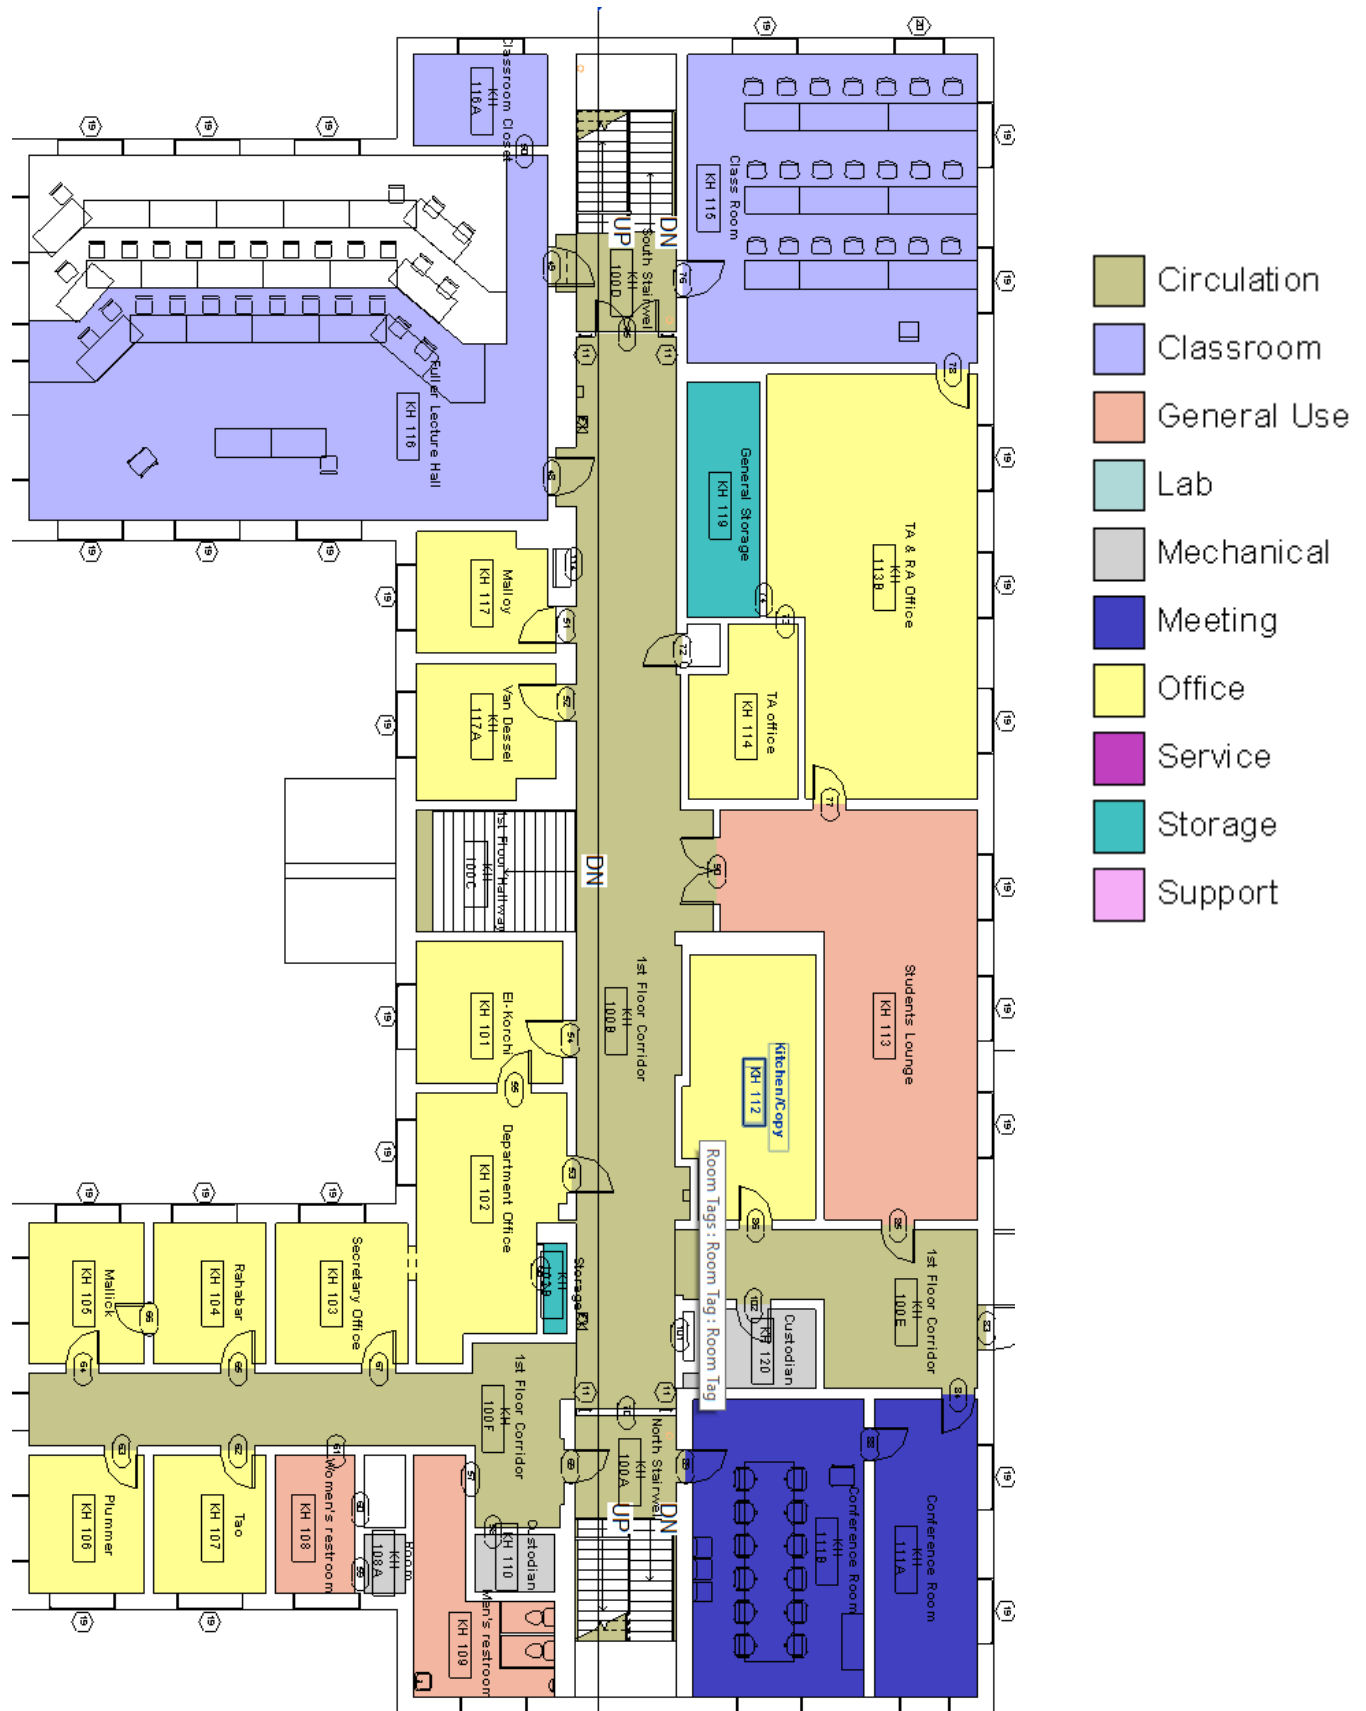
Figure 3: Floor plan of the first floor of Kaven Hall (Revit Model)

The first floor in Kaven Hall is occupied primarily by classrooms, and office spaces. KH115 and KH116 are both found on the first floor as indicated by the purple fill in Figure 3 below. The first floor contains 7 faculty offices, 2 TA offices, the Department office, and an office for the Department Secretary all indicated by yellow fill on the floor plan in Figure 3 below.

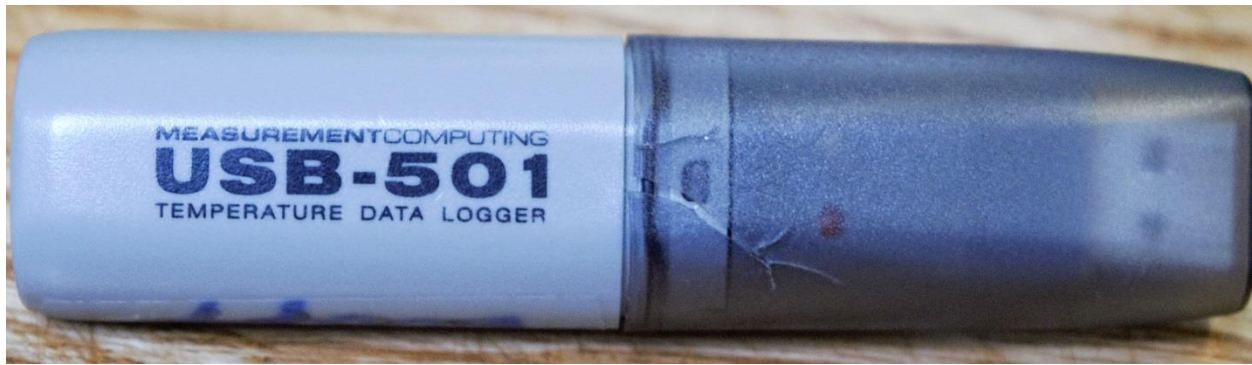
Figure 5: Temperature Data Logger used in Kaven Hall

The team collected data about the temperature throughout Kaven Hall using three USB-501 Battery-Powered Remote Temperature Data Loggers, pictured in Figure 5. The data loggers must be configured to start collecting data using the "USB-500 & 600 Software" configuration application. The group configured the data loggers to take samples once every minute as this allowed for collecting data over eleven days, for a total of 16,382 samples [5]. The group then deployed the temperature sensors in classrooms on the first and second floors of Kaven hall, placing one in KH115, one in KH116, and one in KH203. We placed the data loggers under desks close to the middle of the classroom as this would represent the temperature many students experienced. We collected the data loggers after seven days, so that data was collected during the week when classes were in session as well as over a weekend when the building was not used as heavily. Once the data for those three rooms were logged and downloaded, the project group erased the data loggers and placed them in the labs found in the basement of Kaven Hall. This time all three loggers were placed in the concrete lab in various parts of the room to search for temperature differences throughout this one lab area.

In order to place the temperature data loggers in the labs of Kaven Hall, the group got permission from Russ Lang, the lab supervisor. The temperature data loggers were left in the lab for a week to collect a similar dataset as before. After collecting the temperature sensors, the group downloaded the data using the “USB-500 & 600 Software” used to configure the data logger. In addition to the temperature data loggers that were placed in rooms inside Kaven Hall we were able to obtain outside temperature data from a weather station outside of a graduate student office on the second floor of Kaven Hall. We analyzed the data by graphing the inside temperature readings and outside temperature readings over the same time period.

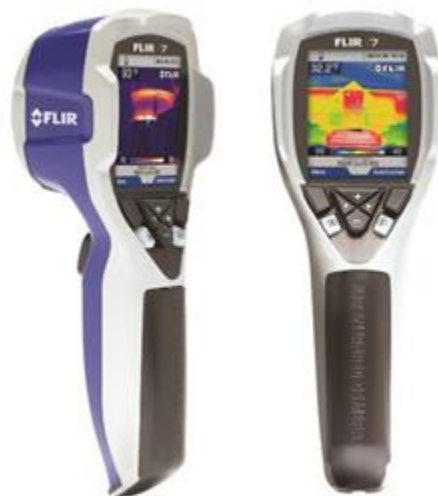
Figure 6: FLIR I7 Camera [21]

The camera that the project team used was a FLIR I7 Camera, as shown above in Figure 6. This is a thermal camera, which, when aimed at a surface, displays the temperature of the surface. The temperature is represented in the image using a color scale, where the darker colors, blue or black, are the coldest parts of the image and the lighter colors, bright yellow and white, represent the hottest parts of the image.

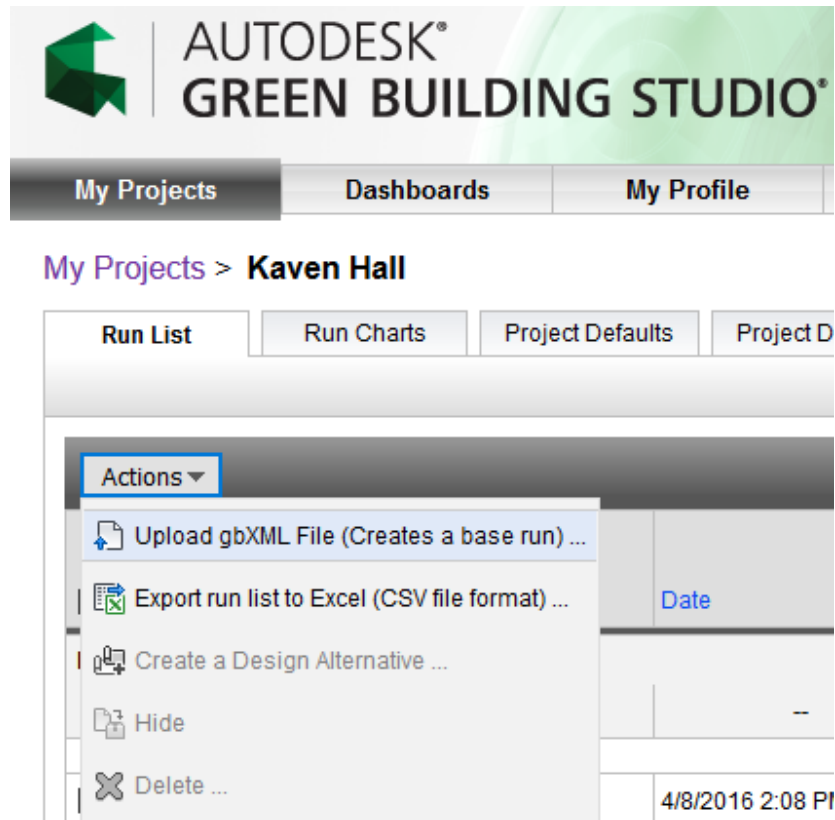
Figure 8: Upload gbXML file through the Green Building Studio web interface

Once we had verified the model's accuracy, we used Autodesk Green Building Studio (GBS) to perform an energy analysis. The group attempted to utilize the GBS integration in Revit, which automates the energy analysis process from one button in the interface. To get around this issue, the group was able to export the required energy model from within Revit as a gbXML file that contains detailed information on the building. We then uploaded the gbXML file through the actions menu, using the "Upload gbXML File (Creates a base run)" option as seen below in Figure 8.

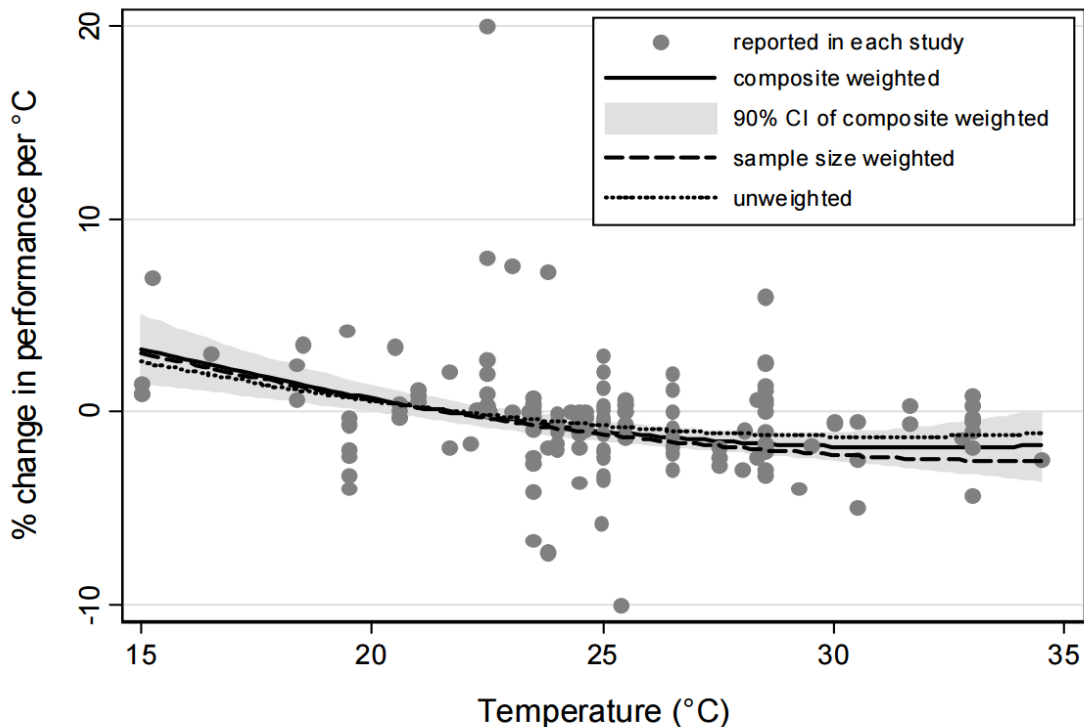
Figure 12: Percentage Change in Performance vs Temperature [35]

Figure 12 is a graphical summary of the results, showing raw data points from each study and the various weighted and unweighted regression lines. This figure shows the percentage change in performance as a function of temperature. Positive y-values are interpreted as positive percent changes in performance and negative values represent a negative percent change in performance per degree Celsius. The confidence interval (grey shaded section) shows a positive change in performance per degree Celsius up to 20°C. This means that up to 21°C, an increase in temperature is associated with a statistically significant improvement in performance and above 24°C increases in temperature are associated with a

statistically significant decrease in performance. In other words, performance of workers in these studies increase with temperature up to 21-22°C and decreases with temperatures above 23-24°C [35].

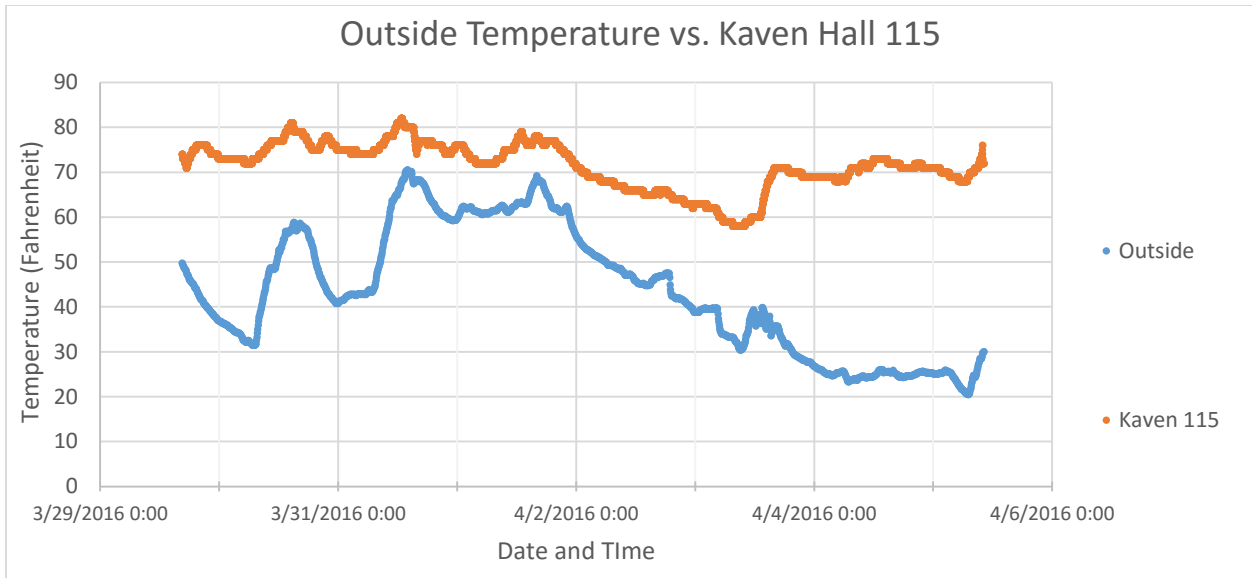
Figure 15: Comparison Outside Temperature vs KH115

Figure 15 details a comparison graph between the outside temperatures and the inside temperatures of Kaven Hall room 115. As the outside temperatures increase and decrease, the temperatures inside also rise and fall in a similar fashion. The inside climate does not rise and fall as severely as the outside, due to the heating and cooling systems in place. Inside, the room is getting much too warm even though the temperature was set to 72 degrees Fahrenheit, reaching 83 degrees on two different school days. On the weekend, the room dropped to 57 degrees Fahrenheit, which could possibly be attributed to an open window.

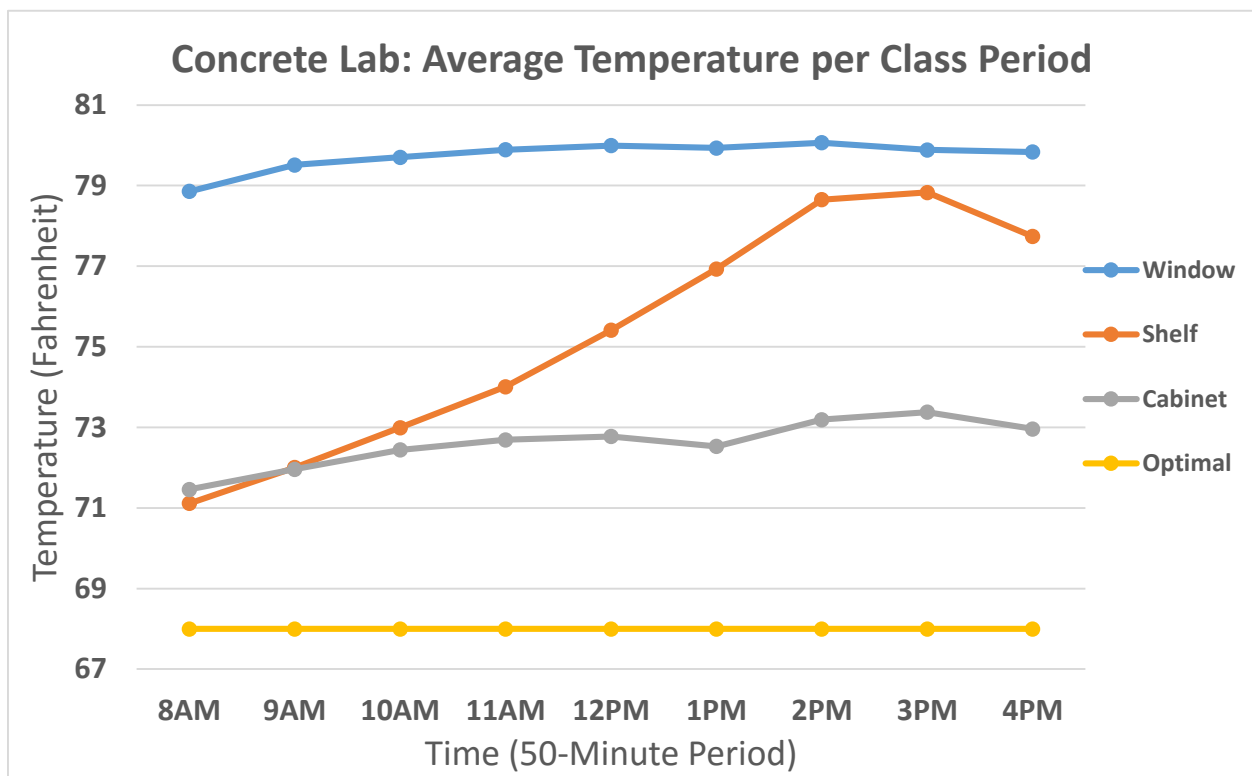
Figure 20: Average Temperatures in Kaven Hall's Concrete Lab

Figure 20 shows the temperatures at three points within the Concrete Lab. Average temperatures in the concrete lab never cross or even come within 3°F of the optimal line. There are some interesting trends to point out in this graph. For example, the window is consistently a high 79°F+ while the shelf, right across the room from the window, tends to approach that temperature by the end of the day. The cabinet, located in a separate room on the lab, on average maintains a constant lower 72°F despite being nearest an outside door. An in-depth, room-by-room analysis of Kaven Hall might look at each classroom's temperature and activity level over a longer period in order to begin examining possible changes to improve that micro-environment. In the end a holistic analysis may be conducted to determine if any changes can be made to Kaven Hall as a whole (i.e. HVAC upgrades, windows upgrades etc.). However, the purpose of the experiment was to create an argument as to the necessity for more in-depth analyses to be conducted so Kaven Hall may begin to improve.

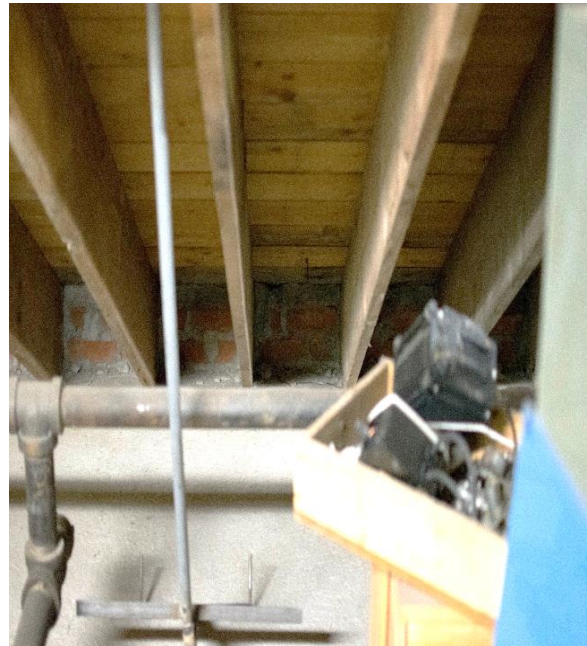
Figure 21: Attic of Kaven Hall Brick Edge (Thermal)

Figure 22: Attic of Kaven Hall Brick Edge

Figure 21 details the thermal energy of the ceiling in the Kaven Hall attic. This image shows the edge where the exterior brick meets the ceiling specifically. In this building the ceiling has no insulation, though the 16" thick concrete floor provides some insulation from the rest of the building. The image shows the ceiling being warm at a temperature around 63 degrees Fahrenheit. There is a difference of about 10 degrees Fahrenheit between the brick edge and the ceiling, which indicates the exterior brick walls have a lower insulation value than the ceiling. In addition, there were several holes in the brick wall that would allow for airflow. These holes and the lack of insulating value provided by the brick allows for heat to escape from the attic. Figure 22 shows a similar area to where the thermal picture was taken.

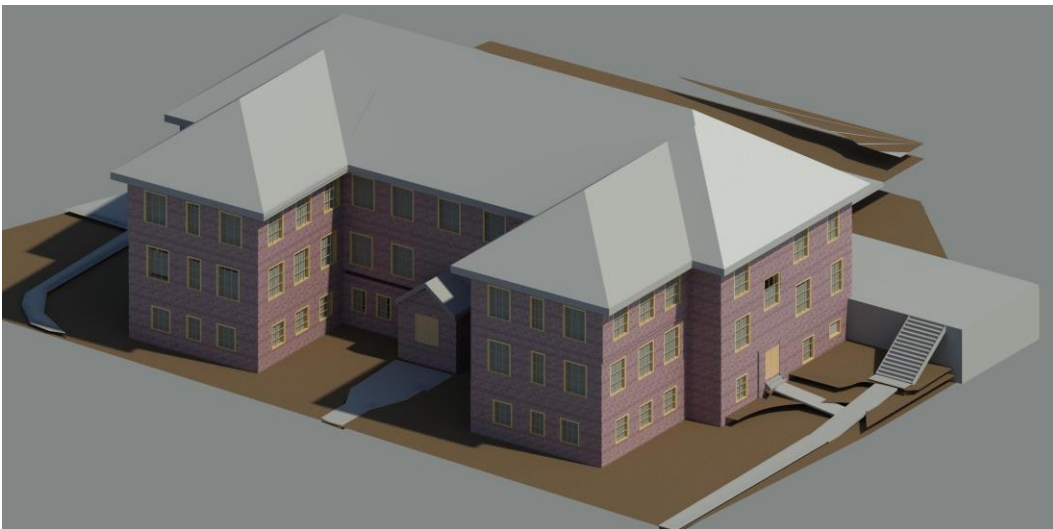
Figure 26: Render of Kaven Hall after windows were added to the Revit model

As windows play an important role in energy simulations, the group decided to add the missing windows to the model. We used the original construction blueprints, as well as measurements of the windows (taken on site) to update the model. The group added a total of 36 windows located on the basement floor of Kaven Hall to the model as seen in Figure 26. With the windows added to the model, we were ready to perform an energy analysis.

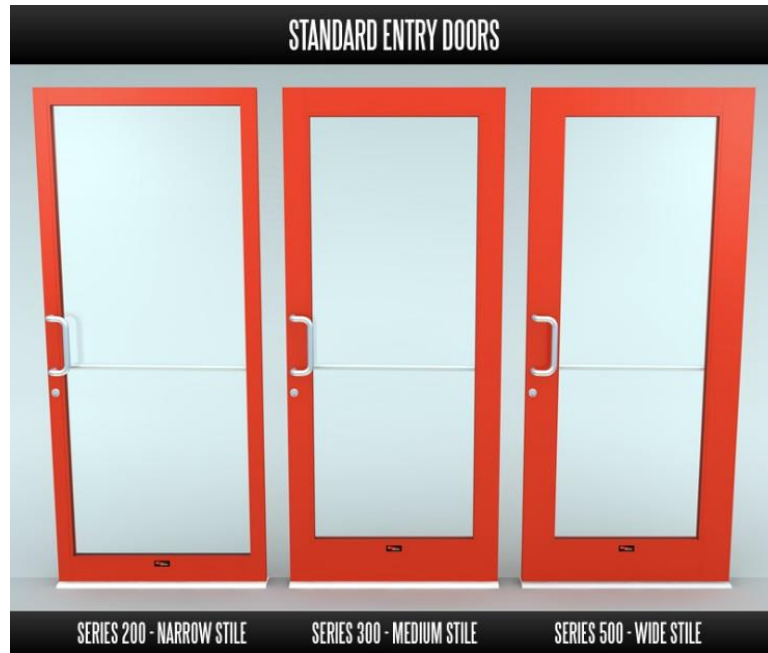
Figure 29: Narrow, Medium, and Wide Stile Doors [9]

Narrow Stile doors are doors in which a large glass window, almost the size of the entire door, is surrounded by a thin frame. In the table above, all of the doors are glass and aluminum, so in a Narrow Stile door, the frame would be aluminum. These are the cheapest model of door, and can be efficient if the glass is a Low-E glass and double or triple-paned, but the price estimate in RS Means doesn't specify which type of glass is used for its doors, so we have assumed standard glass.

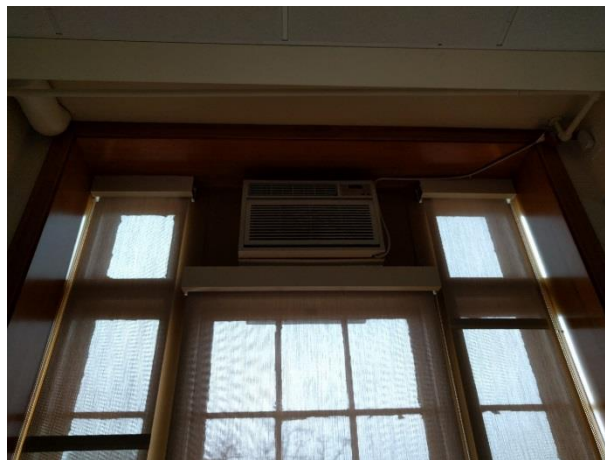
Figure 30: Solar Shade in Kaven Hall

With a Solar Shading solution for Kaven Hall, drapes or shades would be used to control the amount of light that is let into the building [42]. This can decrease the amount of heat due to sunlight in various rooms, allowing the users of the rooms to have some measure of control over how much light and heat their room receives on any given day. Many of the rooms in Kaven already have some measure of solar shading available, but as the group saw during our on-site visits, many of these fixtures are quite dated, and users of the rooms could benefit from having them updated. One of these fixtures can be seen in Figure 30. As shown, the shade is almost transparent, letting most of the outdoor light into the room.

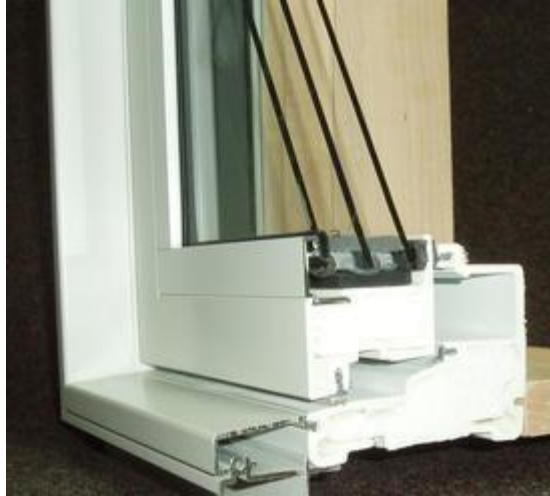
Figure 31: Cutaway of a high-performance window, triple glaze [3]

The proposed change for the windows in Kaven would be to replace the original-construction single-pane windows with triple-pane windows made of MSG Low-E glass, with non-metal improved frames [18]. This type of window is rated to keep indoor temperatures at a neutral level both in summer and in winter, with a U-factor of less than or equal to 0.22 [18]. This corresponds to an R-value of about 4.55, which is 3.55 better than the estimated R-value of the current windows in Kaven, estimated to be around 1.

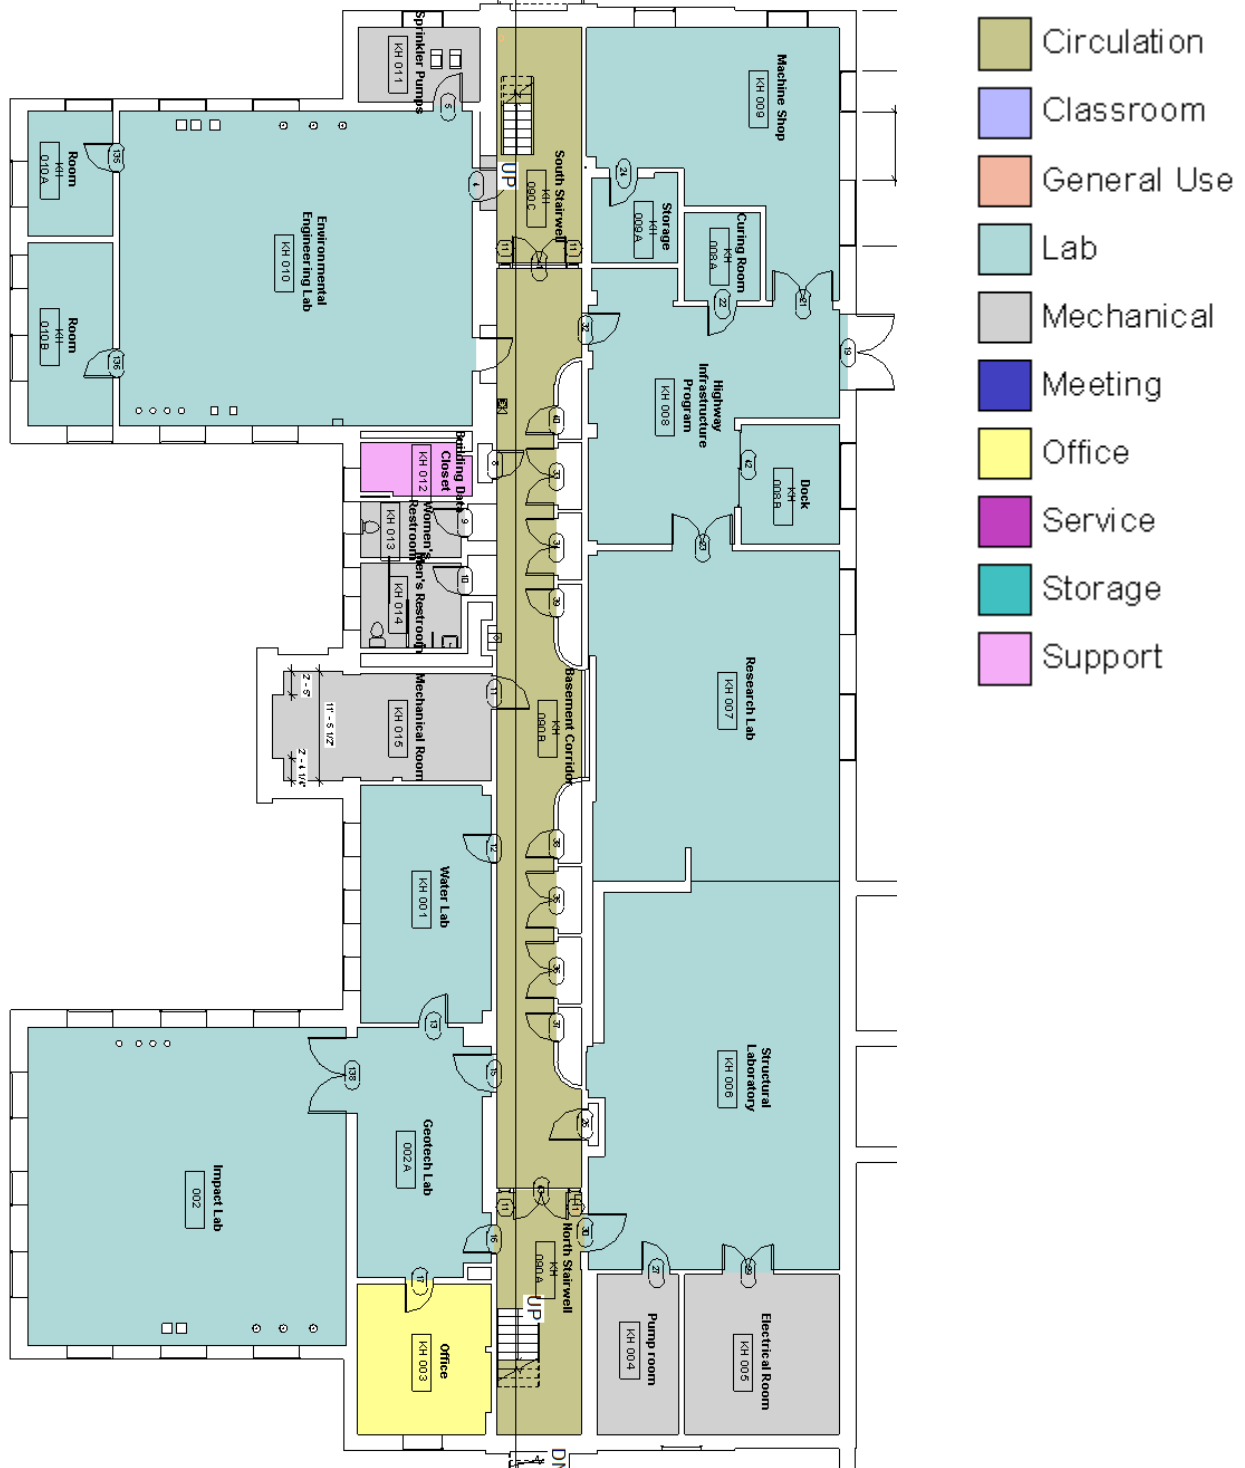
Floor plan of the basement of Kaven Hall

The basement of Kaven Hall doesn't have any traditional classroom space, as it is home to 7 different labs that serve the CEE department. The labs located here include space for the Highway Infrastructure Program, a Structural Laboratory, Water Lab, Geotech Lab, Impact Lab, and the Environmental Engineering Lab. An office, as well as a number of mechanical rooms can also be found in the basement.
