## Preservation and Restoration of Venetian Public Art

### From the Completion of the Public Art Catalog to the Active Restoration Process

An Interdisciplinary Qualifying Project  
Submitted to the faculty of  
Worcester Polytechnic Institute  
in partial fulfillment of the requirements for the  
Degree of Bachelor of Science

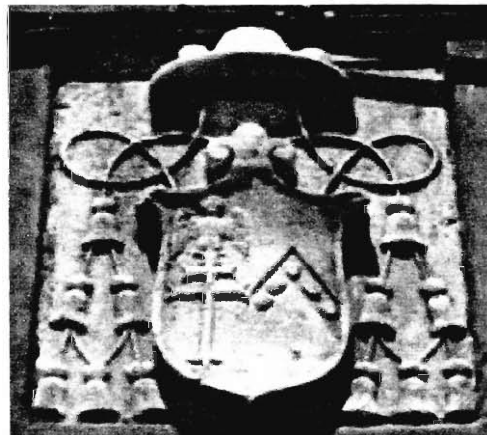
Figure 3: Coat of Arms

Noble families of Venice would often have a coat of arms sculpted on their buildings as a form of display of ownership and power. All have the basic shape of a shield, though they do vary in complexity. The styles span from gothic, to renaissance and baroque. Often the details were chiseled off when a family moved from its location and a new owner occupied the building. **Figure 3** depicts the coat of arms of a cardinal; it is one of 1064 different coats of arms, which are present in Venice.

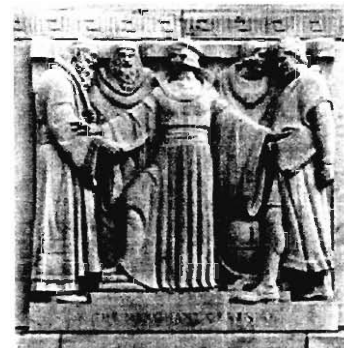
**Figure 4:** Relief depicting The Merchant of Venice

(*bassorilievi*). They are categorized by the amount of the figure that protrudes from the surface. A high relief sculpture has half or more of its depth protruding from the surface, while low relief sculptures are those with less than one half-protruding. There are 386 relief sculptures, shown in **Figure 4**, found on the walls of Venetian buildings.

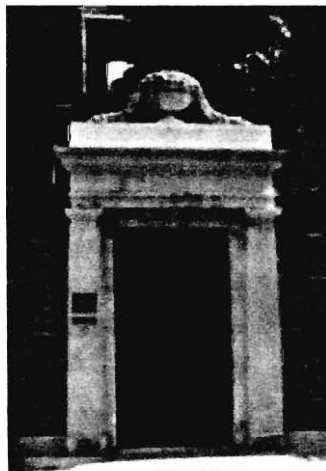
**Figure 6:** *Portale* in Venice

elements, including artwork on the doorjamb and sculptures affixed to the top of the doorjamb. *Portali* were designed to create a sense of grandeur as one enters a building or courtyard. *Portali* were also designed to be unique, as many incorporated the coat of arms of the family that owned the building, as well as biblical scenes. There are 552 *portali*, as shown in **Figure 6**, located around the doors of Venice

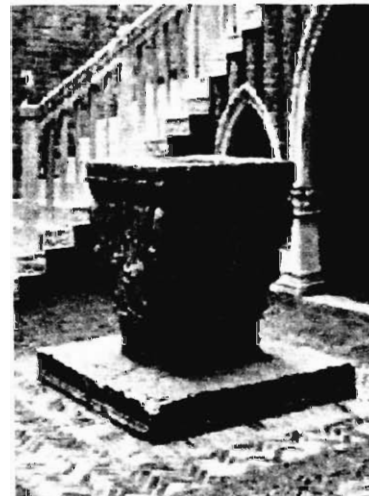
**Figure 5:** Wellhead in Venice

They are often made of Istrian stone and decorated with saints, family crests, inscriptions, or other forms of Venetian history. There

are 217 public wellheads, as shown in **Figure 5**, in Venice today, which were cataloged in 1995.

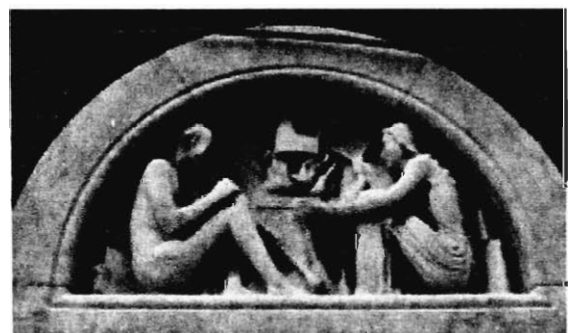
**Figure 7:** *Lunetta* in Venice

*Lunette*<sup>5</sup> are a unique subset of *portali*. *Lunette* are defined as the artistic elements located in an arch above outside doorways; they must utilize the entire arch. The main functions of *lunette* are to decorate an entranceway and to show status. Palace owners showed their wealth by incorporating *lunette* into the outer architecture of their homes with coat of arms, and other illustrative artwork. There are 71 *lunette*, as shown in **Figure 7**, in Venice.

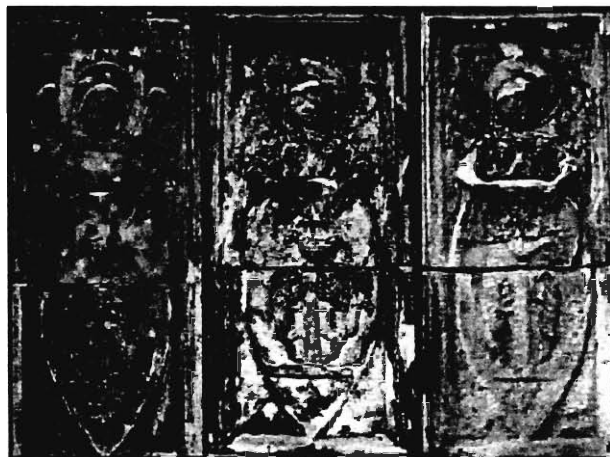
Figure 10: Public art deterioration

to that of the Venice Project Center. Rizzi put together a very detailed catalog of public art in Venice. Twenty nine entries in Rizzi's catalog were not able to be relocated by students from the VPC, this is approximately one percent of the entire collection<sup>6</sup>. Through comparisons with this catalog, we also can see how quickly the artwork is deteriorating. **Figure 10** shows the effect of time on the angel relief, constructed in Cannaregio in 1485. The pictures were taken over the span of 70 years, from the first in 1930, to Rizzi's in 1979, to the recent VPC catalog in 2000.

Degradation occurs due to both the natural decay of the material of the art, and the environment in which it is found. The atmosphere of Venice is unusual because of its heat and humidity in the summer and occasional freezing in the winter. The environment is not conducive to the endurance of stone due to the fact that many parts of the city are flooded multiple times a year. The consequences of being surrounded by water are that the sculptures are continuously hydrated and then dehydrated, causing decay in the stone elements. When this hydration occurs the seawater leaves salt deposits that contribute greatly to the rapid corrosion rate of the stone. Also, bacteria contribute to the decay of stone; the combination of the acid produced when they feed with air and stone results in water, carbon dioxide, and dissolved stone. Other acid producing organisms include algae, lichens, and moss which are often present on the artwork. Other sources of the acid corrosion are the birds of Venice. Much of the city, St. Mark's Square in particular, is infested with pigeons, their droppings containing an acid which promotes decomposition.

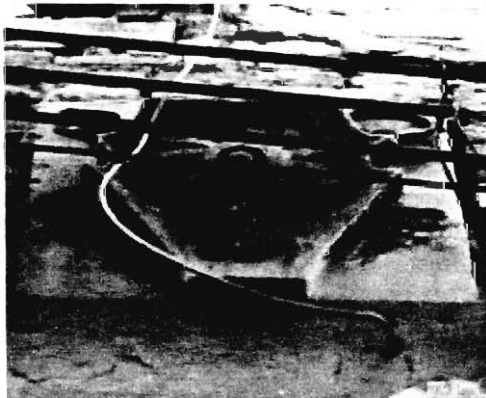
**Figure 12:** Wires on and around public art

Negligence and misuse of public art is common in Venice because it is a crowded city. People use it to hang their laundry, or as a bench, with no concern for the value of the art and the detrimental effects of their actions. **Figure 12** depicts when electric and telephone companies have

been known to nail wire to it as well, as past groups have documented in the database. Wires affect approximately 180 pieces. There is also vandalism, which further shows that the visitors of Venice and even many locals, especially the younger ones, do not give the public art collection the honor and respect that it deserves.

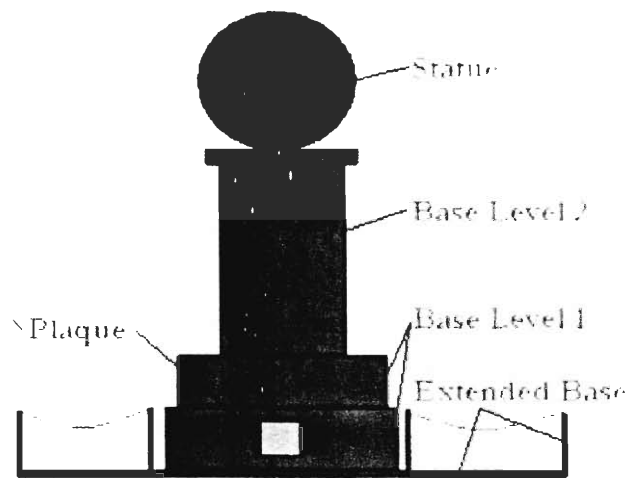
**Figure 20:** General sections of a monument

In order to make our data collection consistent and reproducible, we defined various parts of a monument. These sections can be seen in **Figure 20** and described in the sections that follow. Monuments may contain one or more base sections, as well as any number of statues. Many of the Venetian monuments also contain inscriptions or plaques and separate pieces of art, commonly in the form of a relief. The majority of the monuments also have one or more statues. Complete data was recorded for each individual section or decorative part of each monument.

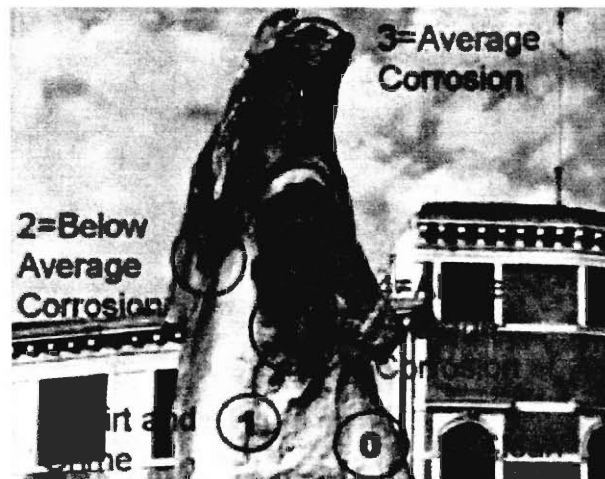
**Figure 22:** Severity Condition Assessment

When ranking the condition of each monument we first ranked the part of the statue that was in the worst condition. Based on the conditions set forth in the *portali* section 0, we have conducted condition assessments of each statue and each base level of the monument. Through counting the number of cracks in each severity level we have made special note of the most severe parts of each portion of the monument.

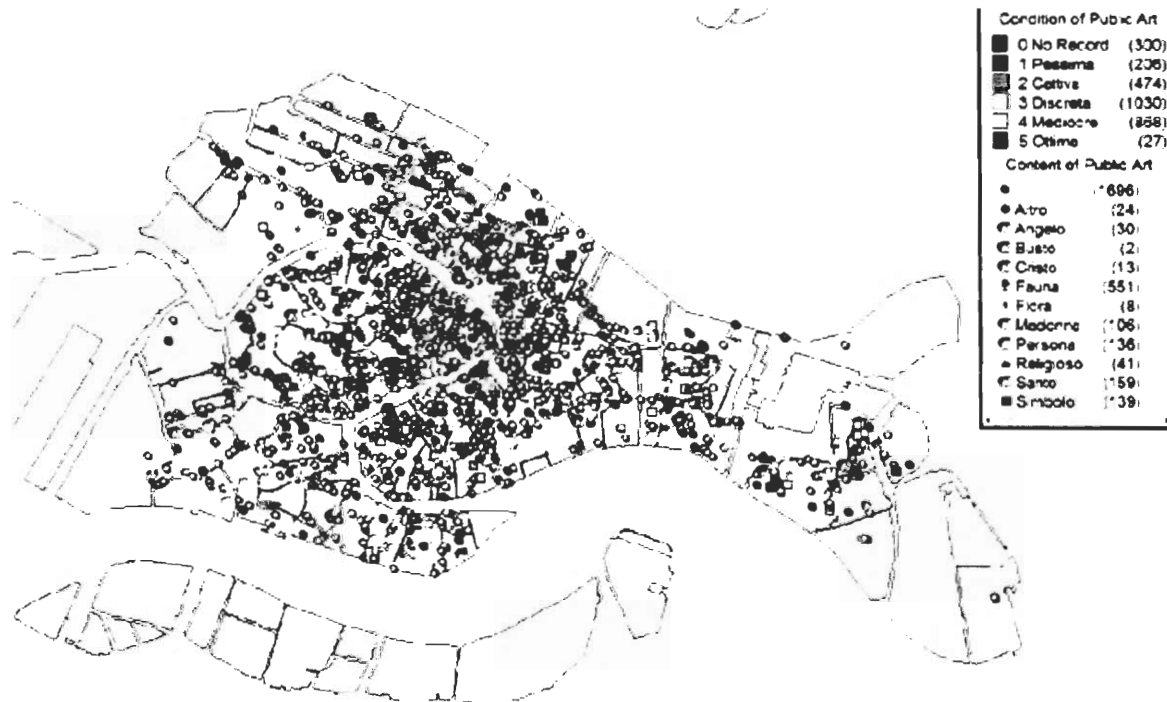
Figure 24: Thematic map of uniqueness and condition of public art

It was necessary to locate an island in the historical center of Venice to be the first restoration project of the Association. To do so, thematic maps were created using GIS to identify the area with the greatest potential for restoration. Wellheads, flagstuffs, *lunette*, *portali*, monuments, and external sculptures were all included in the map indicated by unique symbols, and condition rankings assigned different colors to the symbols. The dark colored symbols indicate the worst condition while lighter colors signify a better condition. The uniqueness levels among the external sculpture were also assigned distinguishing symbols. The following maps, **Figure 23** and **Figure 24**, show the usage of the different colors and symbols.

Although uniqueness and condition are important to the restoration process, they were not the only factors in the decision. Areas with a variety of artwork were also considered to be of higher

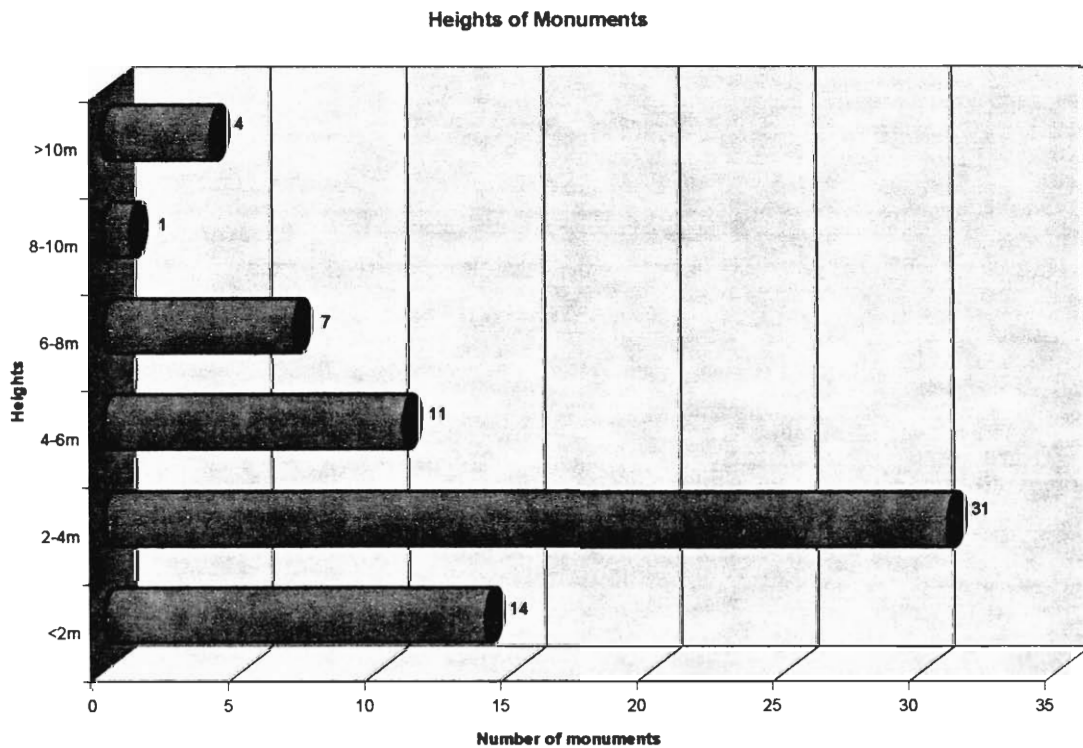
The height of a monument is important to the restoration process since the amount of

scaffolding needed would increase as the height of the monument did. **Figure 27** displays the heights of the monuments located throughout Venice. The majority of studied monuments are less than 4 meters in height, so a scaffold of 5 meters would be sufficient for most restoration projects.

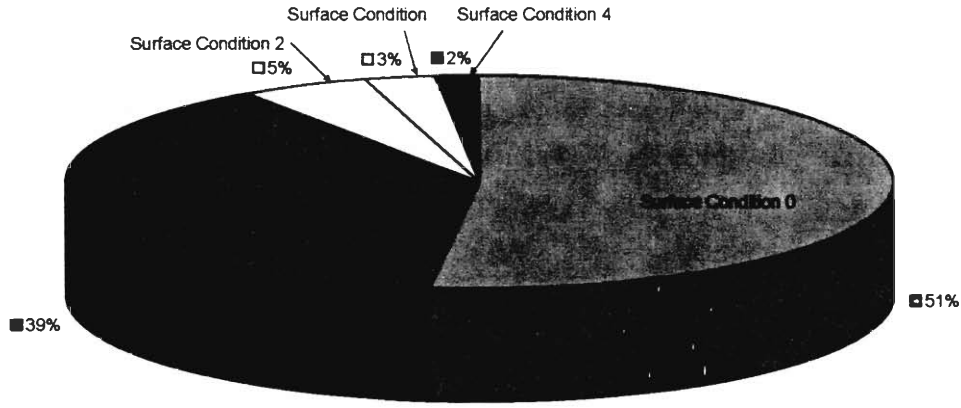
Figure 30: Surface Condition Distribution

### Surface Condition Distribution for all Monument Sections

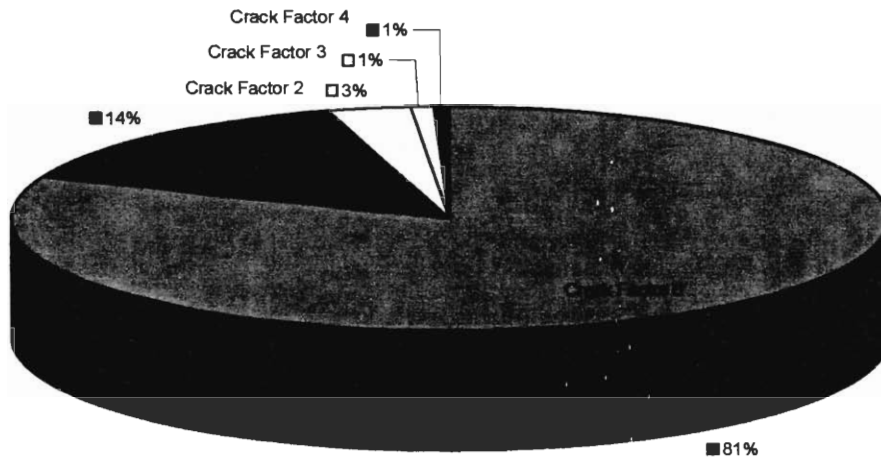
**Figure 31:** Cracks distribution

**Cracks Distribution for all Monument Sections**

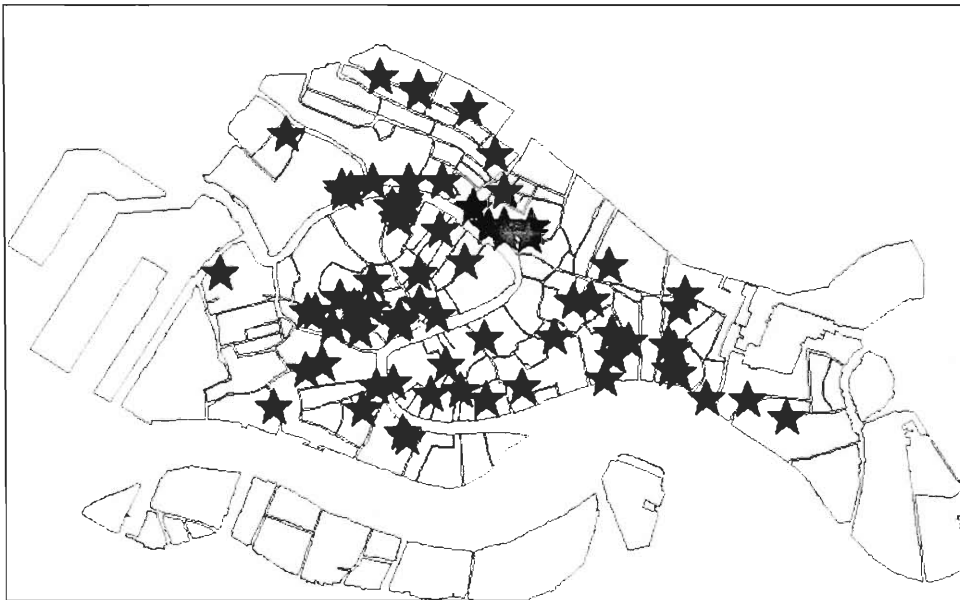
**Figure 33:** Locations of *lunette* in the historical center of Venice

The *lunette* catalog has now been completed for the historical center of Venice and the surrounding lagoon islands. The locations of all *lunette* in the historical center can be seen in **Figure 33**. *Lunette* which are found on churches are indicated with a green star, and those on a standard entranceway are indicated with a blue star.

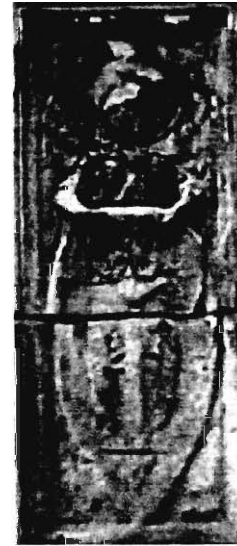
Figure 35: Relief of the angel

A relief of an angel (catalog number CN300) located in the *sestiere* of Cannaregio was the first restoration process we began. The process serves as a model for the Association for the Preservation of Venetian Public Art. The angel is located on the building adjacent to the *Settemari* rowing club of which Professor Fabio Carrera is a member. The rowing club provided the funds for the restoration, and one of the members is inline to perform the restoration. Some preparations had been started before the beginning of our project process. Work within the rowing club and the VPC lead to a draft of a letter to the *soprintendenza* asking for the proper permits, a letter to the Venice police asking for permission for overnight scaffolding for the restoration work on the angel, and a letter to the owner of the building asking him for permission for all the work that needs to be done. Upon our arrival in Venice, the angel had been covered with a temporary protective covering to prevent further destruction.

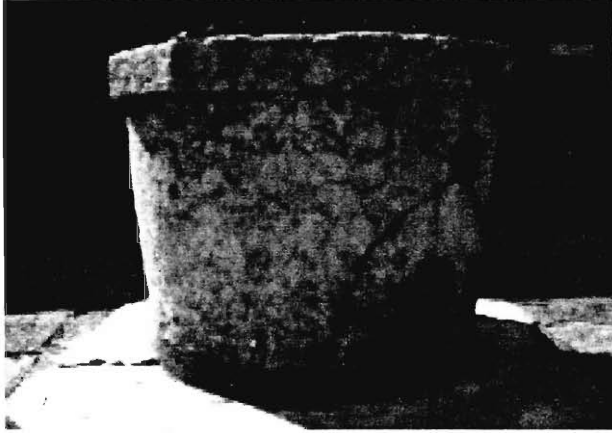
**Figure 38:** Wellhead on San Nicolò

Additionally, he provided a detailed description of the restoration process for each individual piece. The most immediate concern involves the wellhead located on the island, seen in **Figure 38**. It is in poor condition, and since the roads are presently

obtained for each piece of art; this packet can be viewed in **Appendix J**. The architect we have been working with, Emanuele Armani, met us on the island, and he developed time and cost estimates for each restoration.

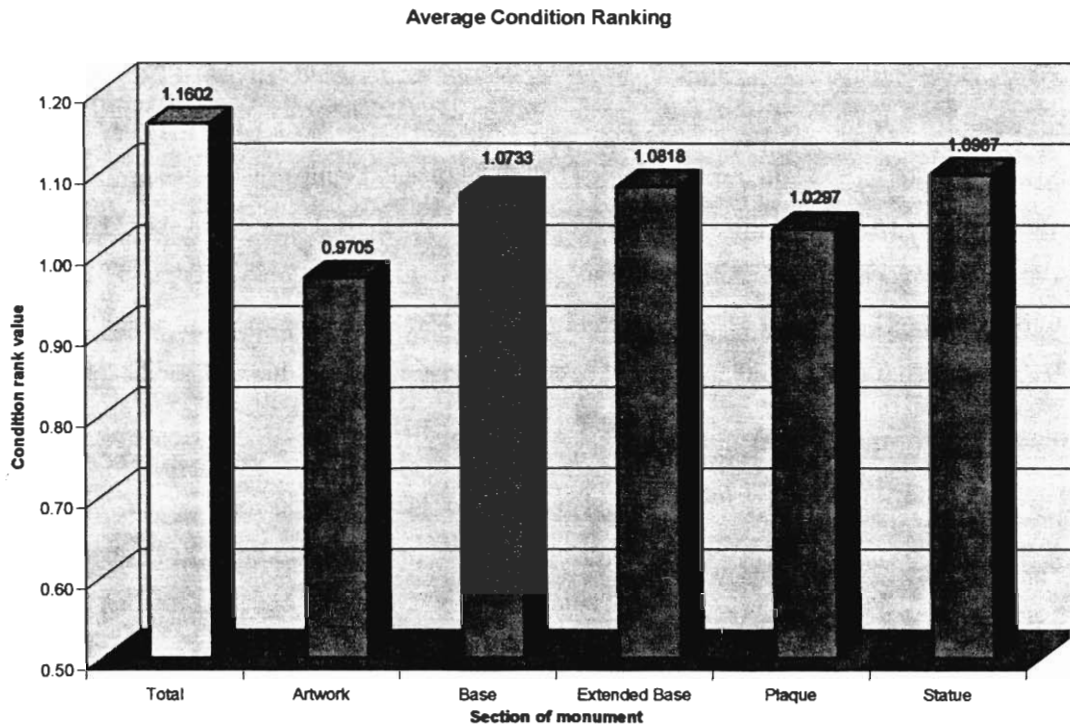
**Figure 39:** Average condition rankings for monuments

The condition ranking was calculated for each individual section of every monument. Following this calculation, each monument was prioritized based upon the results of the condition ranking. This prioritization was done by taking the condition rank for all sections and calculating the mean of these values. For example, if a monument had two bases, an extended base, a statue, and two plaques, the condition rankings for these six sections would be averaged for the entire monument's condition ranking.

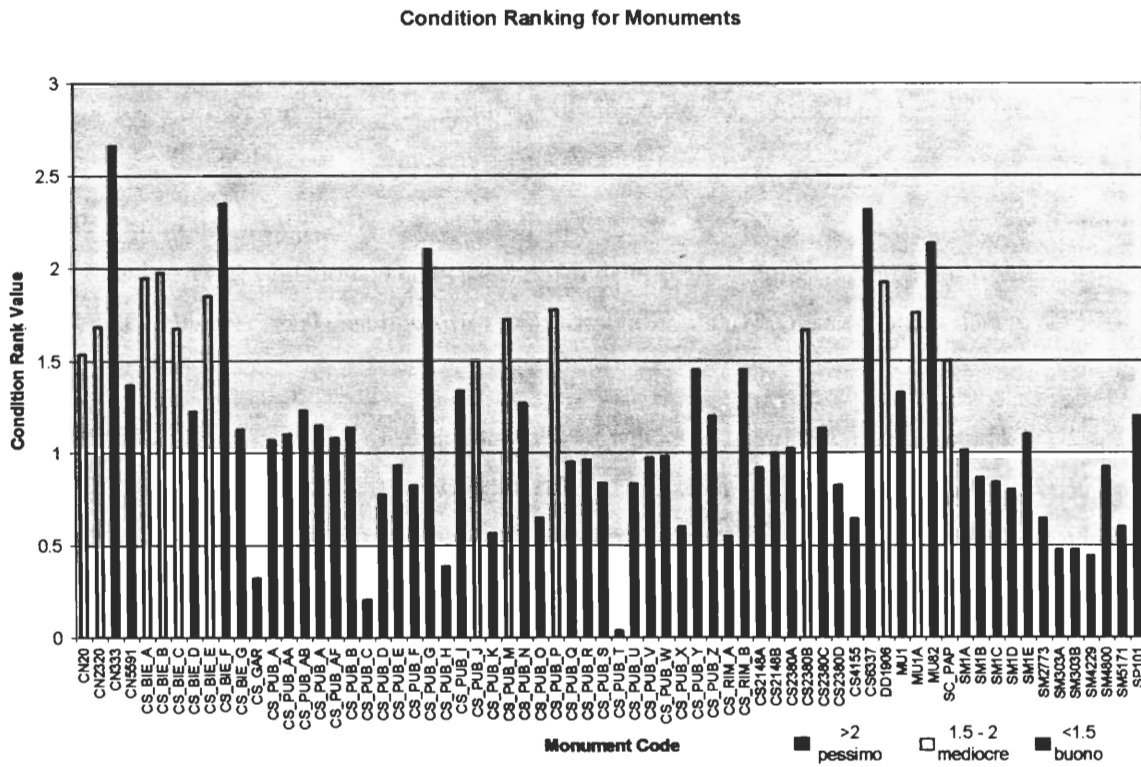
**Figure 40: Monument condition rankings**

good, or *buono*, condition had a condition ranking below 1.5. In **Figure 40** below, the conditions are indicated in red, yellow, and blue, respectively. The map, illustrated in **Figure 41**, shows the distribution of the conditions of the monuments in the historical center of Venice.

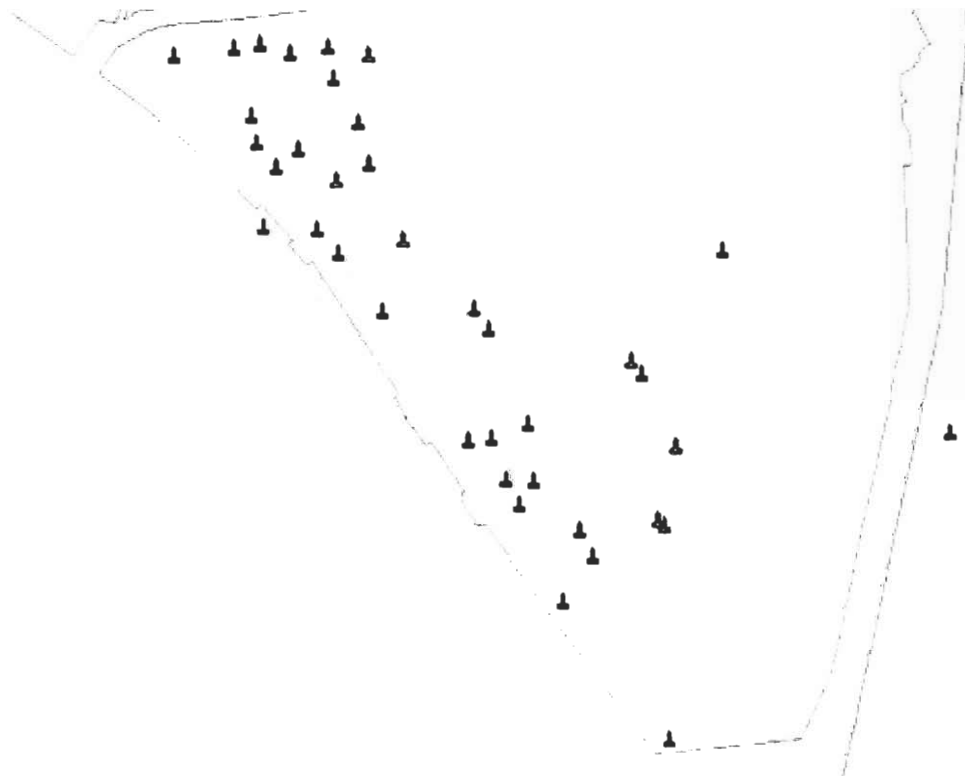
**Figure 42:** *Giardini Pubblici* and *Giardini Biennale* monument conditions

The majority of the monuments in the *Giardini Pubblici* and *Giardini Biennale* are constructed of the same type of stone, *tenera*. This type of stone, as documented in the condition assessments, develops few cracks. While not all monuments made of this stone had little or no cracking, the

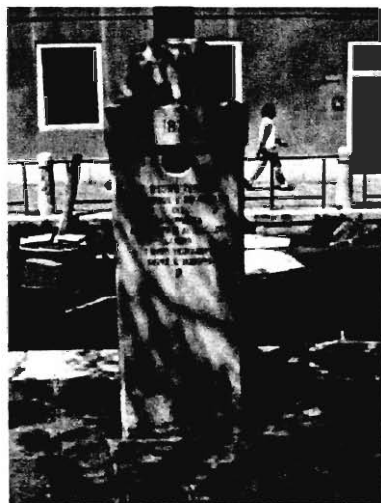
**Figure 45:** Flagstaff on *San Nicolò dei Mendicoli*

The flagstaff, **Figure 45**, requires cleaning and some consolidation along with a coat of surface protection that is projected to last for five years. Also, the city seal is missing from the flagstaff; a similar one will need to be located and used as a replacement.

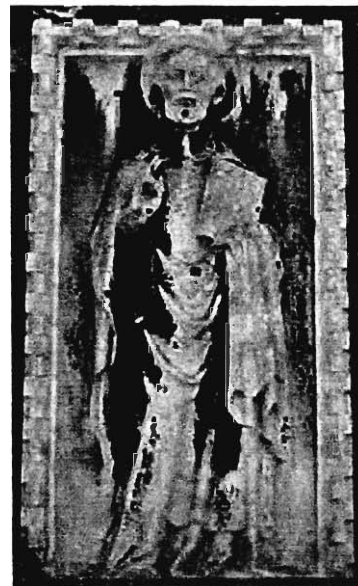
**Figure 46:** Relief of *San Nicolò*

This relief of San Nicolò, **Figure 46**, *Arte Pubblica* number DD193, was crafted in the 1300s and is thought to still hold some of its original paint. For this reason, aggressive cleansing is not recommended. Instead, only water and a sponge will
