Evaluation of the Erosion Control Methods Implemented by the Panama Canal Expansion Program

Major Qualifying Project

Autoridad del Canal de Panamá

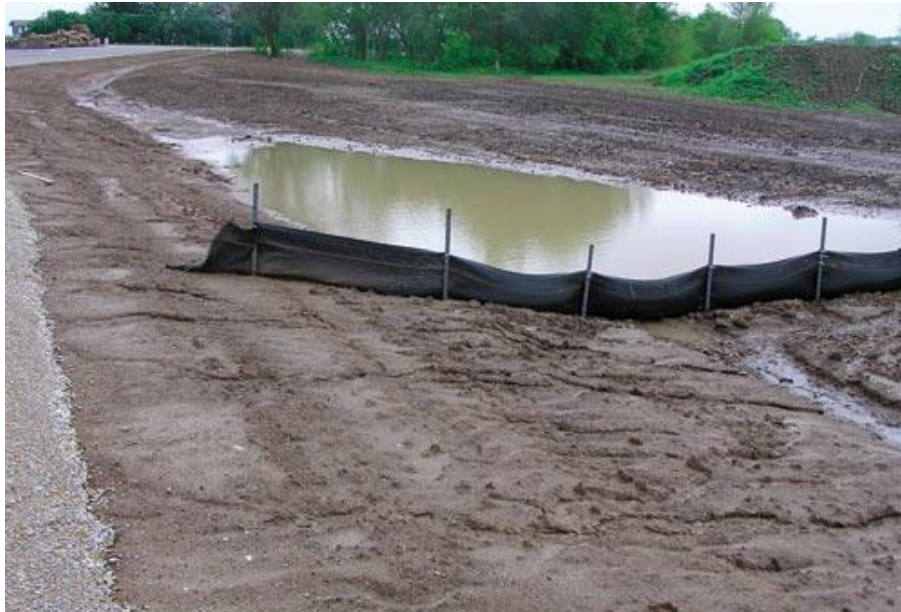
Figure 6 - A properly installed silt fence retaining run-off for sedimentation and filtration to occur (Carpenter, 2006)

which results in ponding of the water, as illustrated in Figure 6. As the water percolates through the silt fence fabric, much of the suspended sediment is filtered out. Silt fences and sediment traps are most effective when combined with other erosion controls, but they are suitable for applications at the bottom of exposed and erodible slopes, above hydroseeding, along stream and channel banks, around temporary spoil areas and stockpiles, and in ditches. They may be made of many different materials, of which straw bales and filter fabric are most common. The filter fabric is usually entrenched, attached to supporting poles and backed by a plastic or wire mesh for support (California Stormwater Quality Association, 2003; Novotny, 2003).

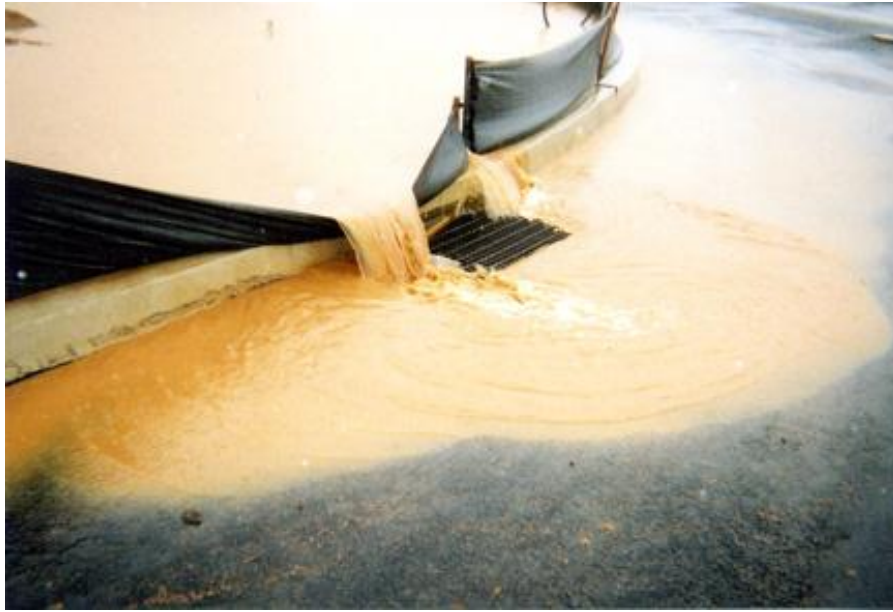
Figure 7 - Overlapping and collapse of a silt fence due to flooding when installed at a concentrated flow (Carpenter, 2006)

Temporary erosion control measures have limitations. First, the BMPs are not effective in streams, channels, drain inlets or anywhere flow is concentrated, because ponding of the water before filtration may lead to flooding on the upstream side of the fence. Flooding may cause undercutting, overlapping or collapsing of the fence. Figure 7 shows the overlapping and collapsing of a silt fence due to flooding that occurs when installed along a concentrated flow. In order to prevent flooding, installation of silt fences needs to follow standards that include trenching (excavation of a ditch to make sure silt fence is below the surface of the soil) and keying (bottom of silt fence should be a minimum of 150 mm (12 inches) into the ground). Also, their use is restricted to slopes of no greater than 4:1 (base:height). Lastly, the water depth must not exceed 1.5 ft at any point during ponding. For these reasons, silt fences are not a permanent solution but rather a temporary practice used for controlling erosion (California Stormwater Quality Association, 2003).

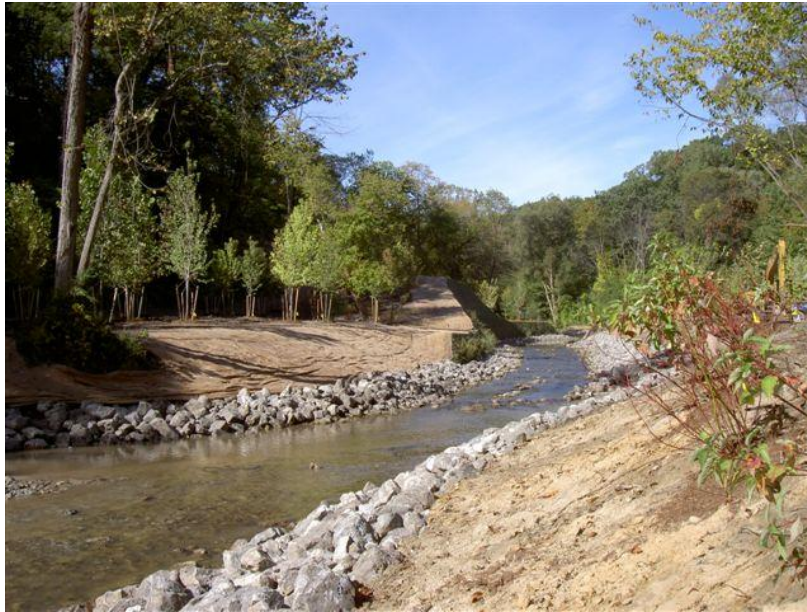
Figure 8 - Stream bank showing the use of riprap for erosion control (Michigan Department of Water Resources, 2011)

erosion. Riprap is used in areas of concentrated flow, turbulence or wave energy as shown in Figure 8. The effectiveness of the riprap depends on the mass and size of the materials that are used. The gaps between the rocks trap and slow the flow of water, reducing its ability cause erosion. A well-graded mixture of rocks is recommended, with predominantly larger stones and sufficient smaller sizes to fill the voids. Channel riprap applies where design flow velocity exceeds 1.21 m/sec (4 ft/sec) and conditions are unsuitable for grass-lined channels (Metropolitan Council/Barr Engineering Co., 2001).

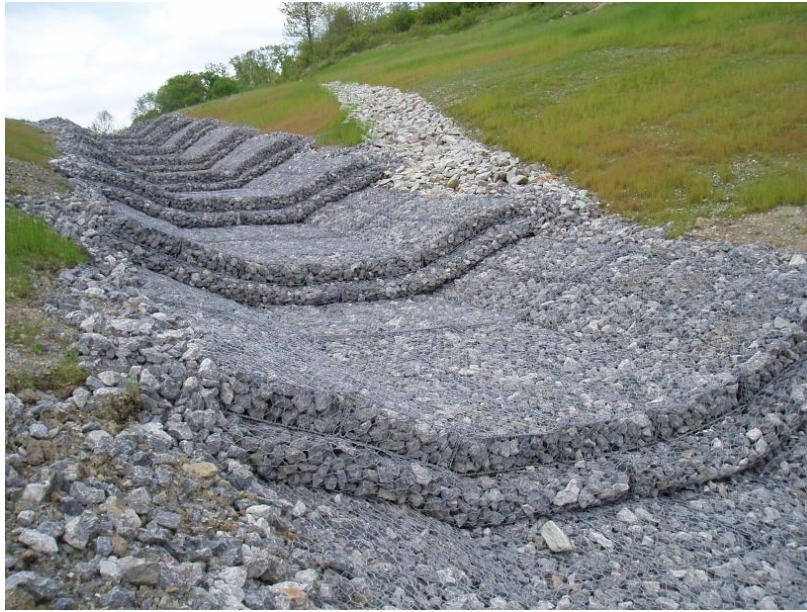
Figure 9 - Stabilization of slope area using gabions (South Fayette Conservation Group, 2008)

Gabions are used to slow the velocity of concentrated runoff or to stabilize slopes with seepage problems and/or non-cohesive soils. They can be used at soil-water interfaces, where the soil conditions, water turbulence, water velocity, and expected vegetative cover are such that the soil may erode under the design flow conditions. Gabions can be used on steeper slopes than riprap and are sometimes the only feasible option for stabilizing an area where there is not enough room to accommodate a vegetated solution (Franklin, Hampden, Hampshire Conservation Districts, 2003).

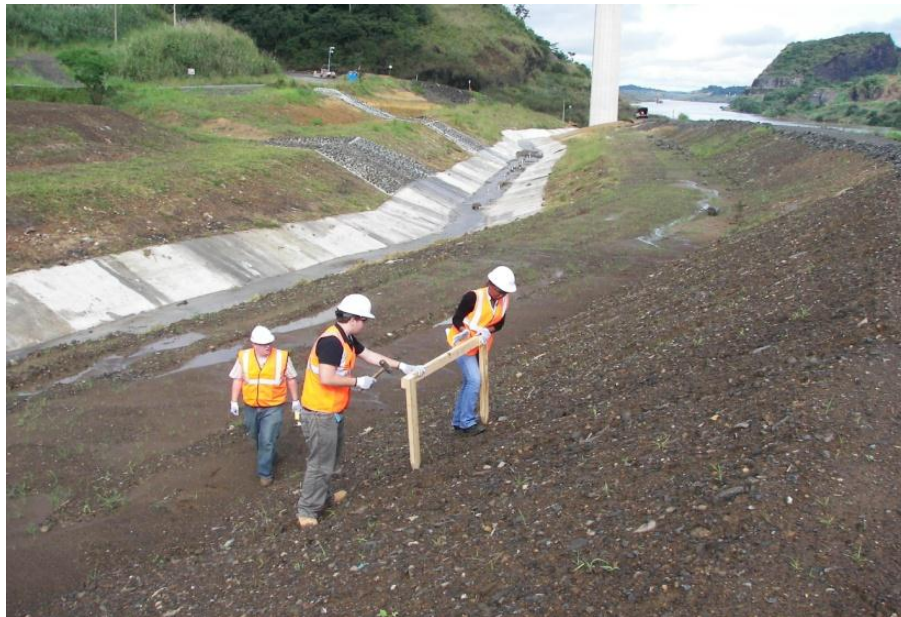
**Figure 15 - Site 1 with steep slope and no BMP at the time of erosion bridge installation
(Photo Credit: Tomás Antonio Edghill, 2011)**

The first site that was evaluated was in the northern area of PAC 4 near the Centennial Bridge in Corozal parallel to Borinquen Road. This site was originally chosen as our control due to its lack of erosion control and steep slope, shown in Figure 15. However, after installation of the soil erosion bridge, the contractor responsible for the site installed silt fences upon the second day of measurement and further planned to implement hydroseeding within the following fifteen days. The hydroseeding of the area did not occur during our project. We were informed during our interview with a member of the environmental management department of Grupos Unidos por el Canal that the installation of silt fences is the first reaction to erosion. Figure 16 shows the site on our second visit to collect data after the silt fences had been installed. This provided us with a unique opportunity to measure erosion control methods before and after implementation, albeit for a short time period. The calculated slope for Site 1 was 56.6% or 29.5 degrees (calculations shown in Appendix D), which was steeper than any of the other site slopes. The soil cores obtained from the ACP showed that the soil in this area was a mix of clay, silt, sand, pebbles and boulders and is associated with the Cucaracha formation discussed in section 2.2.2 of the background chapter.

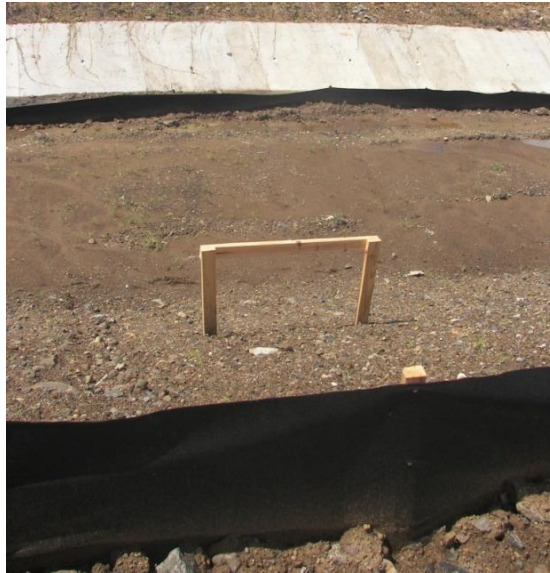
Figure 16 - Site 1 showing silt fences installed after soil erosion bridge (Photo Credit: Bryan Lee, 2011)

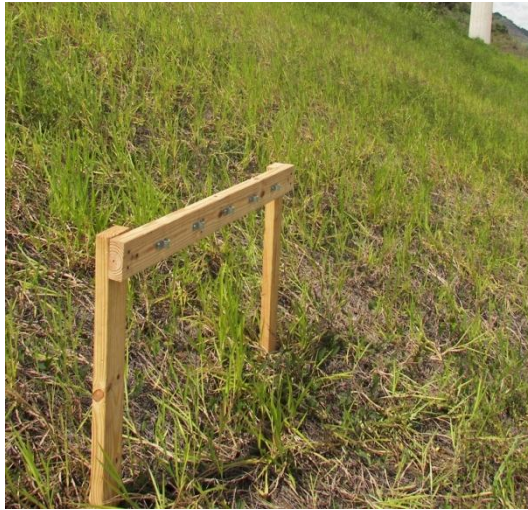
Figure 17 - Soil erosion bridge installed at site 2 which features hydroseeding (Photo Credit: Bryan Lee, 2011)

The second site was located near the first site, on the other side of the hill overlooking the canal channel. This area is used by the ACP surveying department to take measurements of the channel. The erosion control method implemented at this site was hydroseeding, which was implemented in October of 2009. The slope at this site was calculated to be 30.8% or 17.1 degrees (see Appendix D), and there is a construction roadway located at the bottom of the slope. Although the hydroseeding provides vegetation cover that reduces erosion rates due to the root systems holding the soil in place, there were noticeable rill formations. ACP core samples of this site showed a soil structure of the Pedro Miguel formation (section 2.2.2), where pebbles, cobbles and rocks (up to 90 mm in diameter) are mixed with clay, silt and sand. The underlying layer is the Cucaracha formation (section 2.2.2). Figure 17 shows the installed soil erosion bridge at site 2.

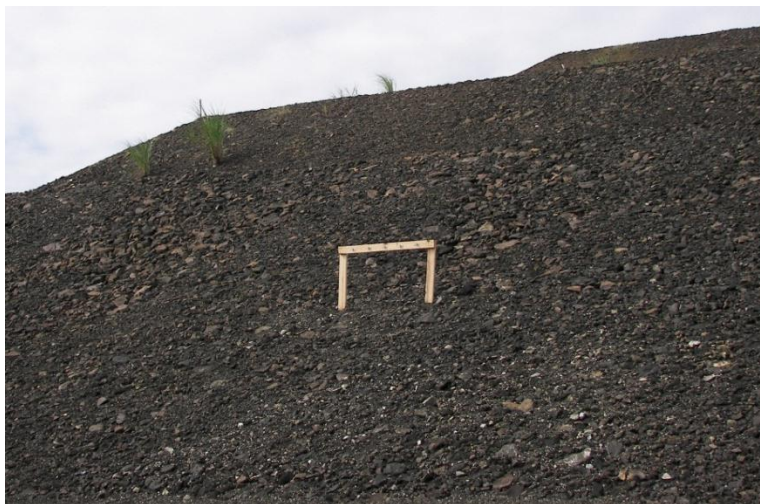
Figure 18 - Soil erosion bridge installed at site 3, with basalt rocks and scattered plant growth (Photo Credit: Bryan Lee, 2011)

Site 3 was located approximately 1.2 km south of the first two sites near a contractor's workshop. During this project, site 3 was used as a deposit area for basalt. Basalt rocks from the Pacific side are used to make cement for canal construction. Terracing at this site was used to mitigate erosion. The large size and density of the basalt rocks promotes high infiltration rates and low runoff potential, which helps reduce soil loss from the area. The slope at this site was calculated to be 43.4% or 23.5 degrees (see Appendix D). No further BMPs were installed at this site as it was deemed unnecessary due to the temporary use of the area. Although this rocky soil does not foster a healthy environment for plant growth, there were some plants found in the area called Saccharin spontaneous (paja blanca) or white straw. Figure 18 shows the soil erosion bridge installed at Site 3, with evidence of scattered plant growth.

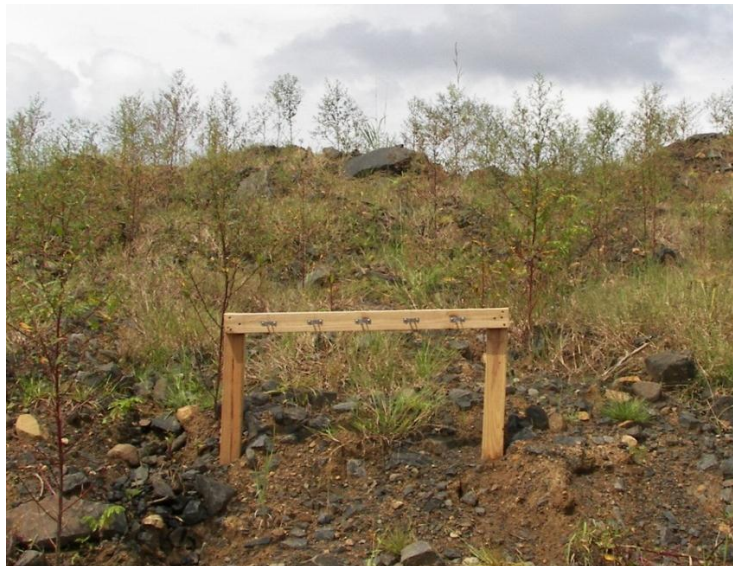
Figure 19 - Soil erosion bridge installed at site 4 with natural vegetation (Photo Credit: Bryan Lee, 2011)

This site was located in the southeastern area of PAC 4 and was also referred to as disposal site number twelve by the contractor from the fourth Pacific Access Channel (PAC 4) project. The material found at this site will not be further used in the locks project and the area is in need of landscaping to control erosion. Approximately 30% of the total area at this site was covered by natural vegetation. Deep rills and gullies were evident where vegetation cover was minimal. An ACP core sample of the soil in this area found the composition to be medium soft to medium hard clay, mixed with sand, basalt pebbles and boulders. The slope of this area was calculated to be 52.9% or 27.9 degrees (see Appendix D). Figure 19 shows the soil erosion bridge installed at site 4.

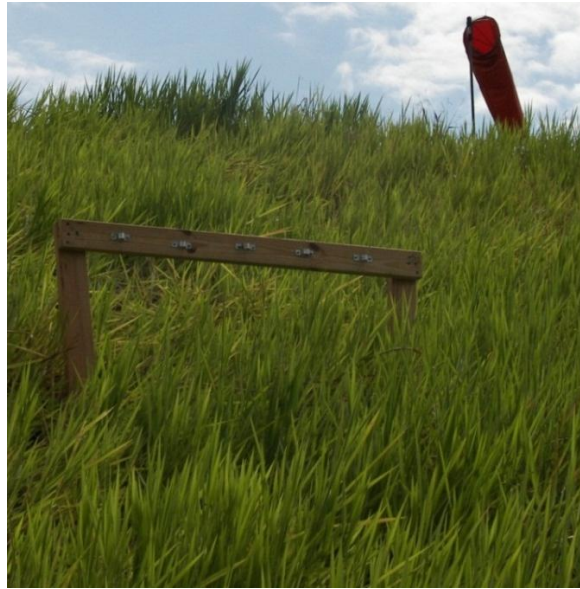
Figure 20 - Location of soil erosion bridge at site 5 showing hydroseeding (Photo Credit: Bryan Lee, 2011)

Site 5 was located in the eastern area of the expansion associated with PAC 4. Hydroseeding and silt fences were installed in August of 2011 by a previous contractor responsible for the area. The grass at this site had grown to a significant height, as shown in Figure 20. Although the grass was well established, there were signs of rill erosion in areas where ground cover was minimal. The slope was calculated to be 29.4% or 16.4 degrees (see Appendix D). The overburden at this site had clay soil and that was mixed with basalt pebbles (up to 3 inches in diameter), according to the ACP core sample.

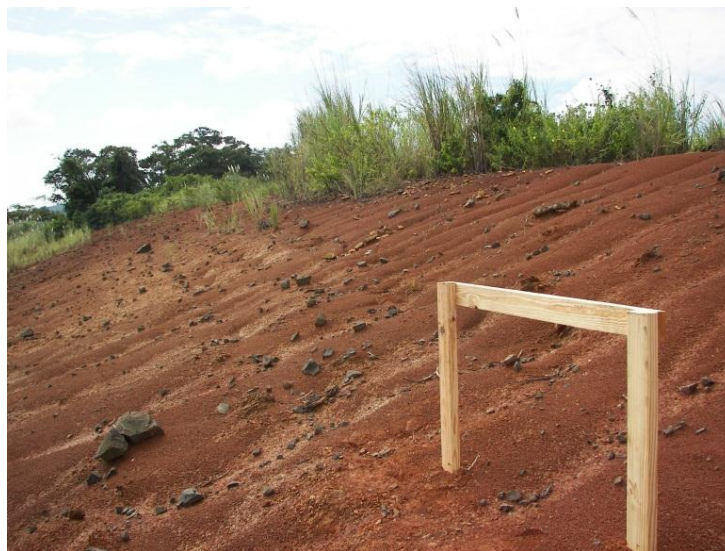
Figure 21 - Soil erosion bridge located at site 6 showing clay, basalt pebbles and rill erosion (Photo Credit: Bryan Lee, 2011)

Site 6 was on the opposite side of the hill from site 5. This area was chosen due to its soil type. As shown in Figure 21, the site had clay as well as basalt pebbles and rocks of up to 3 inches in diameter. Soil erosion was present as demonstrated by rill formations and the outline of the drainage pattern over the area. The slope in the area was calculated to be 28.1% or 15.7 degrees (see Appendix D).

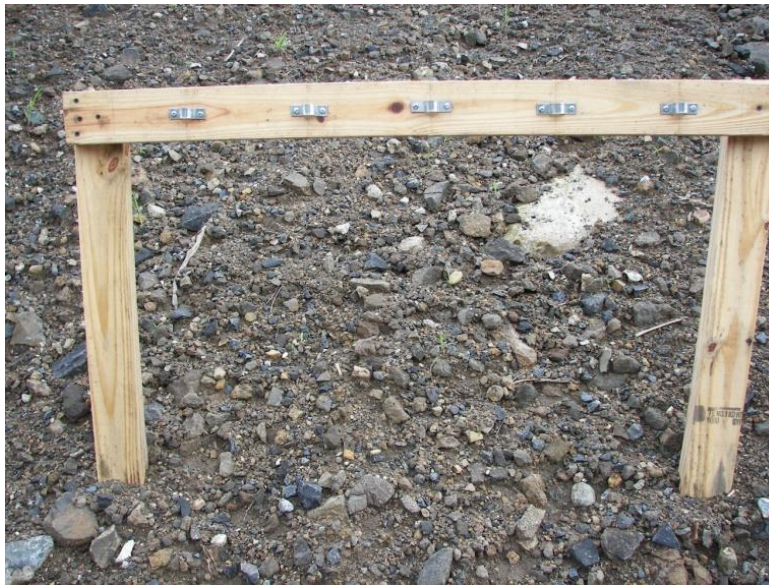
Figure B-2 Soil composition at site 1

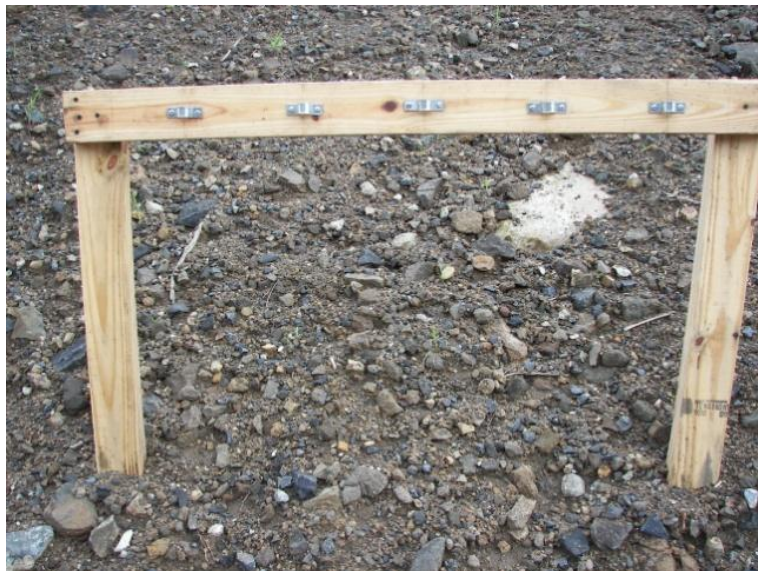
C Factor Sample Calculation for Site 1

By making observations from the image below we can see that there is no real ground cover in relation to vegetation however. About 20% of the ground is cover by rocks and other debris. From this data we can look at the table below and look at the mechanically prepared sites and then over to 20% and see that the C factor for this location is 0.44.

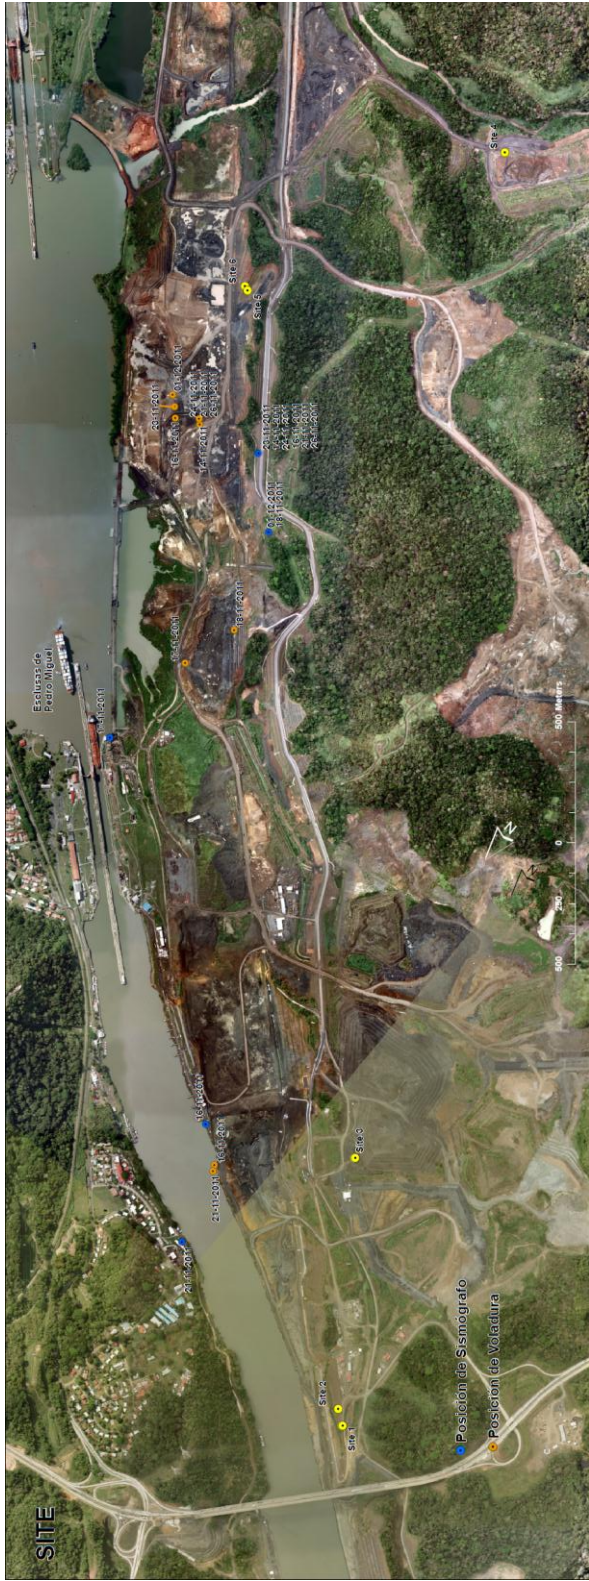
Figure H-1 - GIS map showing blasting locations (yellow dots) and monitoring stations (blue dots)
